# 2012 Savannah-Hilton Head International Airport Pavement Management Plan

# SAVANNAH-HILTON HEAD INTERNATIONAL AIRPORT

## PAVEMENT MANAGEMENT REPORT

**DECEMBER 2012**

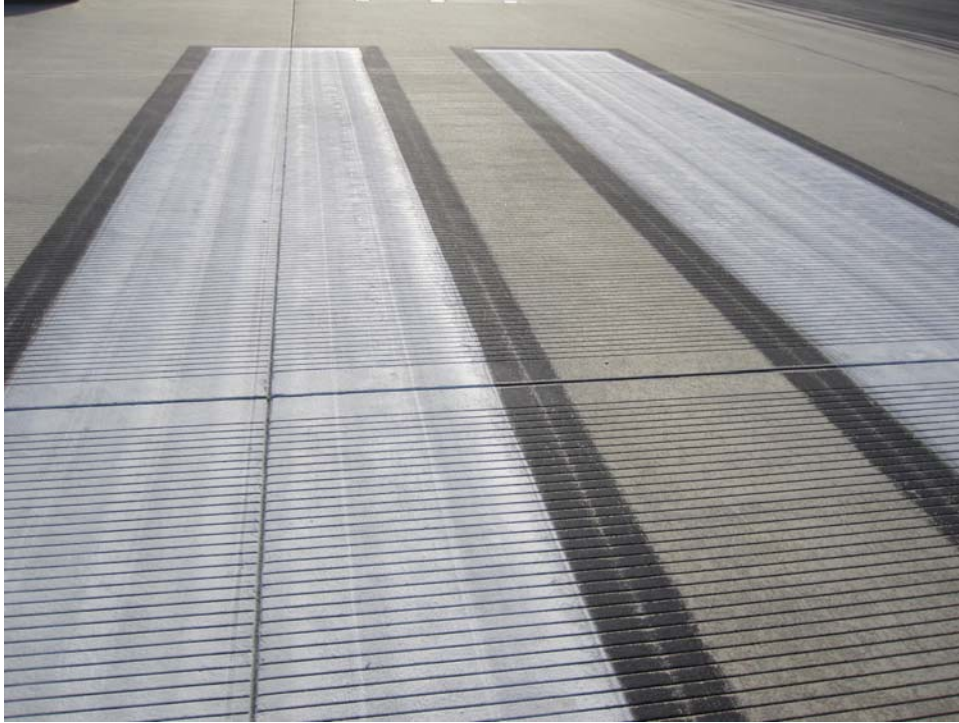
R1028SV-10C. Satisfactory Paint.

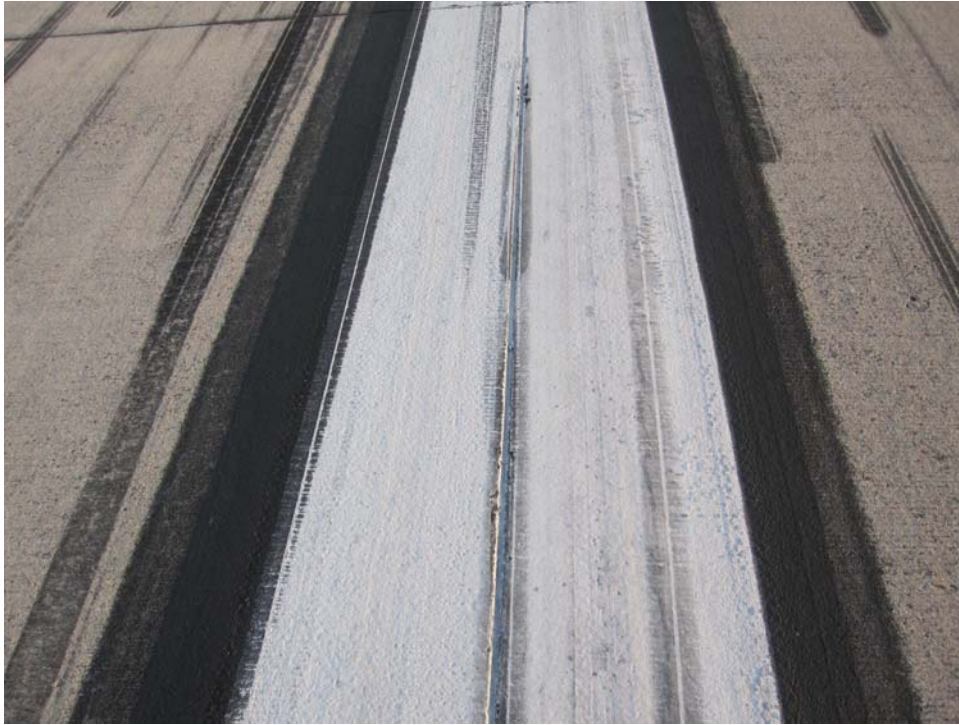
R119SV-10C. ASR (Sample Unit #100).

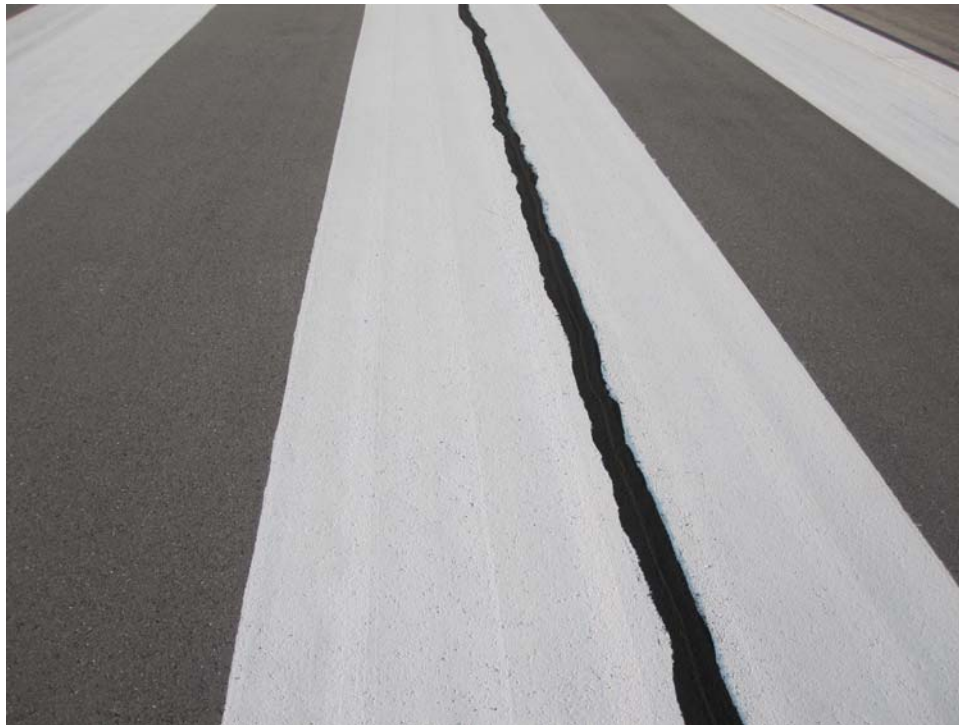
R119SV-10E. Longitudinal and Transverse Cracking (Sample Unit #24).

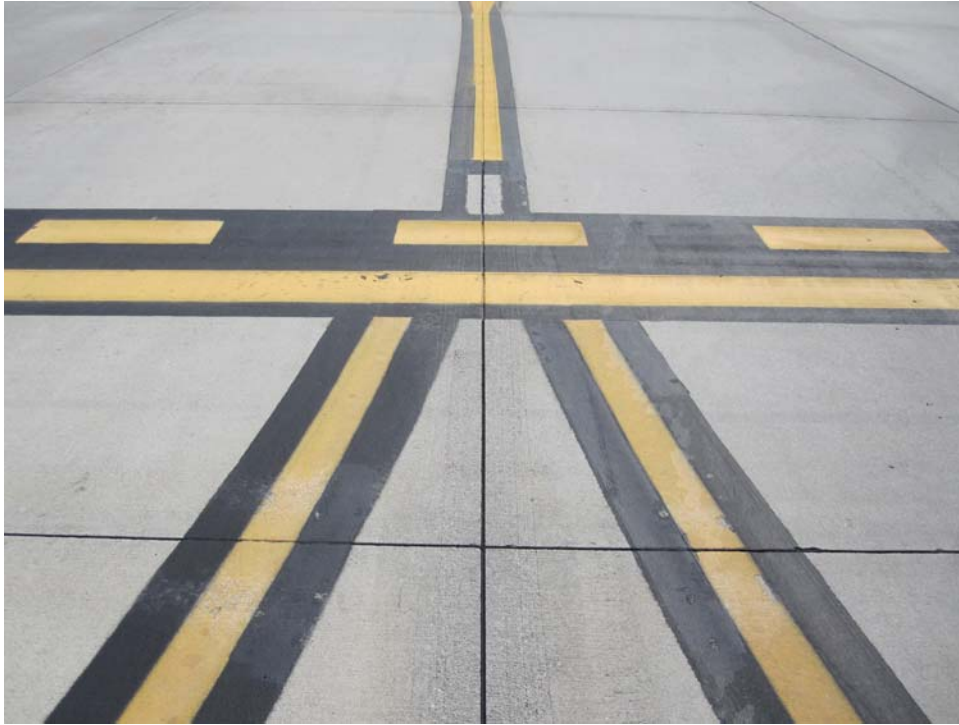
TA2SV-10. Pumping (Sample Unit #02).

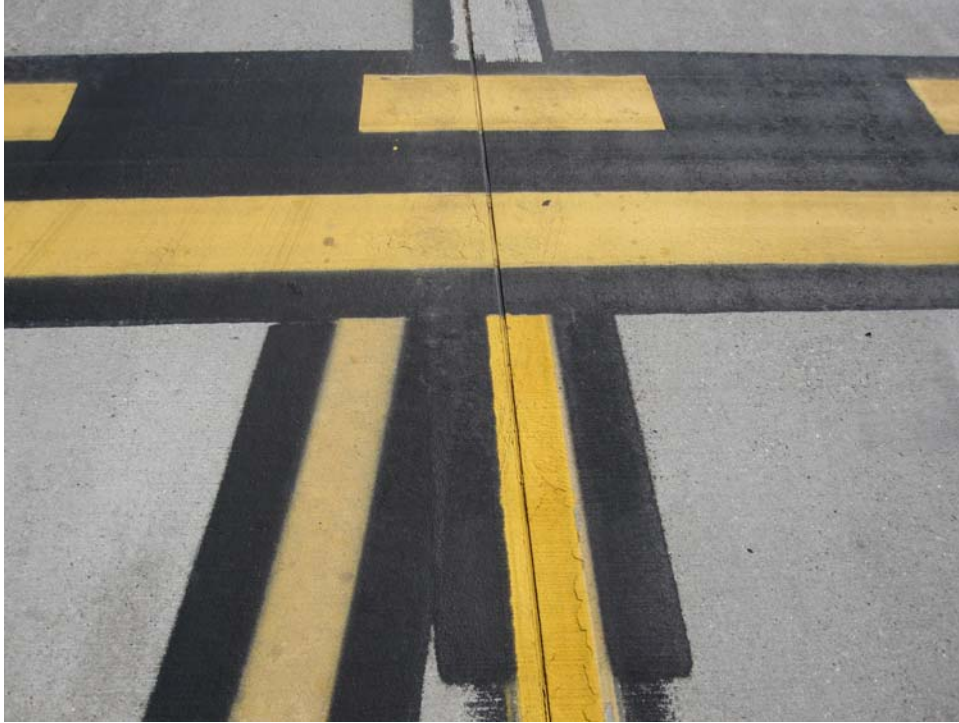
TA3SV-10. Pumping (Sample Unit #02).

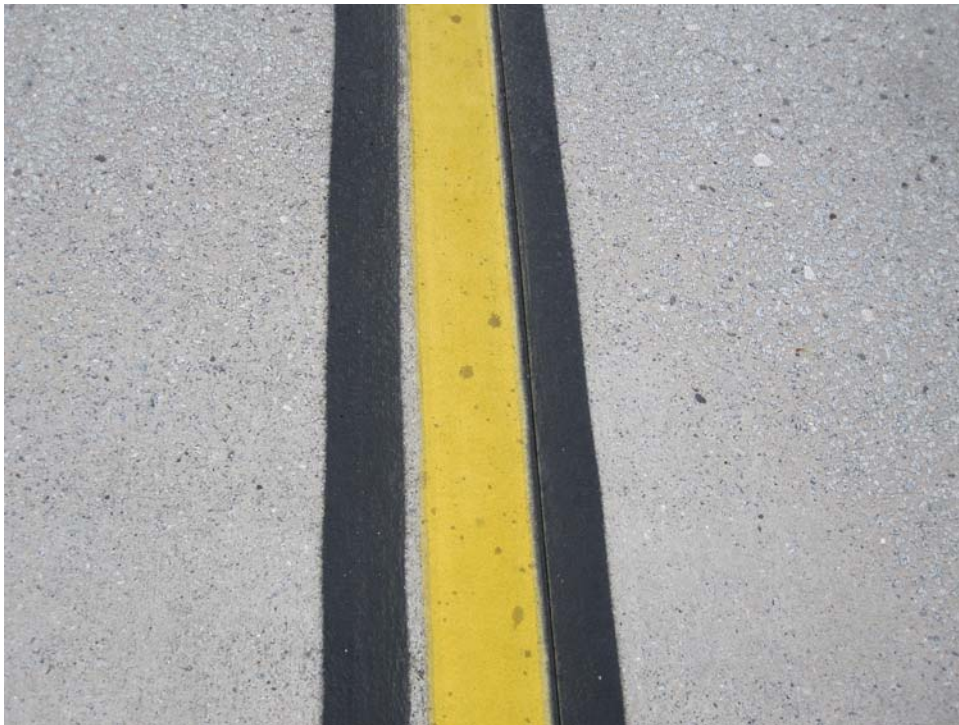
TASV-20. LTD Cracking (Sample Unit #26).

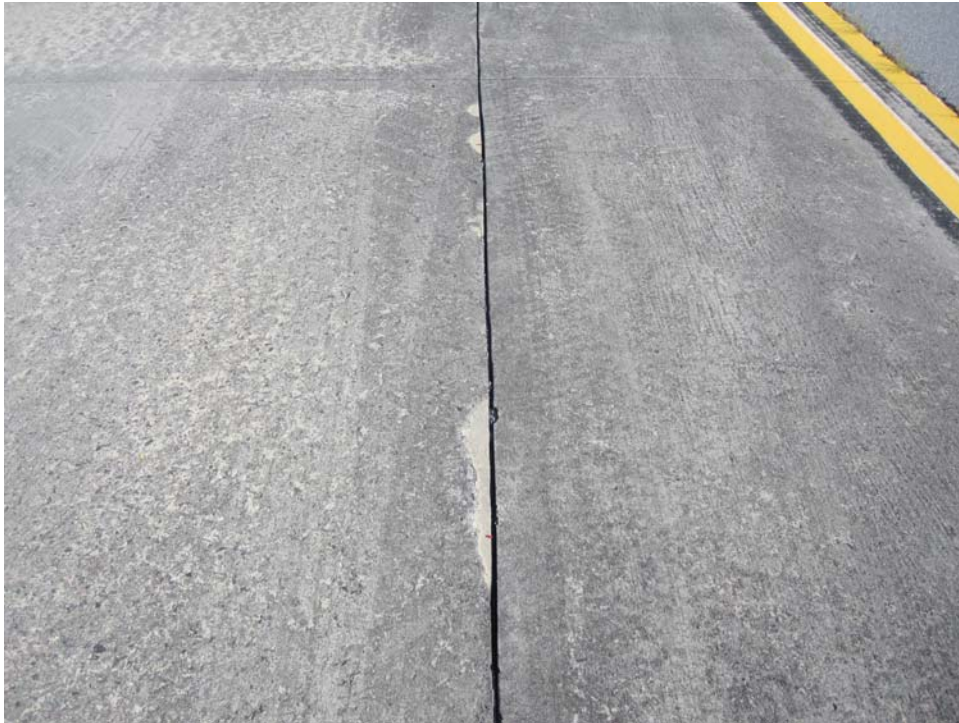
TASV-30. Pumping (Additional Sample Unit #01).

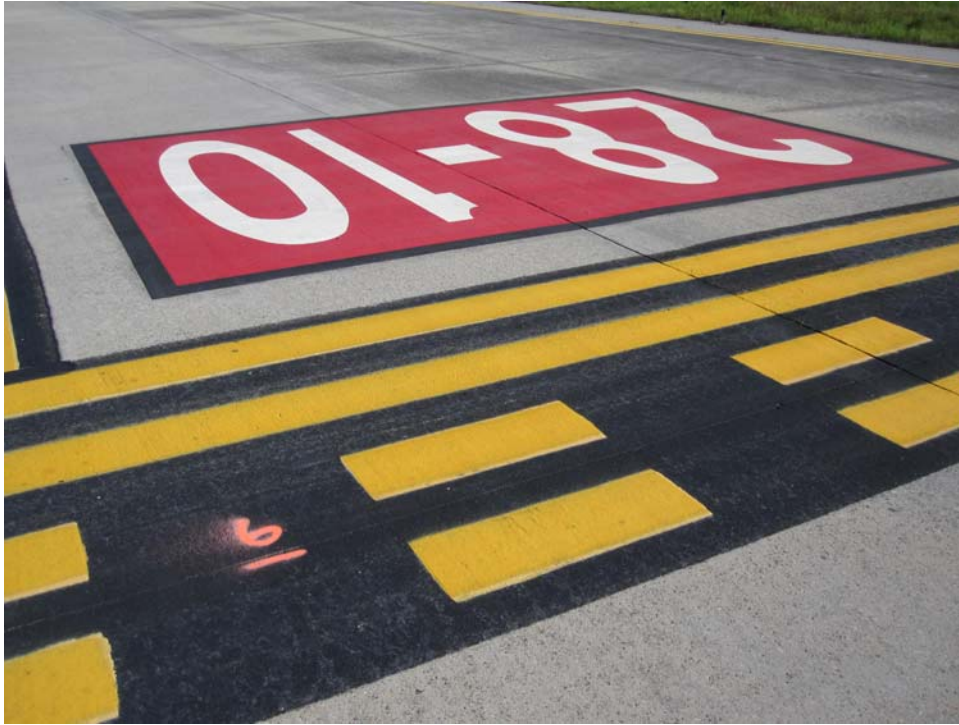
TASV-30. Small Patching (Sample Unit #08).

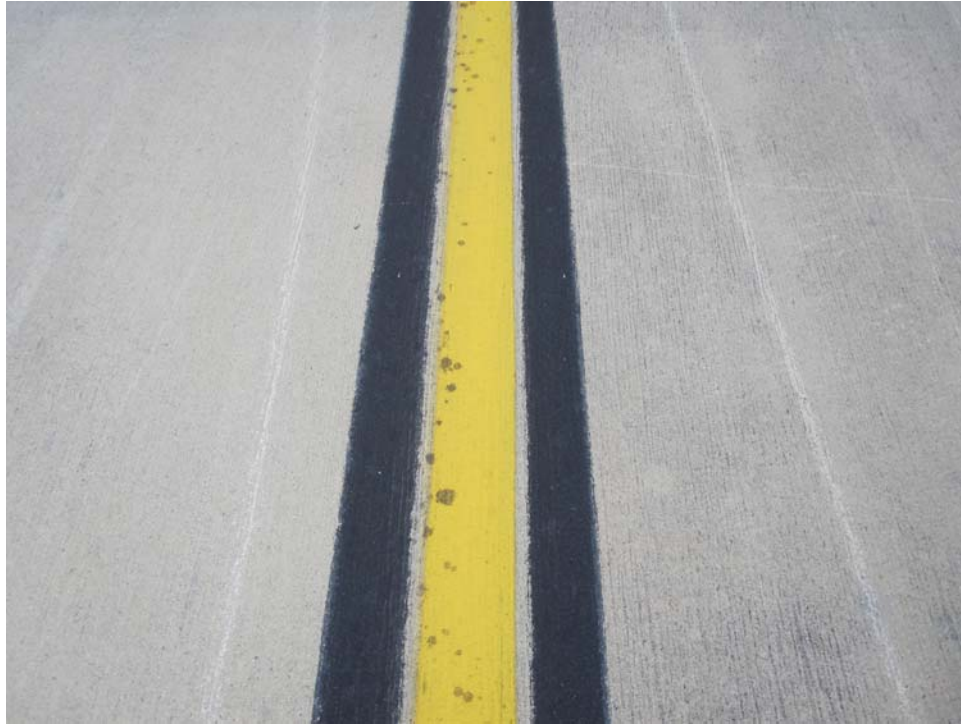
TASV-50. Corner Spalling (Sample Unit #29).

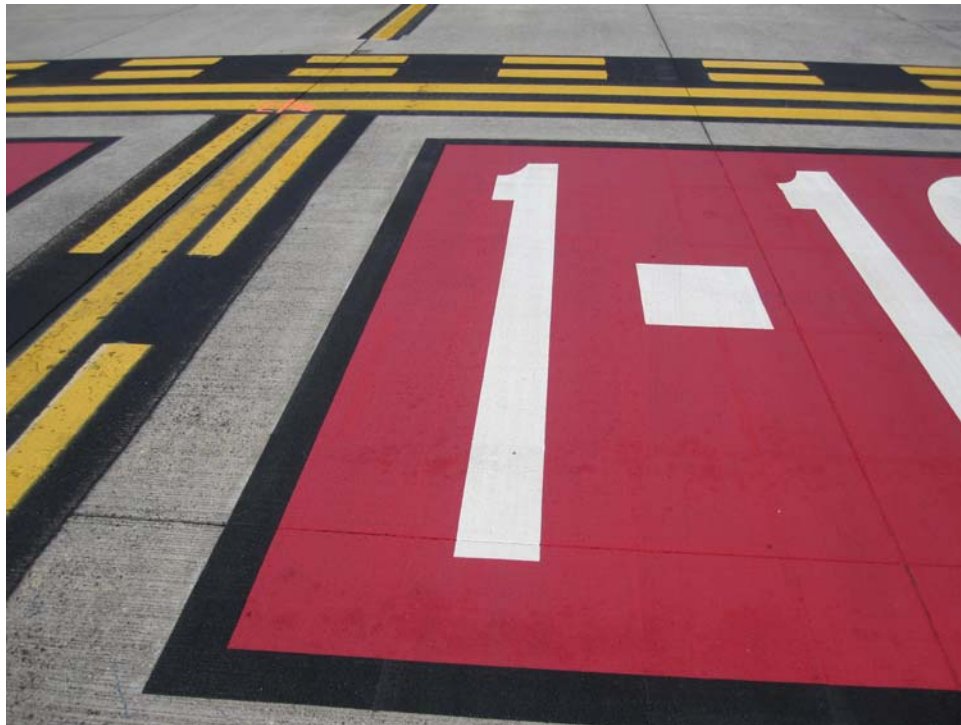
TB1SV-10. ASR (Sample Unit #08).

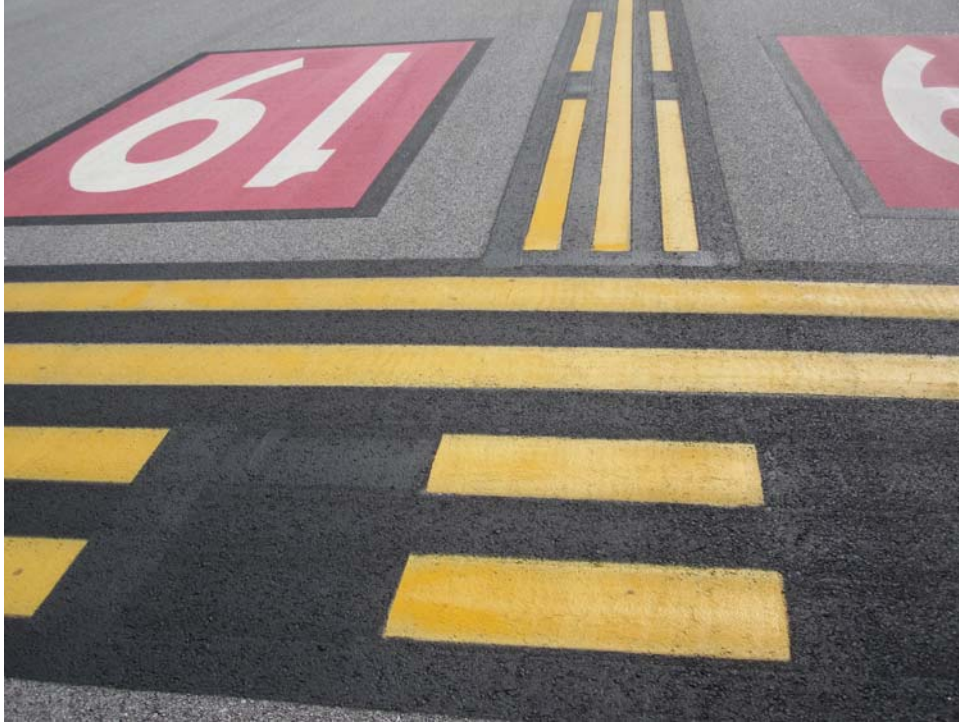
TBSV-10. Longitudinal and Transverse Cracking (Sample Unit #15).

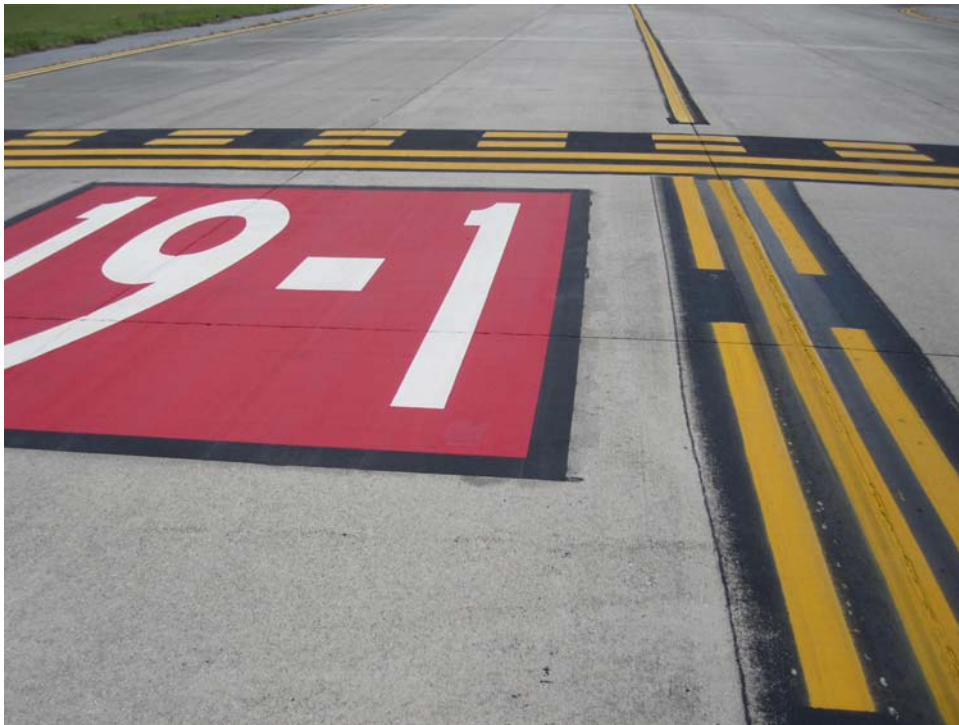
TCSV-20. Corner Spalling (Sample Unit #40).

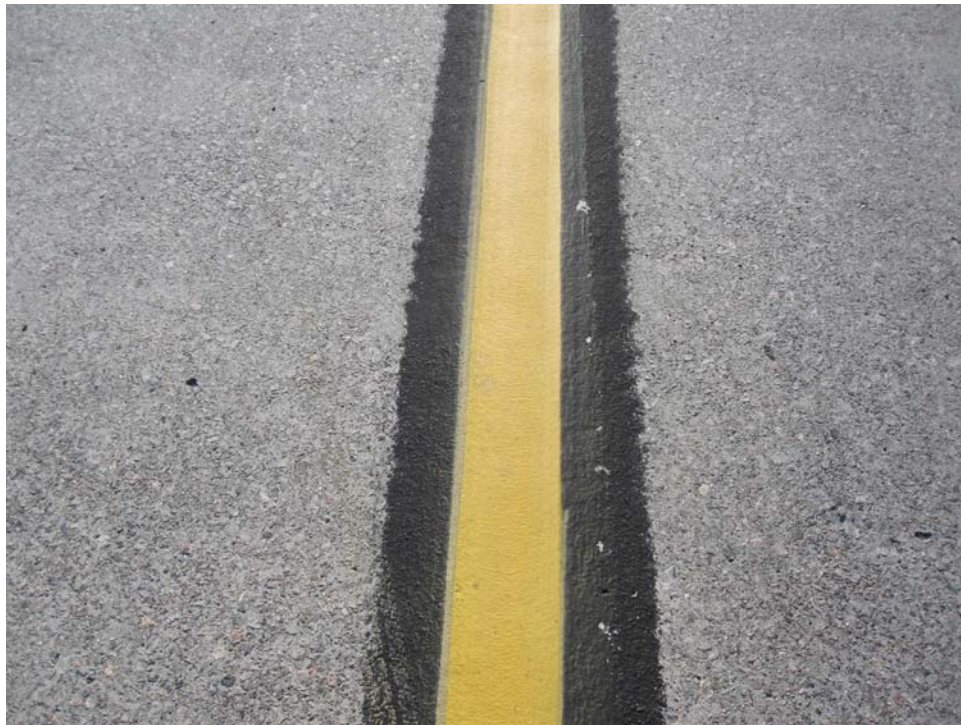
TCSV-30. Joint Spalling (Sample Unit #08).

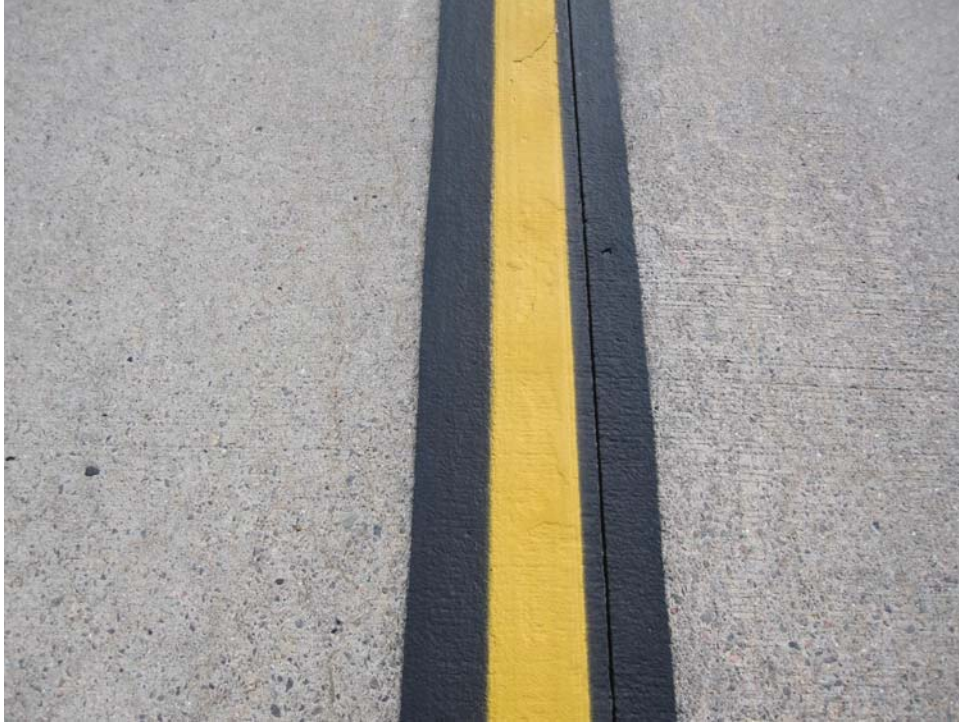
TCSV-40. ASR (Sample Unit #32).

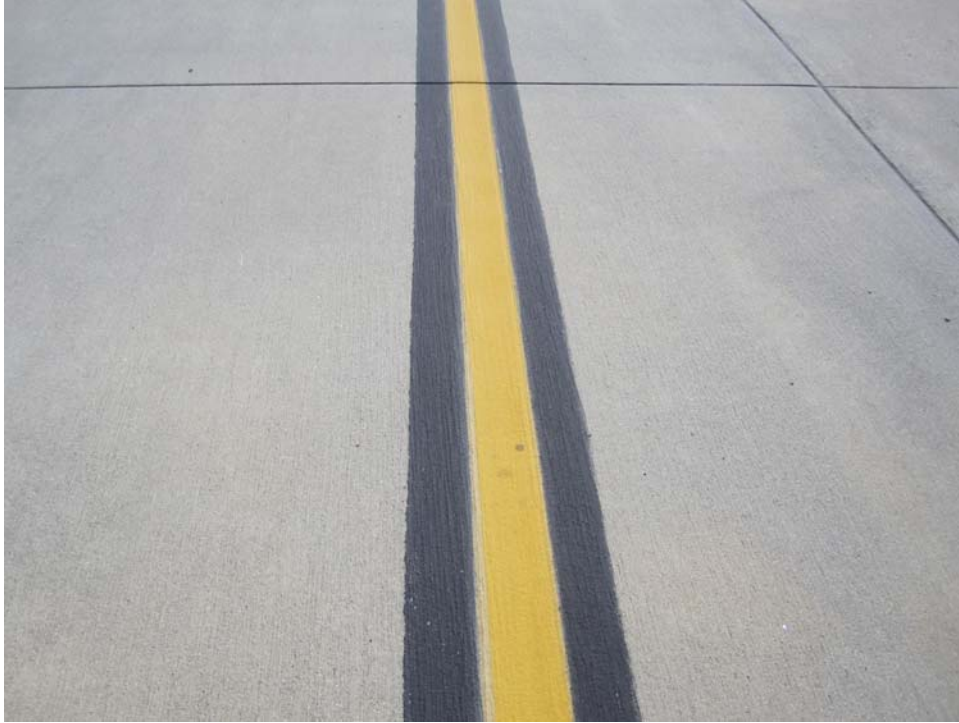
TCSV-50. Satisfactory Paint.

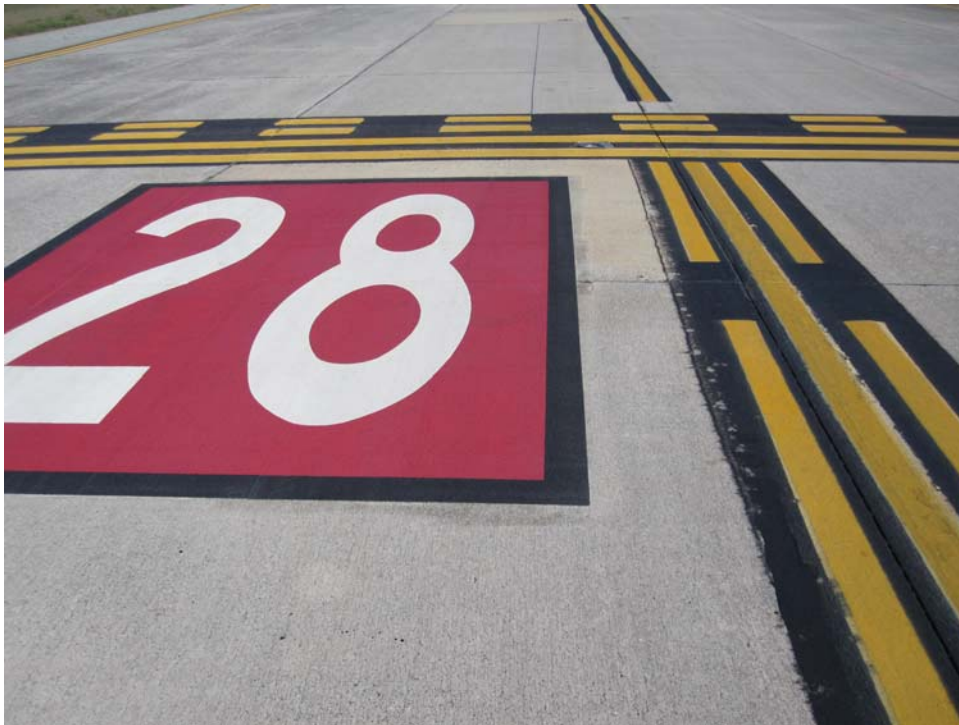
TCSV-60. Satisfactory Paint.

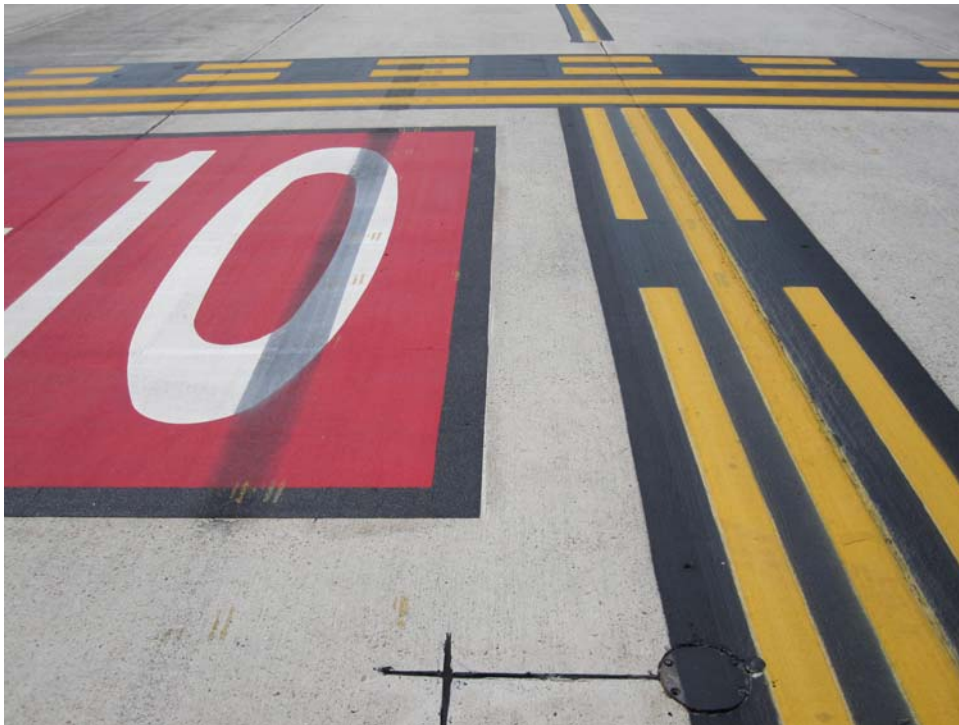
TE1SV-10. Satisfactory Paint (1).

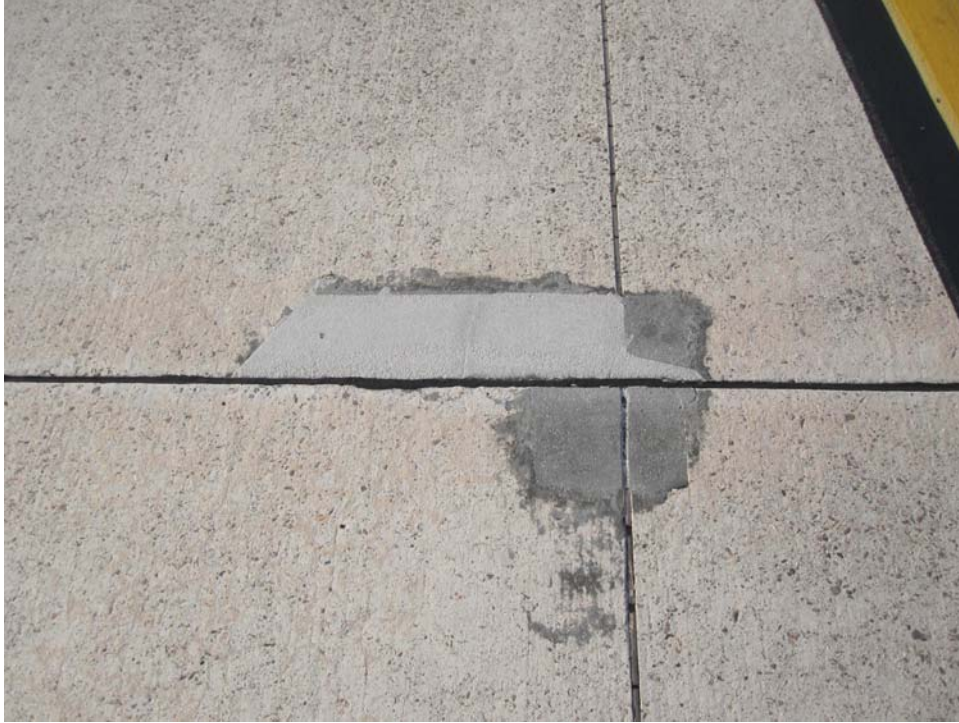
TE1SV-10. Small Patching (Sample Unit #09).

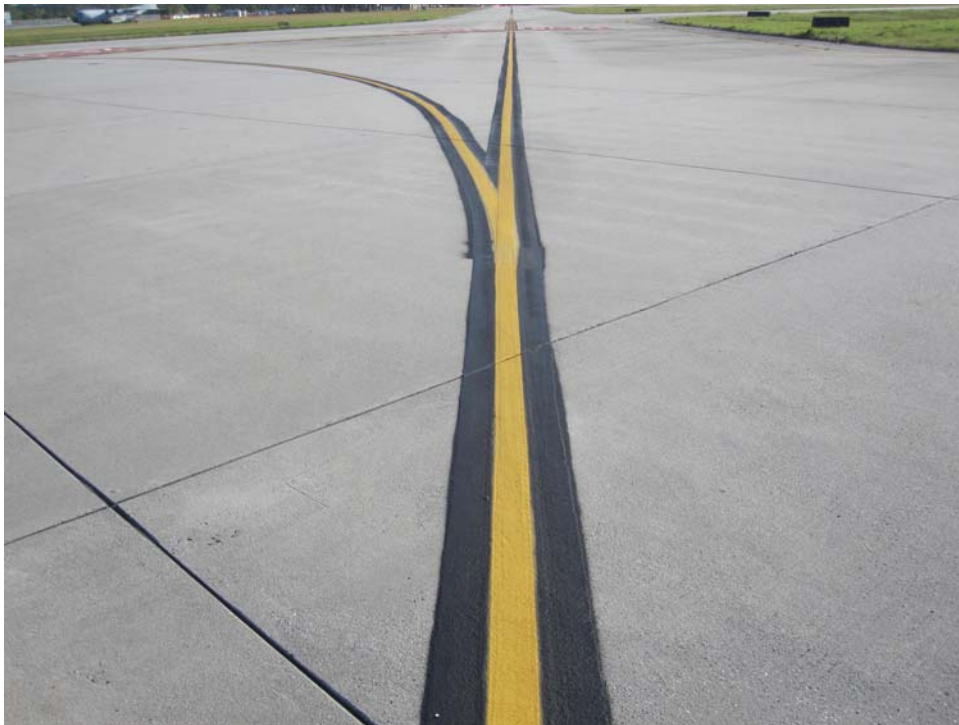
TE2SV-10. Satisfactory Paint.

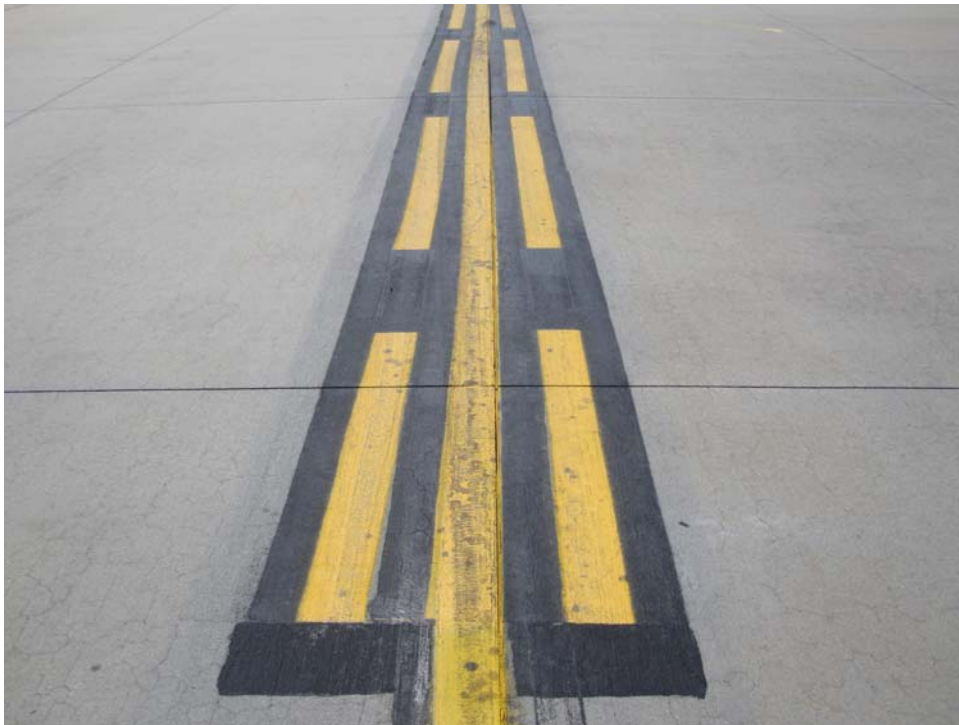
TESV-10. Satisfactory Paint (1).

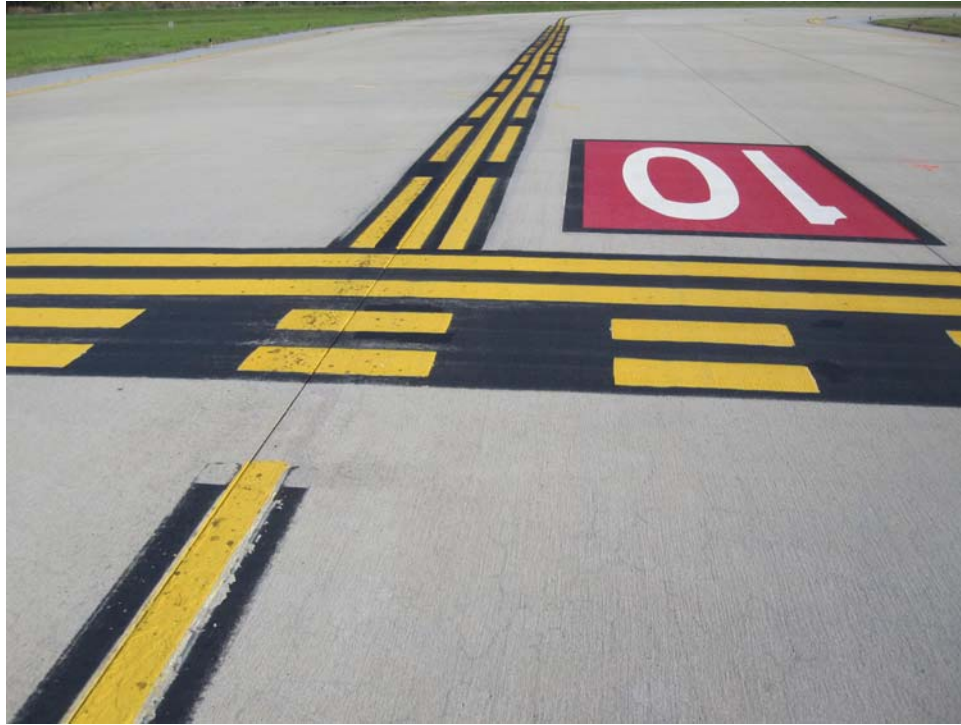
TESV-10. Satisfactory Paint (2).

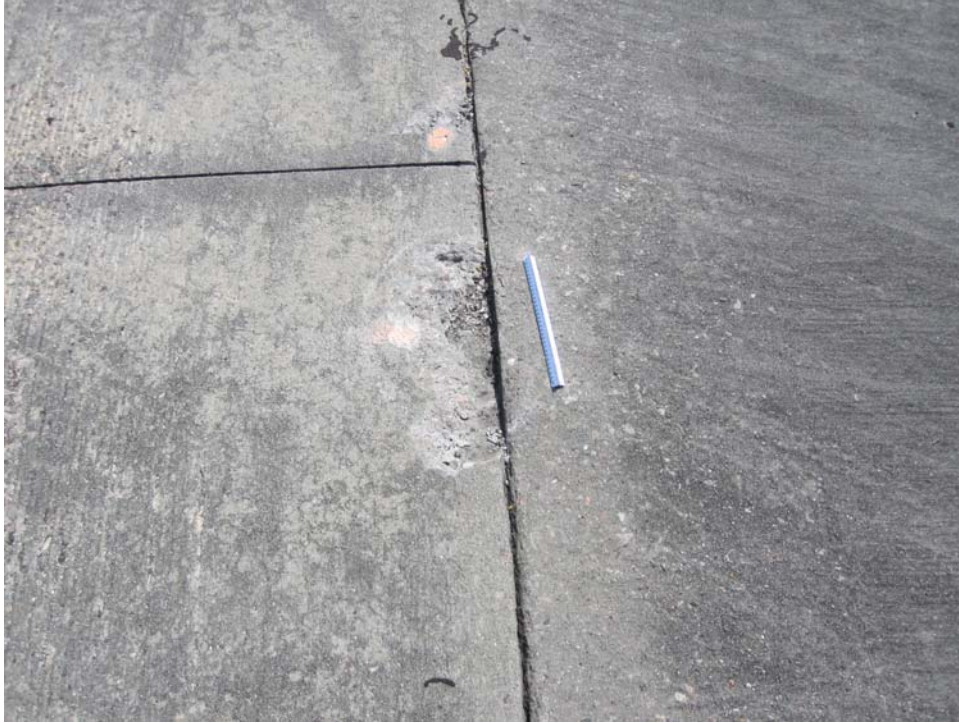
TESV-20. Joint Spalling (Sample Unit #38).

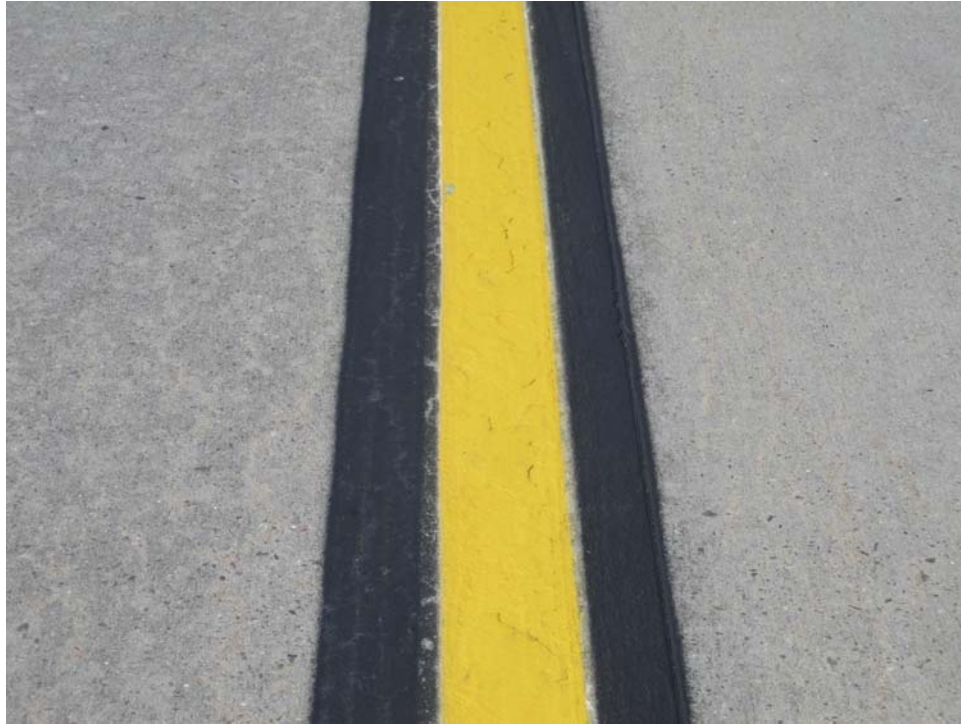
TESV-20. Satisfactory Paint.

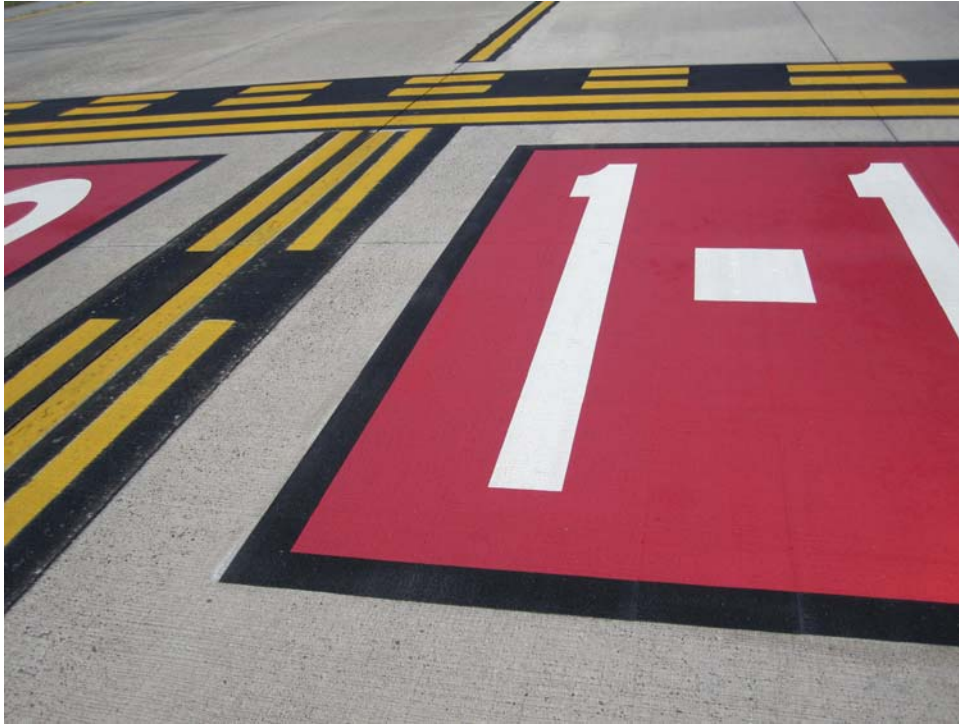
TESV-30. Satisfactory Paint.

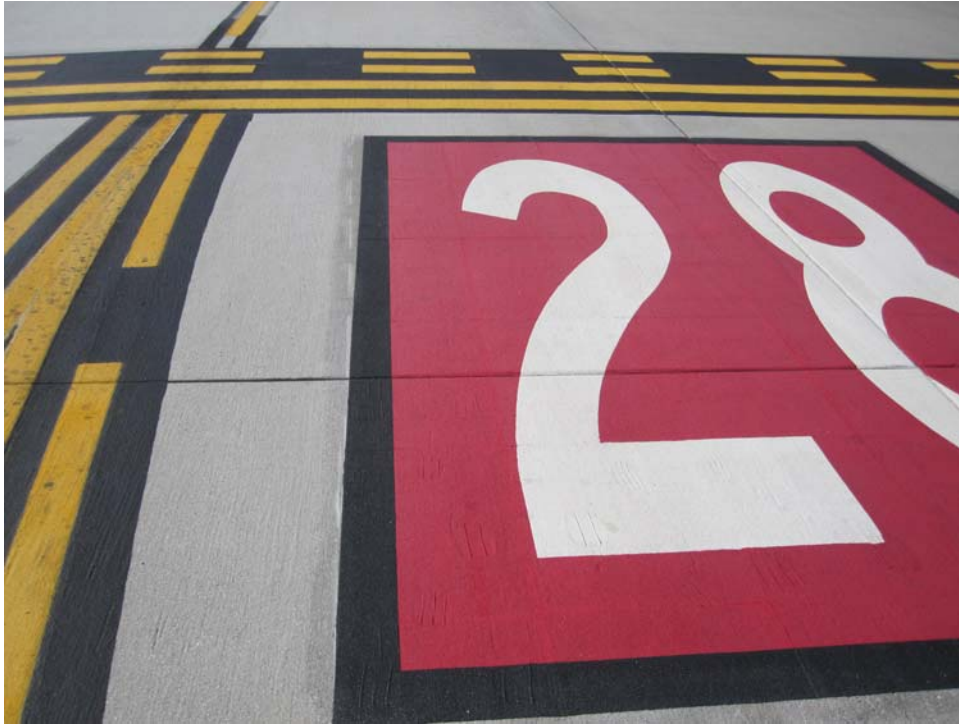
TESV-40. Satisfactory Paint.

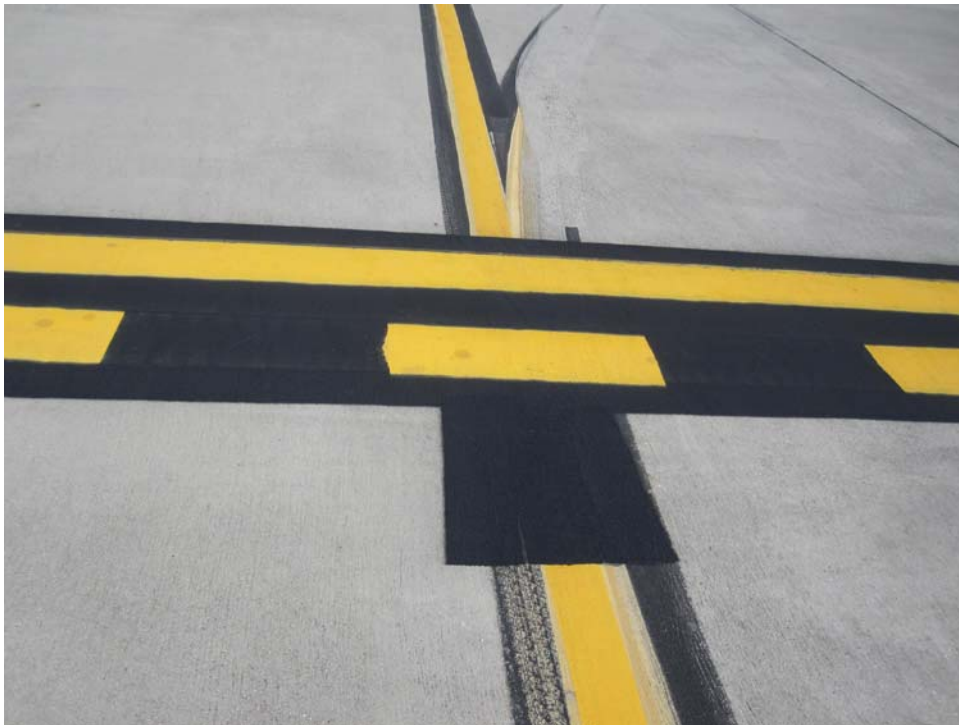
TGA1SV-10. Satisfactory Paint.

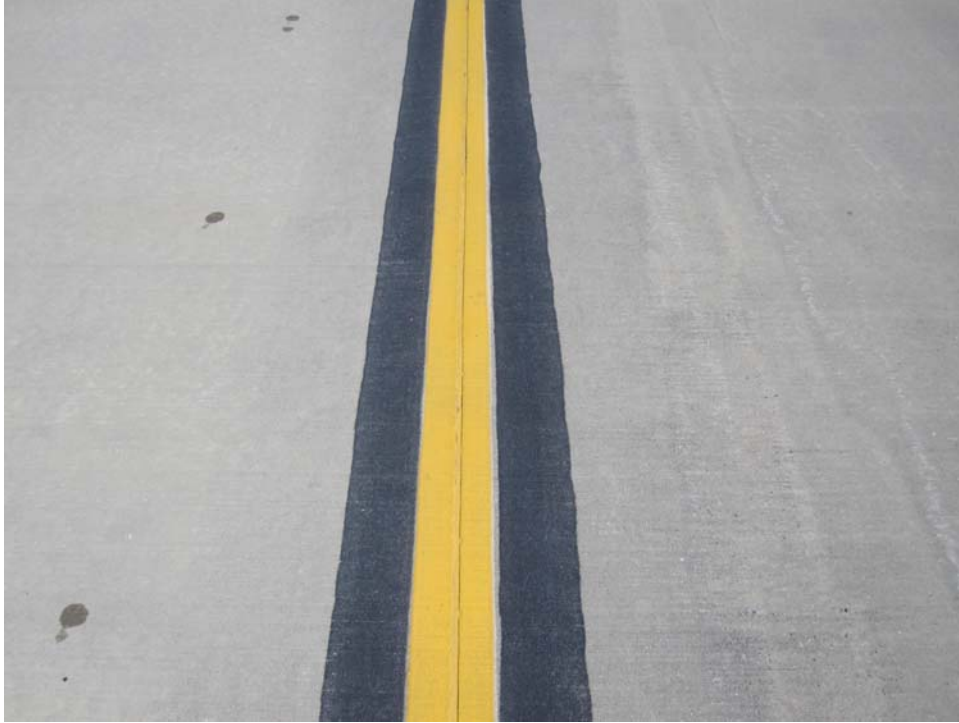
TGA4SV-20. Satisfactory Paint.

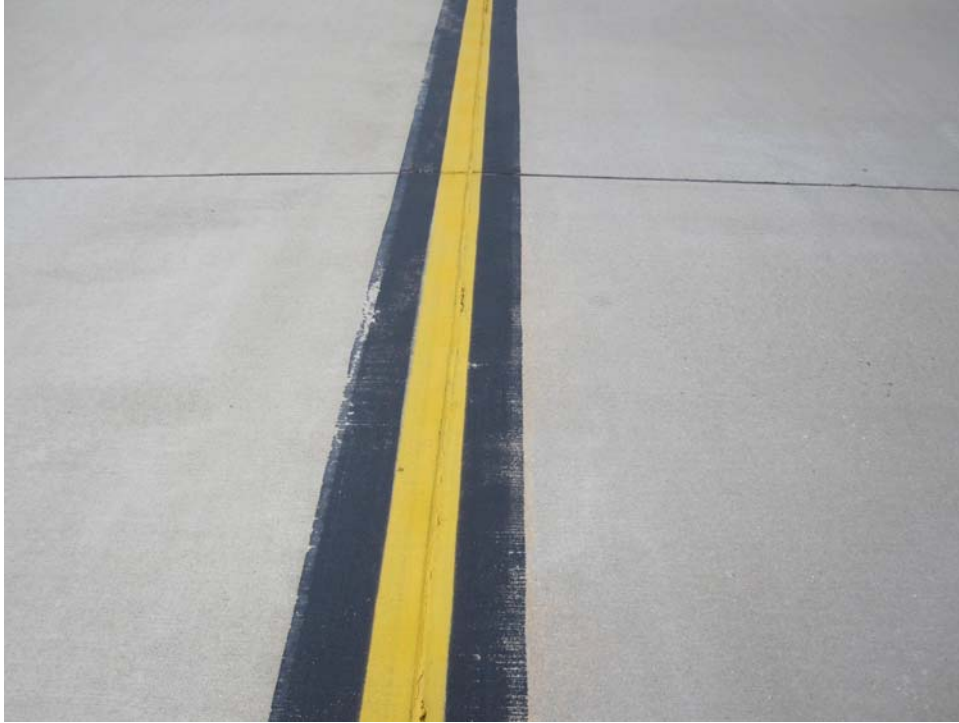
TGA5SV-10. Satisfactory Paint.
