# 2012 Valdosta Regional Airport Pavement Management Plan

# VALDOSTA REGIONAL AIRPORT

## PAVEMENT MANAGEMENT REPORT

**DECEMBER 2012**

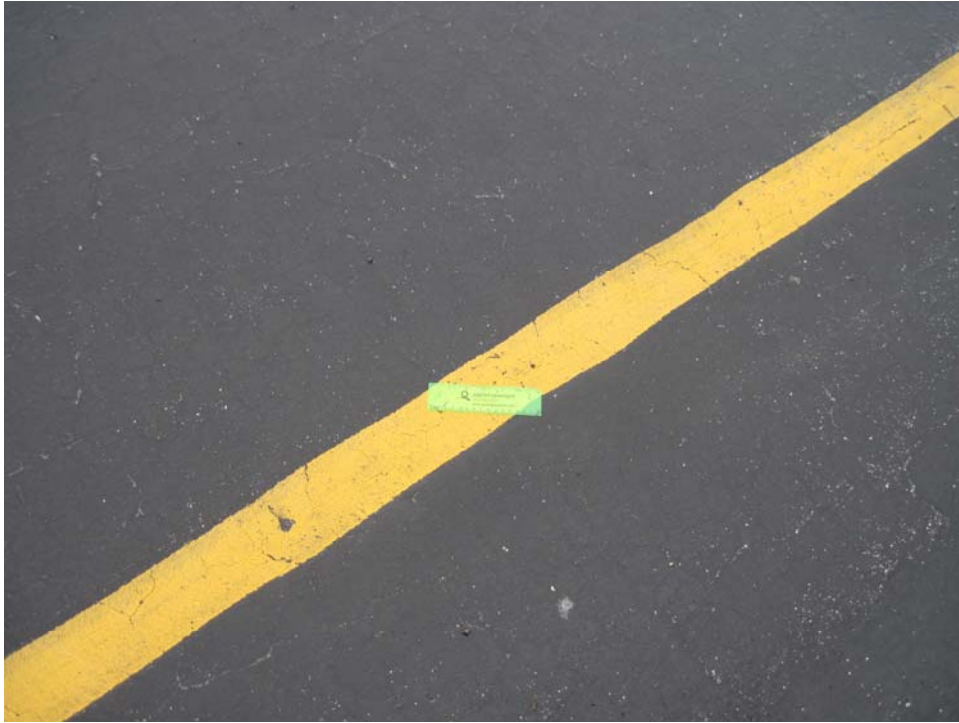
A01VL-10. Satisfactory Paint.

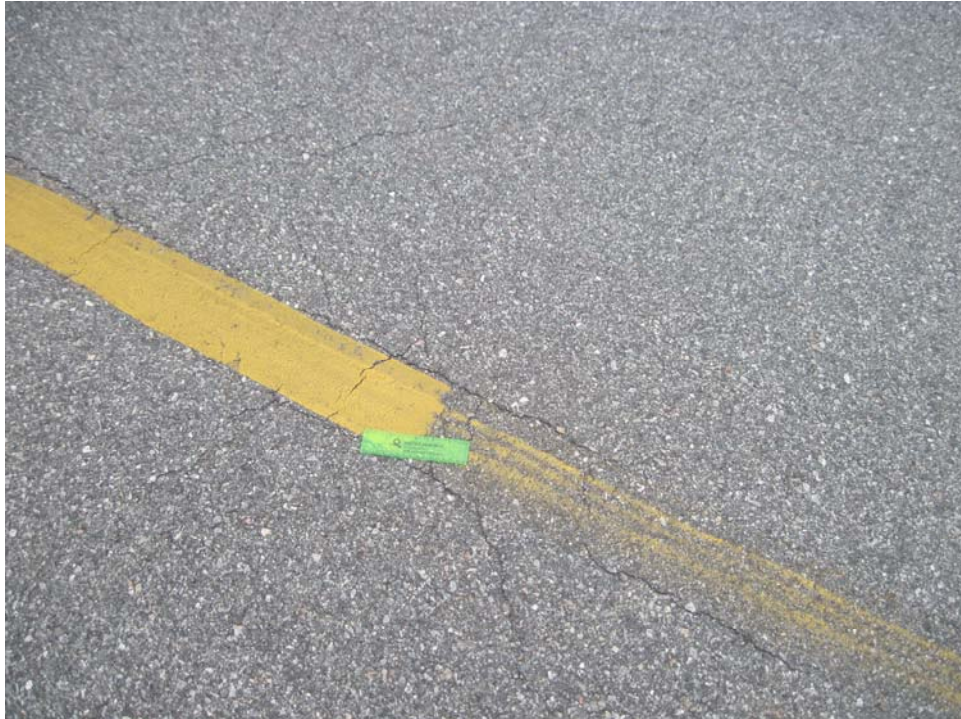
A01VL-40. Satisfactory Paint.

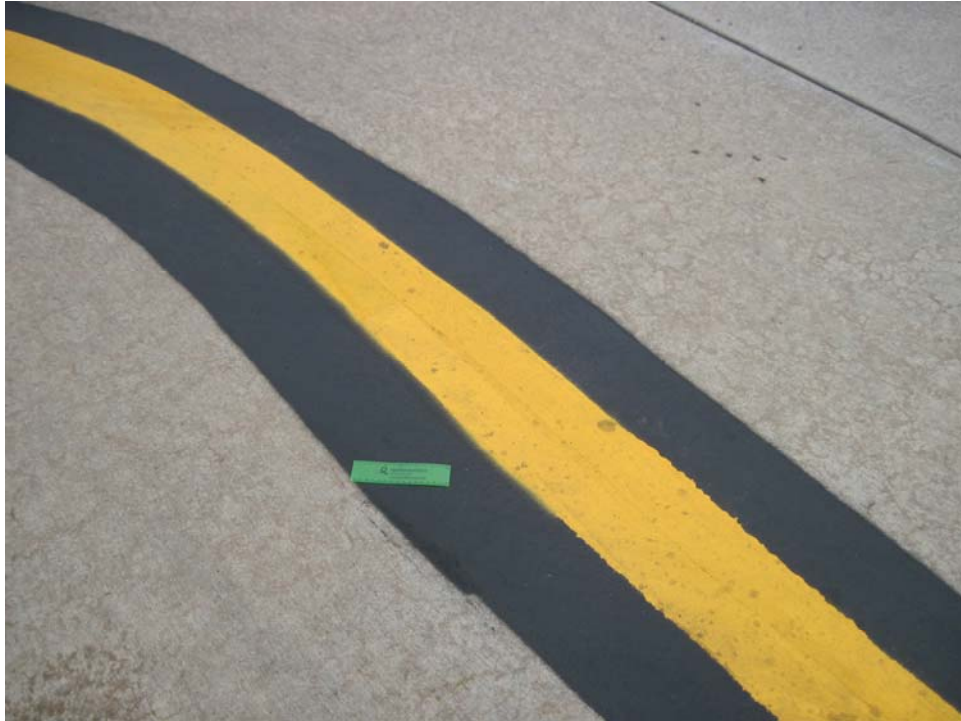
ATERMVL-10. Satisfactory Paint.

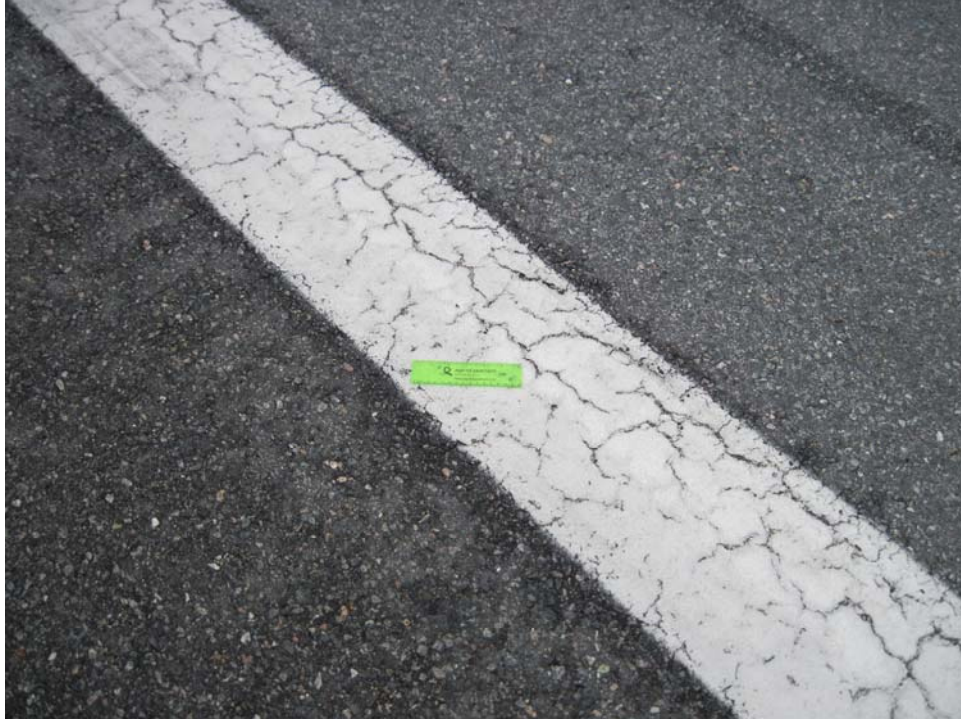
R1331VL-20. Satisfactory Paint.

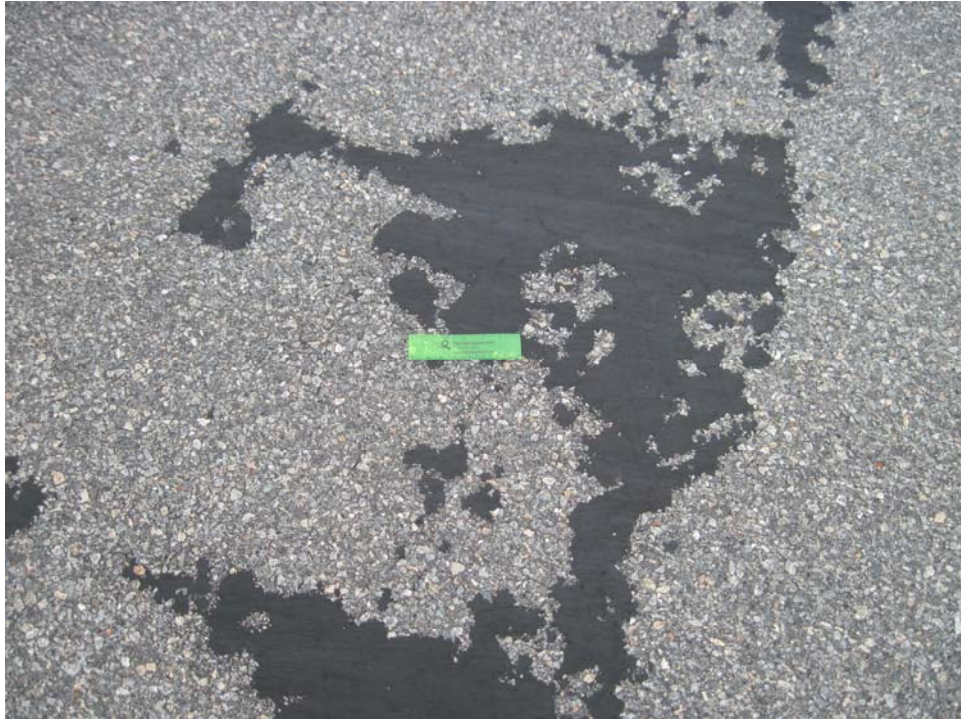
TNVL-10. Bleeding (Sample Unit #1).

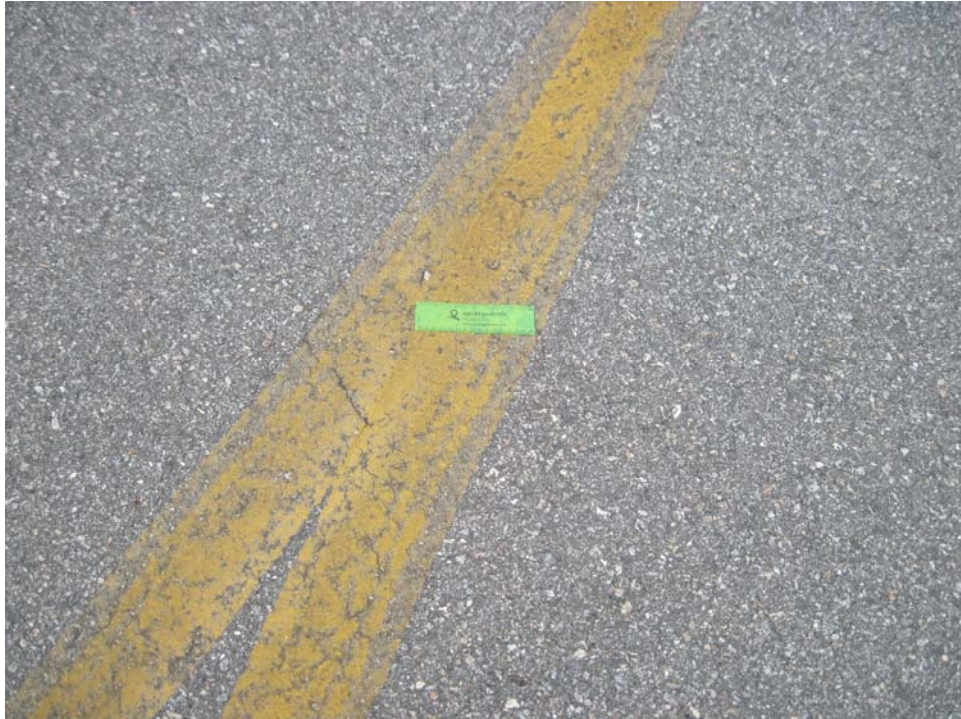
THANG01VL-20. Satisfactory Paint.

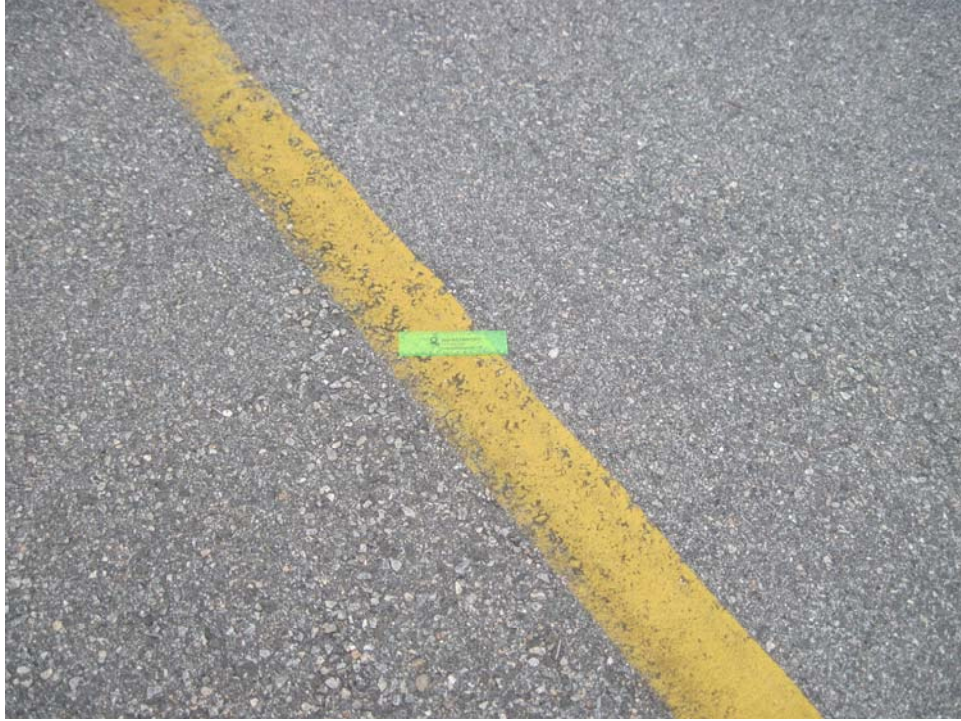
THANG01VL-30. Satisfactory Paint.

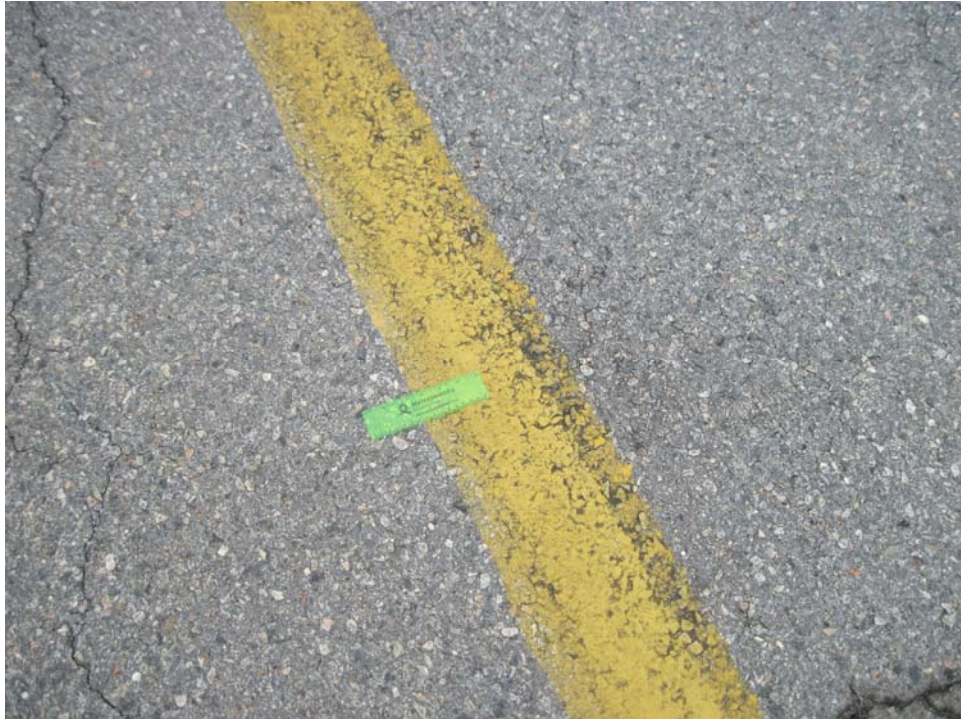
THANG02VL-10. Satisfactory Paint.

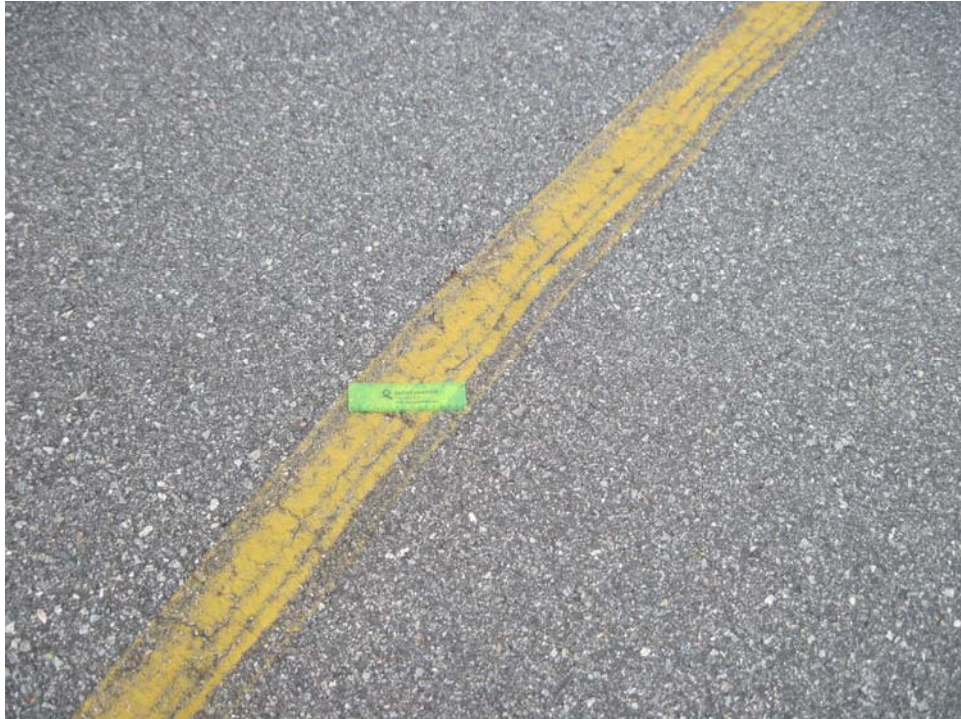
THANG02VL-20. Unsatisfactory Paint.

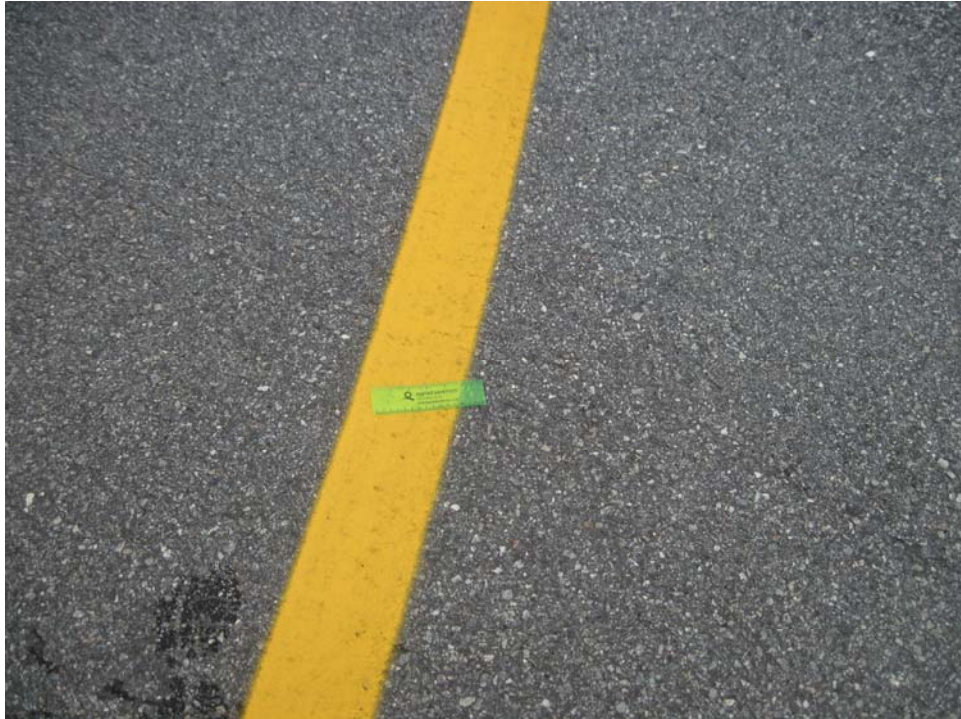
THANG02VL-30. Satisfactory Paint.

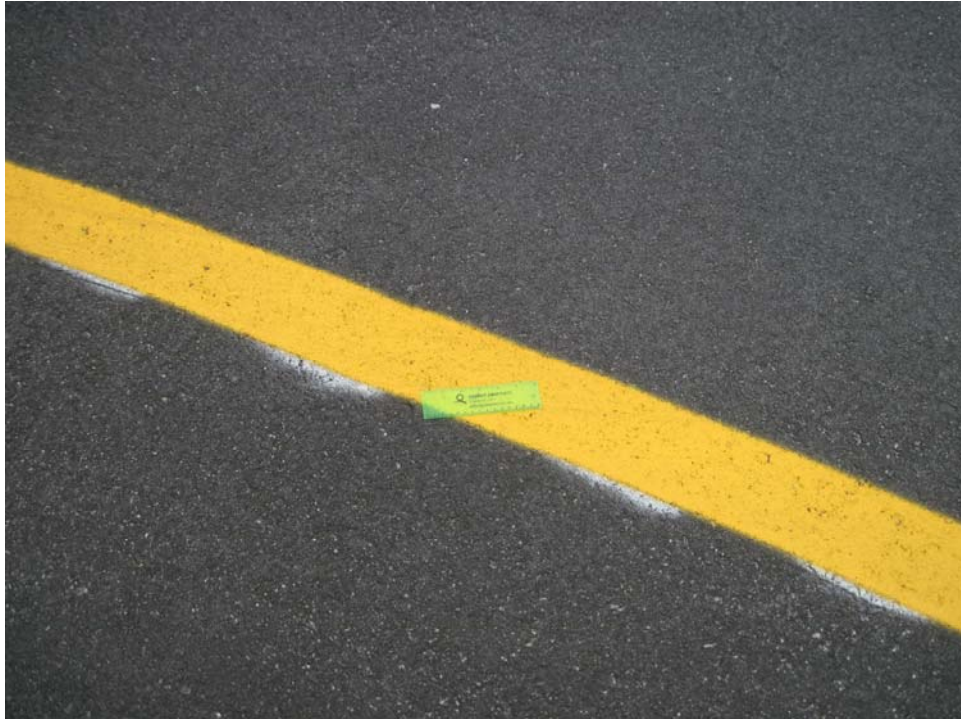
THANG02VL-40. Satisfactory Paint.
