AUGUSTA REGIONAL AIRPORT AT BUSH FIELD

PAVEMENT EVALUATION REPORT

JULY 2002

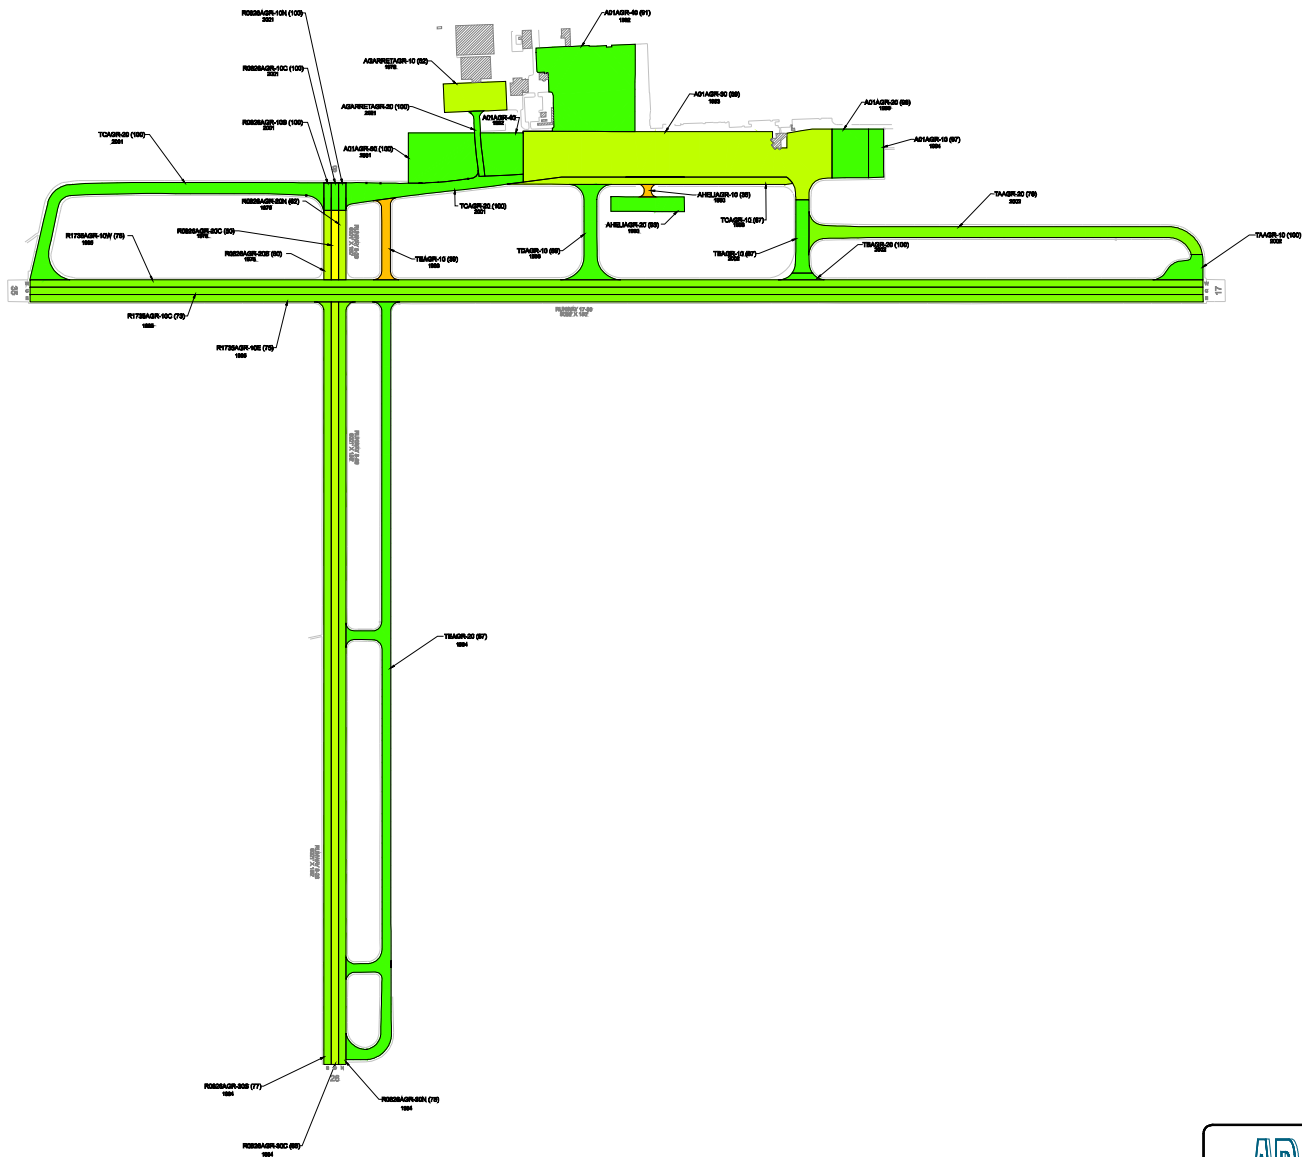
The 2001 area-weighted condition of Augusta Regional Airport at Bush Field is 80, with conditions ranging from 36 to 100 [on a scale of 0 (failed) to 100 (excellent)]. Figures 6 and 7 provide graphs summarizing the overall condition of the pavements at Augusta Regional Airport at Bush Field. Figure 8 is a map that displays the condition of the pavements evaluated. Table 1 summarizes the results of the pavement evaluation.
