COLUMBUS METROPOLITAN AIRPORT

PAVEMENT EVALUATION REPORT

JULY 2002

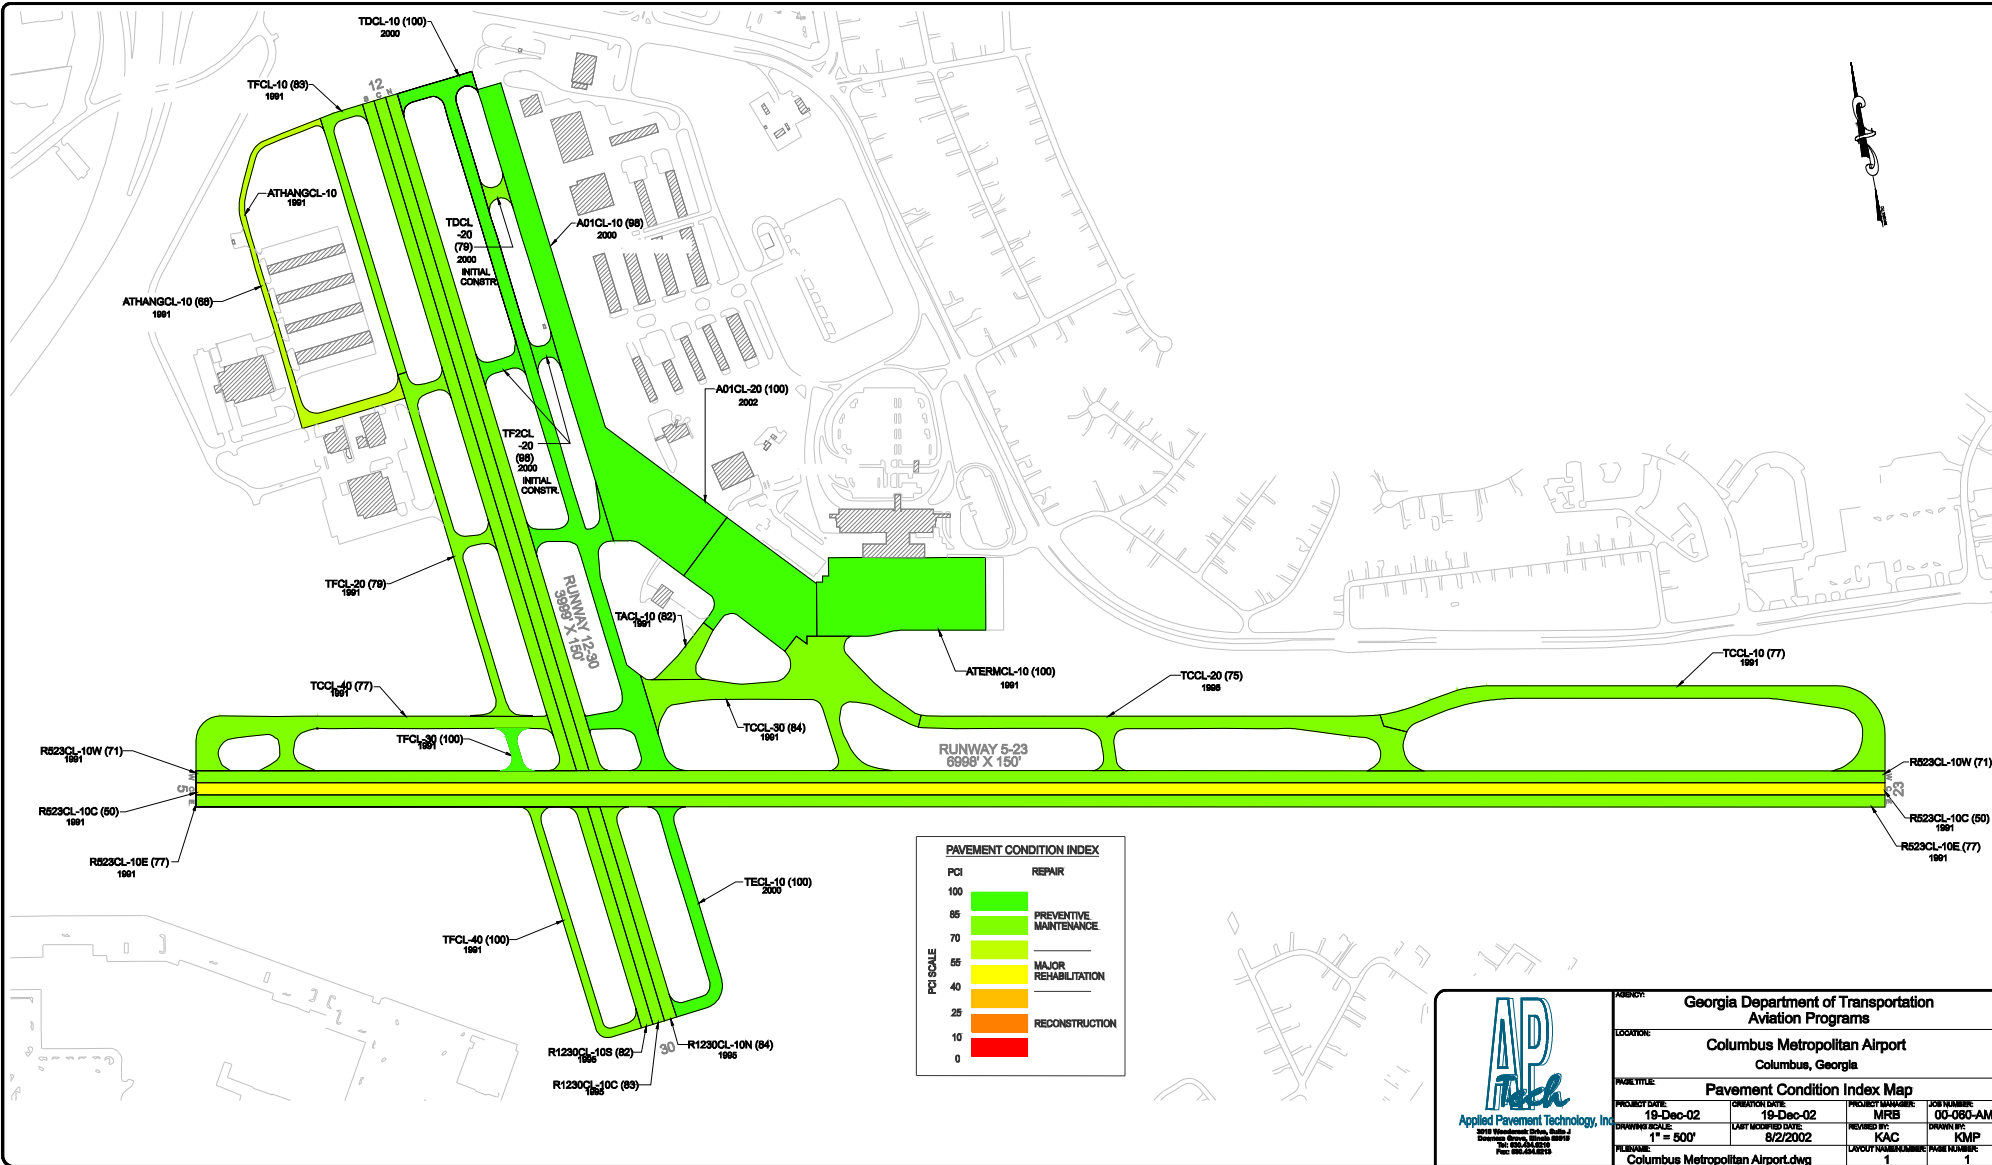
Figure 8. INSERT PCI MAP
(11 x 17)

The 2001 area-weighted condition of Columbus Metropolitan Airport is 82, with conditions ranging from 50 to 100 [on a scale of 0 (failed) to 100 (excellent)]. Figures 6 and 7 provide graphs summarizing the overall condition of the pavements at Columbus Metro Airport. Figure 8 is a map that displays the condition of the pavements evaluated. Table 1 summarizes the results of the pavement evaluation.
