FULTON COUNTY - BROWN FIELD

PAVEMENT EVALUATION REPORT

JULY 2002

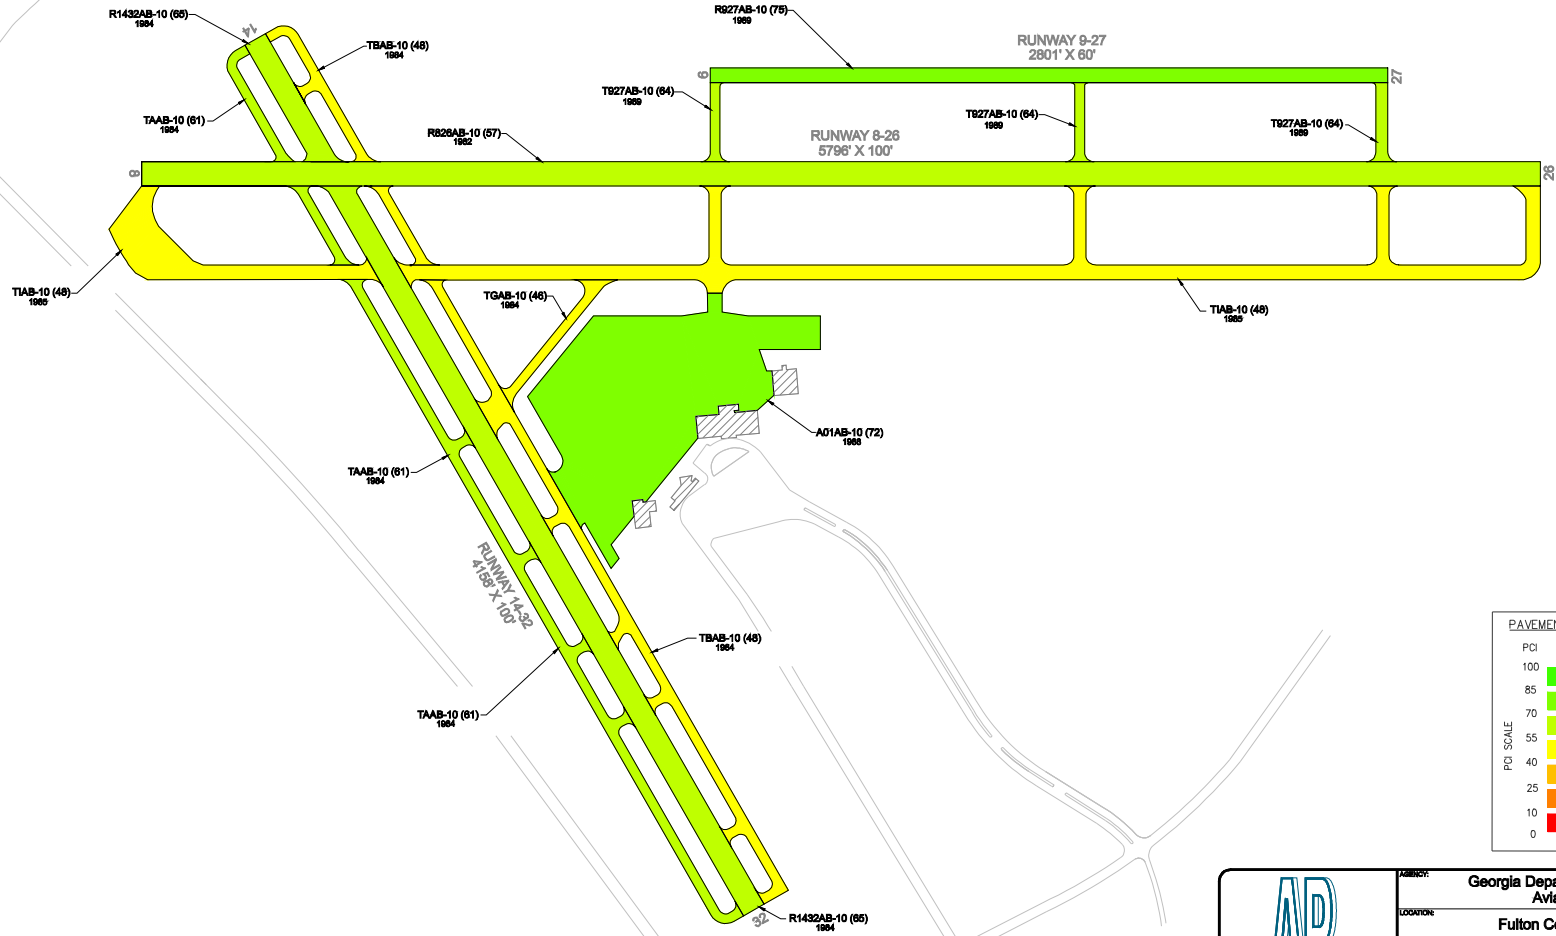
Figure 8. INSERT PCI MAP
(11 x 17)

The 2001 area-weighted condition of Fulton County – Brown Field is 61, with conditions ranging from 46 to 75 [on a scale of 0 (failed) to 100 (excellent)]. Figures 6 and 7 provide graphs summarizing the overall condition of the pavements at Fulton County – Brown Field. Figure 8 is a map that displays the condition of the pavements evaluated. Table 1 summarizes the results of the pavement evaluation.
