DEKALB - PEACHTREE AIRPORT

PAVEMENT EVALUATION REPORT

JULY 2002

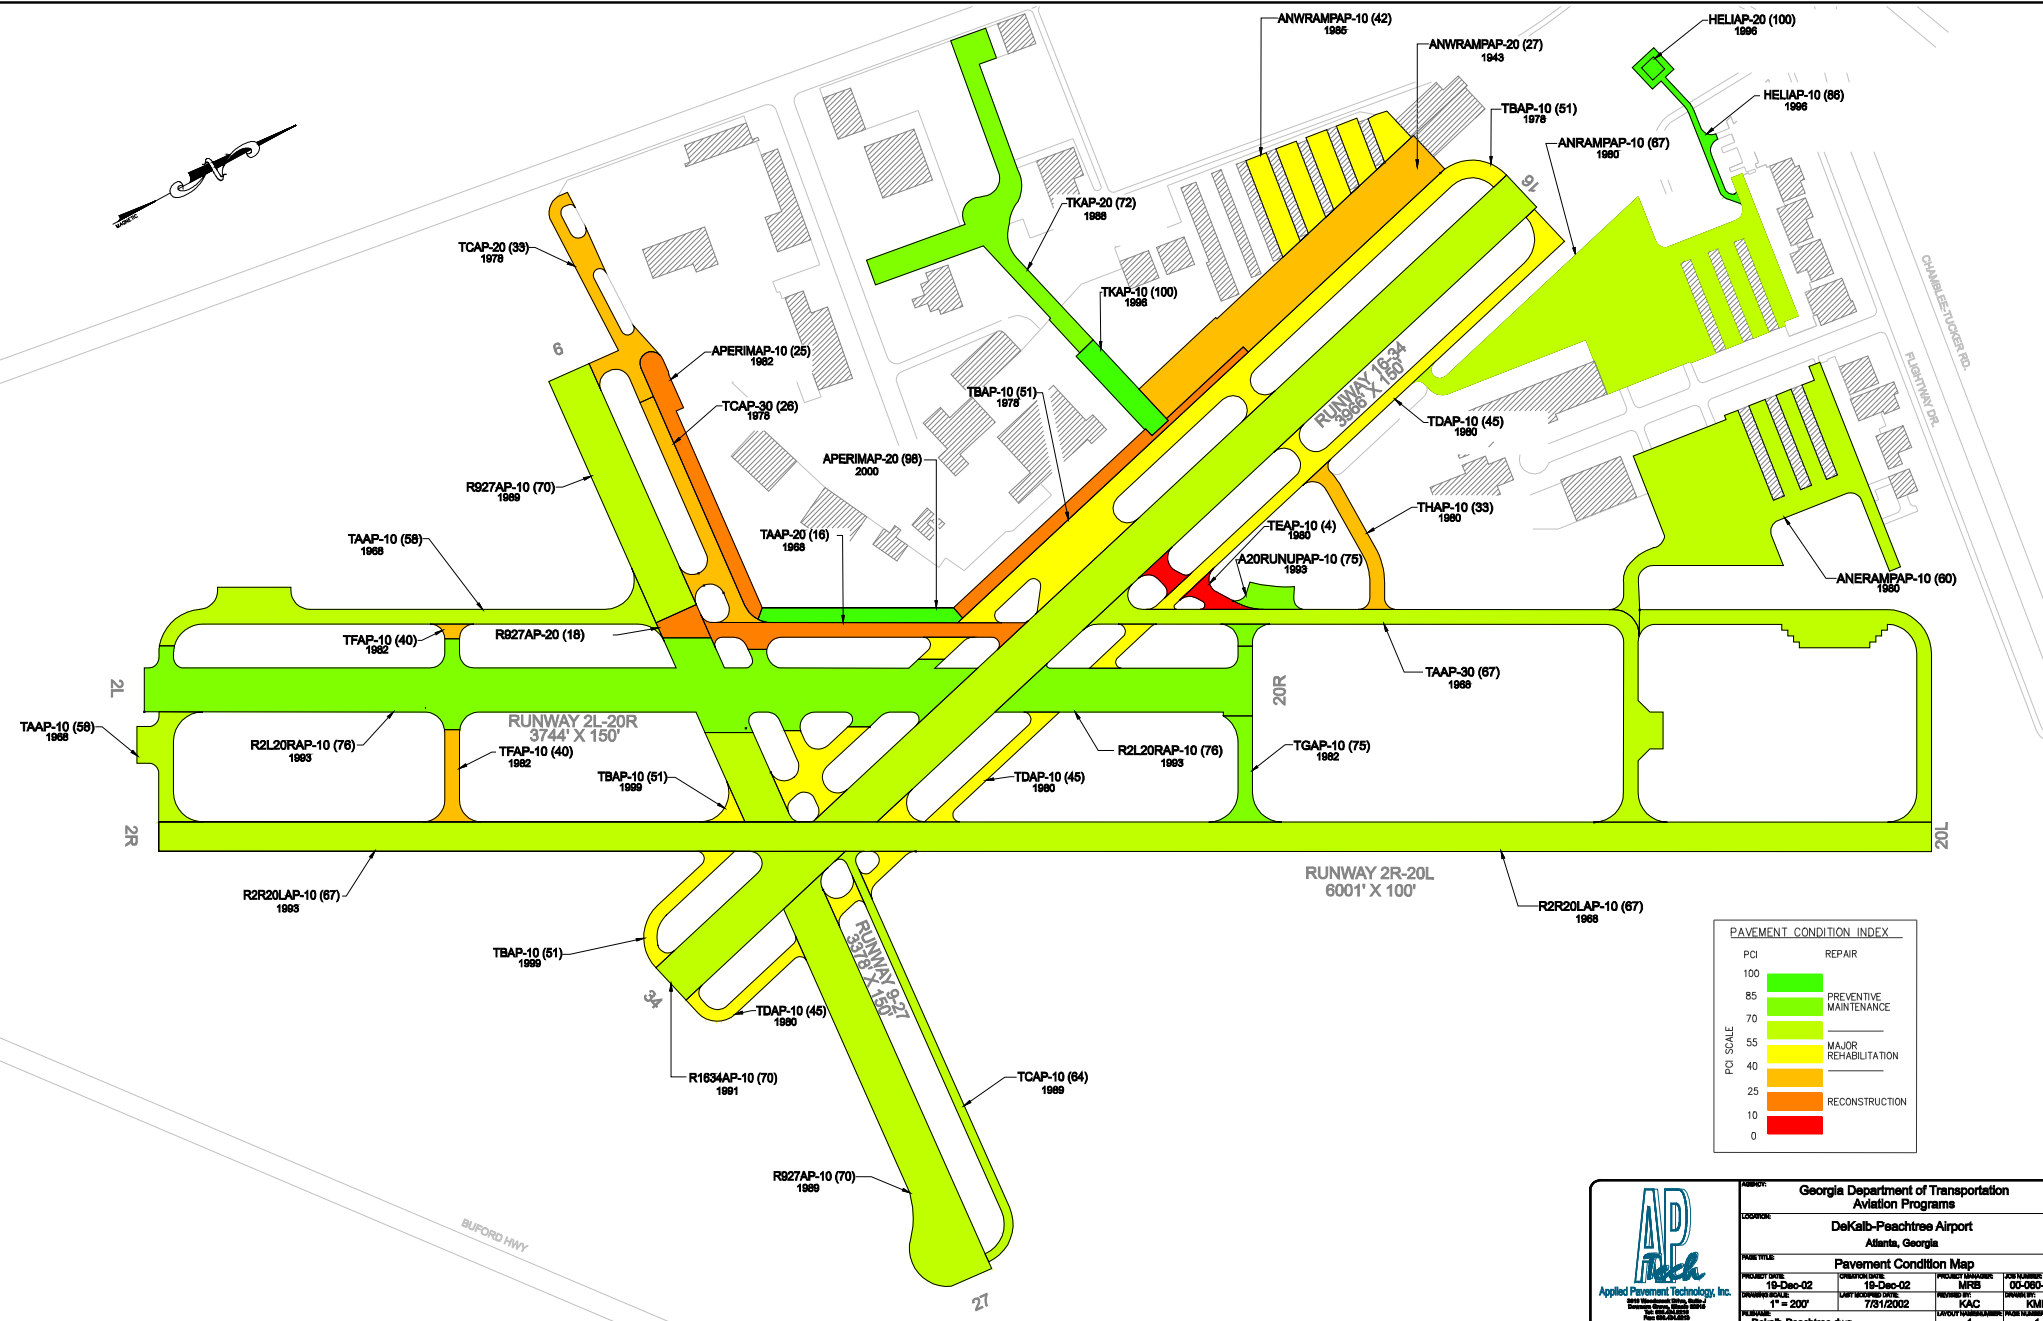
Figure 8. INSERT PCI MAP
(11 x 17)

The 2001 area-weighted condition of Dekalb – Peachtree Airport is 62, with conditions ranging from 4 to 100 [on a scale of 0 (failed) to 100 (excellent)]. Figures 6 and 7 provide graphs summarizing the overall condition of the pavements at Dekalb – Peachtree Airport. Figure 8 is a map that displays the condition of the pavements evaluated. Table 1 summarizes the results of the pavement evaluation.
