# 2012 Cook County Airport Pavement Management Plan

# COOK COUNTY AIRPORT

## PAVEMENT MANAGEMENT REPORT

**DECEMBER 2012**

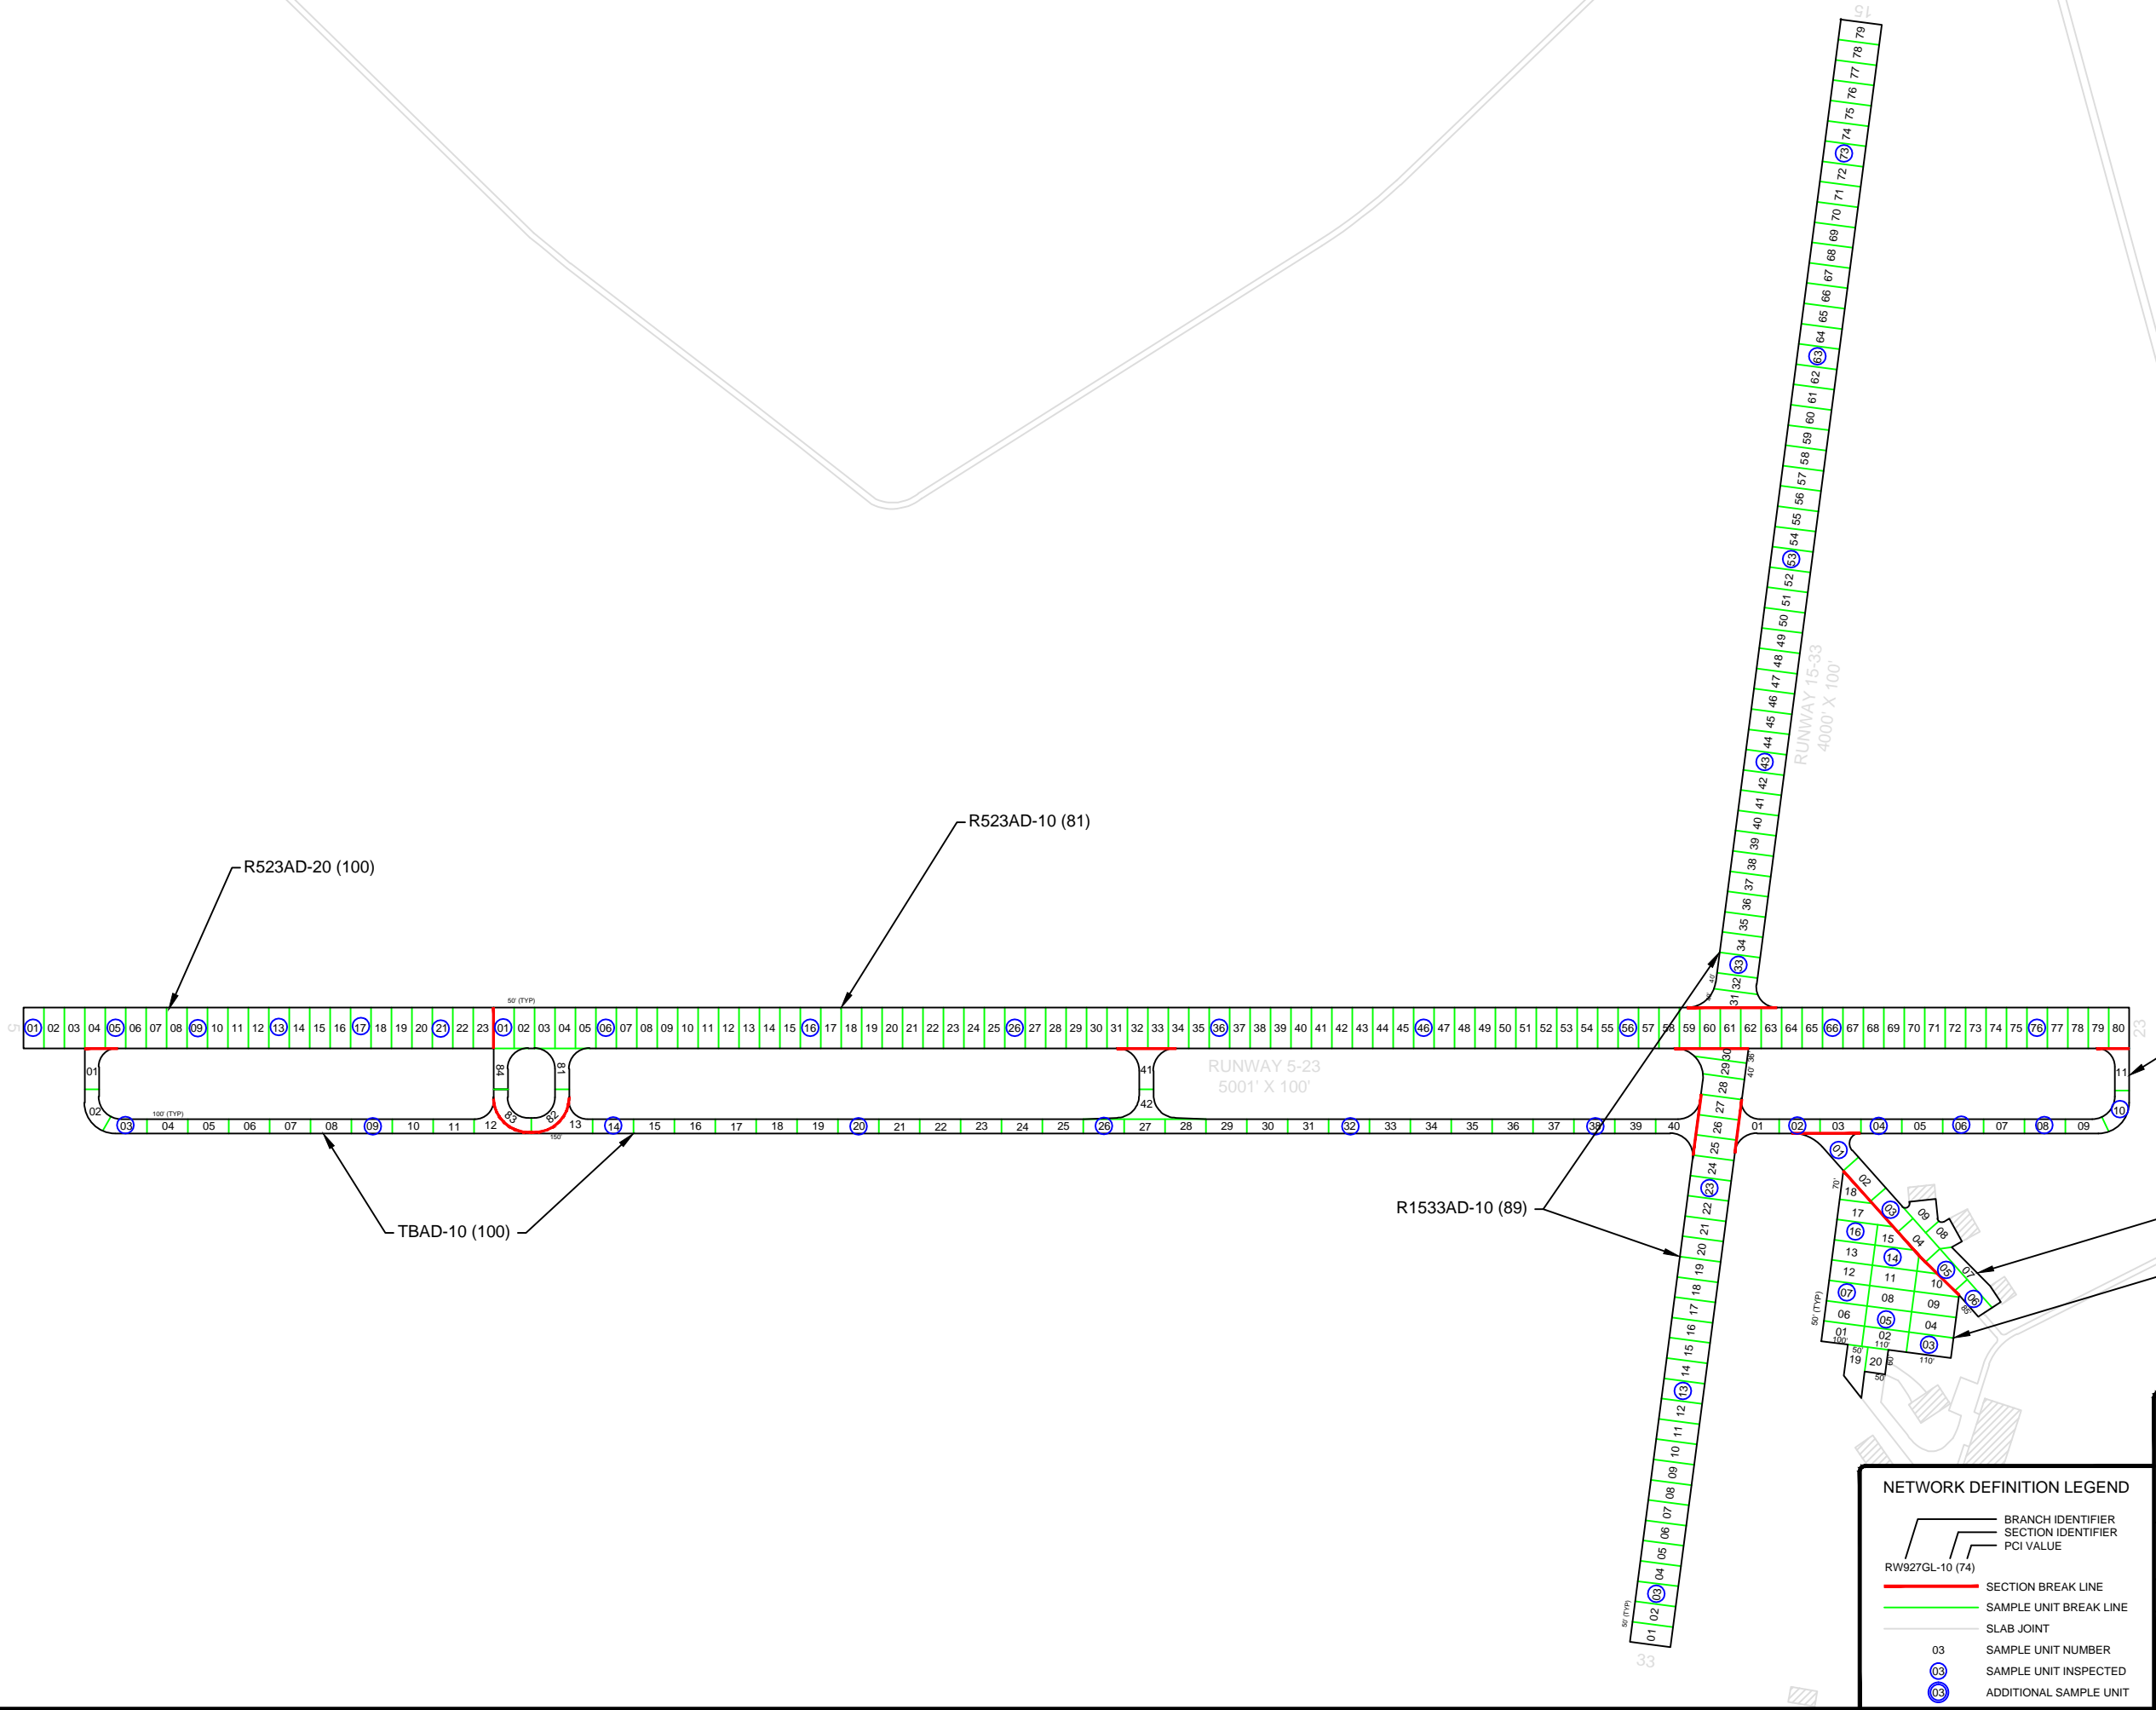
The inspection of Cook County Airport was completed on February 13, 2012 using the PCI procedure described previously. The map presented in Figure 5 identifies the sample units inspected during the pavement evaluation.
