2012 Athens-Ben Epps Field Pavement Management Plan

ATHENS-BEN EPPS FIELD

PAVEMENT MANAGEMENT REPORT

DECEMBER 2012

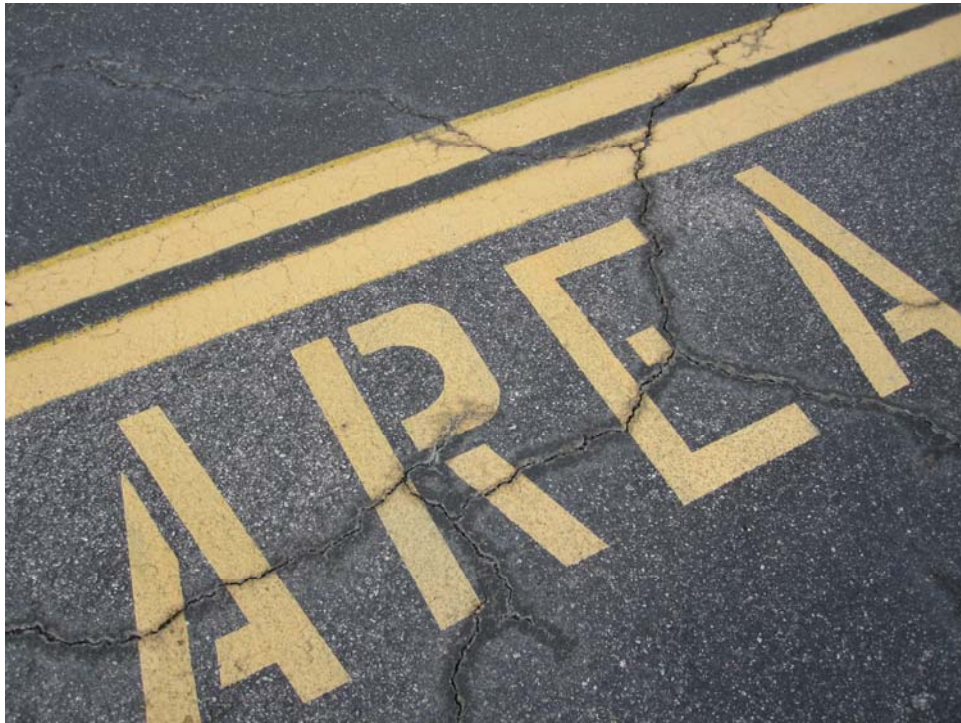
A01AT-10. Satisfactory Paint.

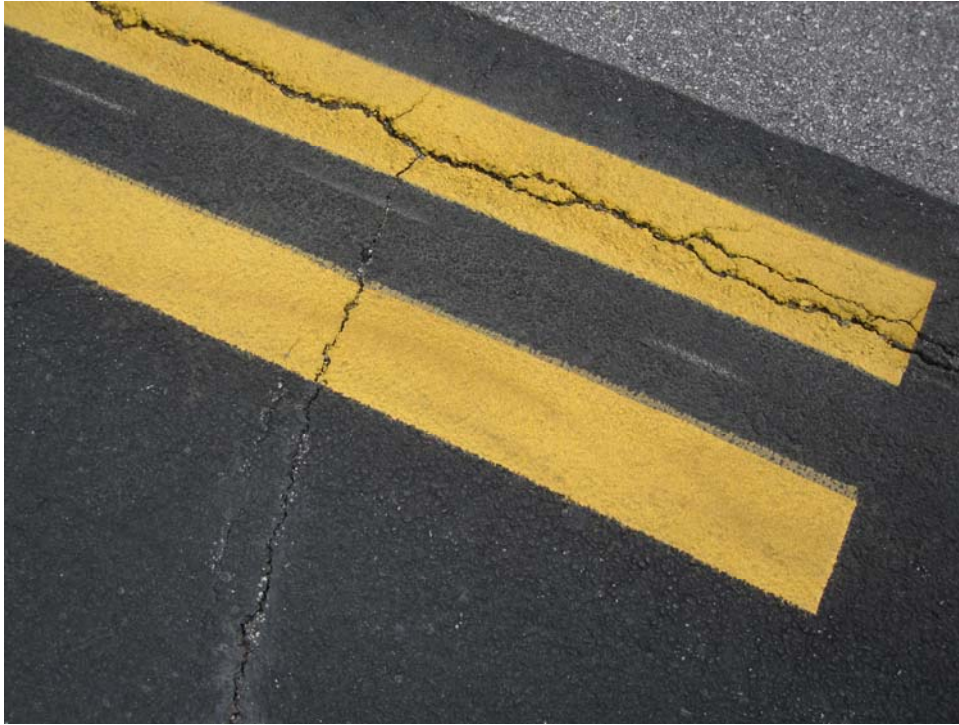
A01AT-20. Satisfactory Paint.

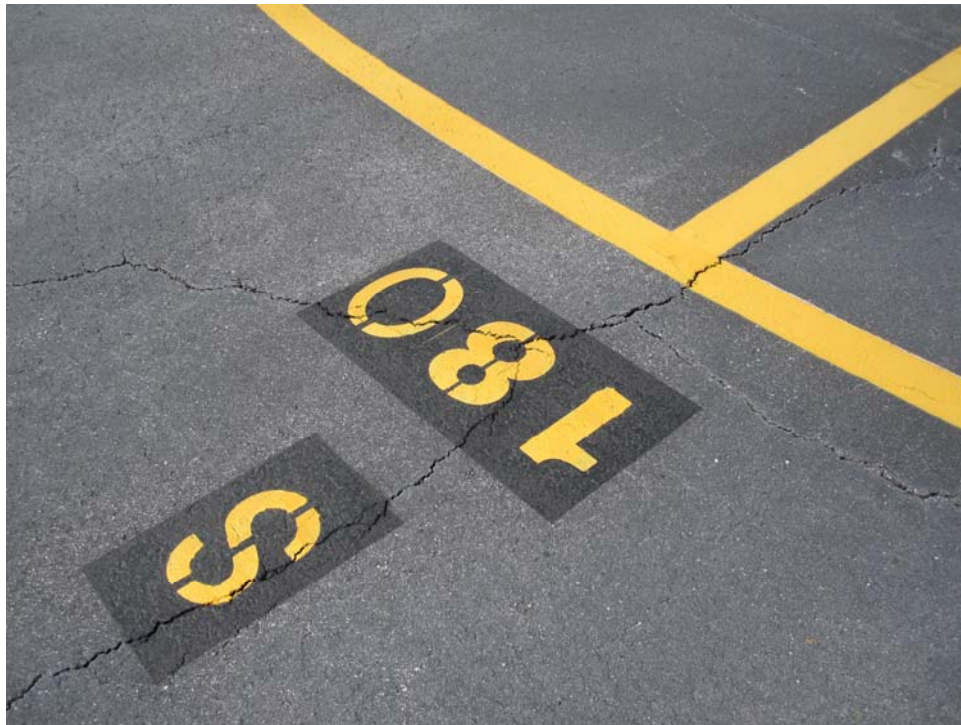
A01AT-30. Satisfactory Paint.

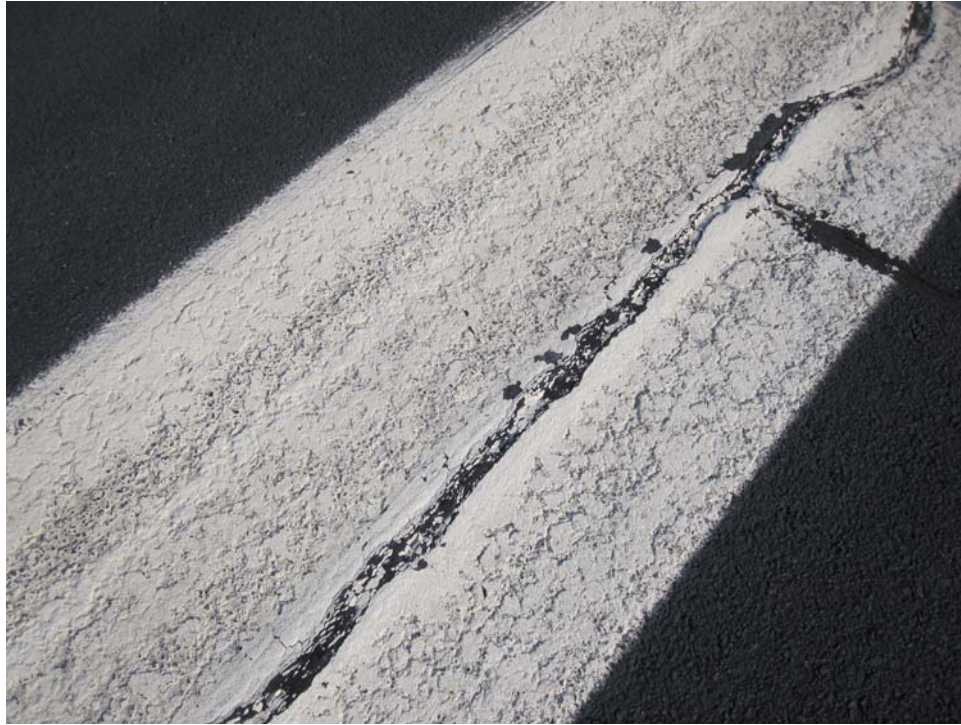
R220AT-10. Satisfactory Paint.

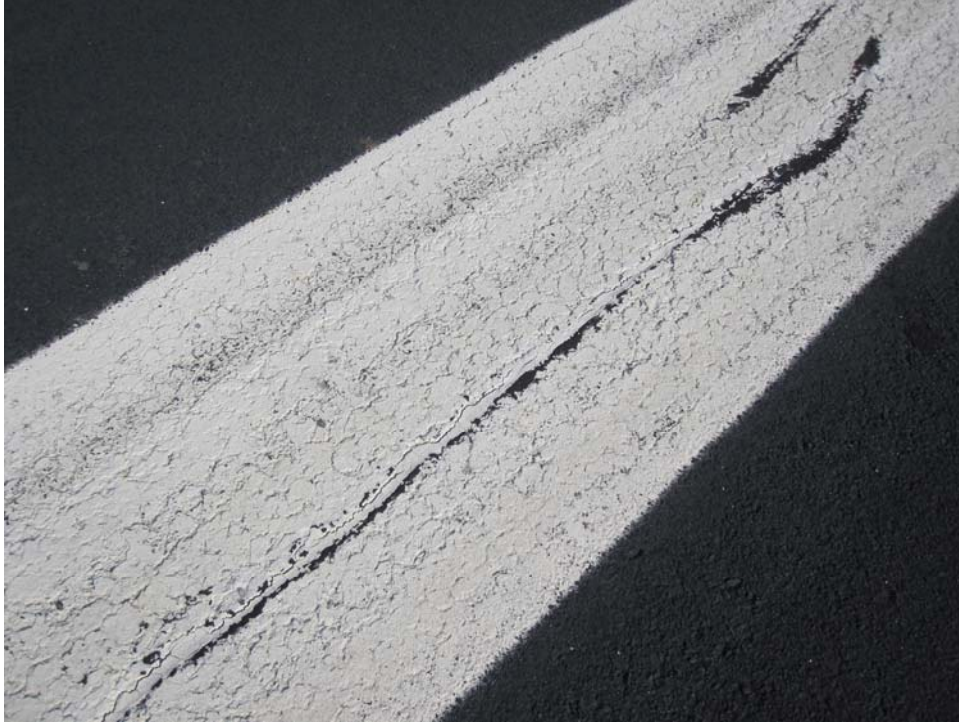
R220AT-30. Satisfactory Paint.

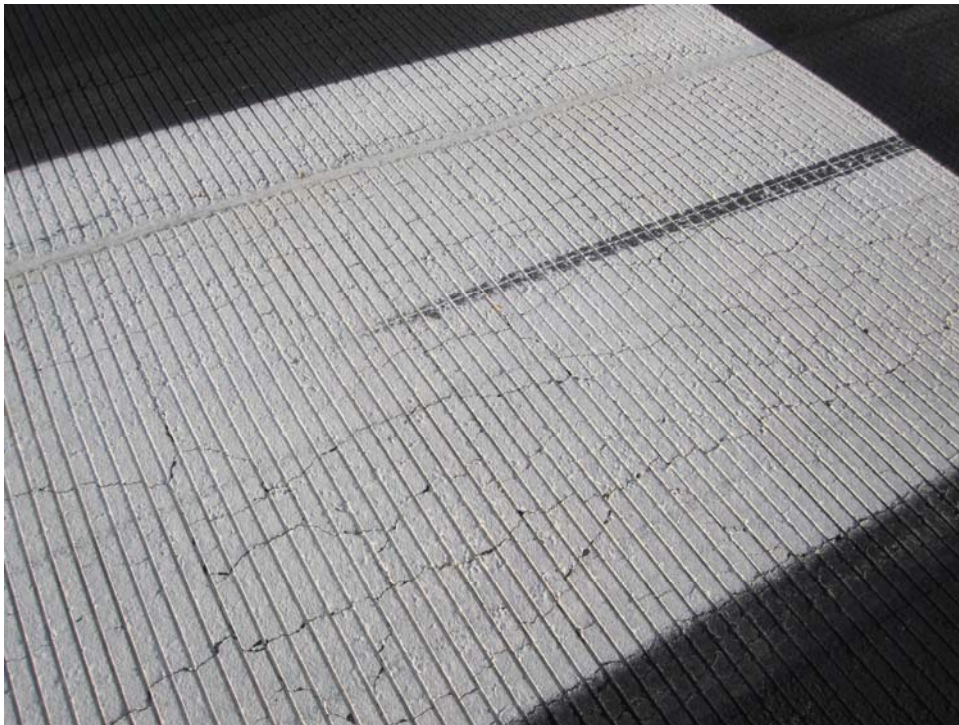
R927AT-20. Satisfactory Paint.

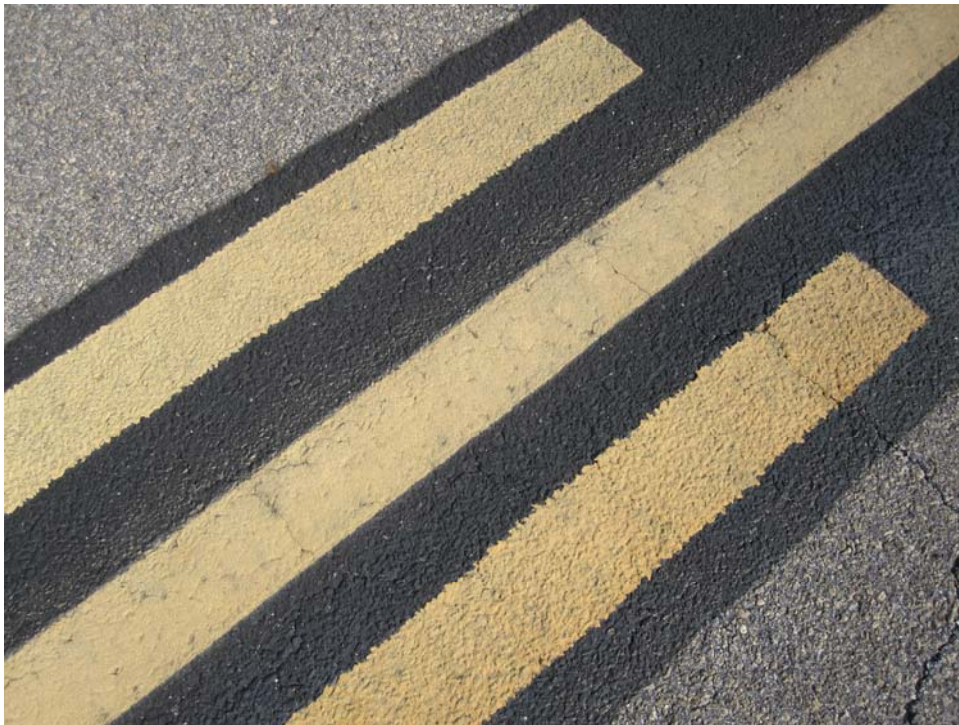
TBAT-10. Satisfactory Paint.

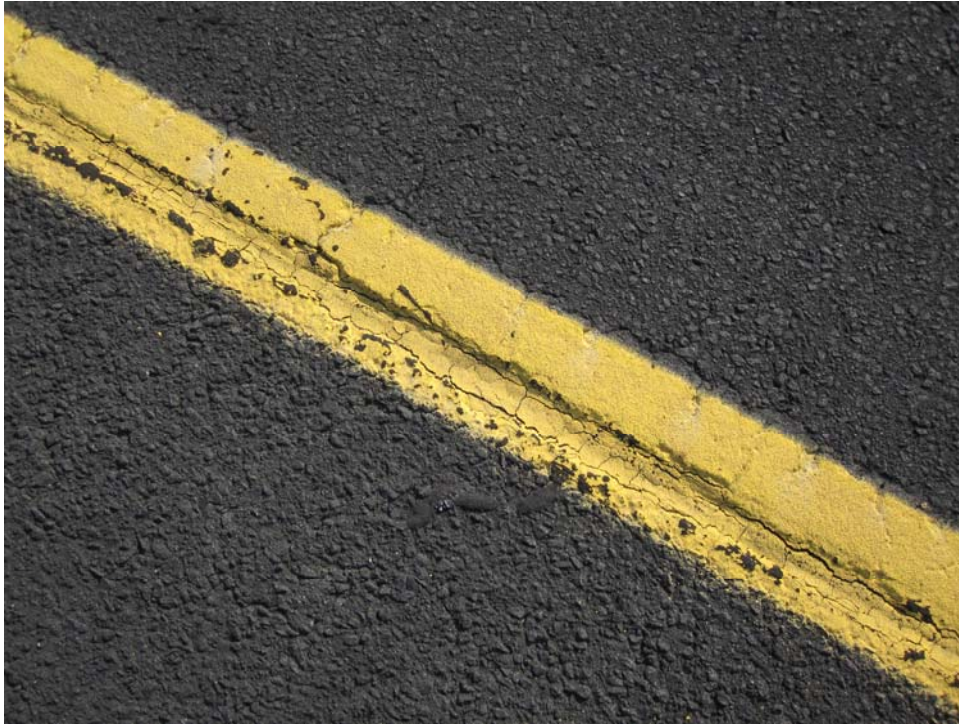
TBAT-20. Satisfactory Paint.

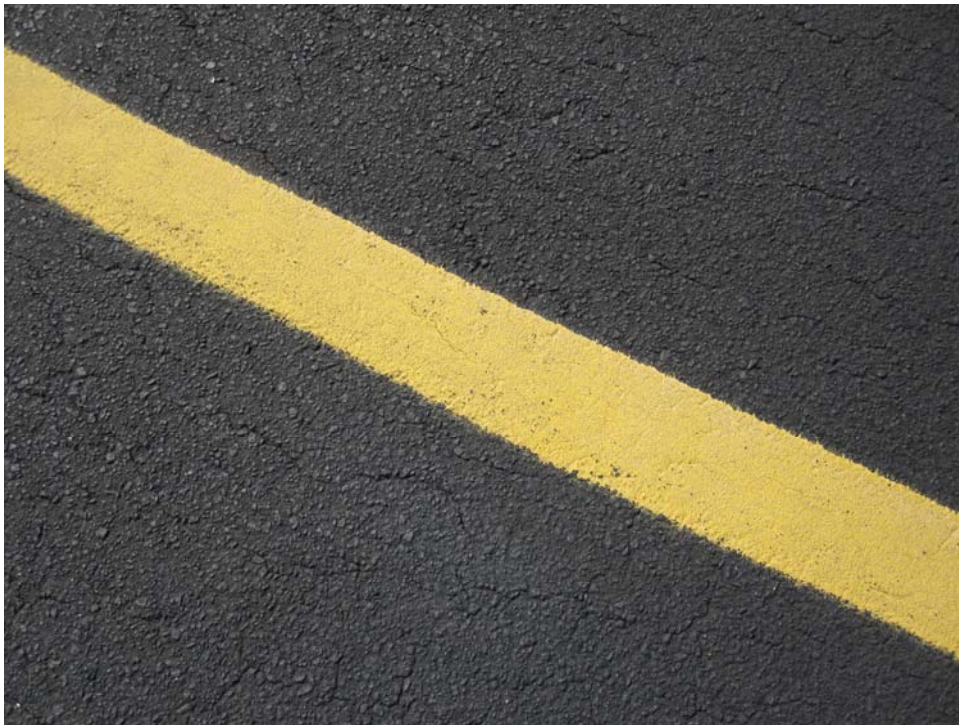
TBAT-30. Satisfactory Paint.

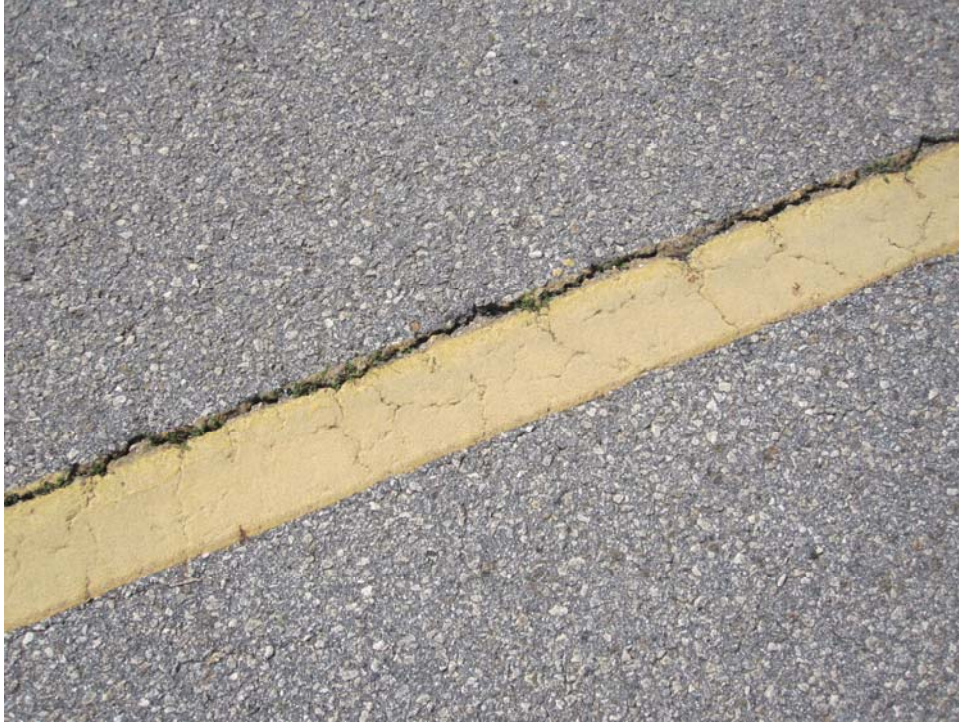
THANGAT-10. Satisfactory Paint.
