2012 DeKalb-Peachtree Airport Pavement Management Plan

DEKALB-PEACHTREE AIRPORT

PAVEMENT MANAGEMENT REPORT

DECEMBER 2012

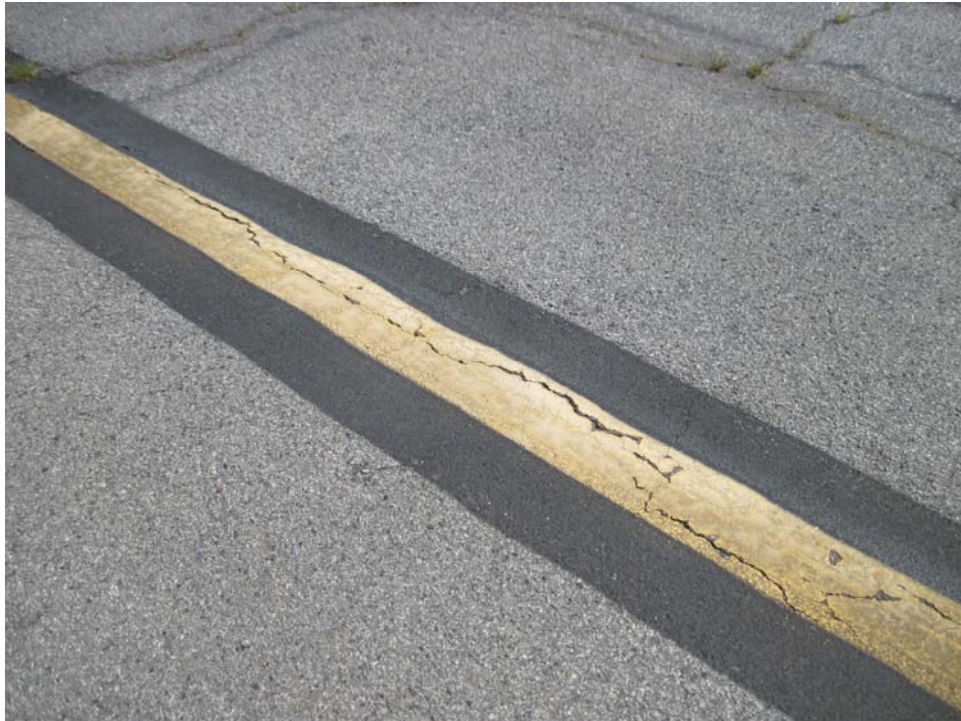
ANERAMPAP-10. Satisfactory Paint.

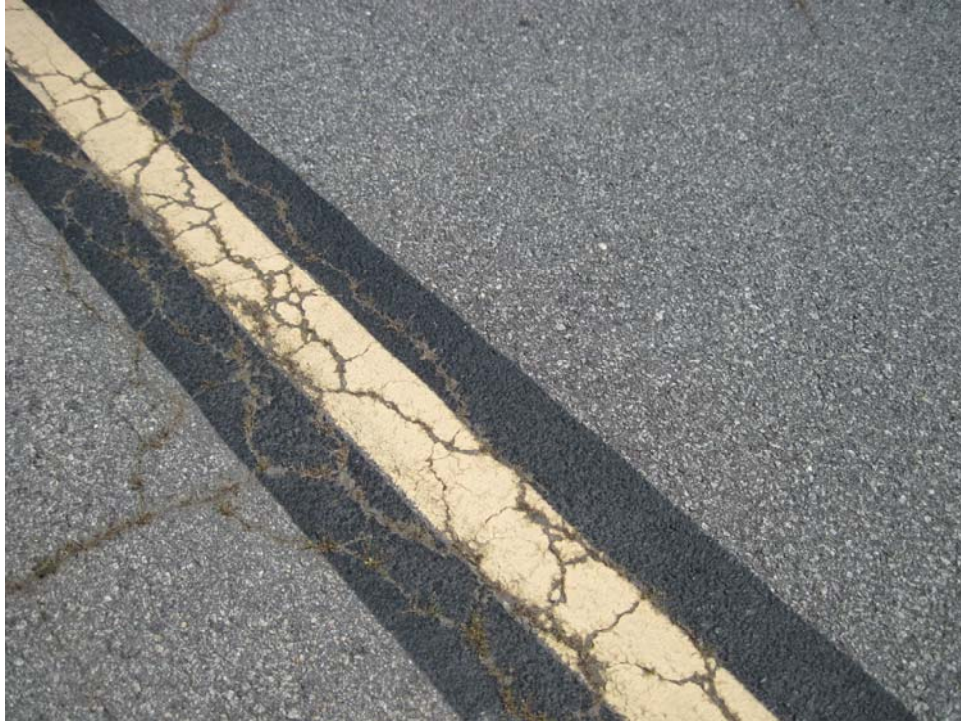
ANRAMPAP-10. Satisfactory Paint.

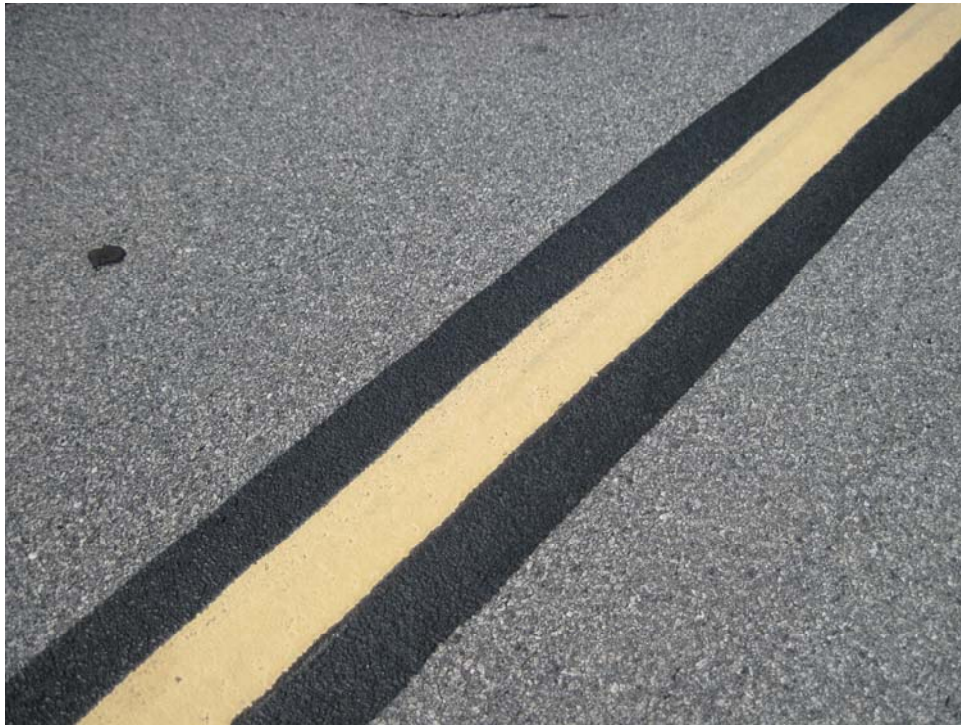
ANWRAMPAP-10. Satisfactory Paint.

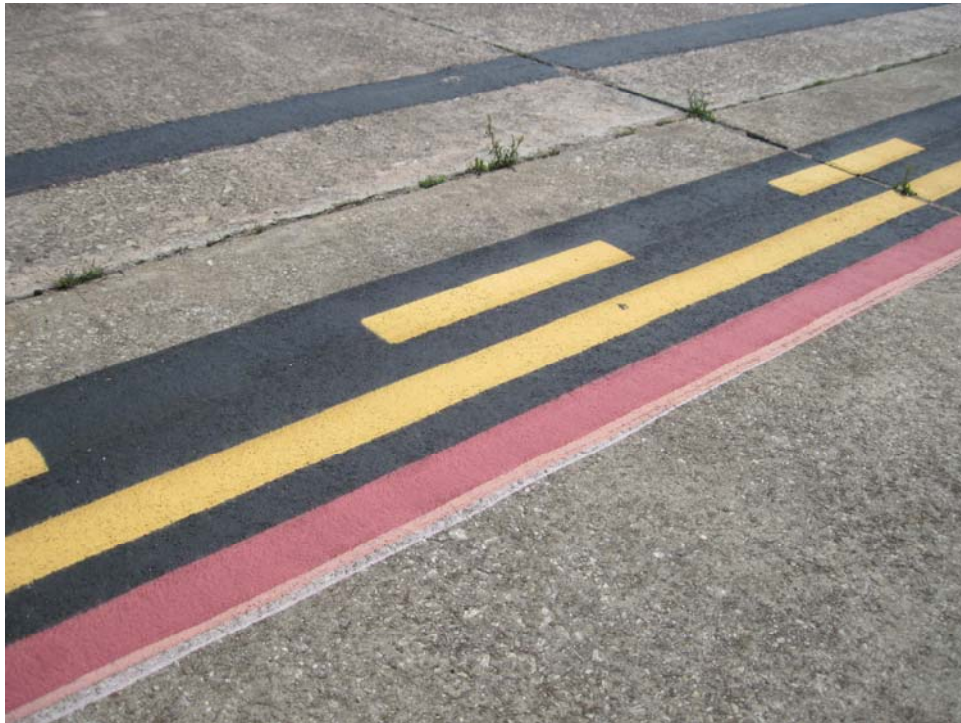
ANWRAMPAP-20. Satisfactory Paint.

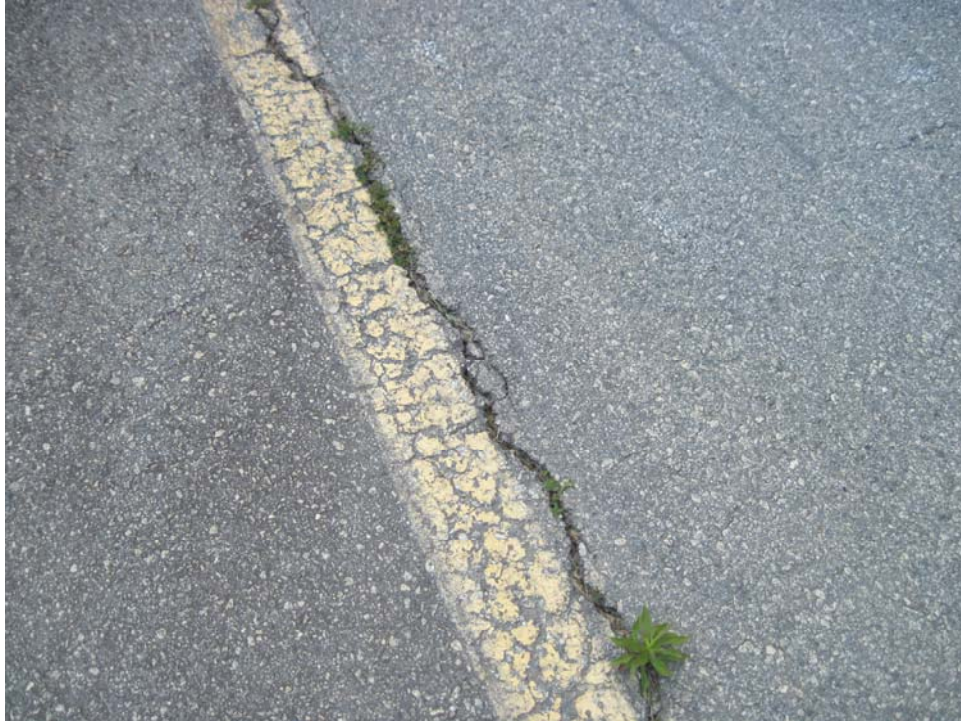
HELIAP-10. Unsatisfactory Paint.

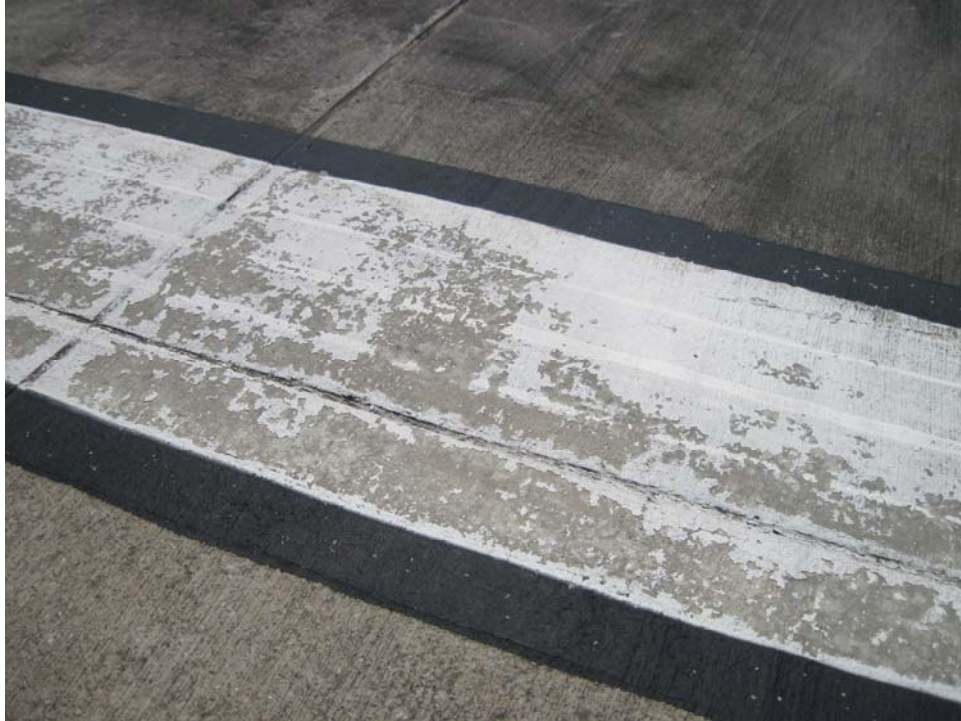
HELIAP-20. Unsatisfactory Paint.

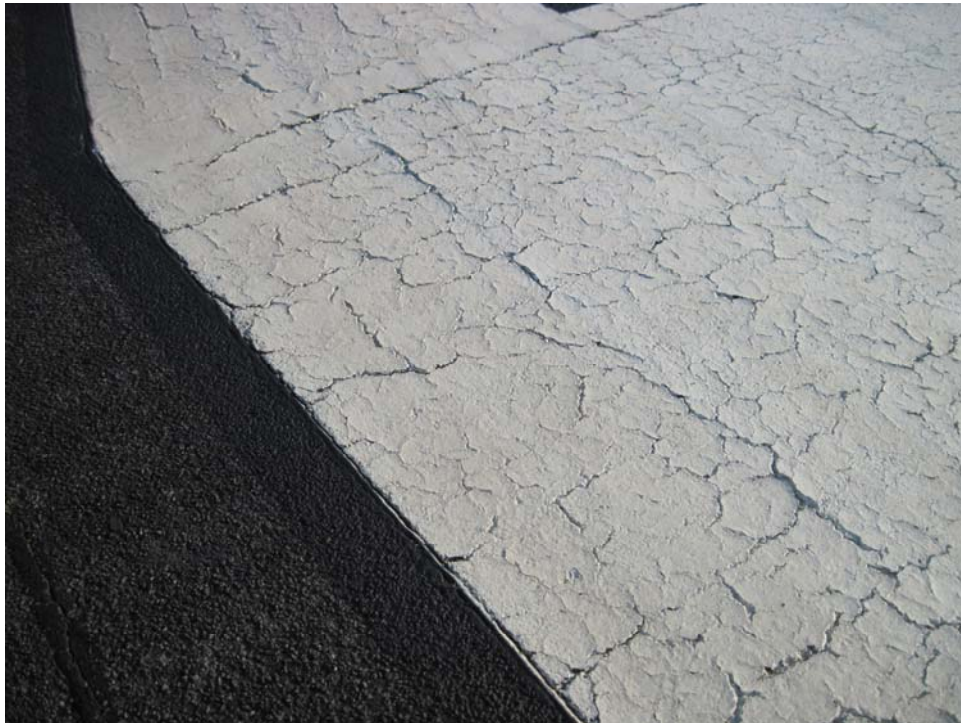
R1634AP-10. Satisfactory Paint.

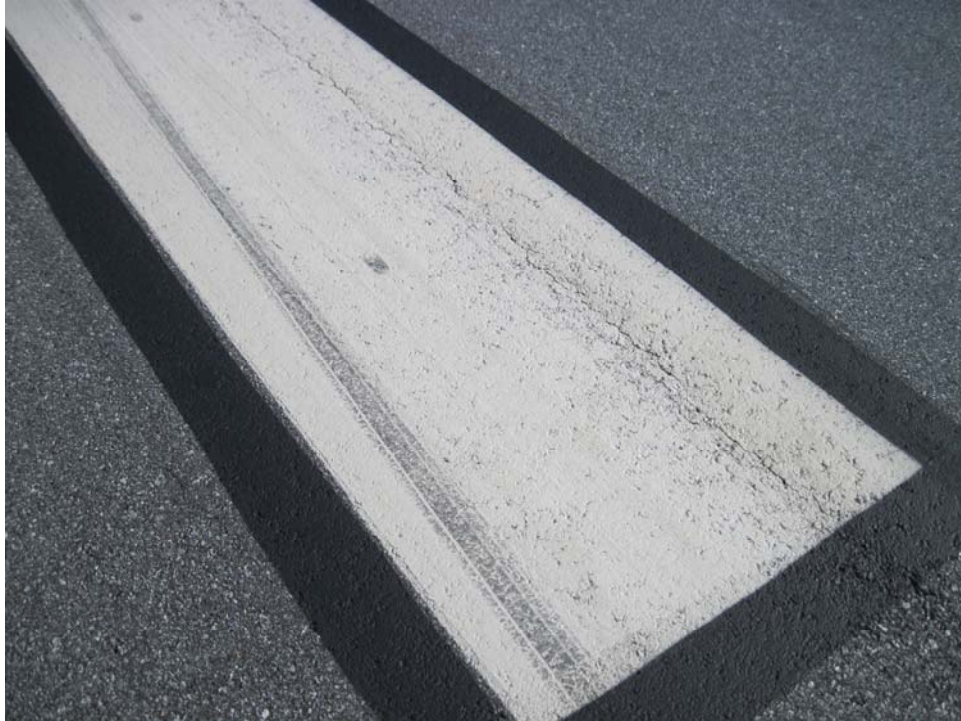
R1634AP-20. Weathering.

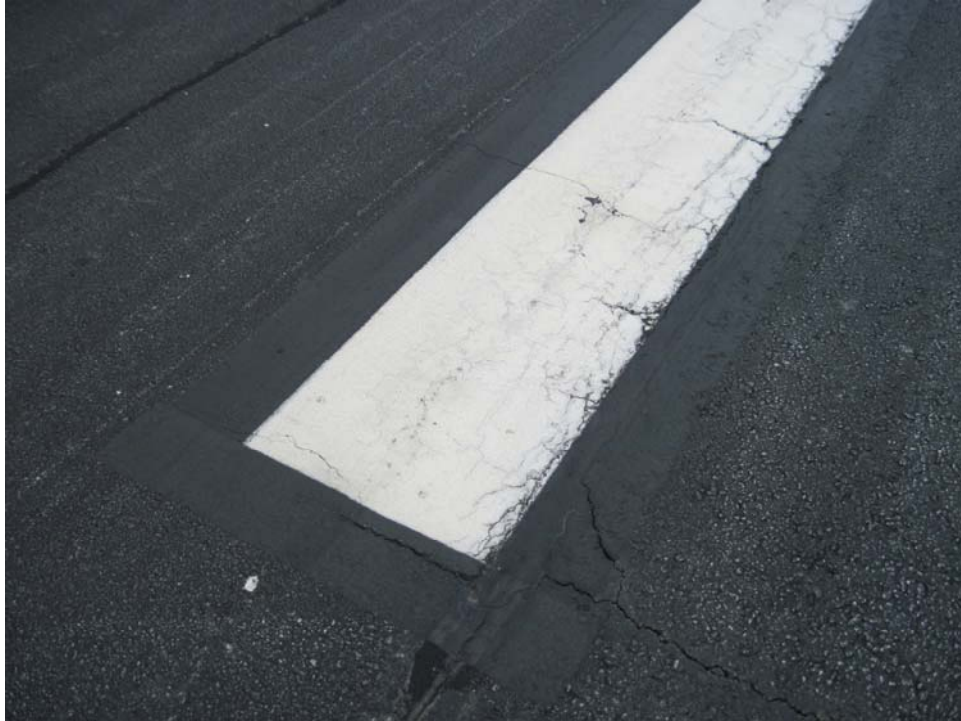
R2L20RAP-10. Overview.

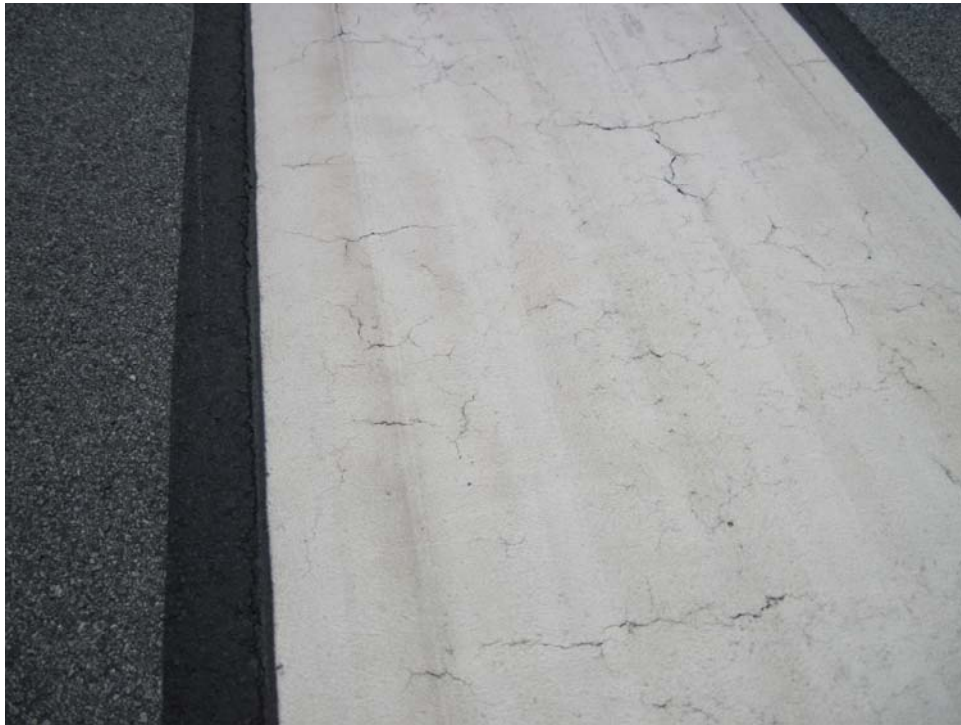
R2L20RAP-20. Longitudinal and Transverse Cracking (Sample Unit #02).

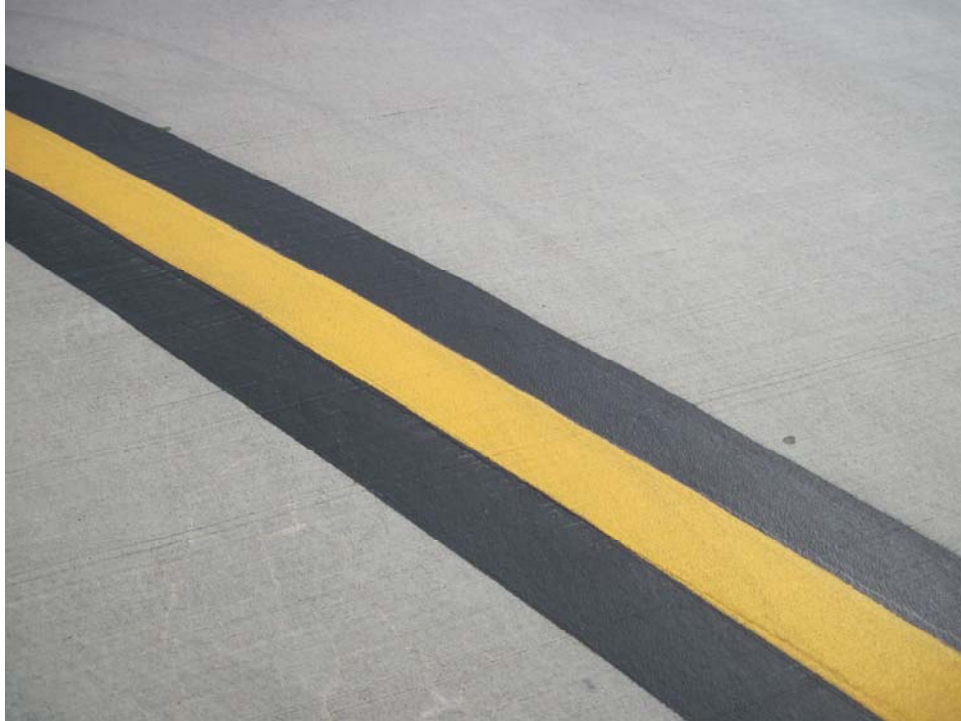
TARUNUPAP-10. Shrinkage Cracking (Sample Unit #02).

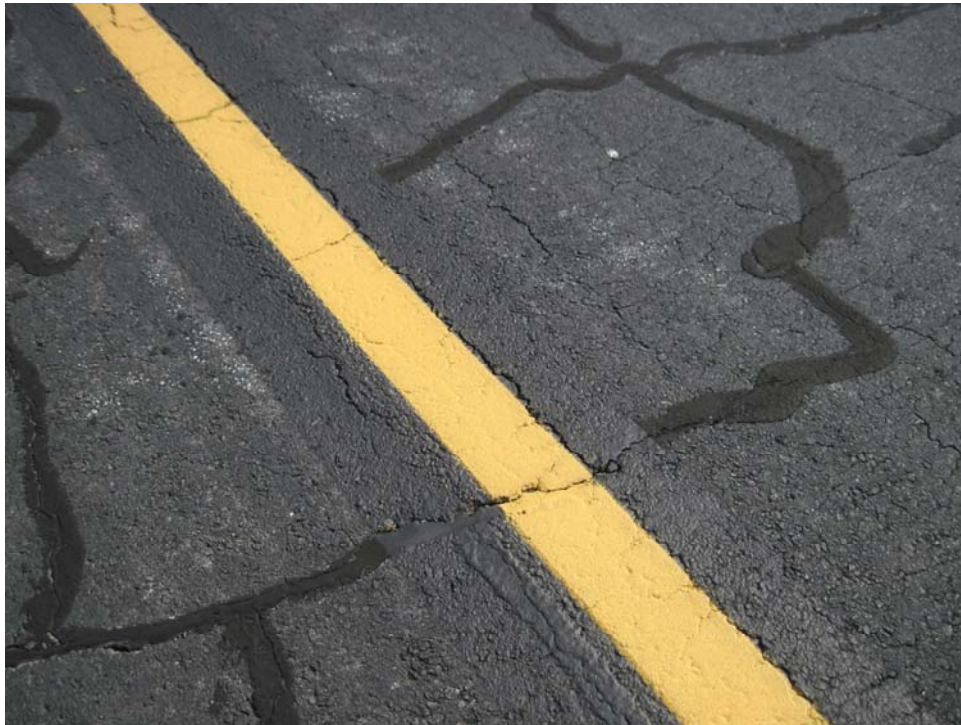
Raveling	Asphalt binder may have hardened significantly, causing coarse aggregate pieces to dislodge.	Patch if isolated. At higher severity levels, consider major rehabilitation if extensive.
Rutting	Usually caused by consolidation or lateral movement of the materials due to traffic loads.	Patch medium- and high-severity levels if localized. If extensive, consider major rehabilitation.
Shoving	Where PCC pavements adjoin flexible pavements, PCC “growth” may shove the asphalt pavement.	Mill and patch as needed.
Slippage Cracking	Low strength surface mix or poor bond between the surface and next layer of pavement structure.	Partial- or full-depth patch.
Swelling	Usually caused by frost action or by swelling soil.	Patch if localized. Major rehabilitation if extensive.
Weathering	Asphalt binder and/or fine aggregate may wear away as the pavement ages and hardens.	Patch if isolated. Consider a surface treatment if extensive.

TBAP-10. Rutting (Sample Unit #03).

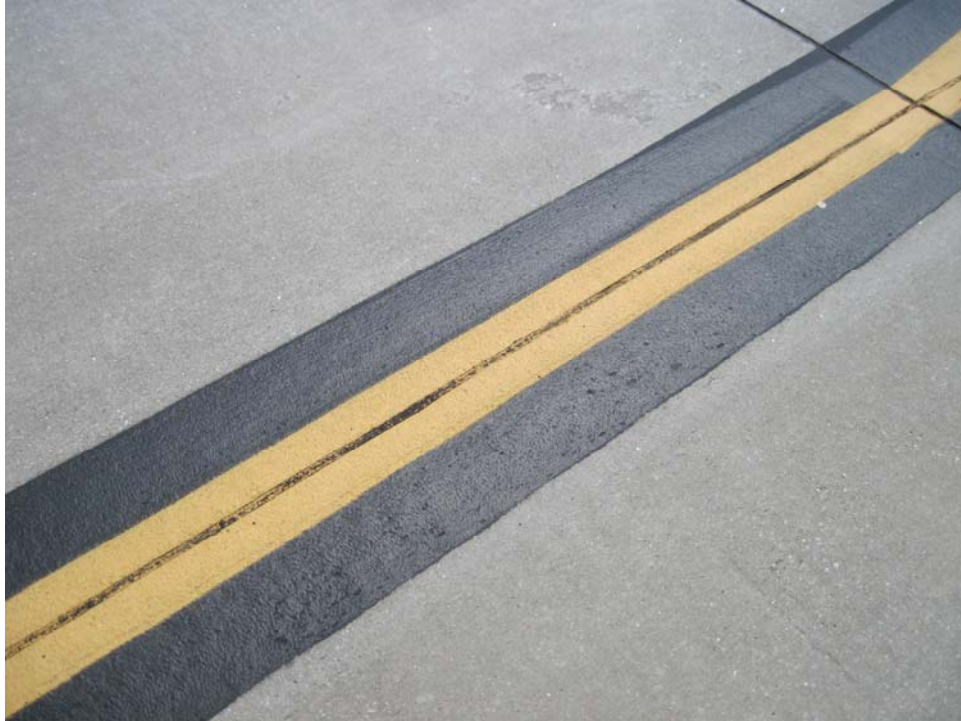
Joint Seal Damage	Stripping of joint sealant, extrusion of joint sealant, weed growth, hardening of the filler (oxidation), loss of bond to the slab edges, or absence of sealant in joint.	Replace joint seal.
Patching (Small and Large)	N/A	Replace patches if deteriorated.
Popouts	Freeze-thaw action in combination with expansive aggregates.	Monitor.
Pumping	Poor drainage, poor joint sealant.	Seal cracks and joints. Underseal is an option if voids have developed. Establish good drainage.
Scaling	Overfinishing of concrete, deicing salts, improper construction, freeze-thaw cycles, and poor aggregate.	At low-severity levels, do nothing. At medium- and high-severity levels, partial-depth patches or slab replacement.
Settlement	Upheaval or consolidation.	At higher severity levels, leveling patch or grind to restore smooth ride.
Shattered Slab	Load repetition.	Replace slab.
Shrinkage	Setting and curing of the concrete.	Monitor.

TBAP-20. Joint Seal Damage (Sample Unit #16).

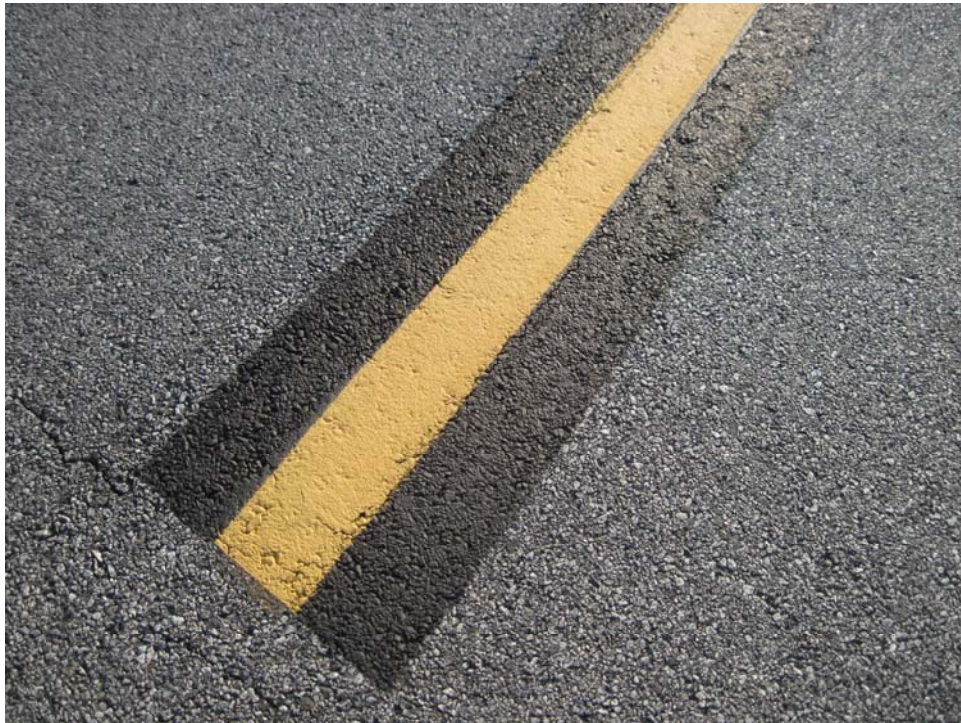
TBAP-30. Weathering (Sample Unit #04).

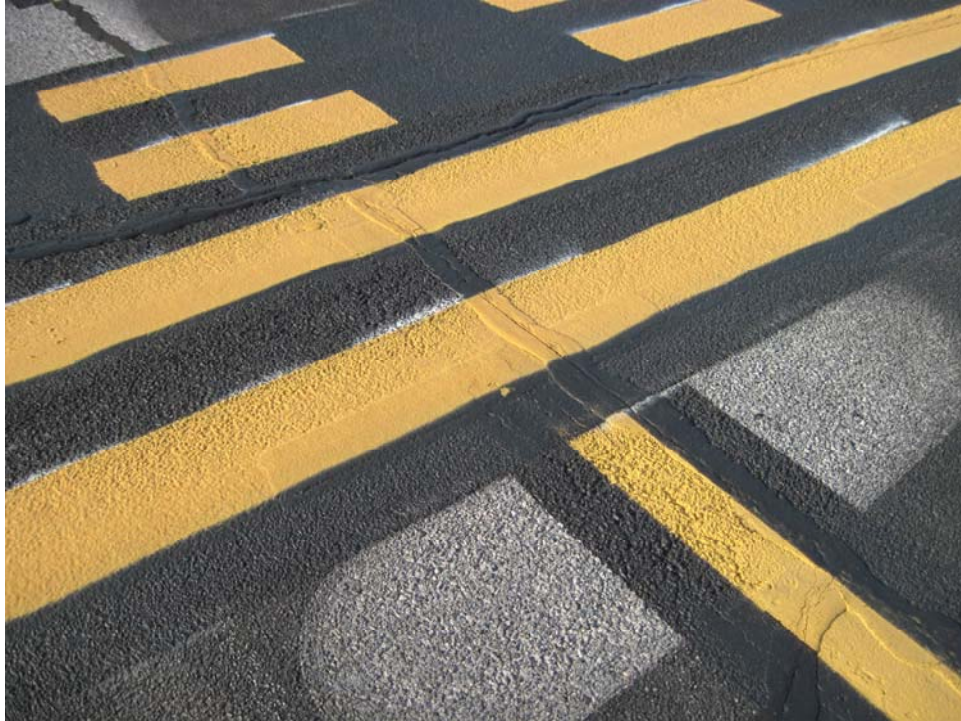
TBAP-40. Weathering and Longitudinal and Transverse Cracking (Sample Unit #4).

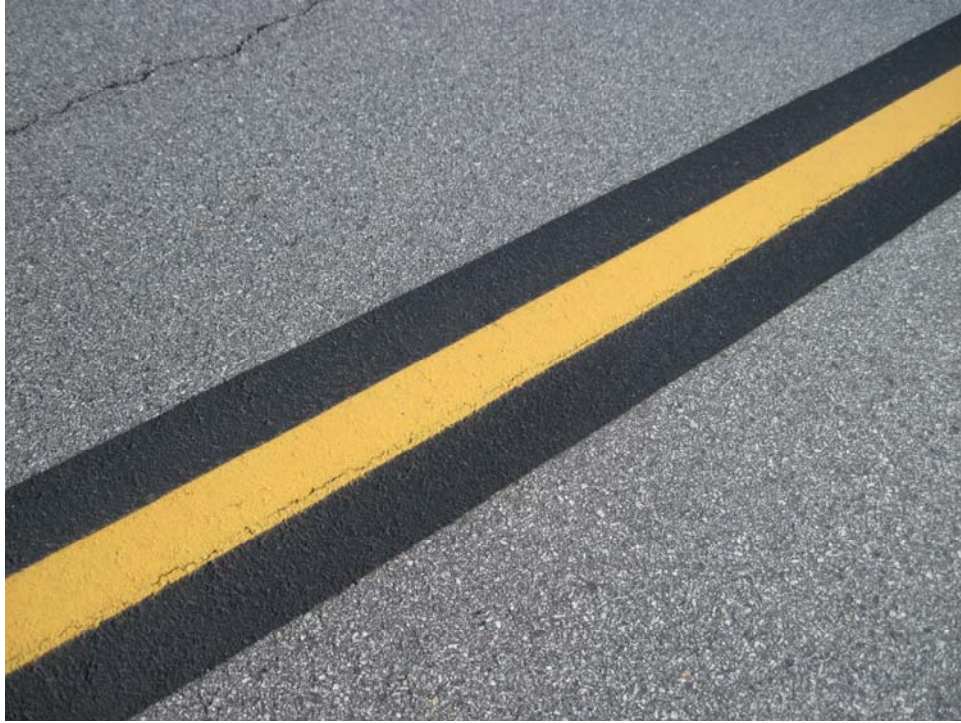
TCAP-10. Longitudinal and Transverse Cracking and Weathering (Sample Unit #02).

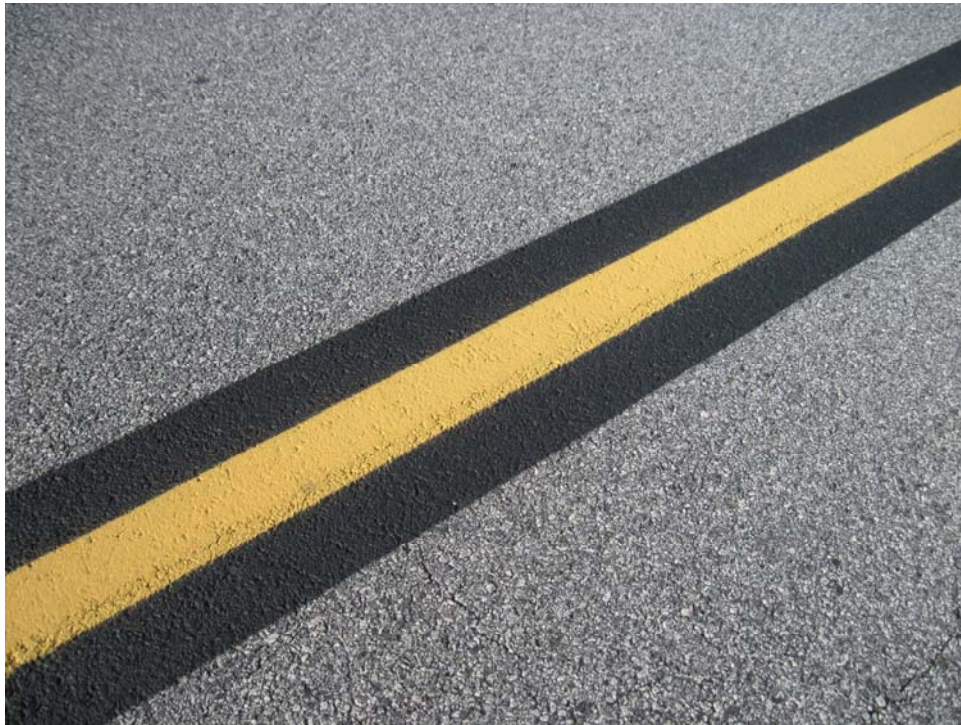
TCAP-20. Weathering and Longitudinal and Transverse Cracking (Sample Unit #01).

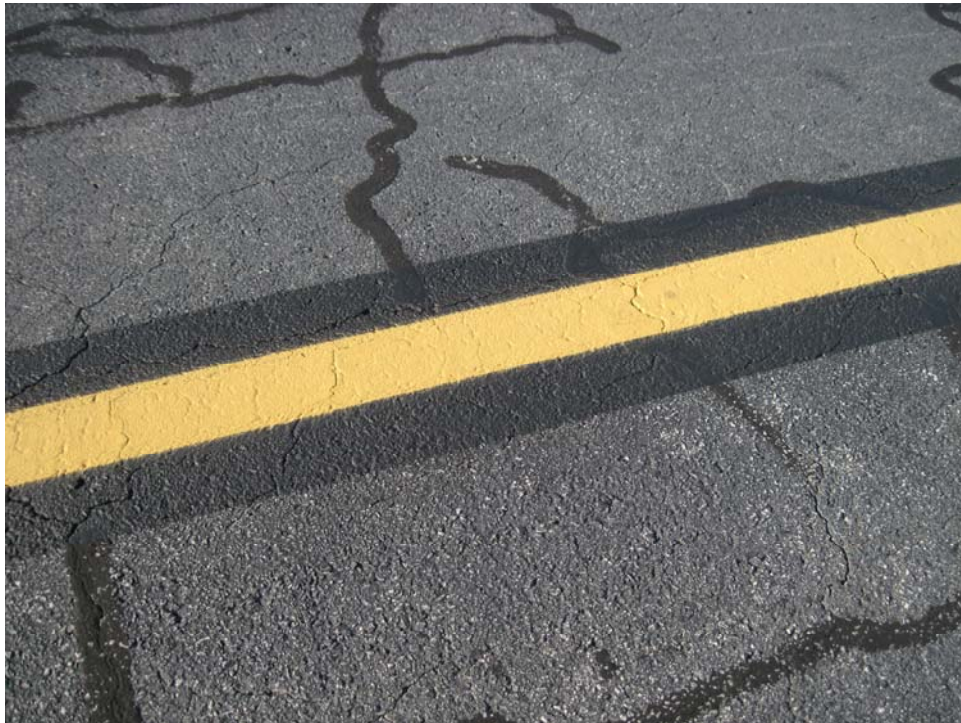
TCAP-30. Satisfactory Paint.

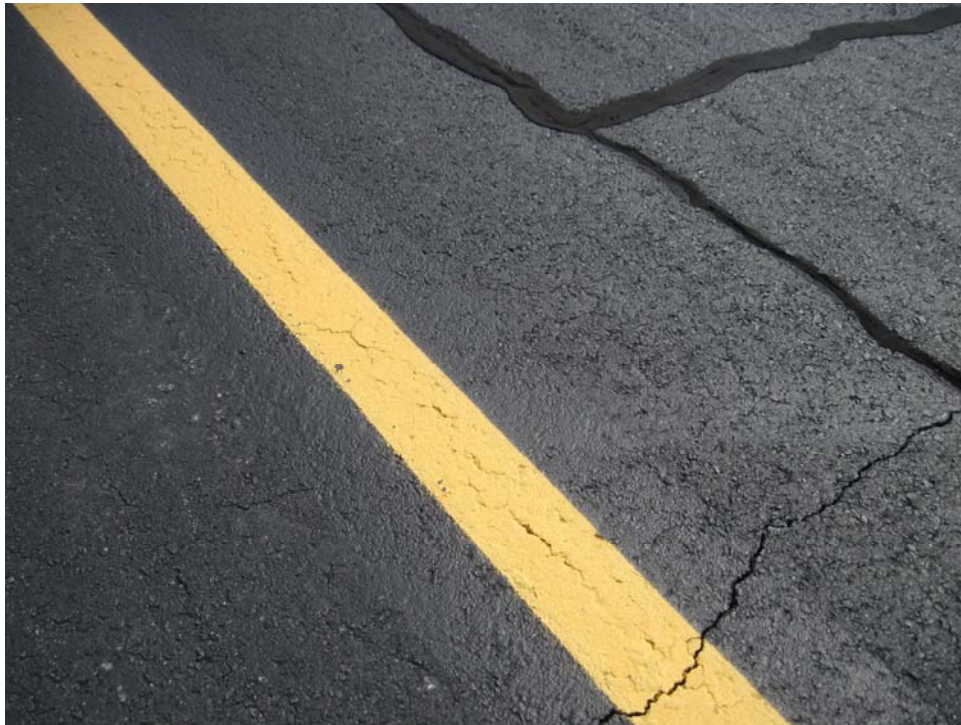
TDAP-10. Satisfactory Paint.

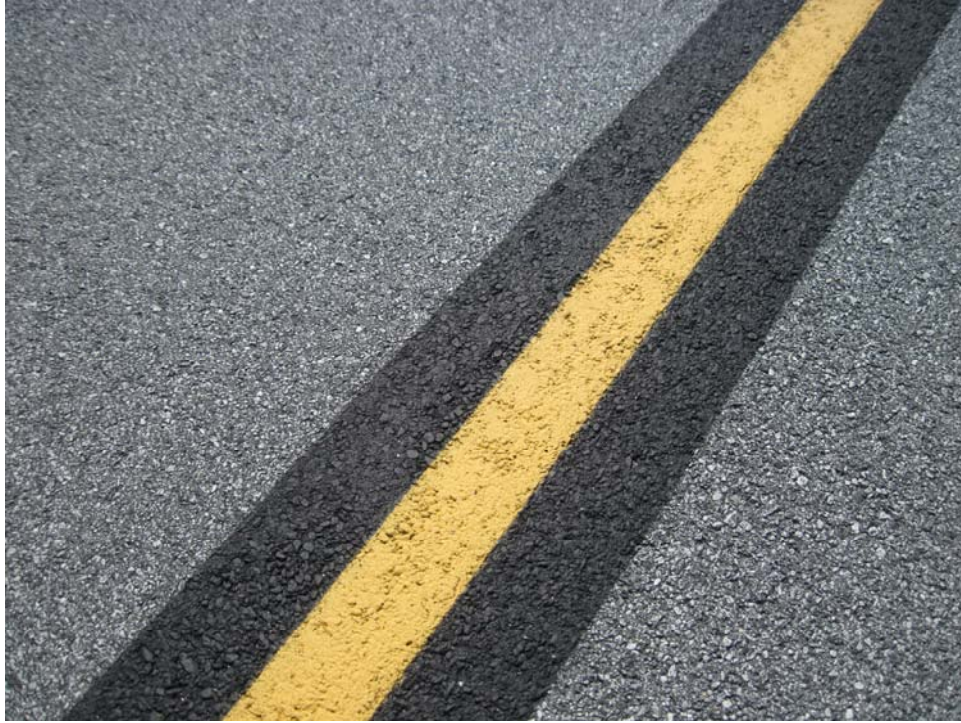
TDAP-20. Satisfactory Paint.

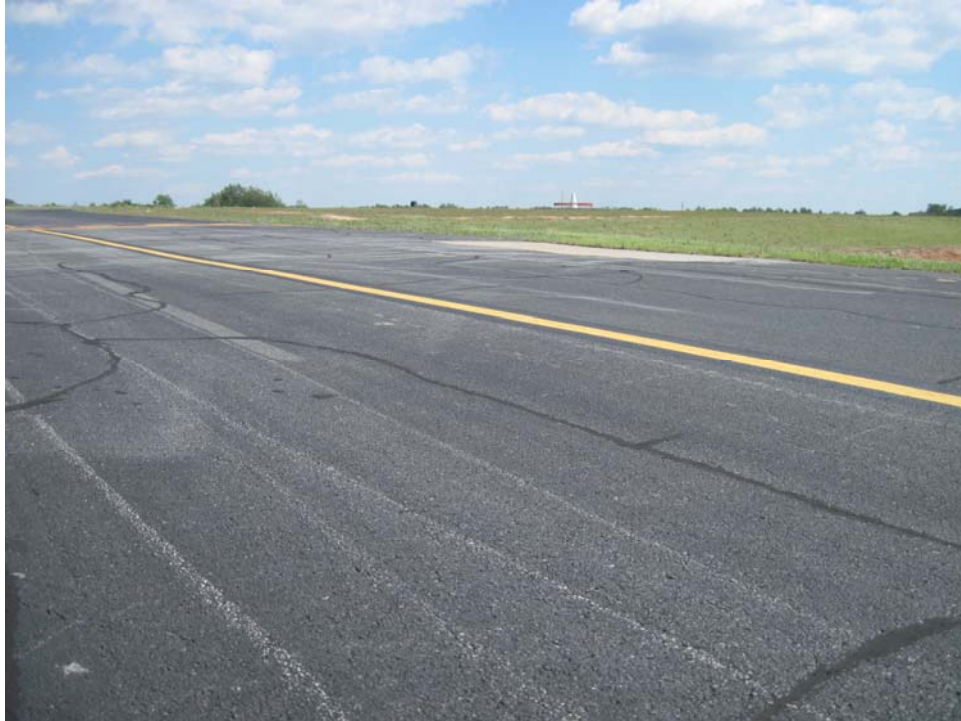
TGAP-10. Rutting (Sample Unit #04).

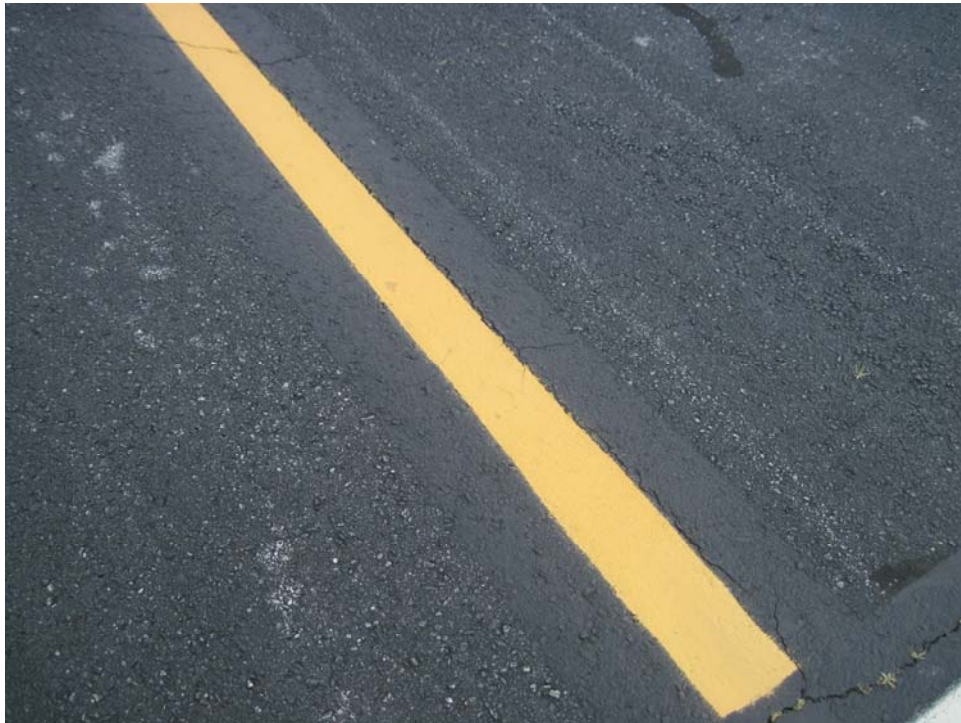
TGAP-10. Satisfactory Paint.

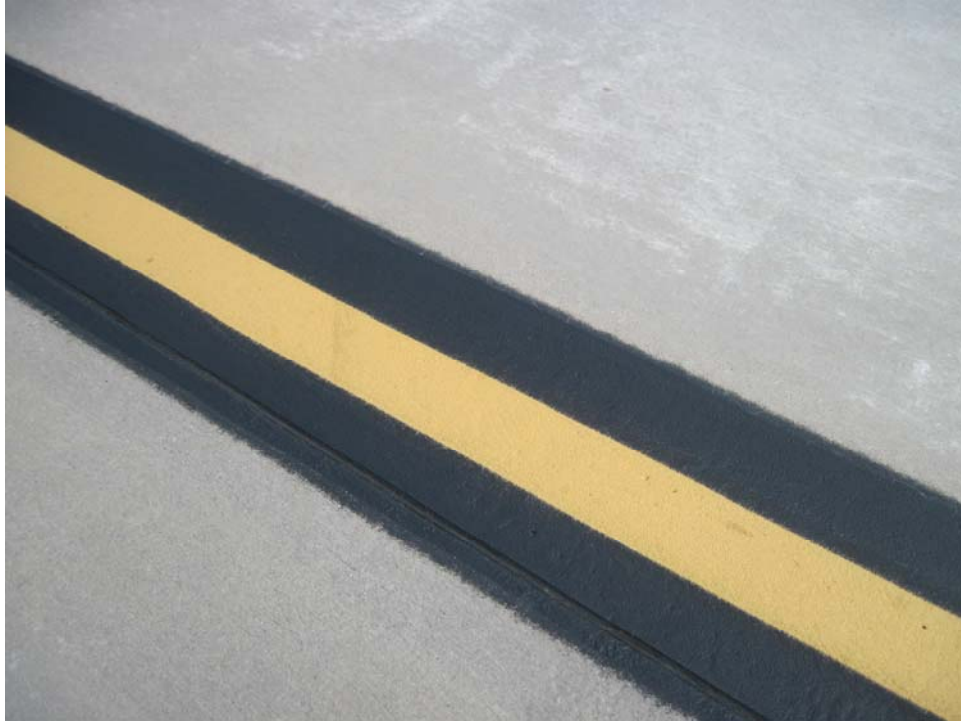
THAP-10. Satisfactory Paint.
