# 2012 Augusta Regional at Bush Field Pavement Management Plan

# AUGUSTA REGIONAL AT BUSH FIELD

## PAVEMENT MANAGEMENT REPORT

**DECEMBER 2012**

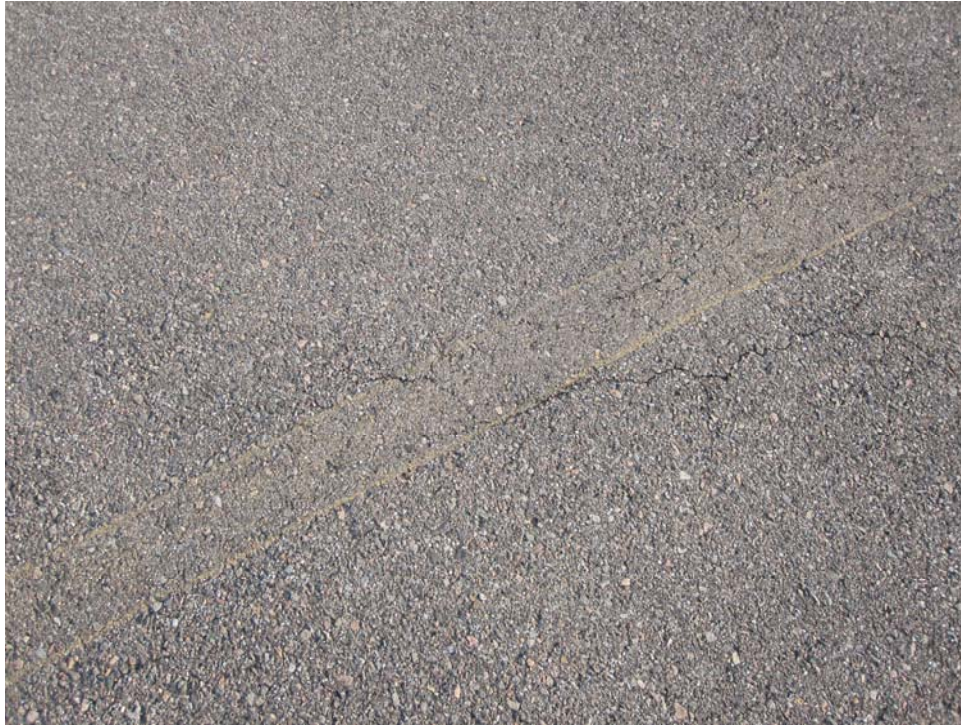
A01AGR-60. Unsatisfactory Paint.

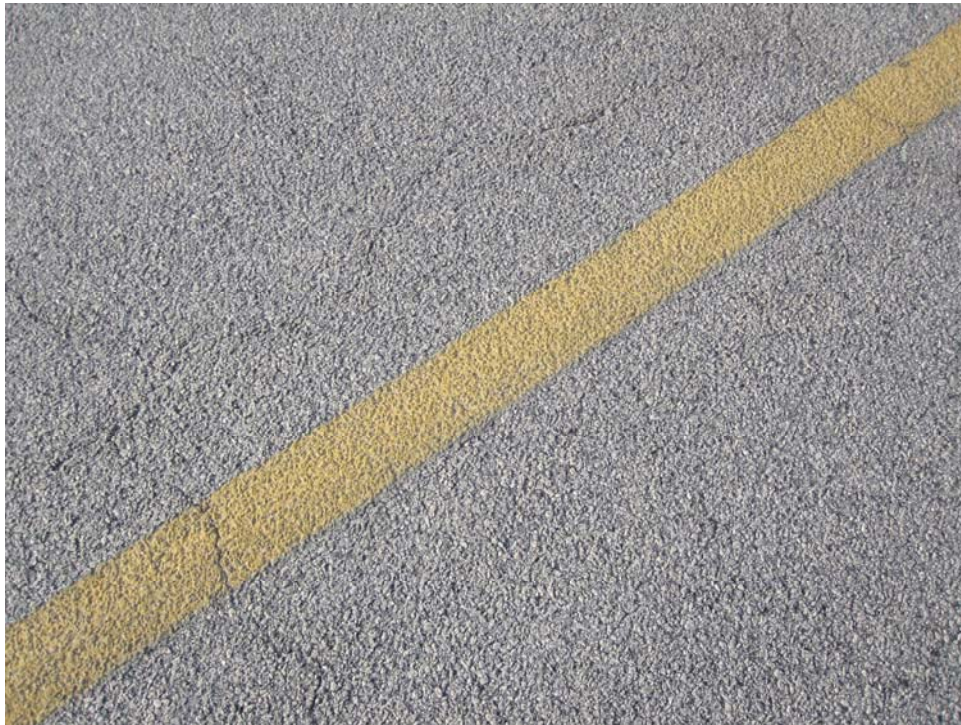
AGARRETAGR-30. Satisfactory Paint.

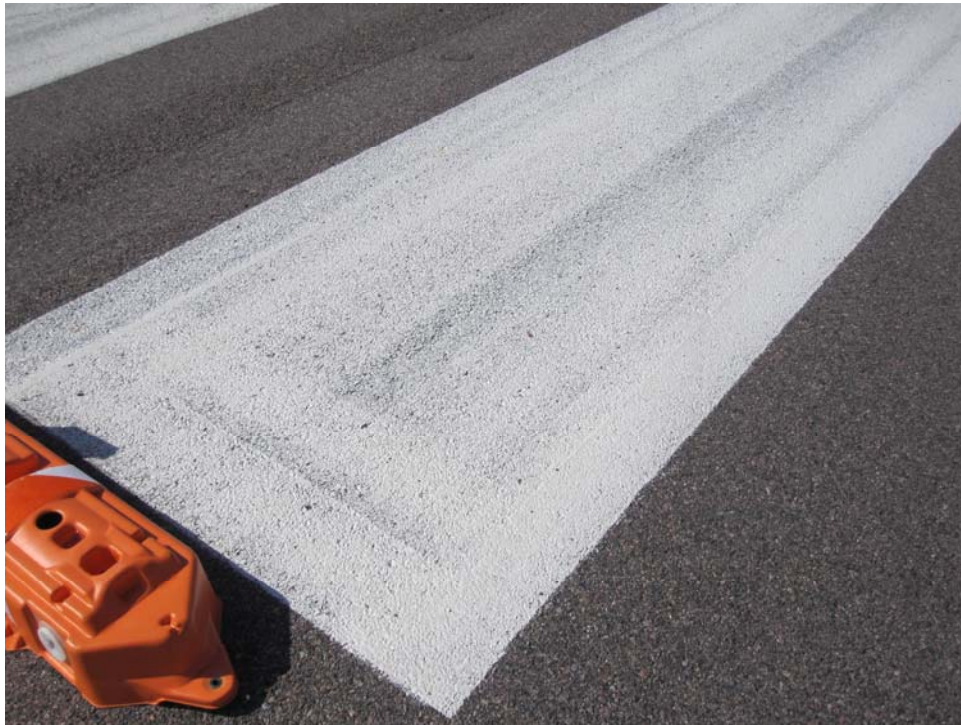
R0826AGR-10. Satisfactory Paint.

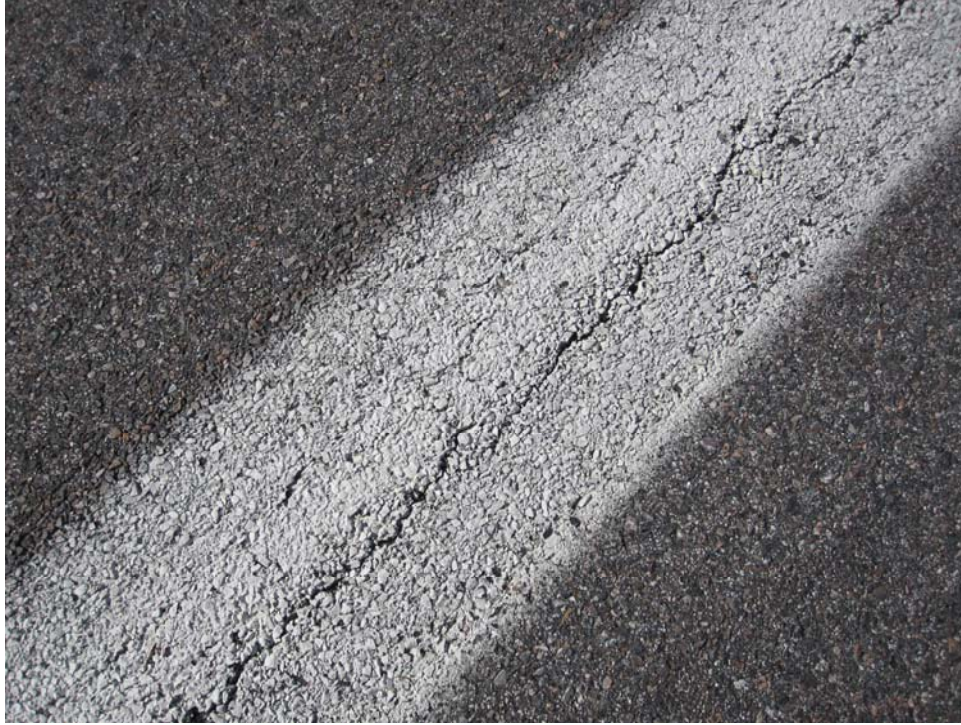
R0826AGR-20. Satisfactory Paint.

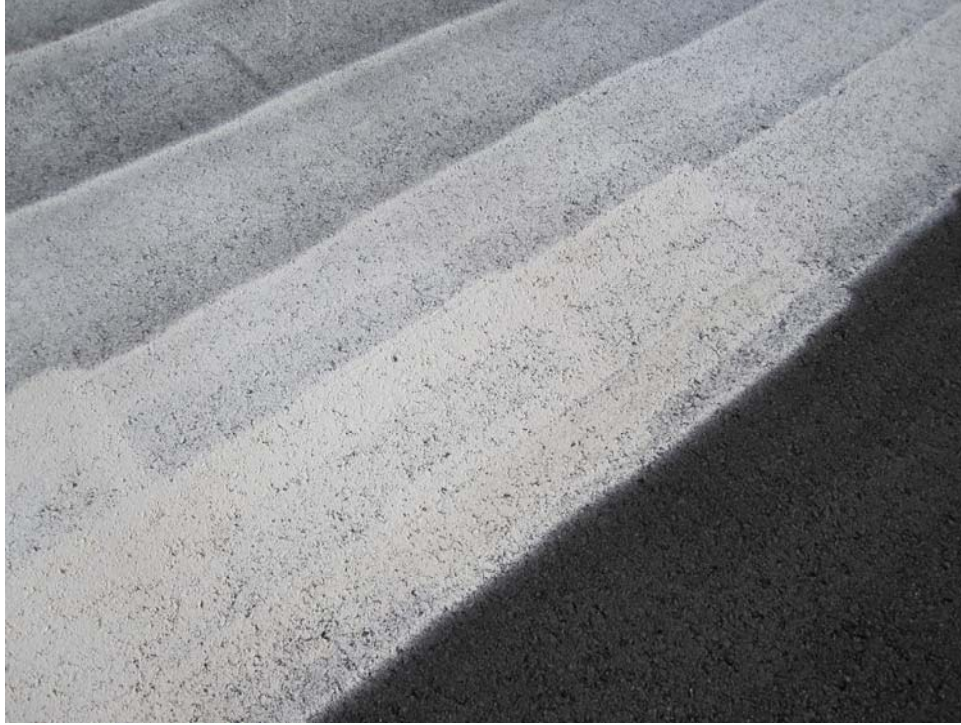
R0826AGR-25. Satisfactory Paint.

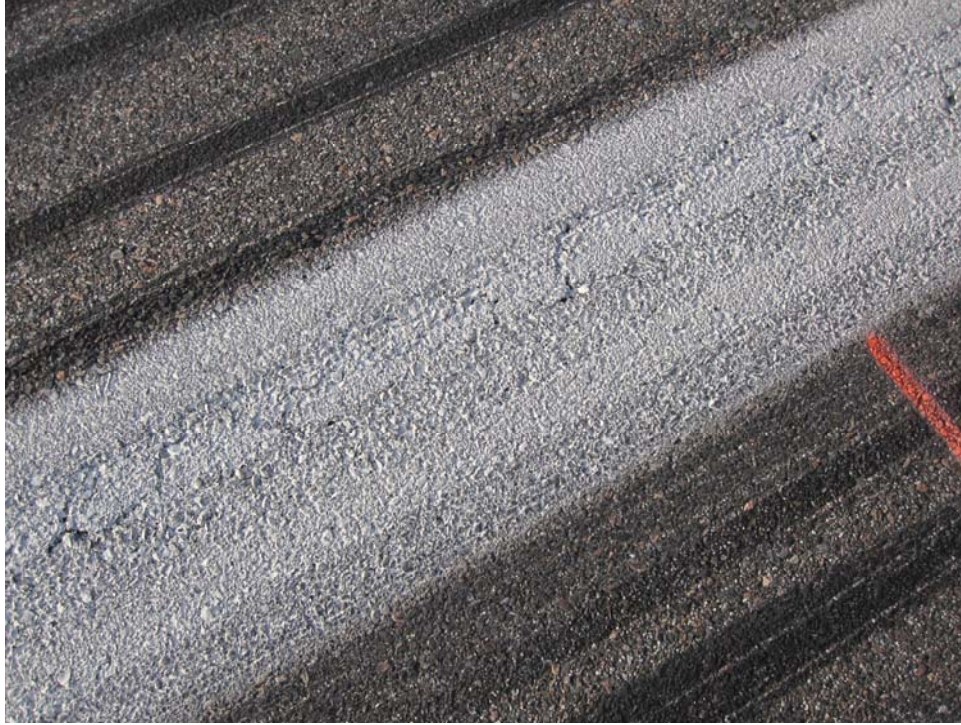
R0826AGR-30. Satisfactory Paint.

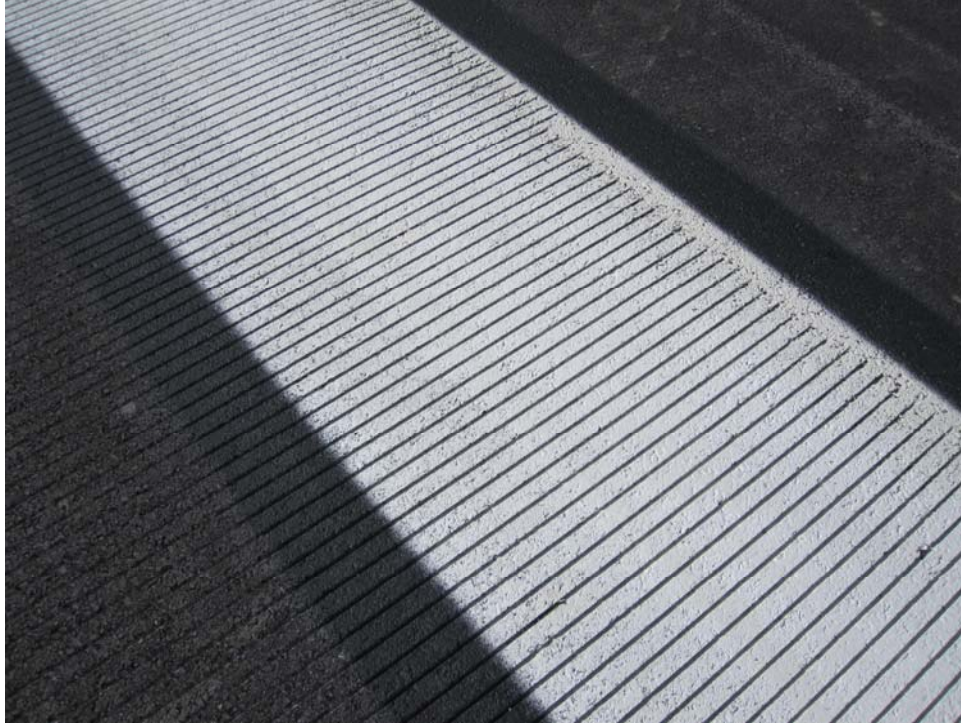
R1735AGR-10W. Satisfactory Paint.

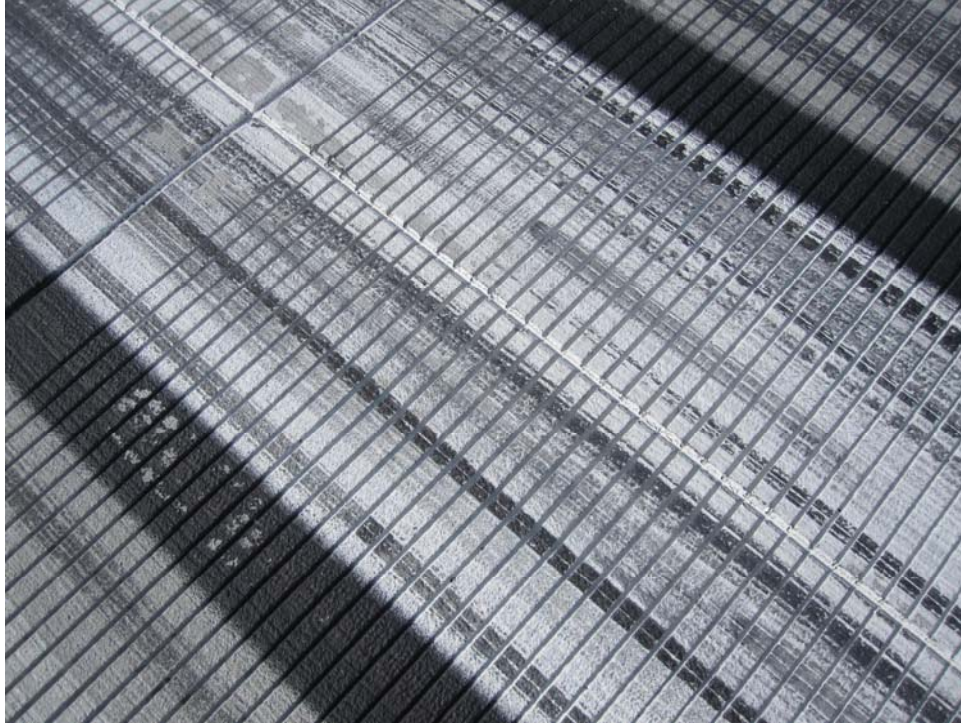
R1735AGR-20C. Satisfactory Paint.

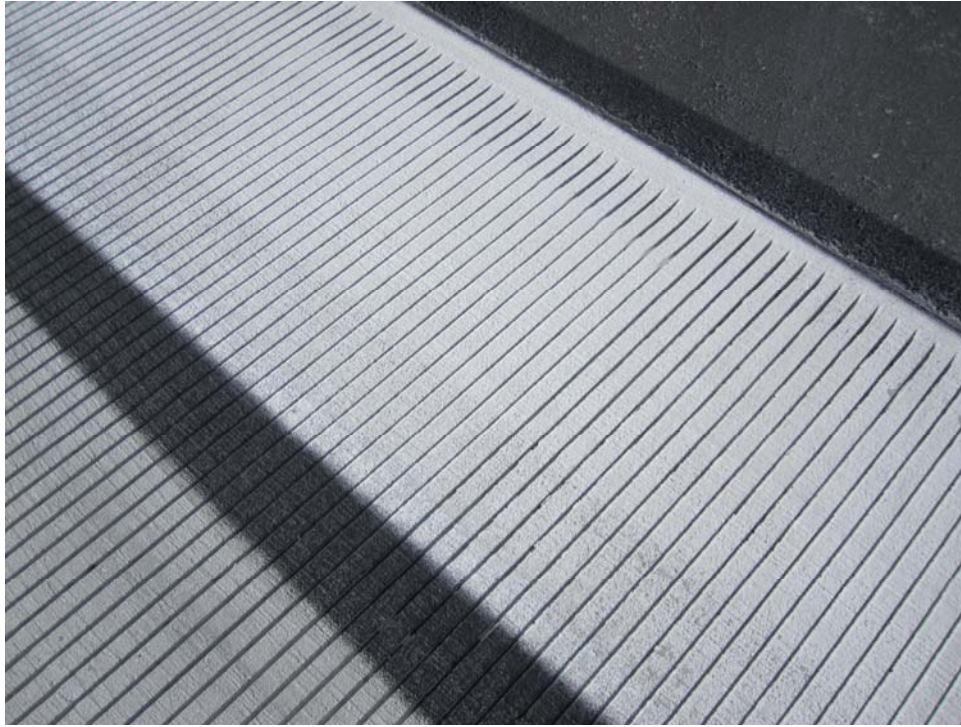
R1735AGR-20W. Satisfactory Paint.

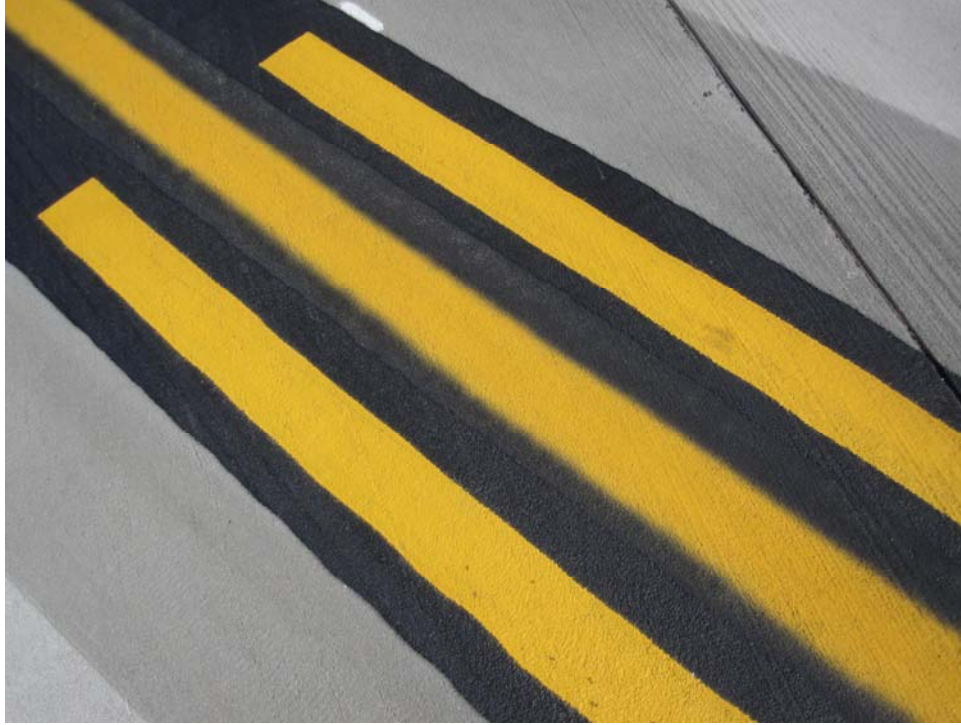
TAAGR-10. Satisfactory Paint.

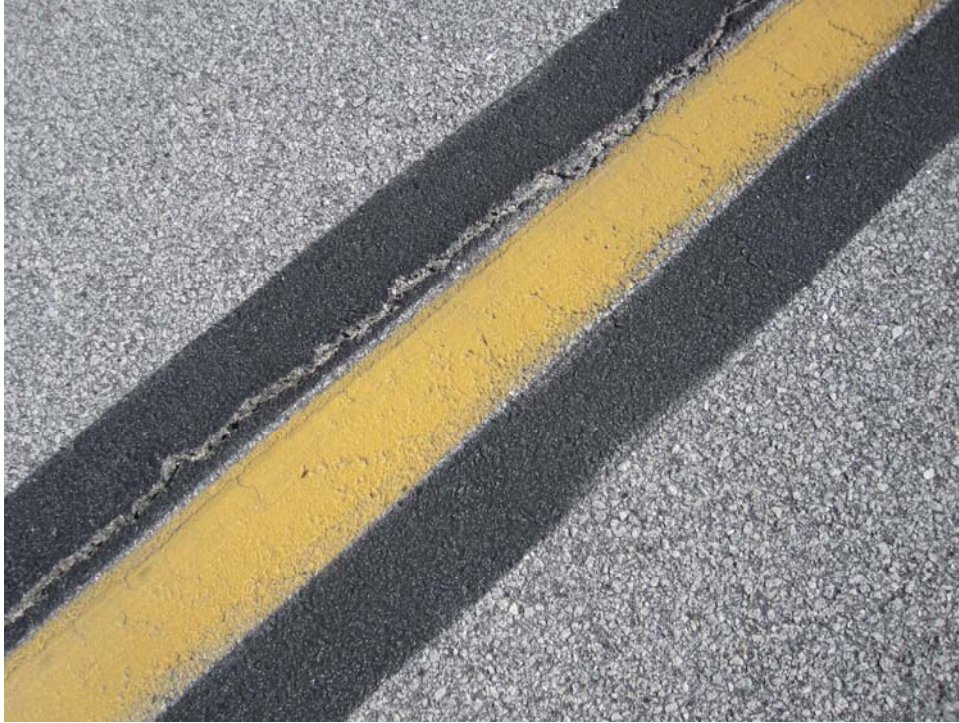
TAAGR-20. Satisfactory Paint.

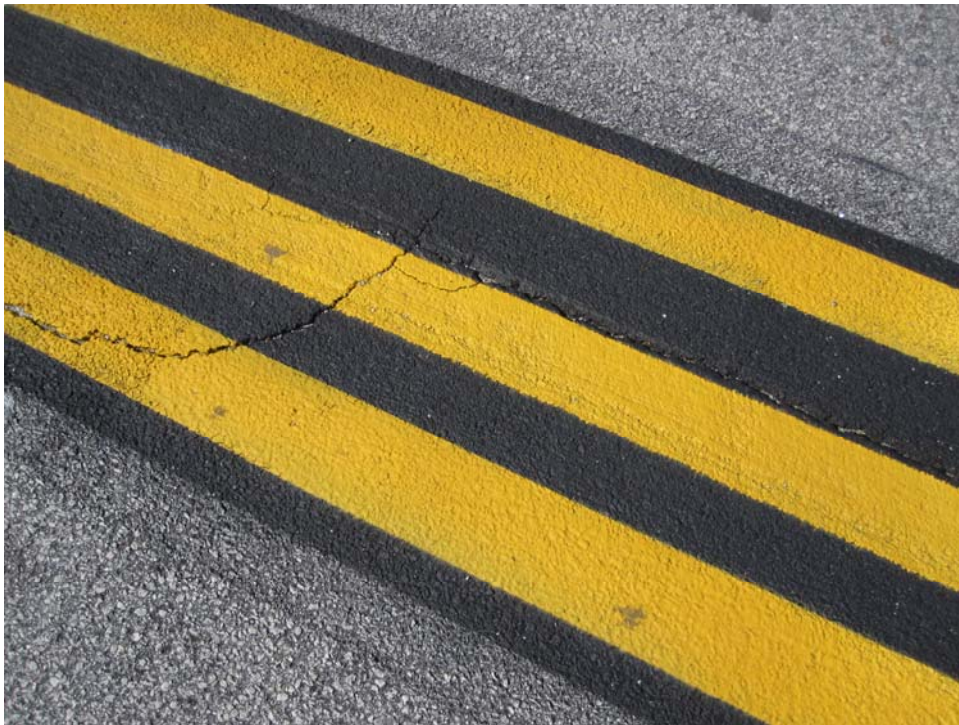
TBAGR-10. Satisfactory Paint.

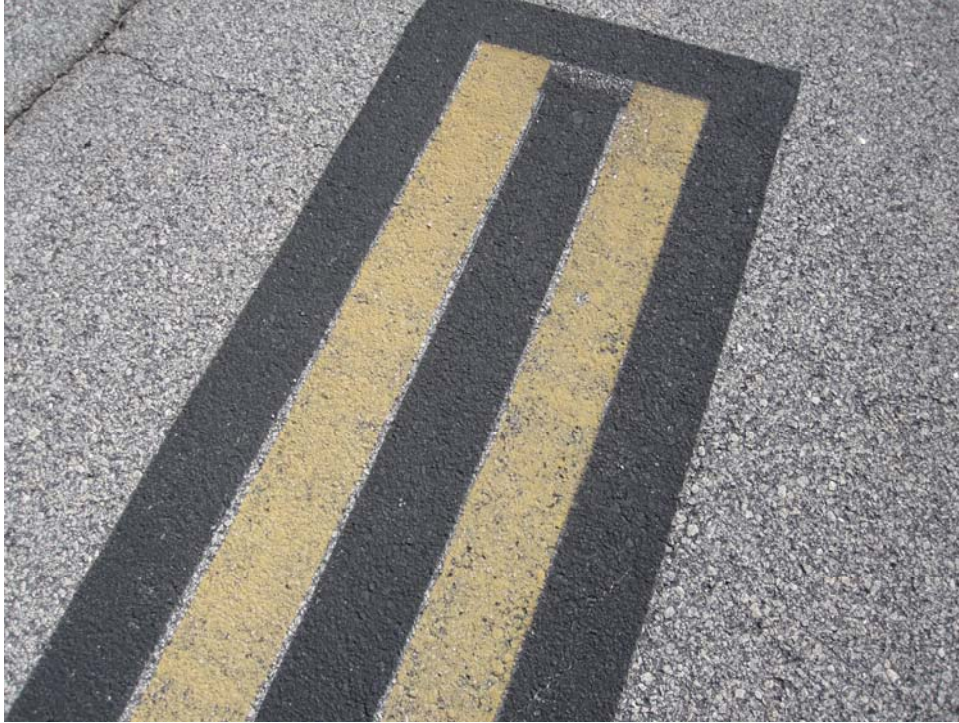
TCAGR-10. Satisfactory Paint.

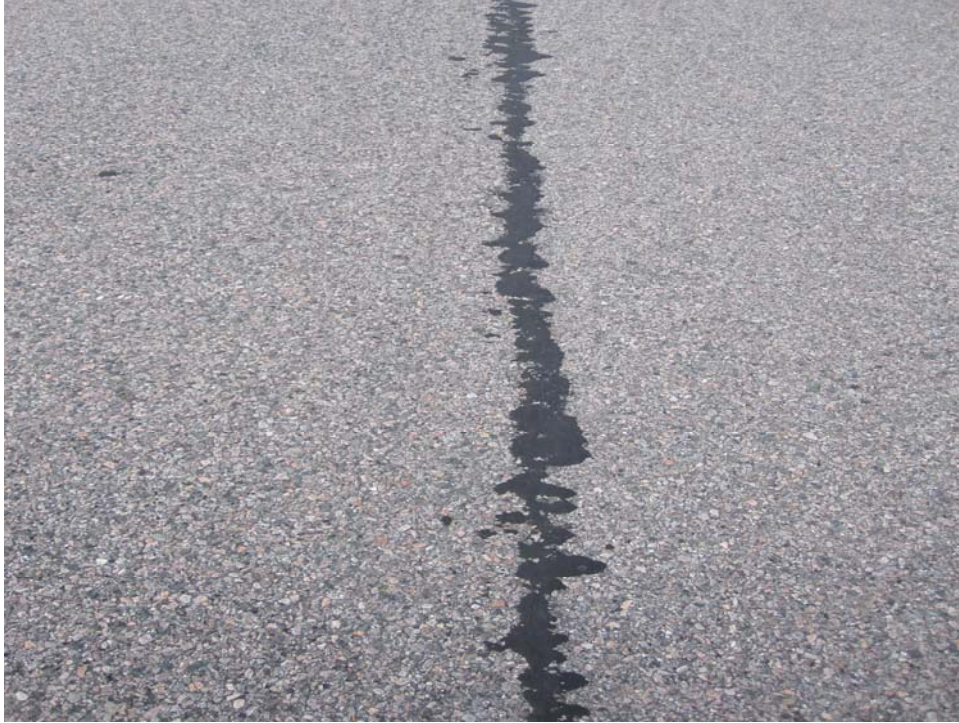
TCAGR-20. Bleeding (Sample Unit #40).

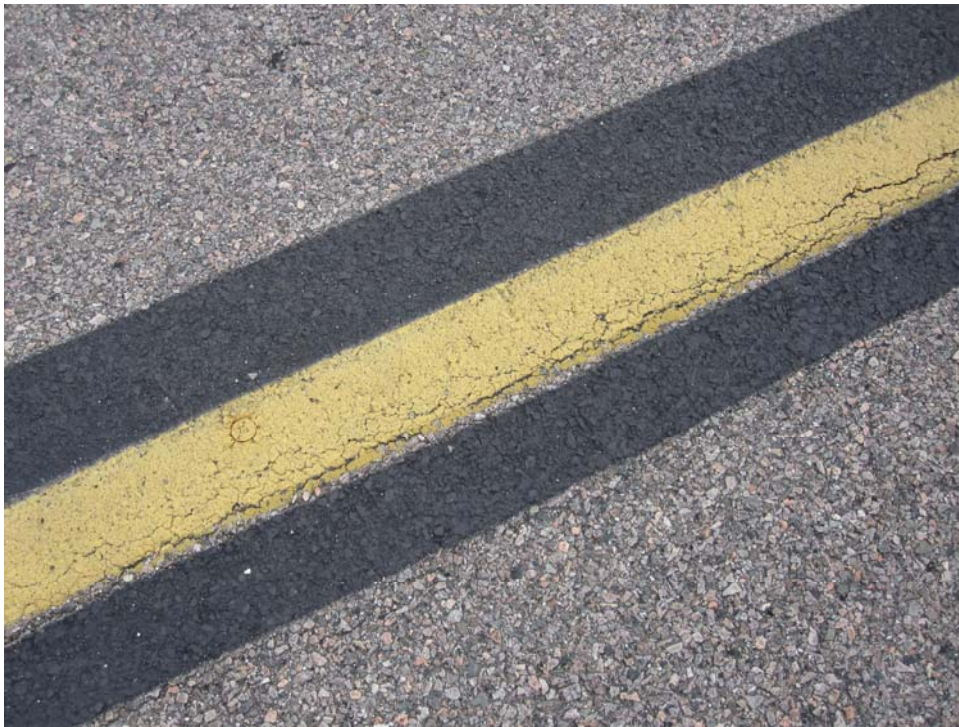
TCAGR-20. Satisfactory Paint.

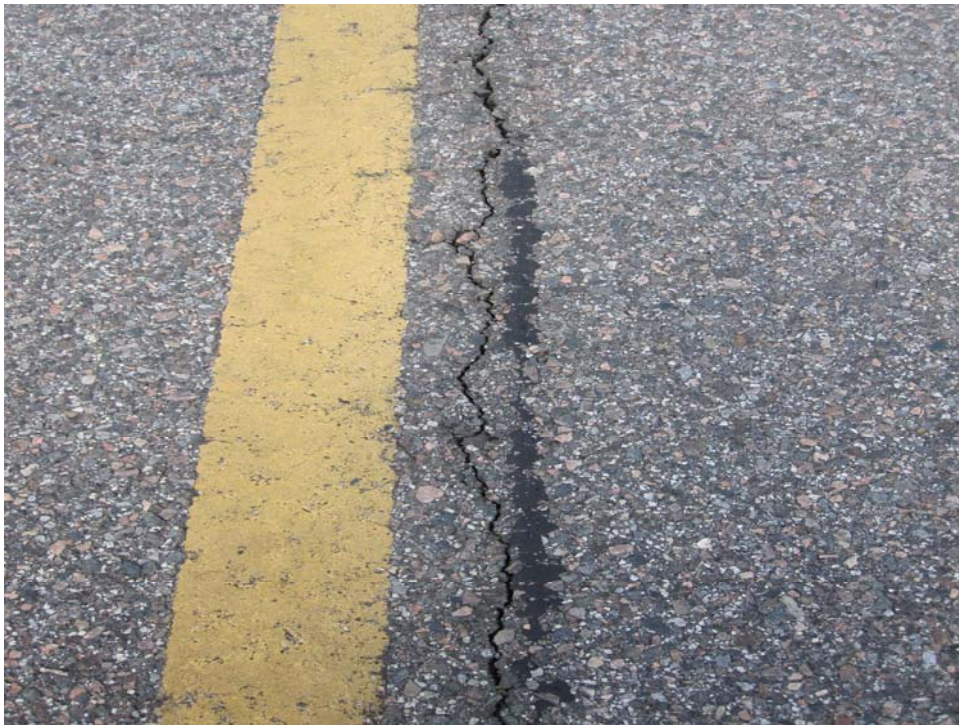
TCAGR-30. Bleeding (Sample Unit #22).

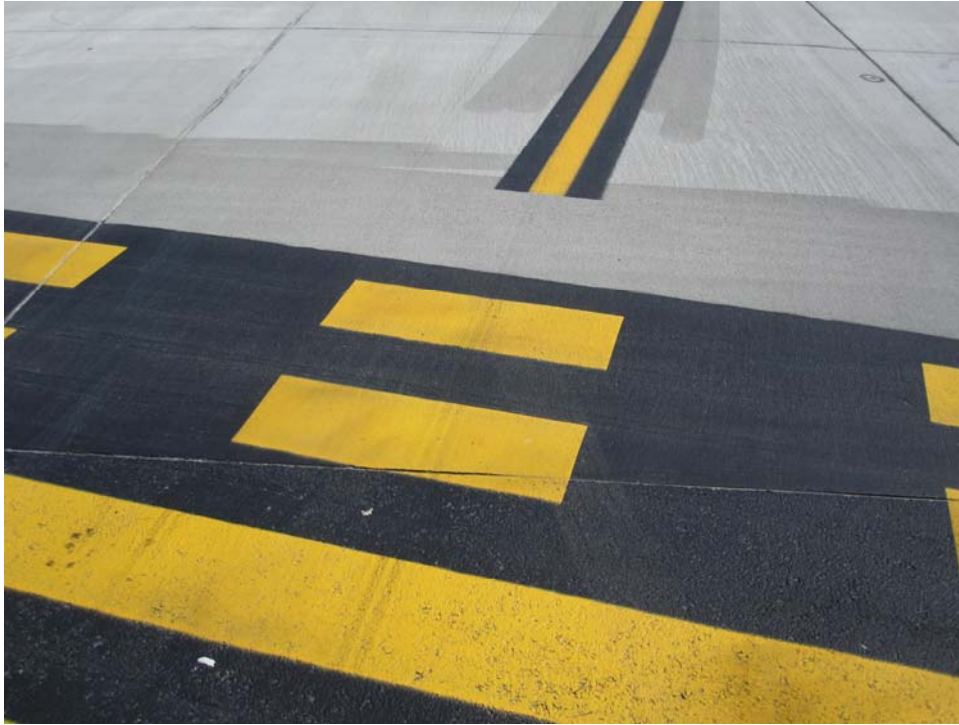
TCAGR-40. Satisfactory Paint.

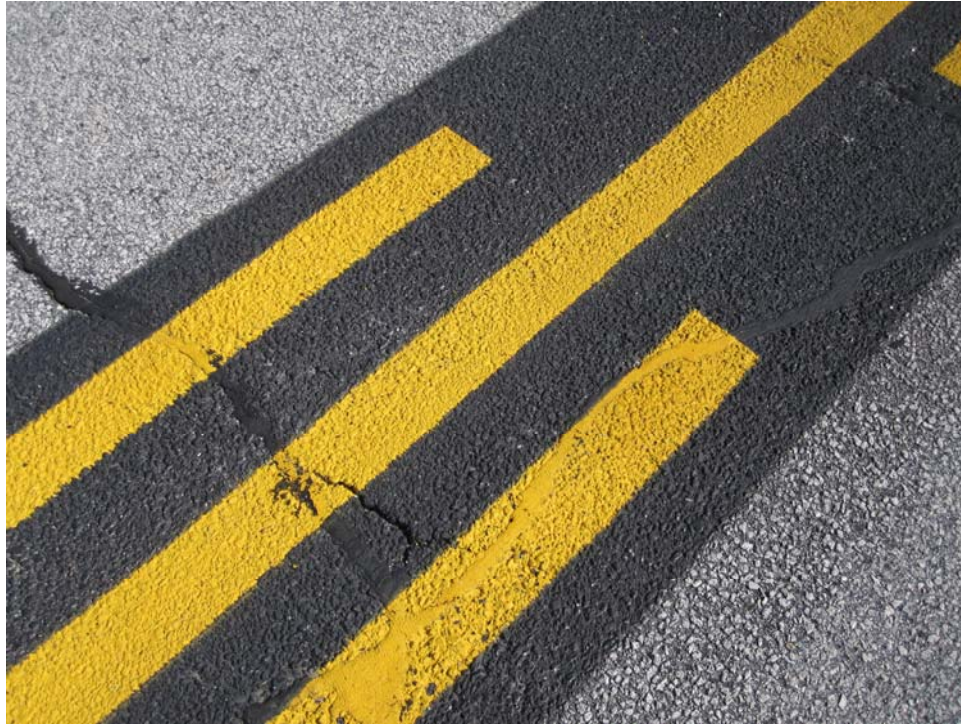
TEAGR-10. Satisfactory Paint.

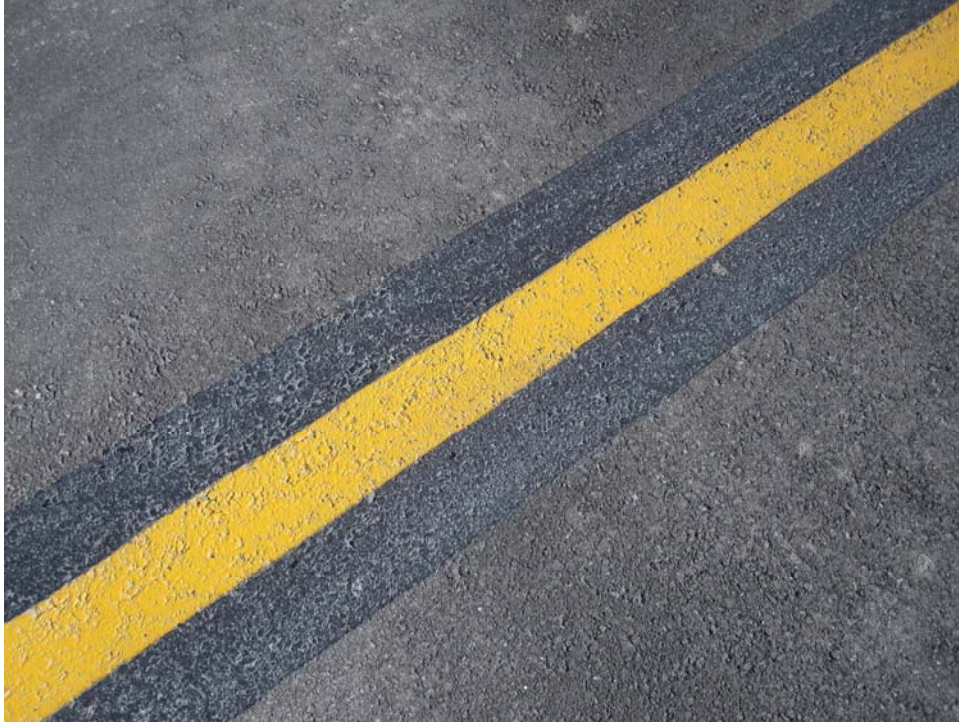
TEAGR-30. Satisfactory Paint.
