# 2012 Middle Georgia Regional Airport Pavement Management Plan

# MIDDLE GEORGIA REGIONAL AIRPORT

## PAVEMENT MANAGEMENT REPORT

**DECEMBER 2012**

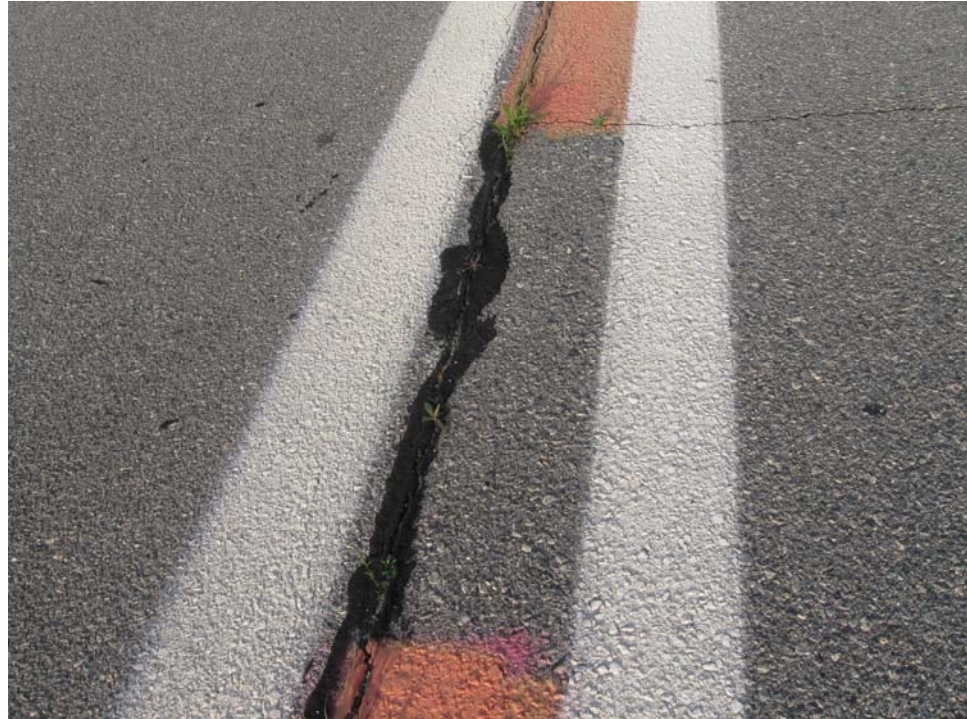
A01MGRA-10. Satisfactory Paint.

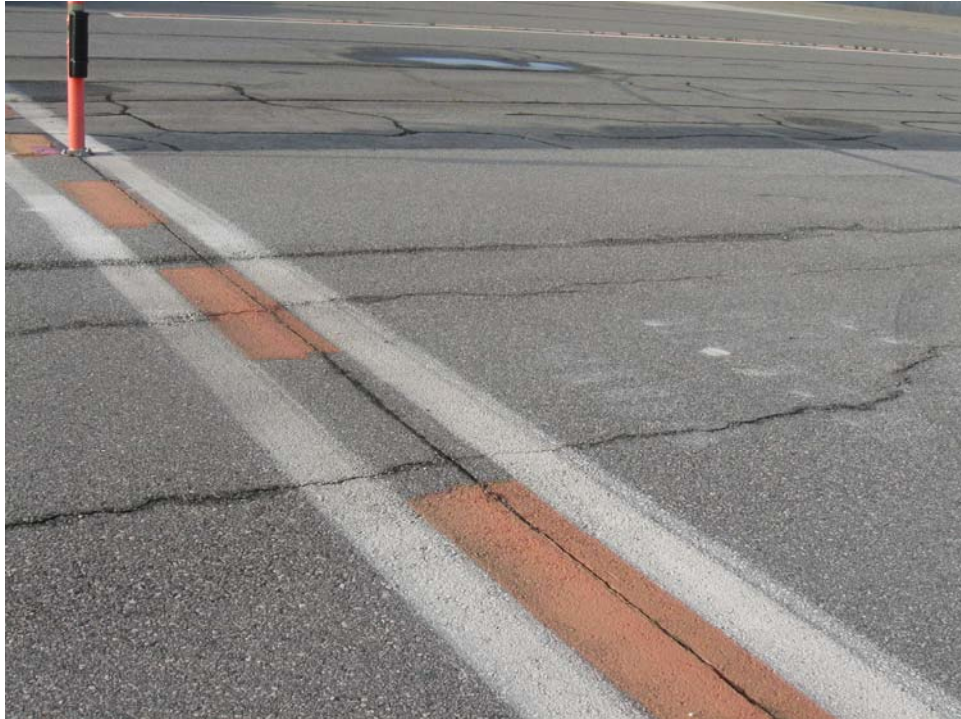
A01MGRA-30. Satisfactory Paint.

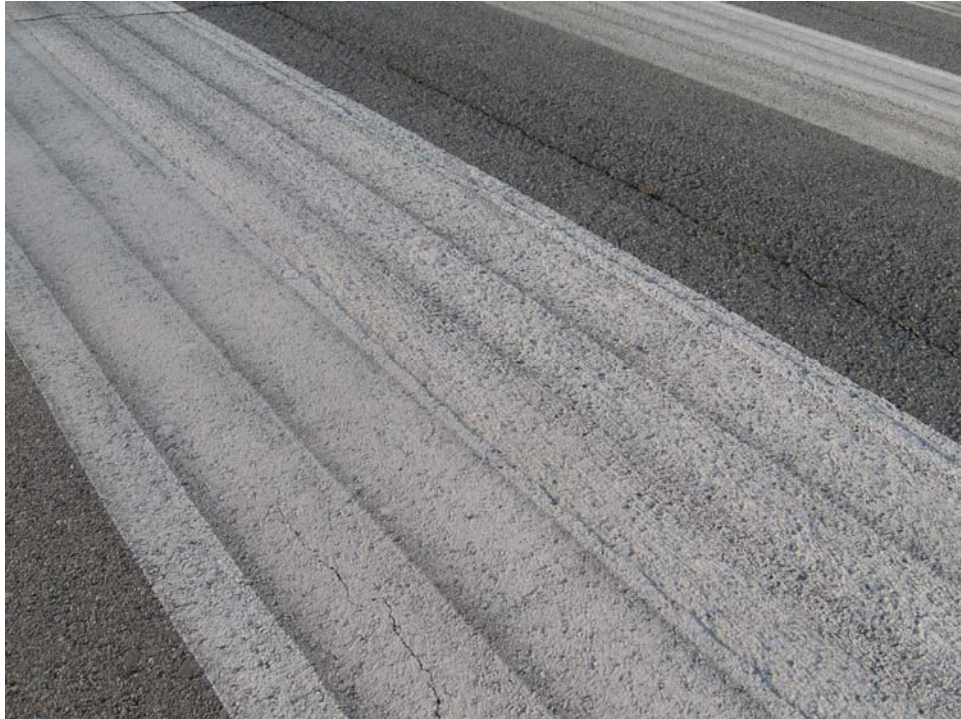
R1311MGRA-10C. Unsatisfactory Paint.

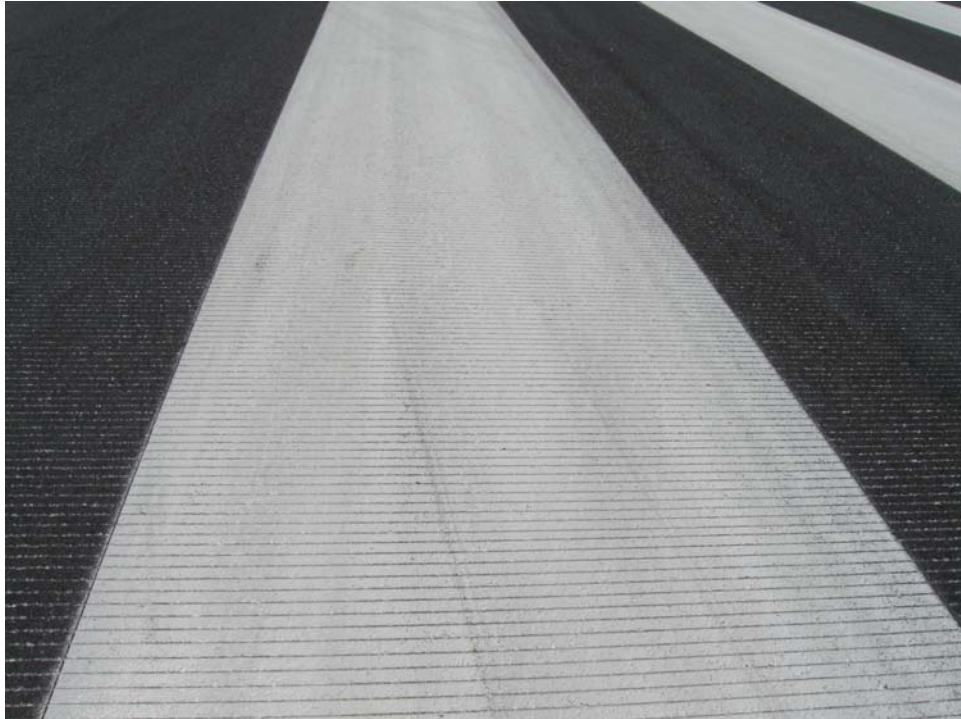
R523MGRA-10C. Satisfactory Paint.

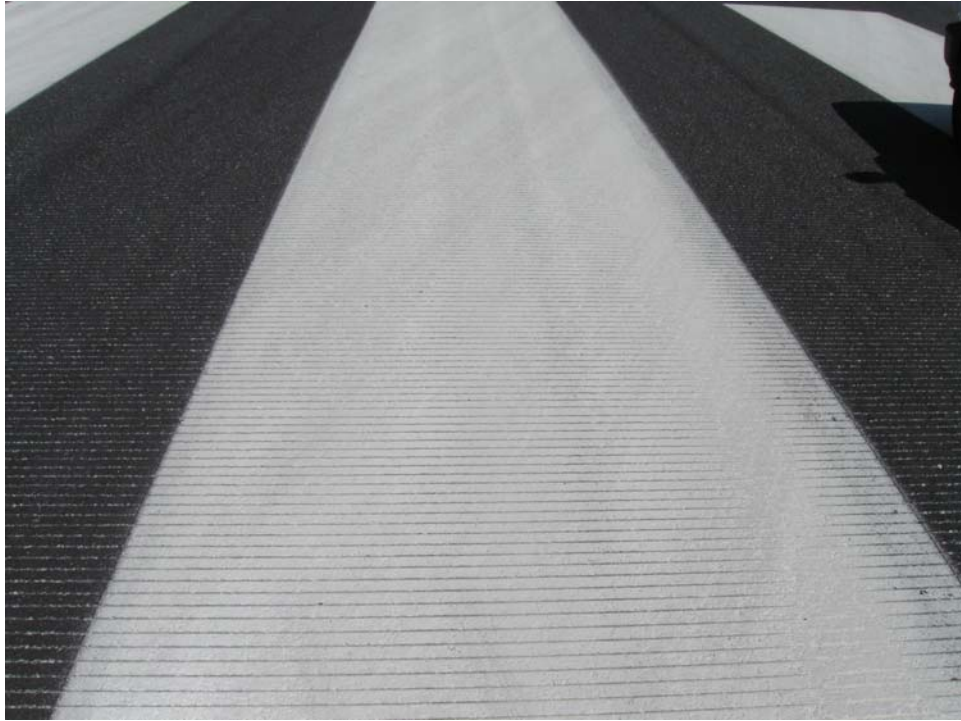
R523MGRA-10N. Satisfactory Paint.

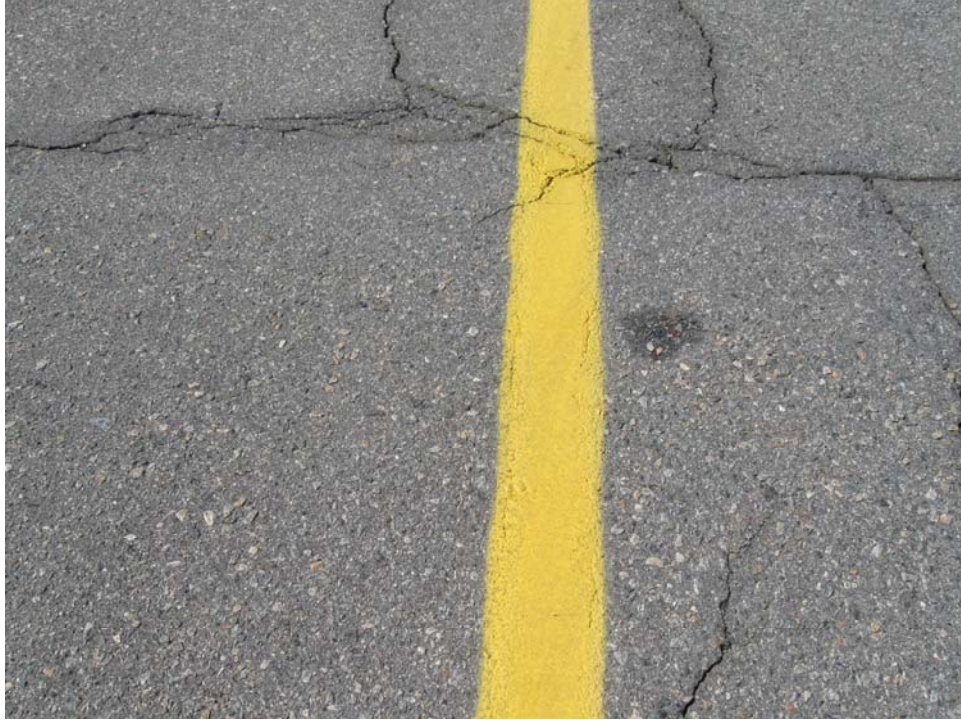
TAMGRA-10. Satisfactory Paint.

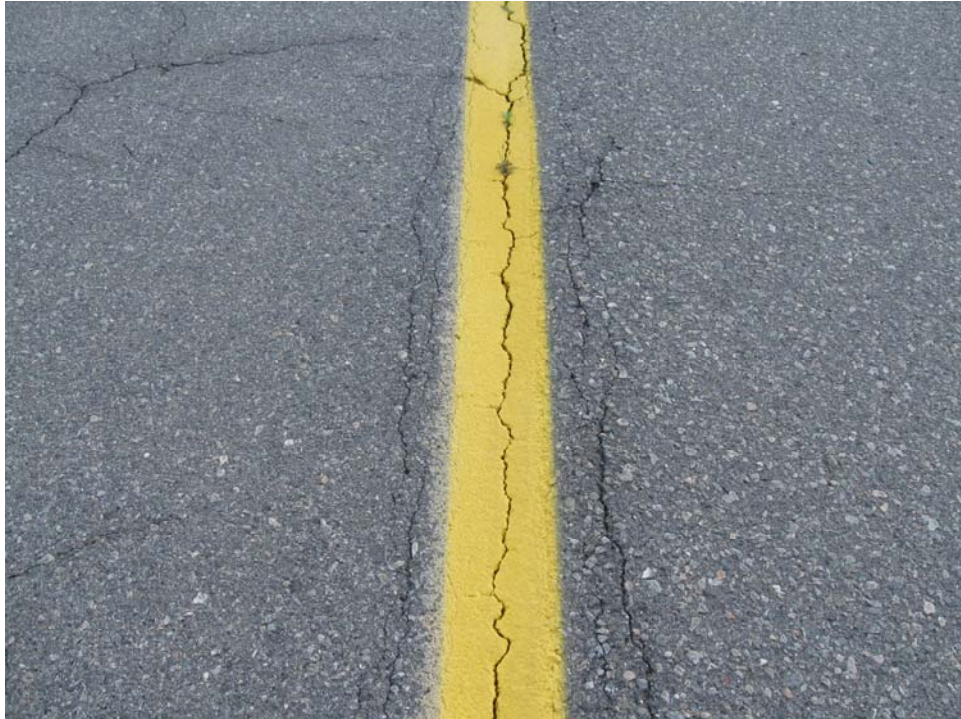
TB3MGRA-10. Satisfactory Paint.

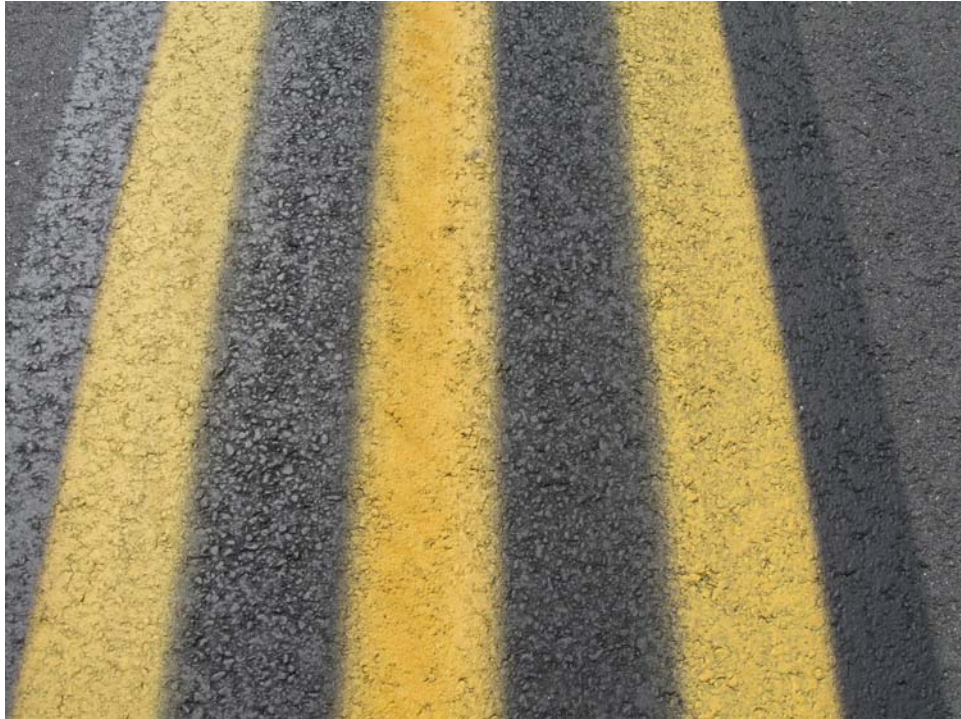
TBMGRA-10. Satisfactory Paint.

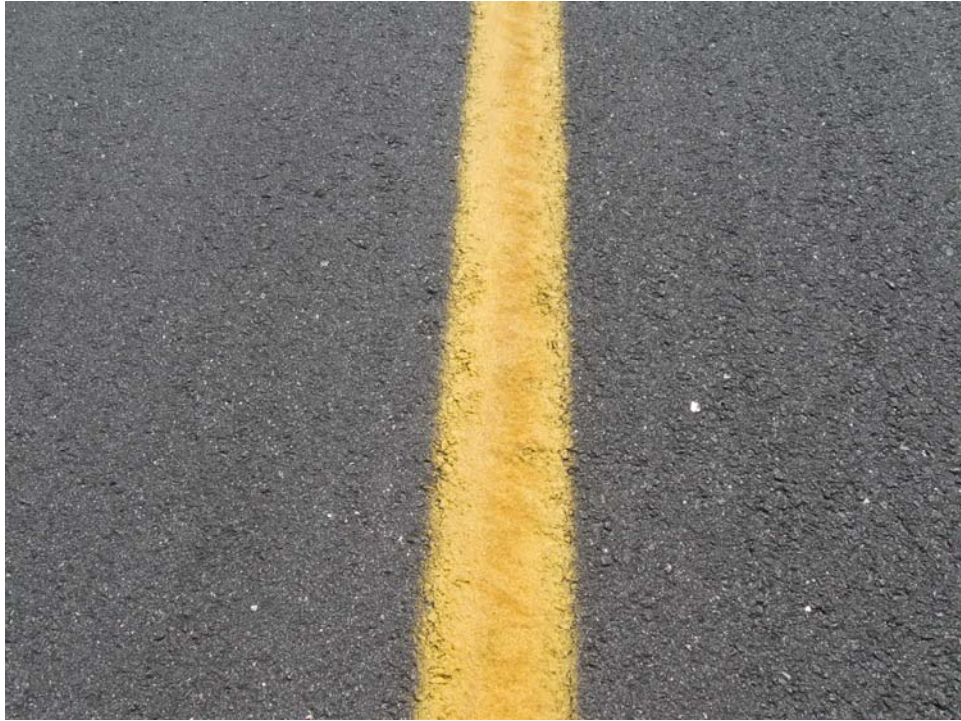
TBMGRA-20. Satisfactory Paint.

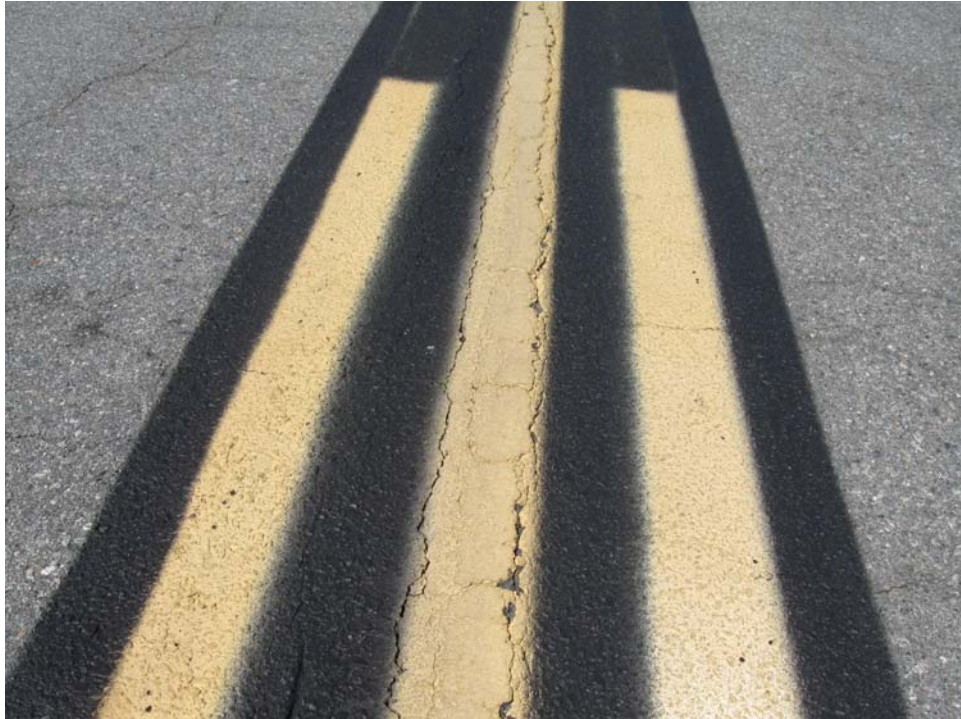
TCMGRA-10. Satisfactory Paint.

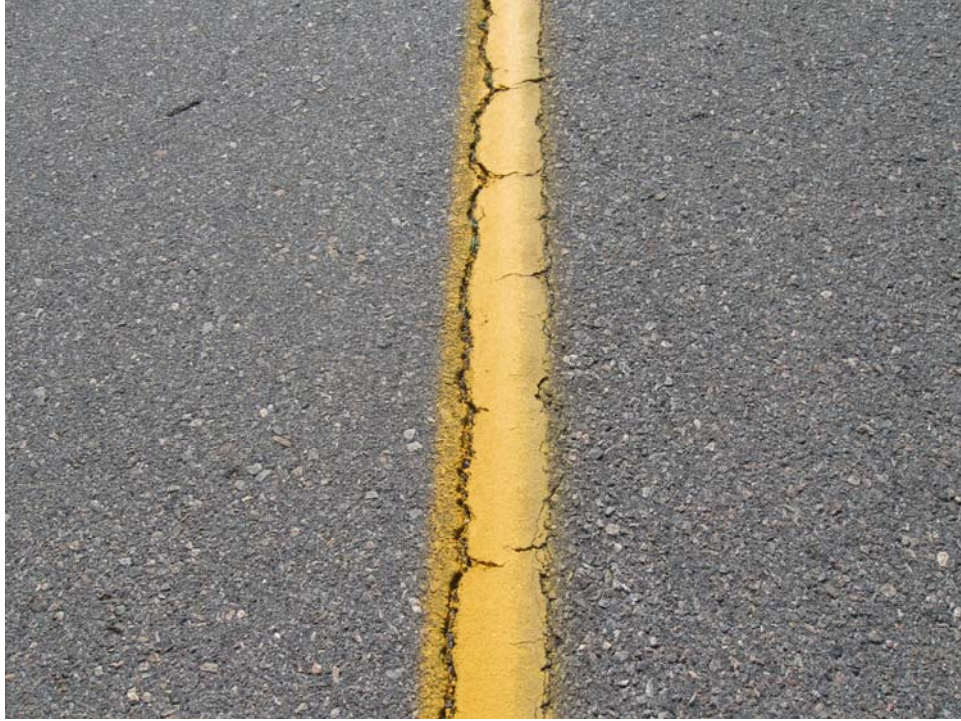
TCMGRA-20. Satisfactory Paint.
