MILLEN AIRPORT

PAVEMENT EVALUATION REPORT

JULY 2002

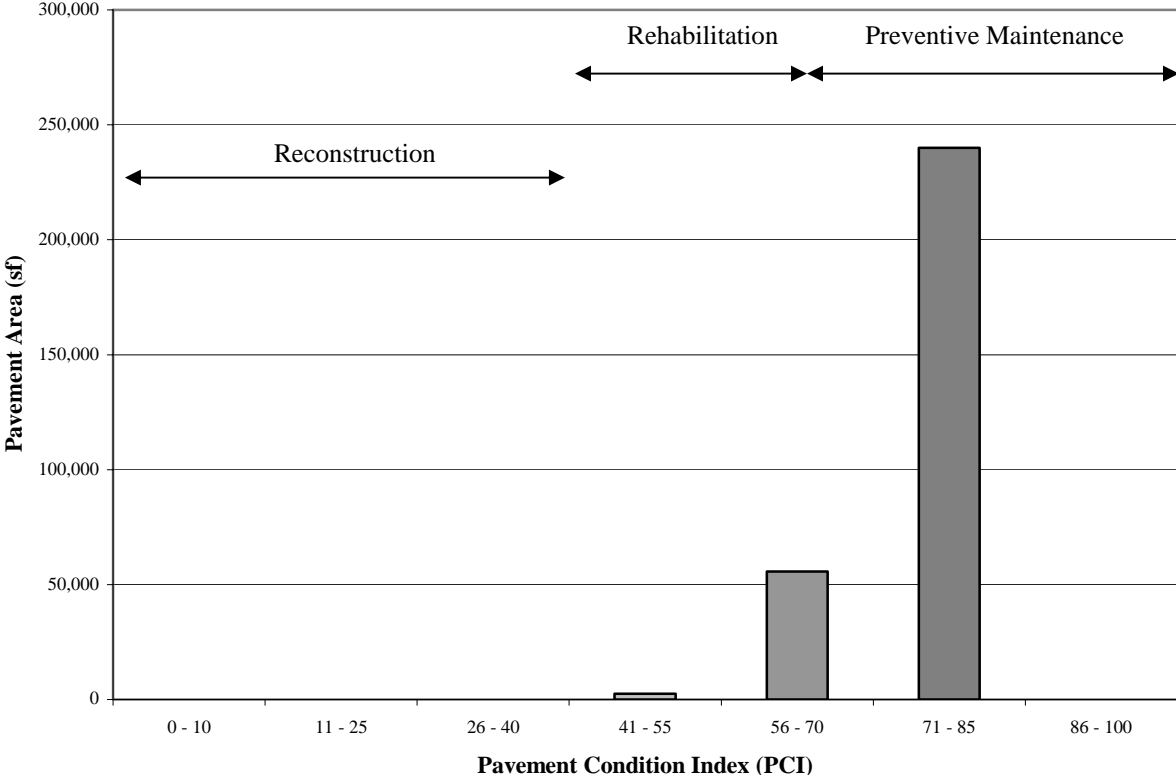
Figure 6. Condition distribution.

The 2001 area-weighted condition of Millen Airport is 72, with conditions ranging from 43 to 73 [on a scale of 0 (failed) to 100 (excellent)]. Figures 6 and 7 provide graphs summarizing the overall condition of the pavements at Millen Airport. Figure 8 is a map that displays the condition of the pavements evaluated. Table 1 summarizes the results of the pavement evaluation.
