2012 Bacon County Airport Pavement Management Plan

BACON COUNTY AIRPORT

PAVEMENT MANAGEMENT REPORT

DECEMBER 2012

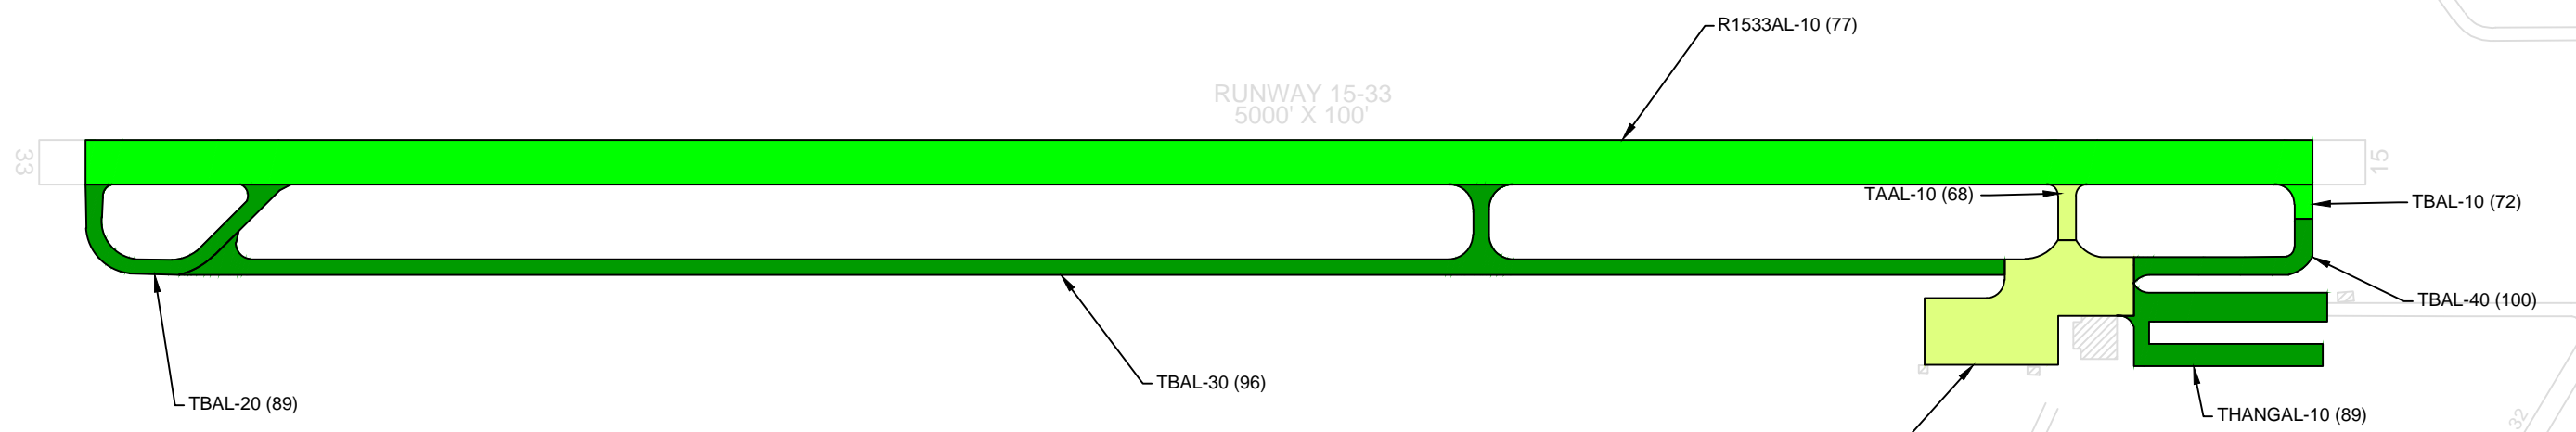
The 2012 area-weighted condition of Bacon County Airport is 80, with conditions ranging from 62 to 100 [on a scale of 0 (failed) to 100 (excellent)]. This compares to a 2007 PCI of 79.

Figures 6 and 7 provide graphs summarizing the overall condition of the pavements at Bacon County Airport. Figure 8 is a map that displays the condition of the pavements evaluated. Table 2 summarizes the results of the pavement evaluation and paint assessment and also presents both the 2007 and 2012 PCI values. Please note that modifications have been made to the PCI methodology since the time of the last pavement inspection in 2007, as detailed in ASTM 5340-11. These changes include the separation of the raveling and weathering distress type on asphalt-surfaced pavements into two distress types along with the addition of the alkali silica reaction (ASR) distress type on PCC pavements.
