2012 Homerville Airport Pavement Management Plan

HOMERVILLE AIRPORT

PAVEMENT MANAGEMENT REPORT

DECEMBER 2012

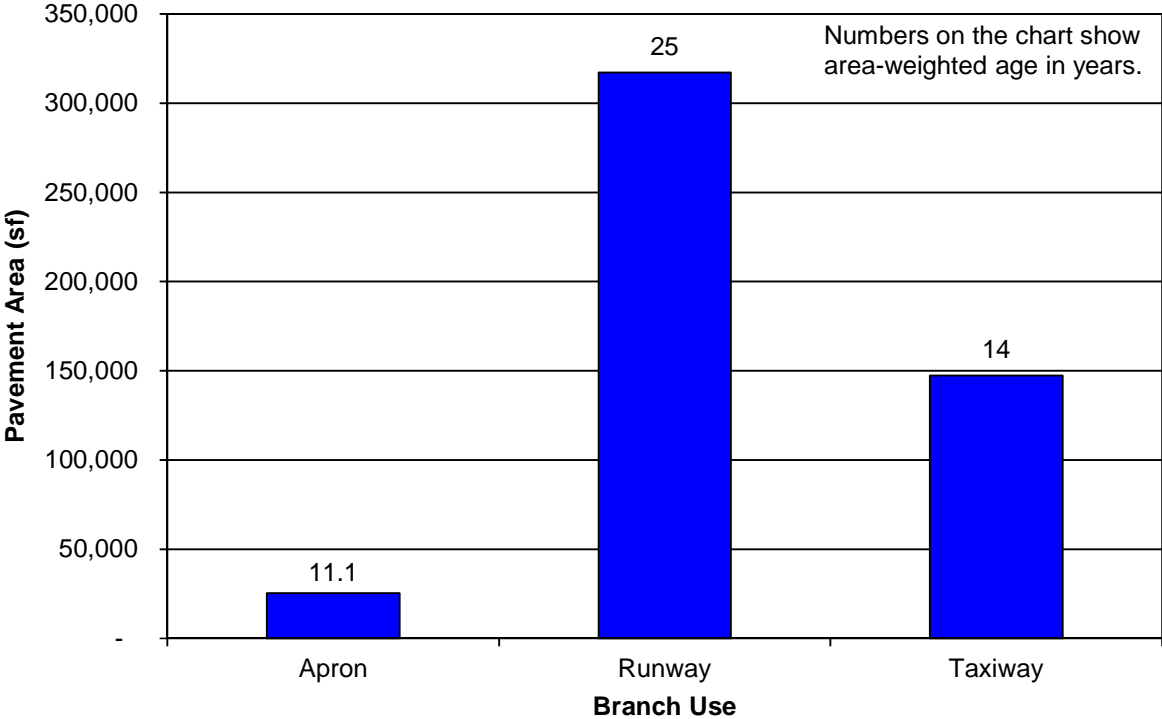
Figure 4. Pavement Inventory.

Homerville Airport has over 490,152 square feet of pavement, as shown in Figure 4. Figure 5 is a network definition map of the airport showing the pavement system broken down into management units, as described on page 3 of this report. It also shows the nomenclature used in the MicroPAVER™ pavement management database to identify the different pavement areas. Additionally, the map summarizes the construction history information compiled during the records review and identifies the areas inspected during the visual survey.

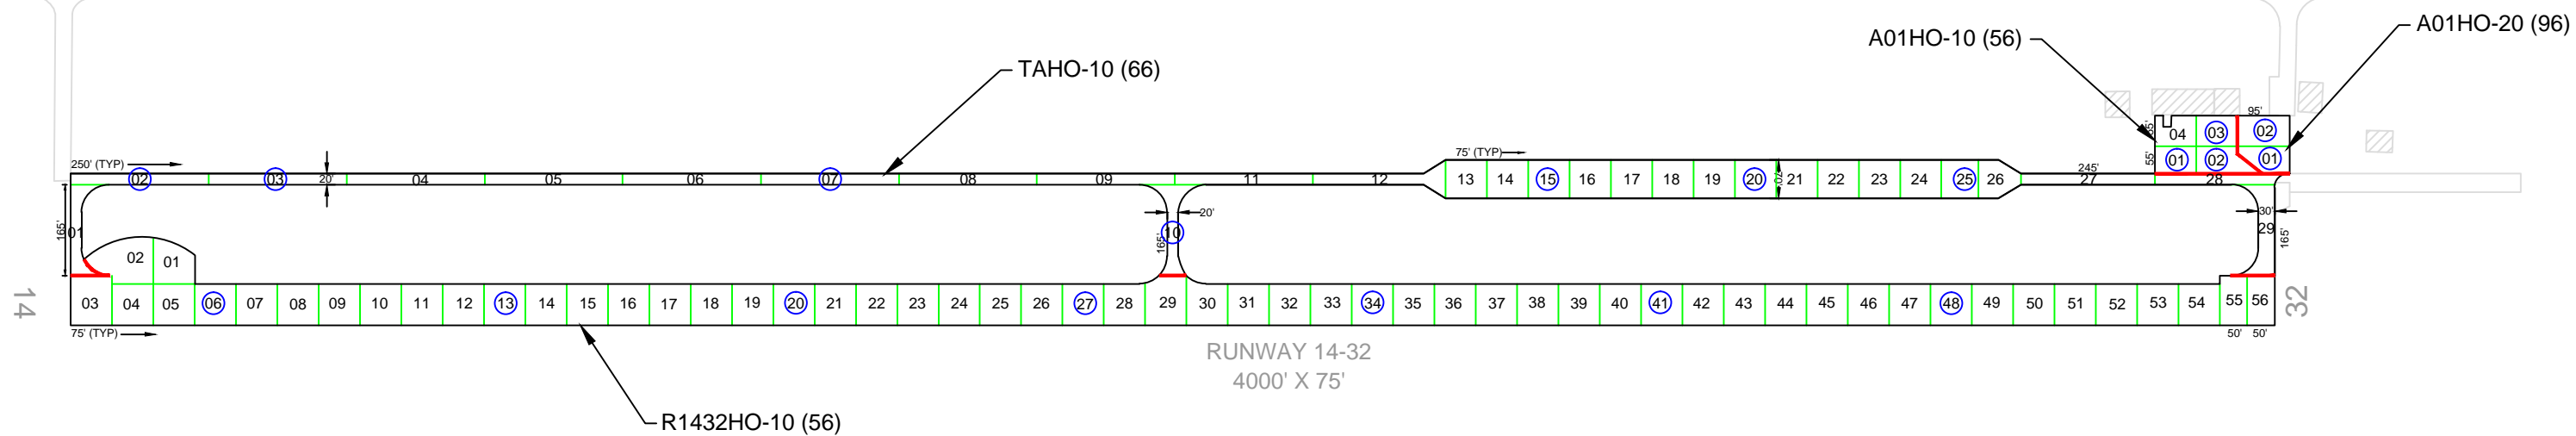
The inspection of Homerville Airport was completed on February 12, 2012 using the PCI procedure described previously. The map presented in Figure 5 identifies the sample units inspected during the pavement evaluation.

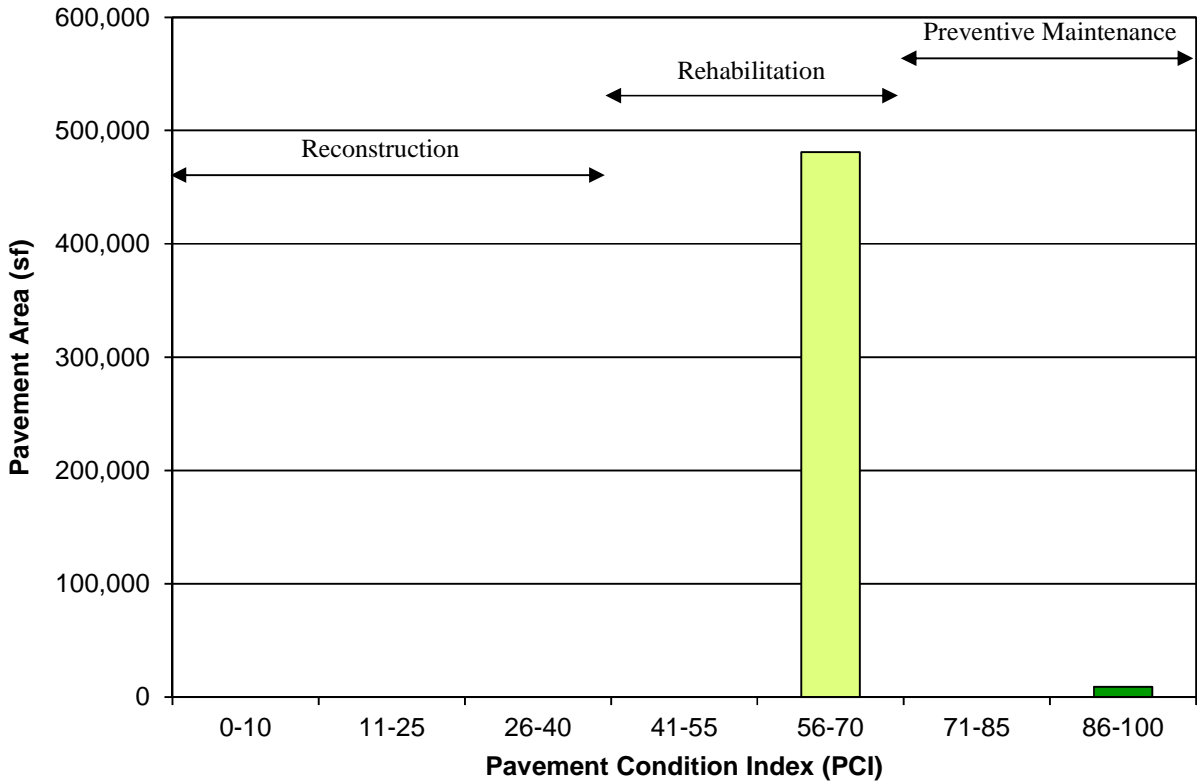
Figure 6. Condition Distribution.

Figures 6 and 7 provide graphs summarizing the overall condition of the pavements at Homerville Airport. Figure 8 is a map that displays the condition of the pavements evaluated. Table 2 summarizes the results of the pavement evaluation and paint assessment and also presents both the 2007 and 2012 PCI values. Please note that modifications have been made to the PCI methodology since the time of the last pavement inspection in 2007, as detailed in ASTM 5340-11. These changes include the separation of the raveling and weathering distress type on asphalt-surfaced pavements into two distress types along with the addition of the alkali silica reaction (ASR) distress type on PCC pavements.
