# 2012 Jekyll Island Airport Pavement Management Plan

# JEKYLL ISLAND AIRPORT

## PAVEMENT MANAGEMENT REPORT

**DECEMBER 2012**

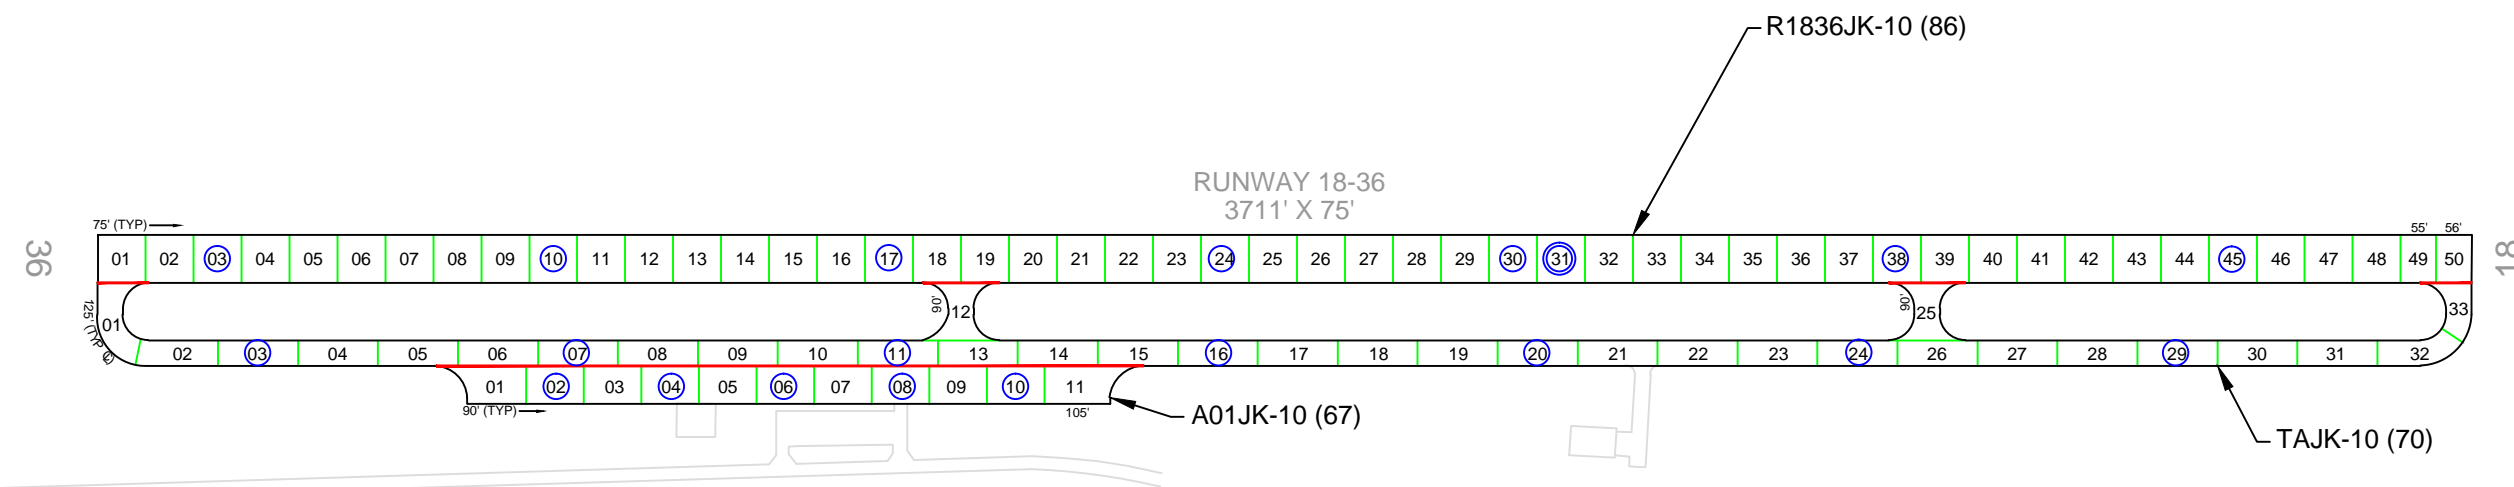
The inspection of Jekyll Island Airport was completed on February 10, 2012 using the PCI procedure described previously. The map presented in Figure 5 identifies the sample units inspected during the pavement evaluation.

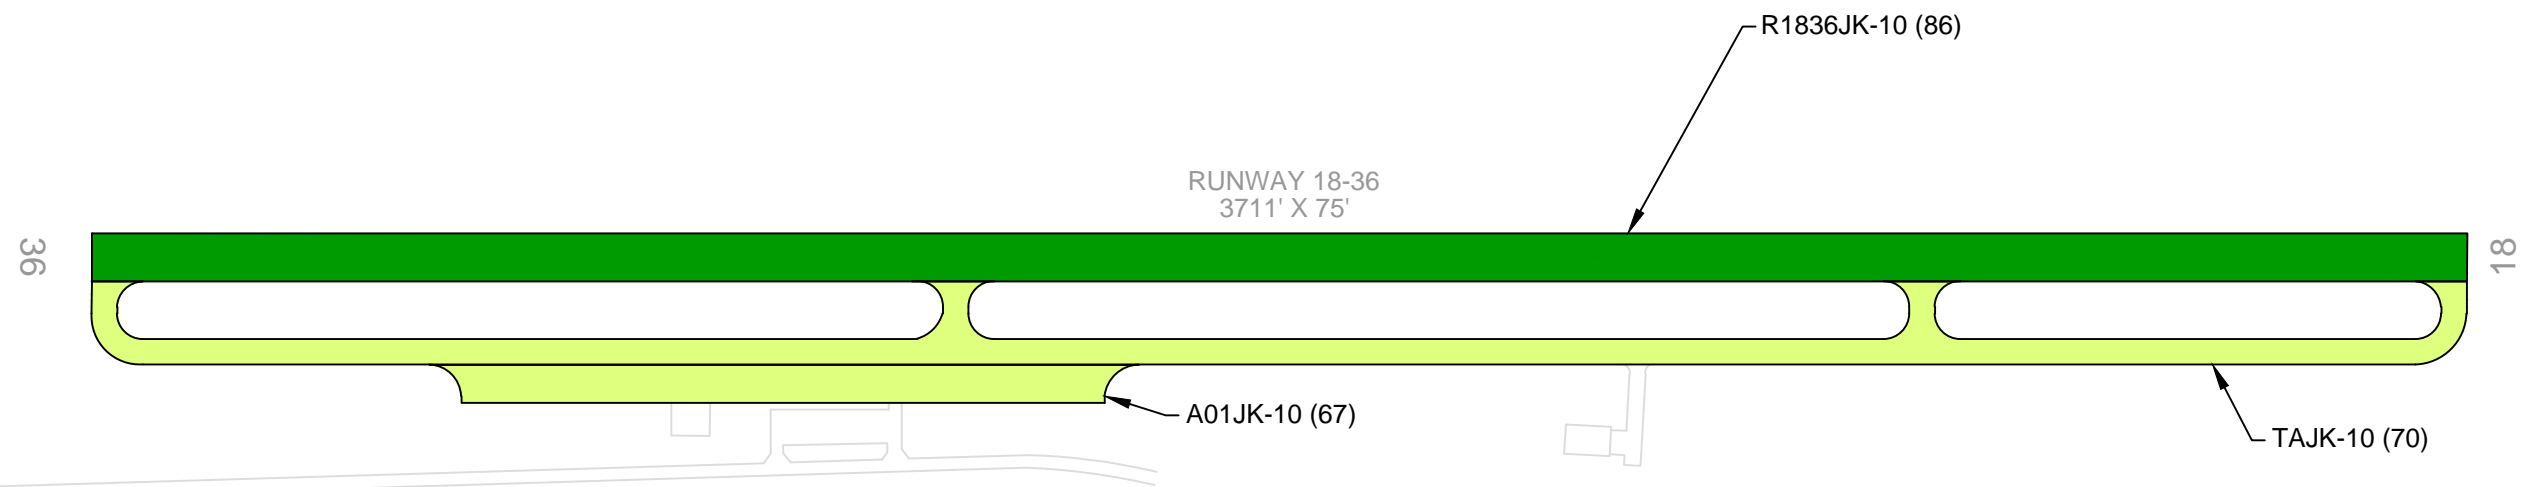
PAGE TITLE: PAVEMENT CONDITION INDEX MAP

Figures 6 and 7 provide graphs summarizing the overall condition of the pavements at Jekyll Island Airport. Figure 8 is a map that displays the condition of the pavements evaluated. Table 2 summarizes the results of the pavement evaluation and paint assessment and also presents both the 2007 and 2012 PCI values. Please note that modifications have been made to the PCI methodology since the time of the last pavement inspection in 2007, as detailed in ASTM 5340-11. These changes include the separation of the raveling and weathering distress type on asphalt-surfaced pavements into two distress types along with the addition of the alkali silica reaction (ASR) distress type on PCC pavements.
