2012 Millen Airport Pavement Management Plan

MILLEN AIRPORT

PAVEMENT MANAGEMENT REPORT

DECEMBER 2012

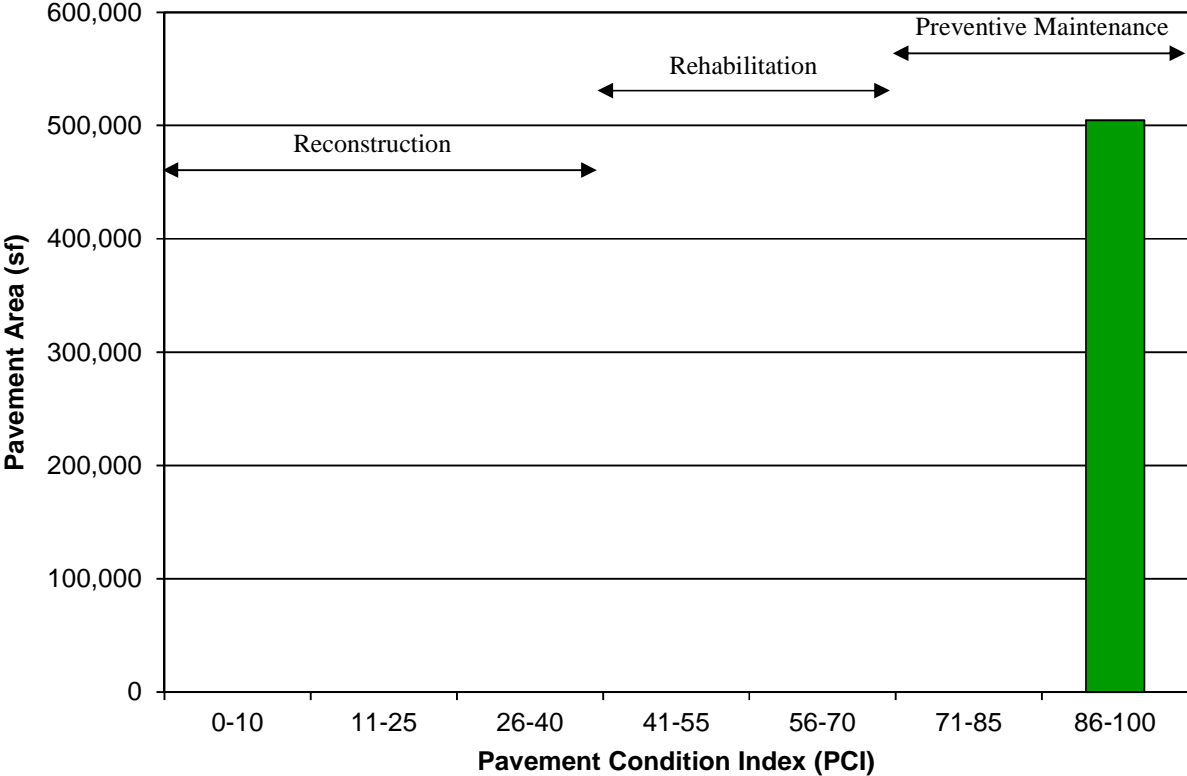
Figure 6. Condition Distribution.

Figures 6 and 7 provide graphs summarizing the overall condition of the pavements at Millen Airport. Figure 8 is a map that displays the condition of the pavements evaluated. Table 2 summarizes the results of the pavement evaluation and paint assessment and also presents both the 2007 and 2012 PCI values. Please note that modifications have been made to the PCI methodology since the time of the last pavement inspection in 2007, as detailed in ASTM 5340-11. These changes include the separation of the raveling and weathering distress type on asphalt-surfaced pavements into two distress types along with the addition of the alkali silica reaction (ASR) distress type on PCC pavements.
