2012 Burke County Airport Pavement Management Plan

BURKE COUNTY AIRPORT

PAVEMENT MANAGEMENT REPORT

DECEMBER 2012

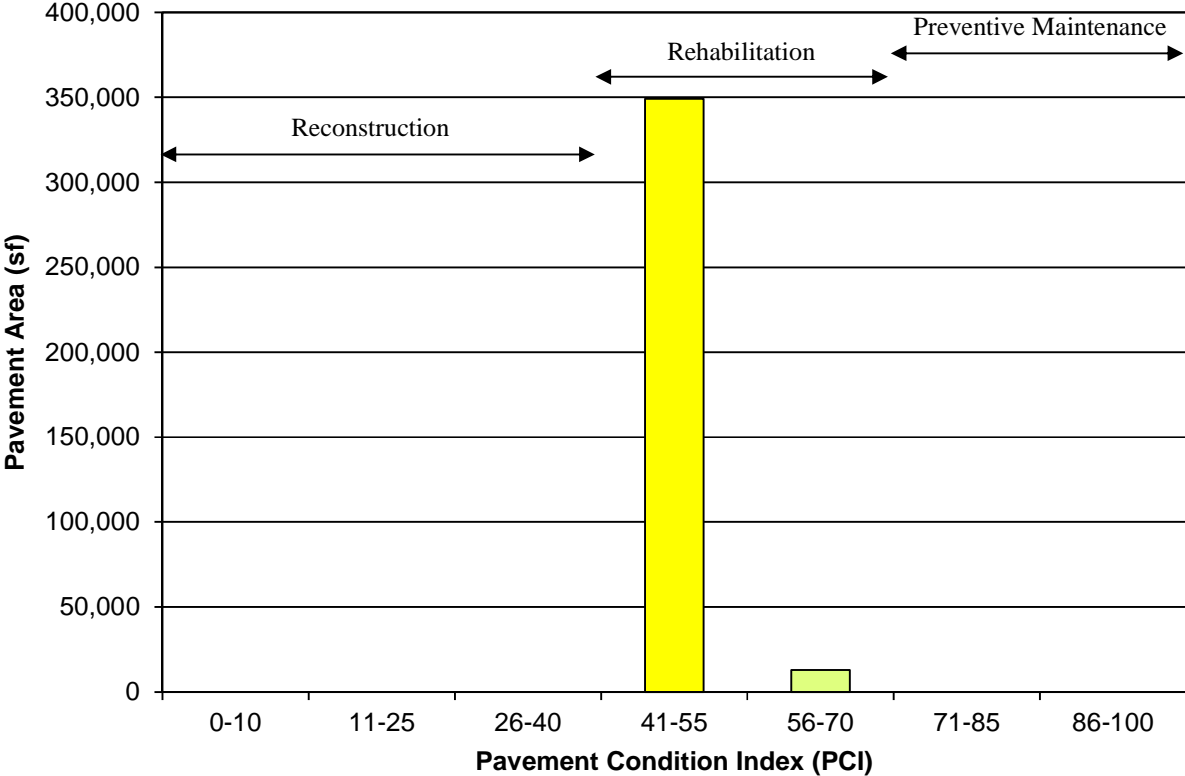
Figure 6. Condition Distribution.

Figures 6 and 7 provide graphs summarizing the overall condition of the pavements at Burke County Airport. Figure 8 is a map that displays the condition of the pavements evaluated. Table 2 summarizes the results of the pavement evaluation and paint assessment and also presents both the 2007 and 2012 PCI values. Please note that modifications have been made to the PCI methodology since the time of the last pavement inspection in 2007, as detailed in ASTM 5340-11. These changes include the separation of the raveling and weathering distress type on asphalt-surfaced pavements into two distress types along with the addition of the alkali silica reaction (ASR) distress type on PCC pavements.
