Report:

Heart of Georgia Regional Airport Pavement Management Plan

PRESERVING
GEORGIA'S
CRITICAL
PAVEMENT
INFRASTRUCTURE

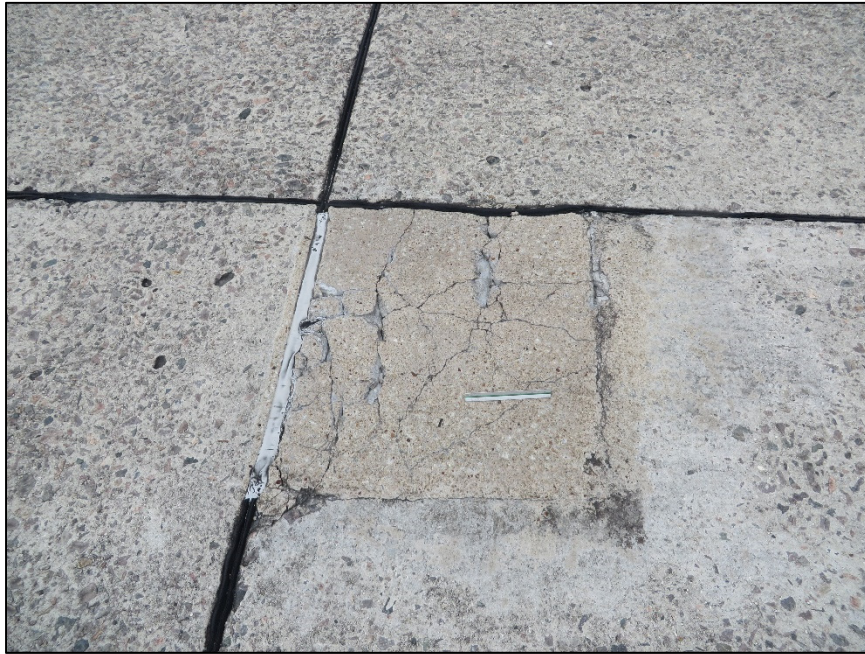
FIGURE H-14 HIGH-SEVERITY PATCHING

A patch is an area where the original pavement has been removed and replaced by a filler material. High-severity patches must be replaced. An example of a high-severity patch is shown in FIGURE H-14.

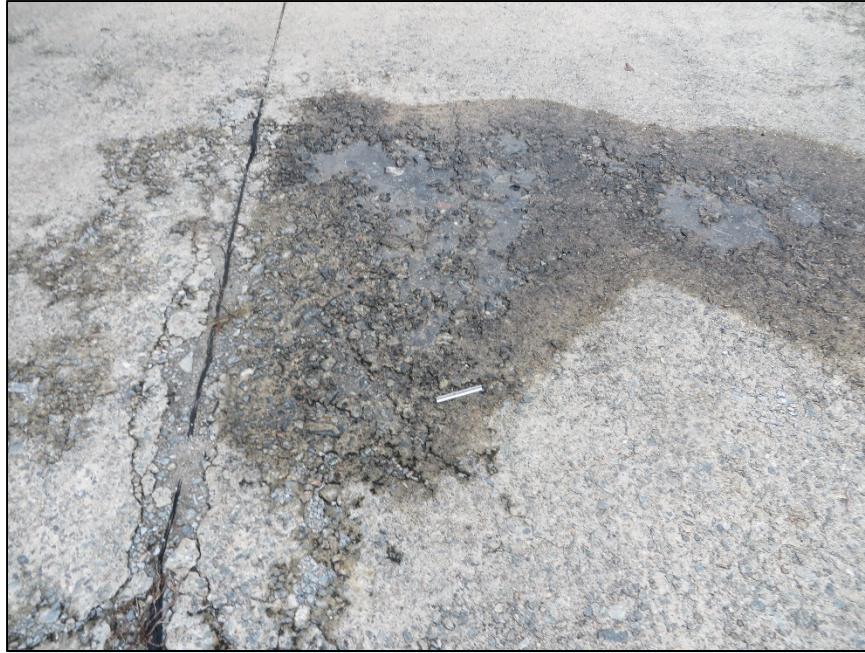
FIGURE H-15 HIGH-SEVERITY SCALING

Scaling is the breakdown of the slab surface to a depth of approximately 0.25 to 0.5 in. (6 to 13 mm). Scaling appears as a flaking away of the pavement's surface and presents FOD potential. The over-finishing of the concrete surface during construction usually causes this distress. Other causes of scaling include improper construction, reactions to deicing salts, poor aggregate, and the impact of multiple freeze-thaw cycles.

At the high-severity level, there is substantial FOD potential, and slab replacement is usually the only viable alternative. FIGURE H-15 is a photograph of high-severity scaling.

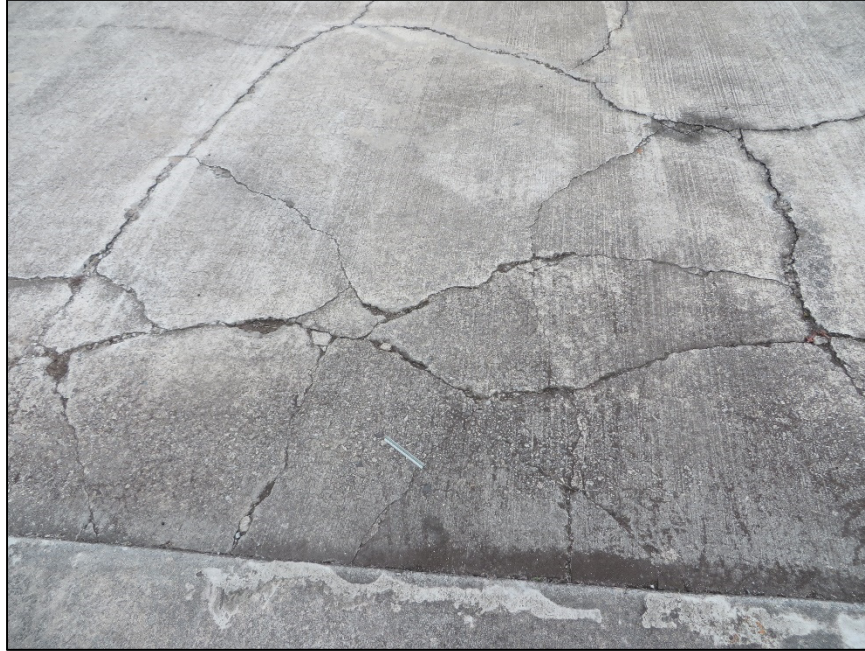
A shattered slab is defined as intersecting cracks *that break a slab into four or more pieces due to overloading or inadequate support, or both*. The only option at the high-severity level is to replace the slab. An example of a high-severity shattered slab is shown in FIGURE H-17.

FIGURE H-17 HIGH-SEVERITY SHATTERED SLAB

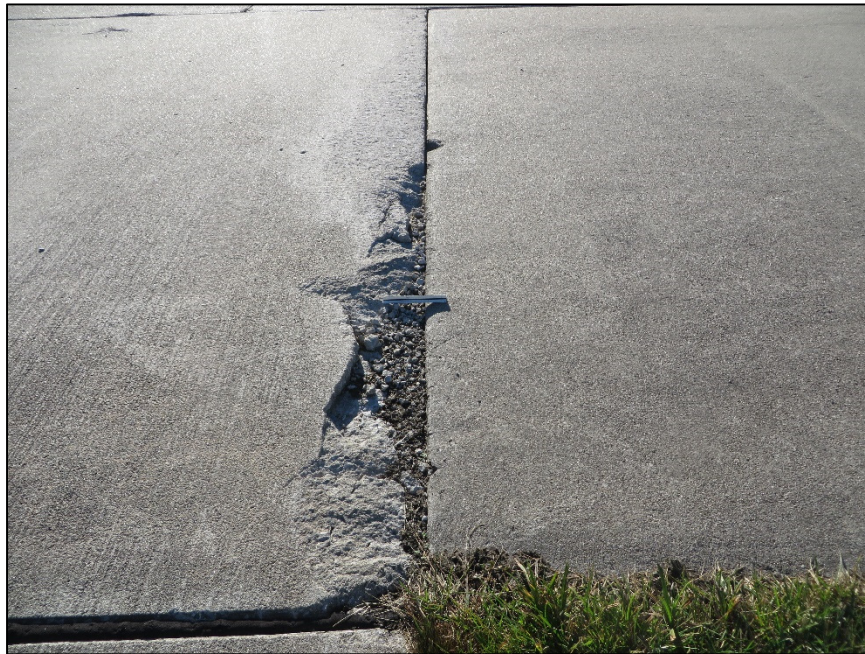
ASTM D5340-12 defines this distress as *the breakdown of the slab edges within 2 feet of the side of the joint. A joint spall usually does not extend vertically through the slab but intersects the joint at an angle.* Spalling is typically caused by the introduction of incompressible material in the joint, weaker pavement at the joint caused by overworking of the pavement during construction, traffic loading, or a combination of these.

For a joint spall to be recorded at high-severity, it must be greater than 2 feet long. The joint spall is either *broken into more than three pieces defined by one or more high-severity cracks with high FOD potential and high possibility of the pieces becoming dislodged, or the joint is severely frayed with high FOD potential.* This distress should be repaired with a partial-depth patch. FIGURE H-18 shows this distress type.

FIGURE H-18 HIGH-SEVERITY JOINT SPALLING

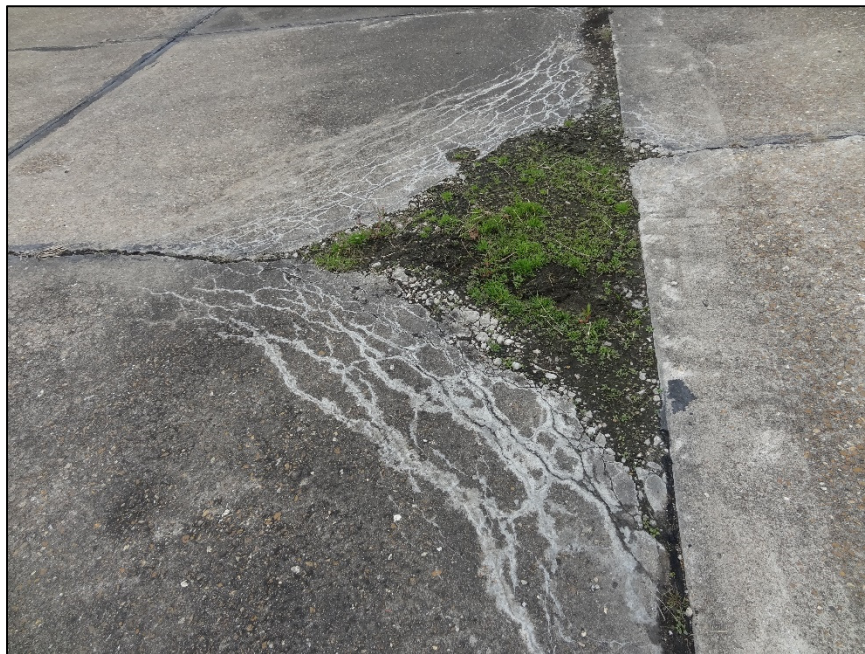
ASR is caused by chemical reaction between alkalis and certain reactive silica minerals which form a gel. This gel expands in the presence of water, causing the fracturing of the aggregates and paste. Visual indicators that ASR may be present include: (1) cracking of the concrete pavement (often in a map pattern); (2) white, brown, gray or other colored gel or staining may be present at the crack surface; (3) aggregate popouts; or (4) increase in concrete volume (expansion) that may result in distortion of adjacent or integral structures or physical elements.

For ASR to be recorded at high-severity, *one or both of the following exist: (1) loose or missing concrete fragments and poses high FOD potential, (2) slab surface integrity and function significantly degraded and pavement requires immediate repairs; may also require repairs to adjacent structures or elements.* This distress should be repaired with a slab replacement. If extensive, reconstruction may be the only viable option. FIGURE H-20 depicts this distress type.

FIGURE H-20 HIGH-SEVERITY ASR
