Report:

Homerville Airport Pavement Management Plan

PRESERVING
GEORGIA'S
CRITICAL
PAVEMENT
INFRASTRUCTURE

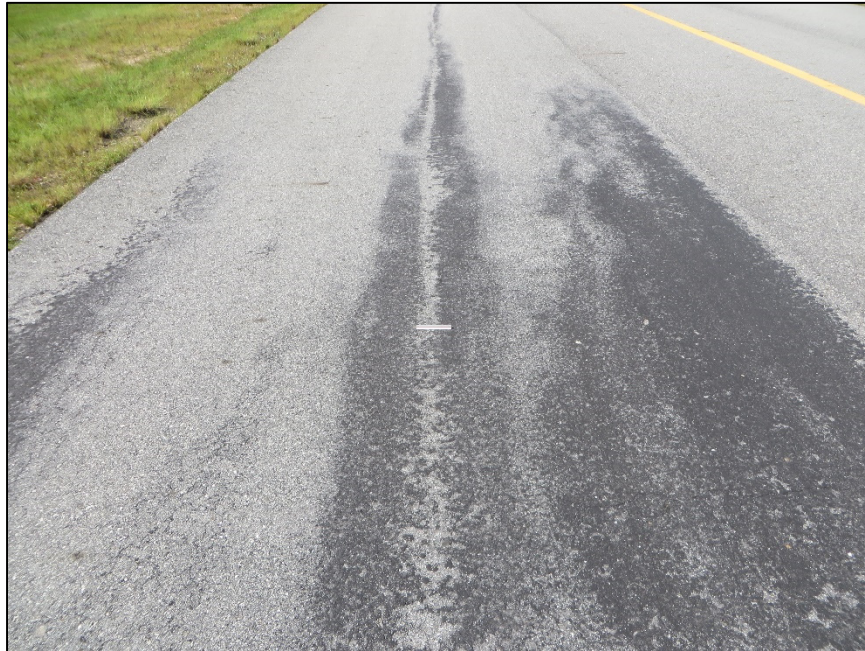
FIGURE H-2 EXTENSIVE BLEEDING

Bleeding is a film of bituminous material on the pavement surface that creates a shiny, glass-like, reflecting surface that usually becomes quite sticky. Bleeding is caused by excessive amounts of asphaltic cement or tars in the mix or low-air void content, or both. It occurs when asphalt fills the voids of the mix during hot weather and then expands out onto the surface of the pavement. Since the bleeding process is not reversible during cold weather, asphalt or tar will accumulate on the surface.

At its most severe, bleeding can result in a severe reduction in skid resistance. If bleeding is extensive and severe, as shown in FIGURE H-2, the AC layer should be removed and replaced.

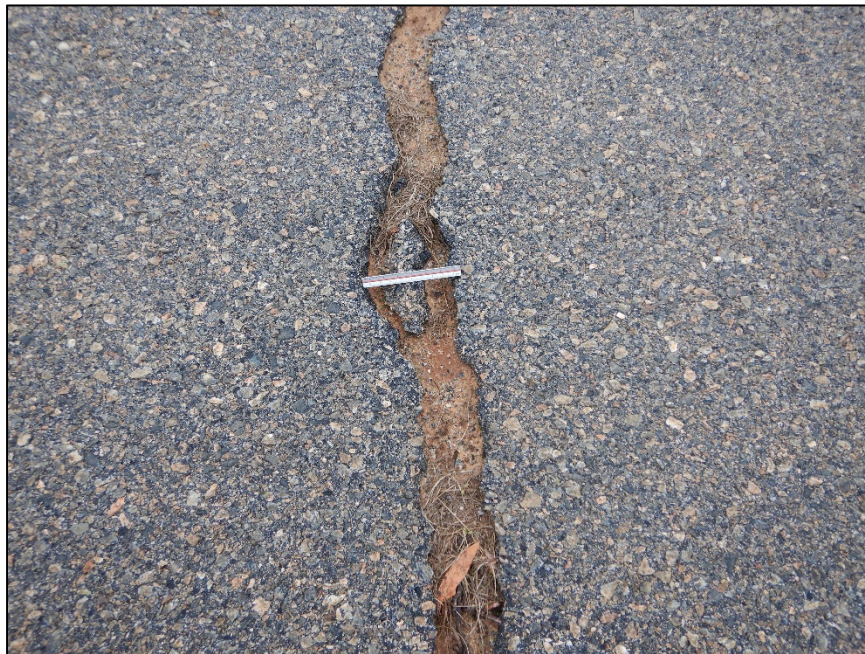
FIGURE H-4 HIGH-SEVERITY CRACKING

Longitudinal cracking is parallel to the pavement's center line. Transverse cracking is approximately perpendicular to the pavement's center line or direction of laydown. L&T cracking can be caused by separation of the pavement at the paving lane joints, shrinkage of the AC pavement due to temperature differentials in older or brittle pavements, or reflection cracking from underlying existing cracks in overlaid pavements.

At the high-severity level, the cracks are severely spalled and pieces are loose or missing, causing FOD potential. These cracks need to be sealed. If the crack width is extensive, consider patching the affected area. FIGURE H-4 shows a crack that needs immediate attention.

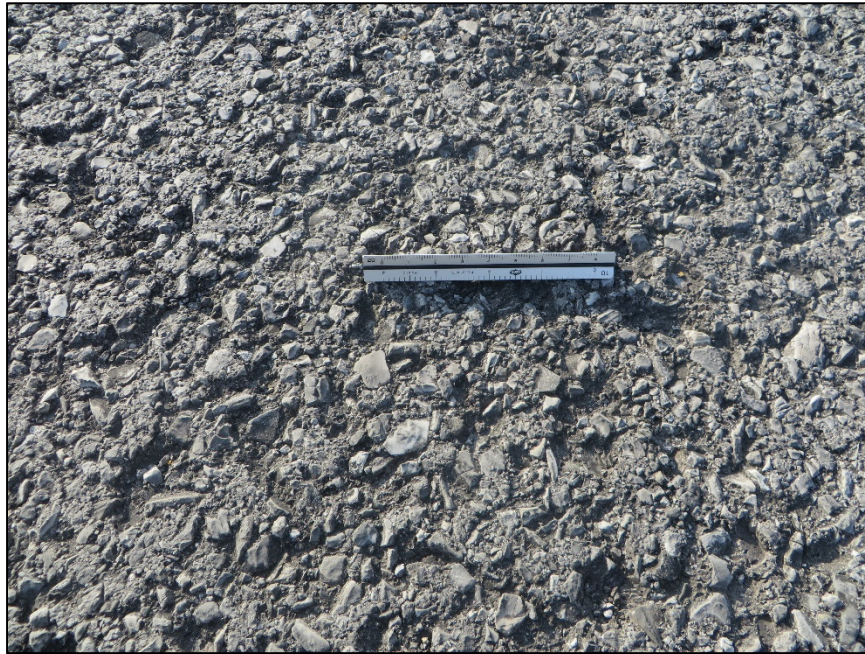
FIGURE H-6 HIGH-SEVERITY RAVELING

Raveling occurs as the coarse aggregate pieces begin to dislodge and produce loose pieces of material. It may indicate that the AC binder has hardened significantly.

At high-severity, the aggregate has worn away, which causes a high FOD potential and safety hazard since it could be ingested by aircraft engines. The surface texture is severely rough and pitted. If localized, high-severity raveling can be corrected with a patch; if extensive, an overlay will probably be needed. FIGURE H-6 shows high-severity raveling.

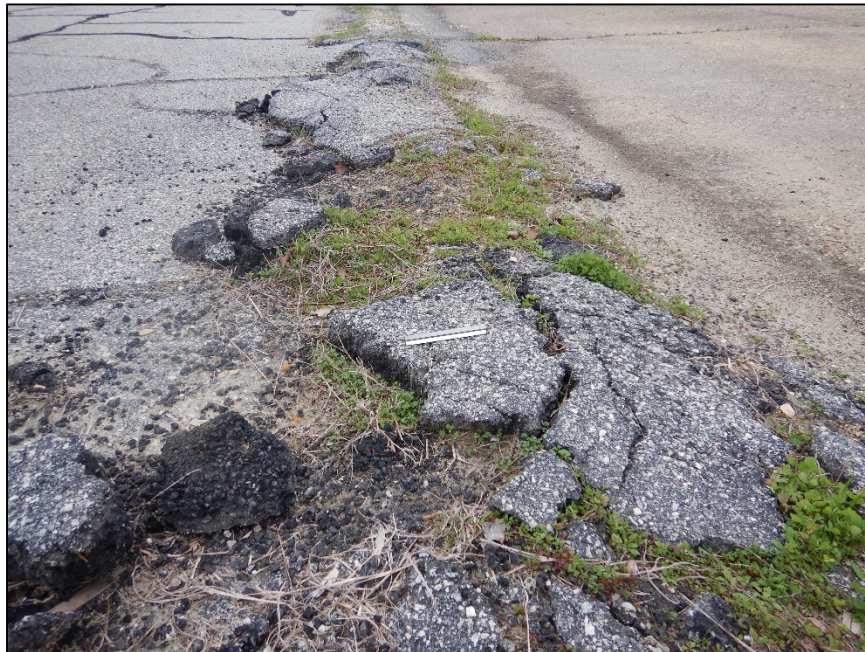
FIGURE H-8 HIGH-SEVERITY SHOVING AT AC/PCC INTERFACE

Pavement expands as its temperature increases. Due to its greater strength, when PCC pavement expands adjacent to AC pavement, it can cause a permanent vertical deformation in the AC pavement. Additionally, PCC pavement has a tendency to grow as gradual openings at the joint widen and are filled with incompressible material or distresses such as alkali-silica reaction (ASR) cause the pavement to expand. This is referred to as pavement growth and can also produce vertical deformation in adjacent AC pavements. This deformation is called shoving.

At high-severity, *a large amount of shoving has occurred, causing severe roughness or break-up of the asphalt pavement.* This situation can be corrected by milling the AC surface to restore smoothness and patching as needed. Installing an expansion joint may minimize the potential for recurrence of the distress. FIGURE H-8 depicts high-severity shoving.

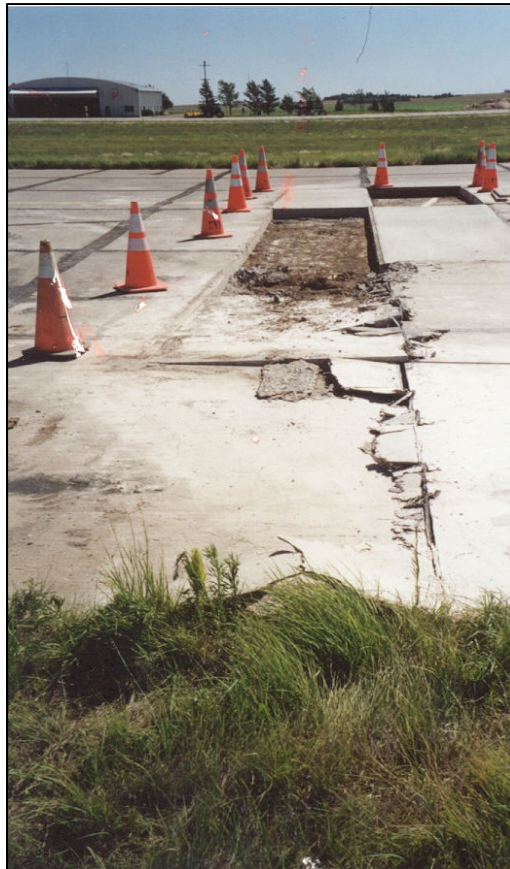
FIGURE H-10 HIGH-SEVERITY BLOWUP IN THE PROCESS OF BEING REPAIRED

Blowups occur in hot weather, usually at a transverse crack or joint that is not wide enough to permit expansion of the concrete slabs. The insufficient width is usually caused by infiltration of incompressible materials into the joint space. When expansion cannot relieve enough pressure, a localized upward movement of the slab edges (buckling) or shattering will occur in the vicinity of the joint. Blowups can also occur at utility cuts and drainage inlets. This type of distress is almost always repaired immediately because of severe damage potential to aircraft.

Depending on the situation, a full-depth patch or slab replacement will be required. An expansion joint must be provided during the repair. FIGURE H-10 shows this distress type.

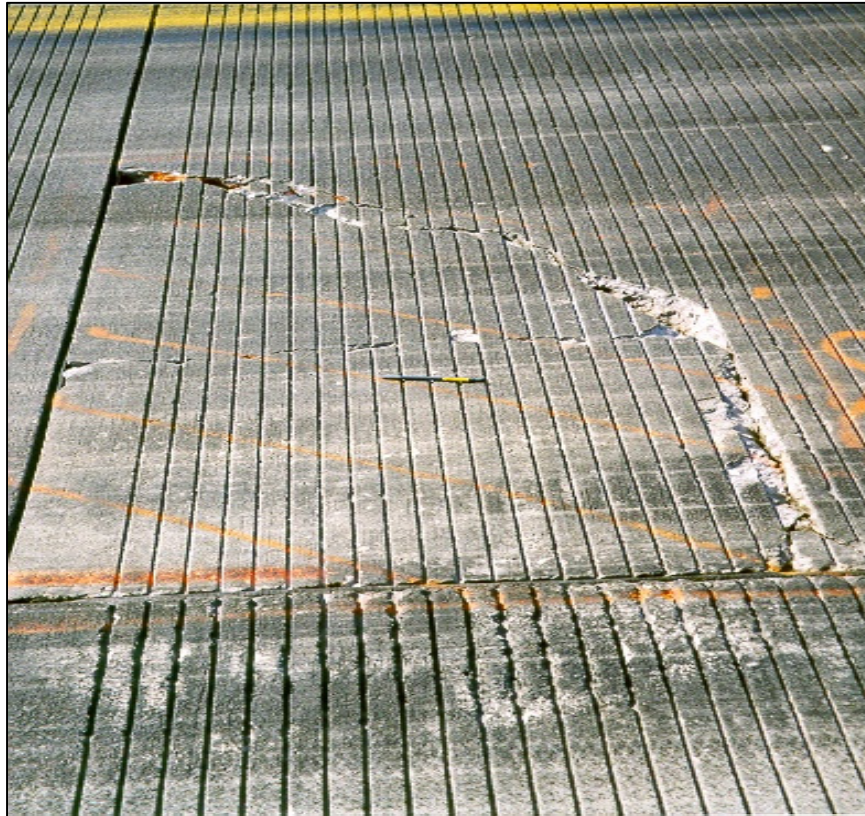
FIGURE H-11 HIGH-SEVERITY CORNER BREAKING

A corner break is a crack that intersects the joints at a distance less than or equal to one half of the slab length on both sides, measured from the corner of the slab. Load repetition combined with loss of support and curling stresses usually cause corner breaks.

At high-severity, the crack is severely spalled, causing definite FOD potential; a nonfilled crack has a mean width greater than approximately 1 inch, creating tire damage potential; or the area between the corner break and the joints is severely cracked. This distress needs to be repaired with a full-depth patch or in some cases with a slab replacement. This distress type is shown below in FIGURE H-11.

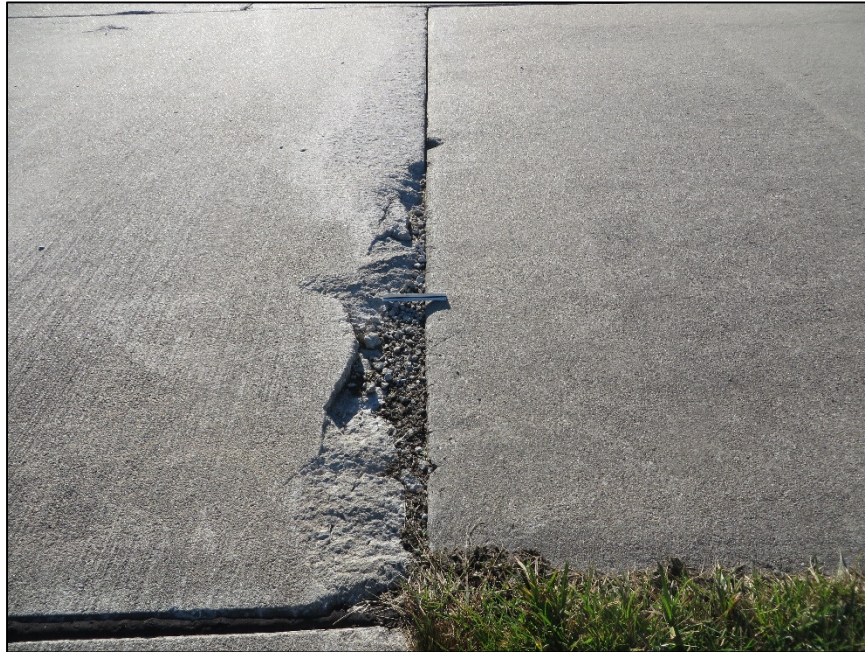
ASTM D5340-12 defines this distress as *the breakdown of the slab edges within 2 feet of the side of the joint. A joint spall usually does not extend vertically through the slab but intersects the joint at an angle.* Spalling is typically caused by the introduction of incompressible material in the joint, weaker pavement at the joint caused by overworking of the pavement during construction, traffic loading, or a combination of these.

For a joint spall to be recorded at high-severity, it must be greater than 2 feet long. The joint spall is either *broken into more than three pieces defined by one or more high-severity cracks with high FOD potential and high possibility of the pieces becoming dislodged, or the joint is severely frayed with high FOD potential.* This distress should be repaired with a partial-depth patch. FIGURE H-18 shows this distress type.

FIGURE H-18 HIGH-SEVERITY JOINT SPALLING
