Report:

Millen Airport Pavement Management Plan

PRESERVING
GEORGIA'S
CRITICAL
PAVEMENT
INFRASTRUCTURE

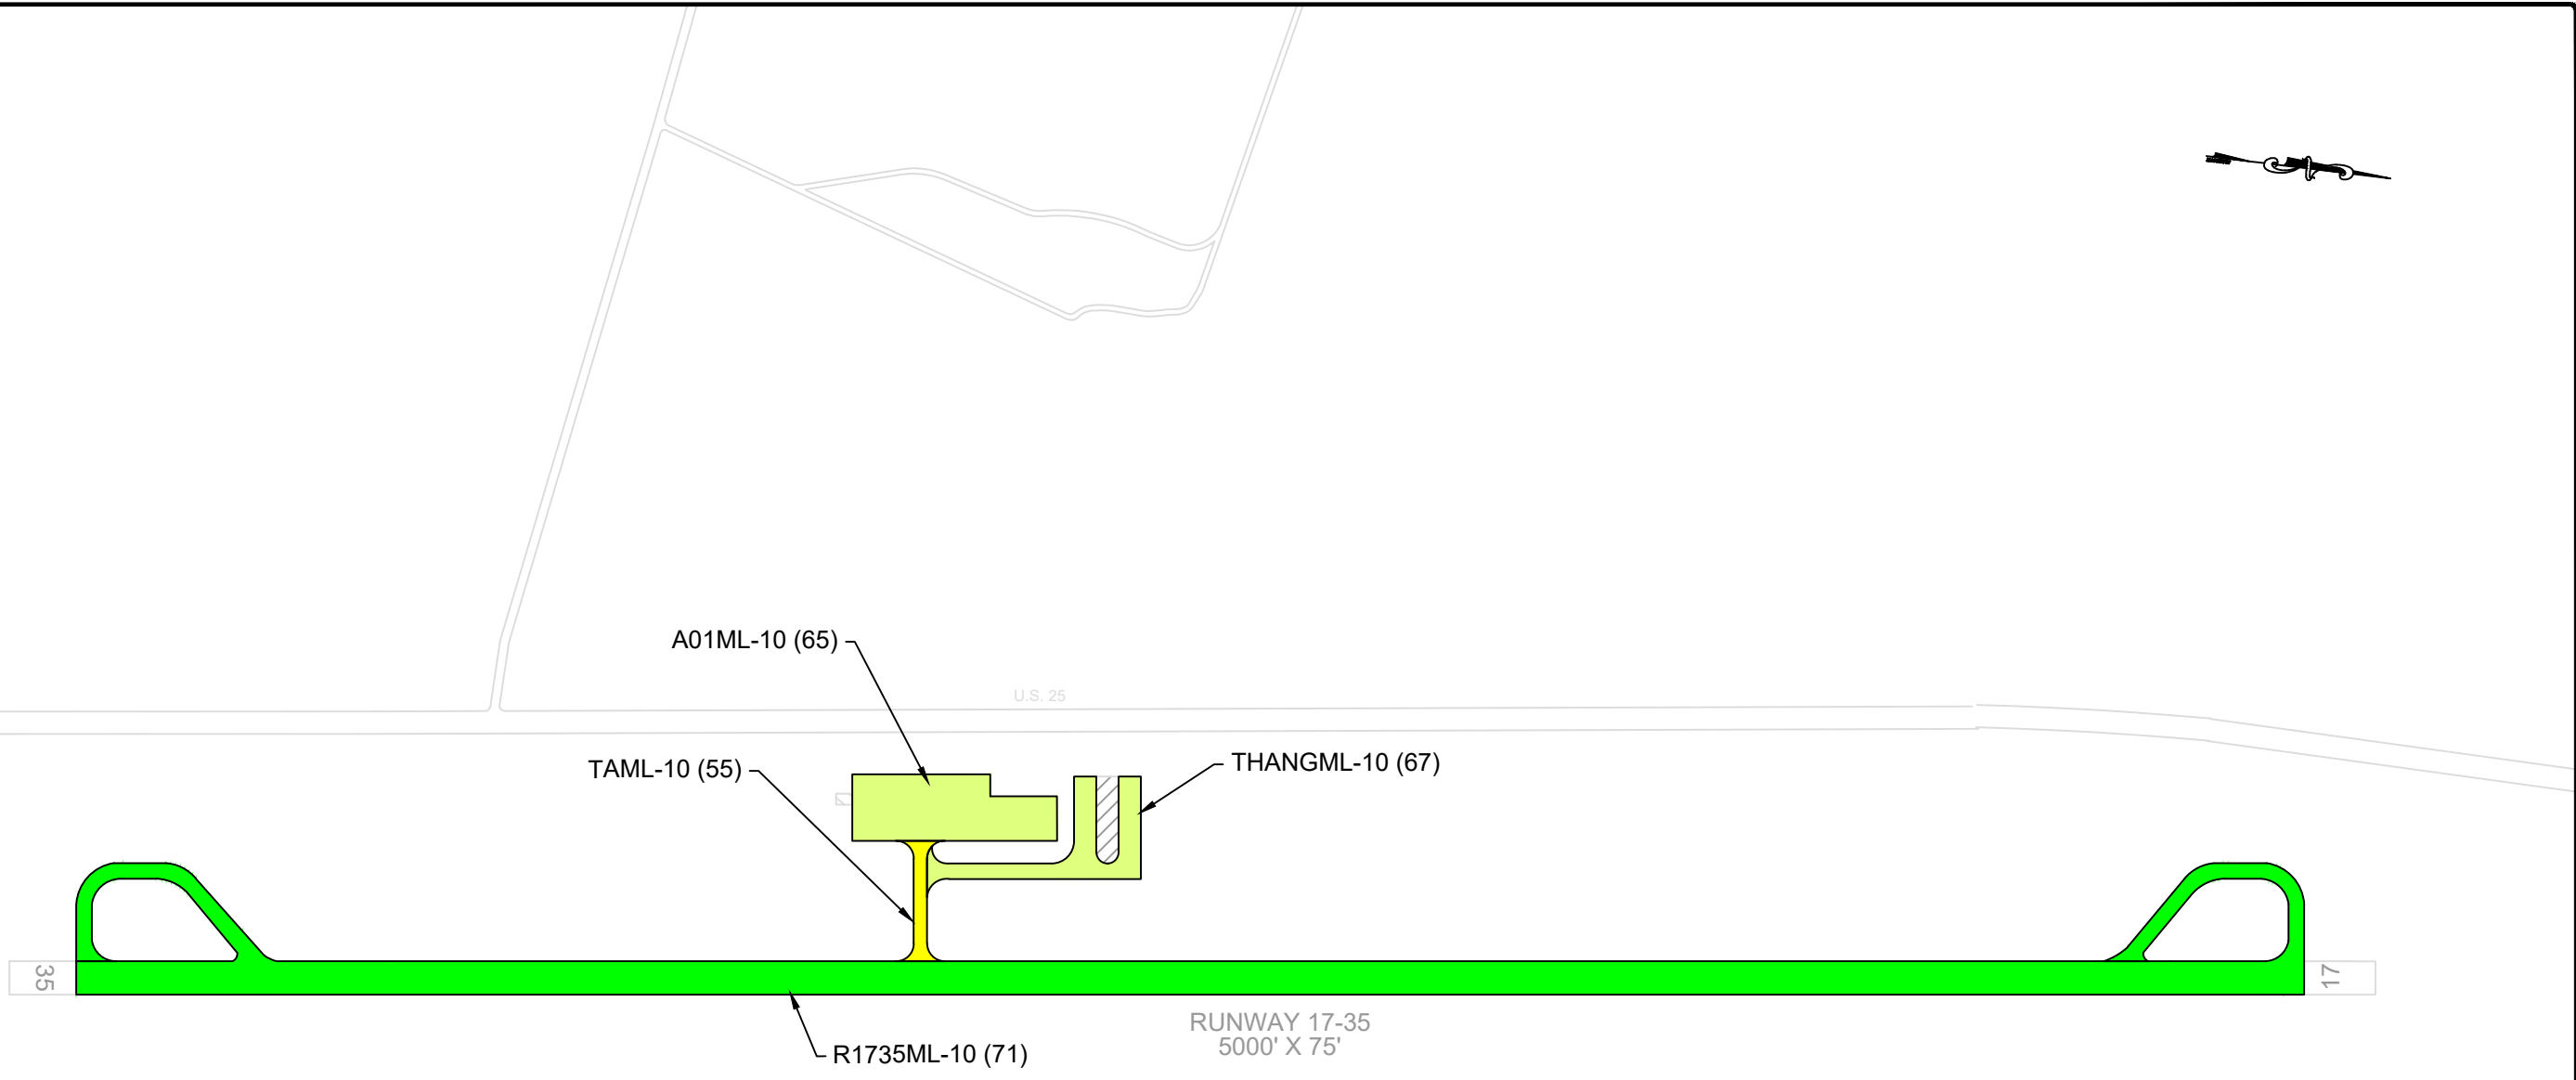
PAGE TITLE: PAVEMENT CONDITION INDEX MAP

The 2018 area-weighted condition of Millen Airport is 70, with conditions ranging from 55 to 71 [on a scale of 0 (failed) to 100 (excellent)]. This compares to a 2012 PCI of 100.

Branch ¹	Section ¹	Surface Type ²	Section Area (sf)	LCD ³	2012 PCI	2018 PCI	% Distress due to:		Distress Types ⁶
							Load ⁴	Climate or Durability ⁵	
A01ML	10	AC	61,278	6/5/2011	100	65	15	81	L&T Cracking, Raveling, Rutting, Swelling, Weathering
R1735ML	10	AC	423,813	6/5/2011	100	71	0	97	L&T Cracking, Raveling, Swelling, Weathering
TAML	10	AC	9,455	6/5/2011	100	55	0	96	L&T Cracking, Raveling, Swelling, Weathering
THANGML	10	AC	38,065	6/3/2006	95	67	0	95	Depression, L&T Cracking, Raveling, Swelling, Weathering

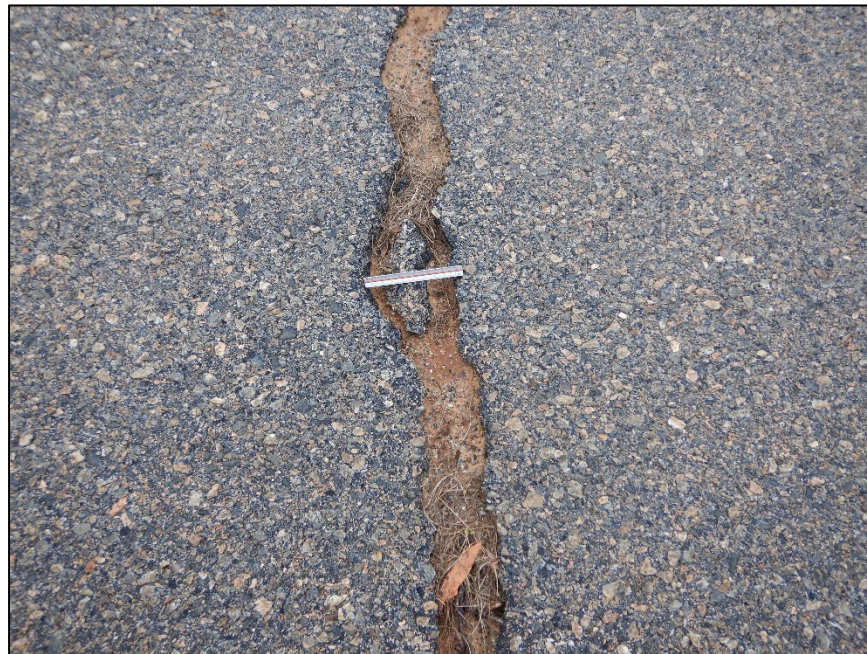
FIGURE H-4 HIGH-SEVERITY CRACKING

Longitudinal cracking is parallel to the pavement's center line. Transverse cracking is approximately perpendicular to the pavement's center line or direction of laydown. L&T cracking can be caused by separation of the pavement at the paving lane joints, shrinkage of the AC pavement due to temperature differentials in older or brittle pavements, or reflection cracking from underlying existing cracks in overlaid pavements.

At the high-severity level, the cracks are severely spalled and pieces are loose or missing, causing FOD potential. These cracks need to be sealed. If the crack width is extensive, consider patching the affected area. FIGURE H-4 shows a crack that needs immediate attention.

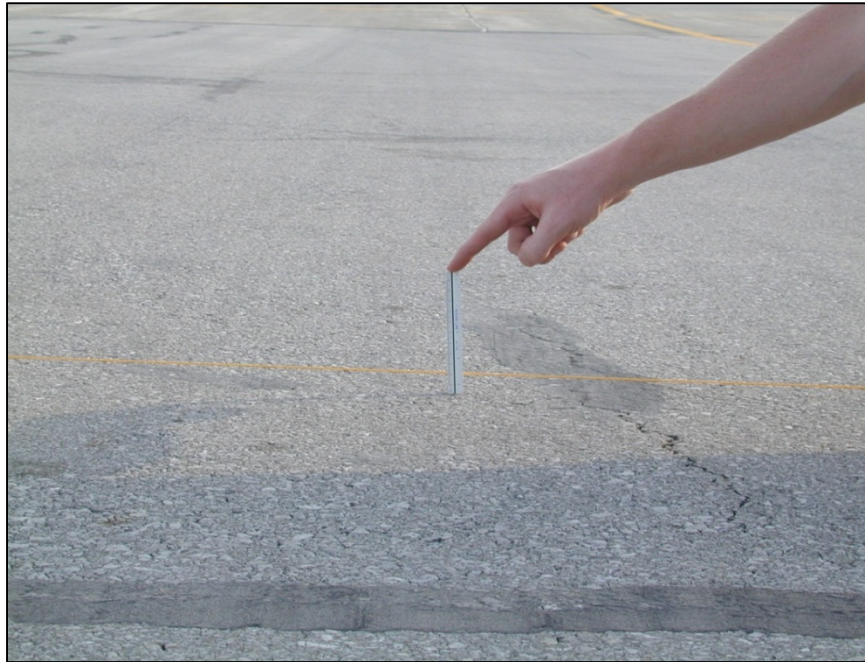
FIGURE H-7 HIGH-SEVERITY RUTTING

Rutting is a surface depression in the pavement that is caused by repeated wheel loading in excess of the structural capacity of any or all of the pavement layers. Rutting is a load-related distress and is typically found in the wheel paths of aircraft.

At the high-severity level, the mean depth of the rutting is greater than 1 inch. If localized, this distress can be corrected with a patch. If it is an extensive problem, consider major rehabilitation. High-severity rutting is shown below in FIGURE H-7.

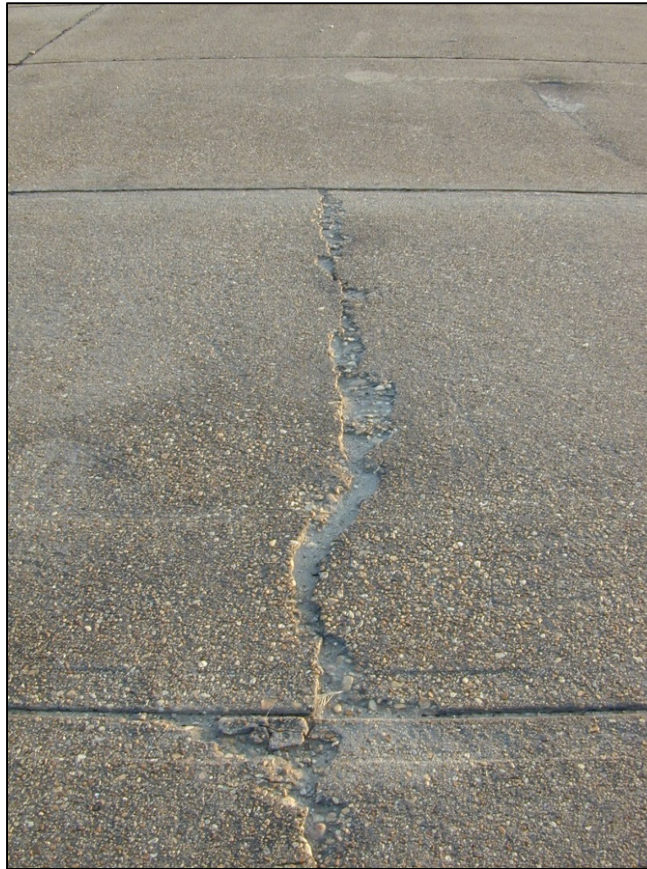
FIGURE H-12 HIGH-SEVERITY LTD CRACKING

LTD cracks divide a slab into two or more pieces. These types of cracks are usually caused by a combination of repeated loading, curling stresses, and/or shrinkage stresses. Low-severity cracks are usually caused by curling or warping stresses (or both) and are not considered serious structural problems. Medium- and high-severity cracks are usually working cracks and typically constitute structural problems. At the high-severity level, the slab will often require replacement or large, full-depth patches. FIGURE H-12 depicts a high-severity LTD crack.

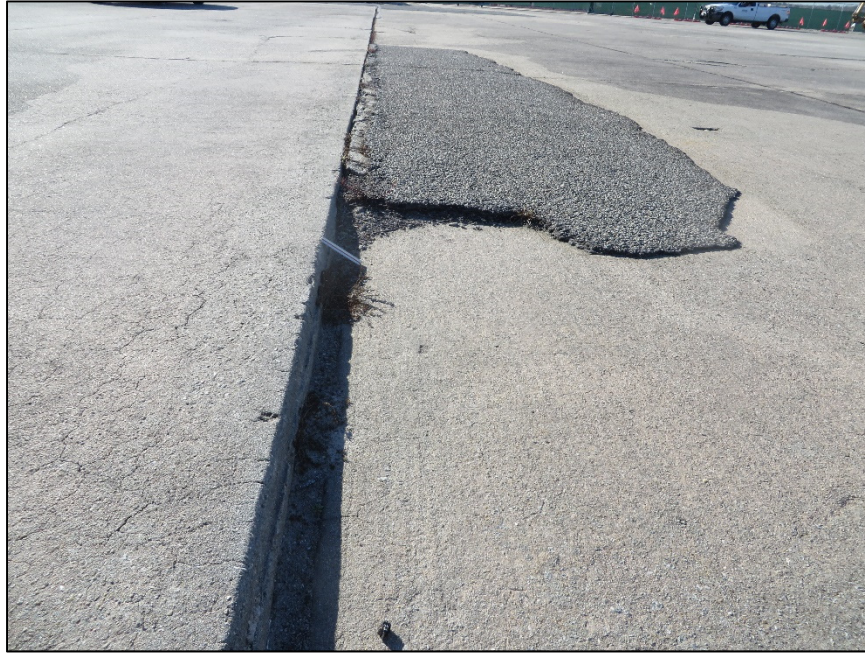
FIGURE H-16 HIGH-SEVERITY FAULTING/SETTLEMENT

ASTM D5340-12 defines faulting/settlement as *a difference of elevation at a joint or crack caused by upheaval or consolidation*. Instability in load transfer mechanisms, softening or loss of underlying support, or expanding materials in the subgrade are common causes of this type of distress. At the high-severity level, shown in FIGURE H-16, faulting/settlement can cause tire damage potential. Grinding may be considered to restore a smooth ride quality.
