Report:

Barrow County Airport Pavement Management Plan

JULY 2019

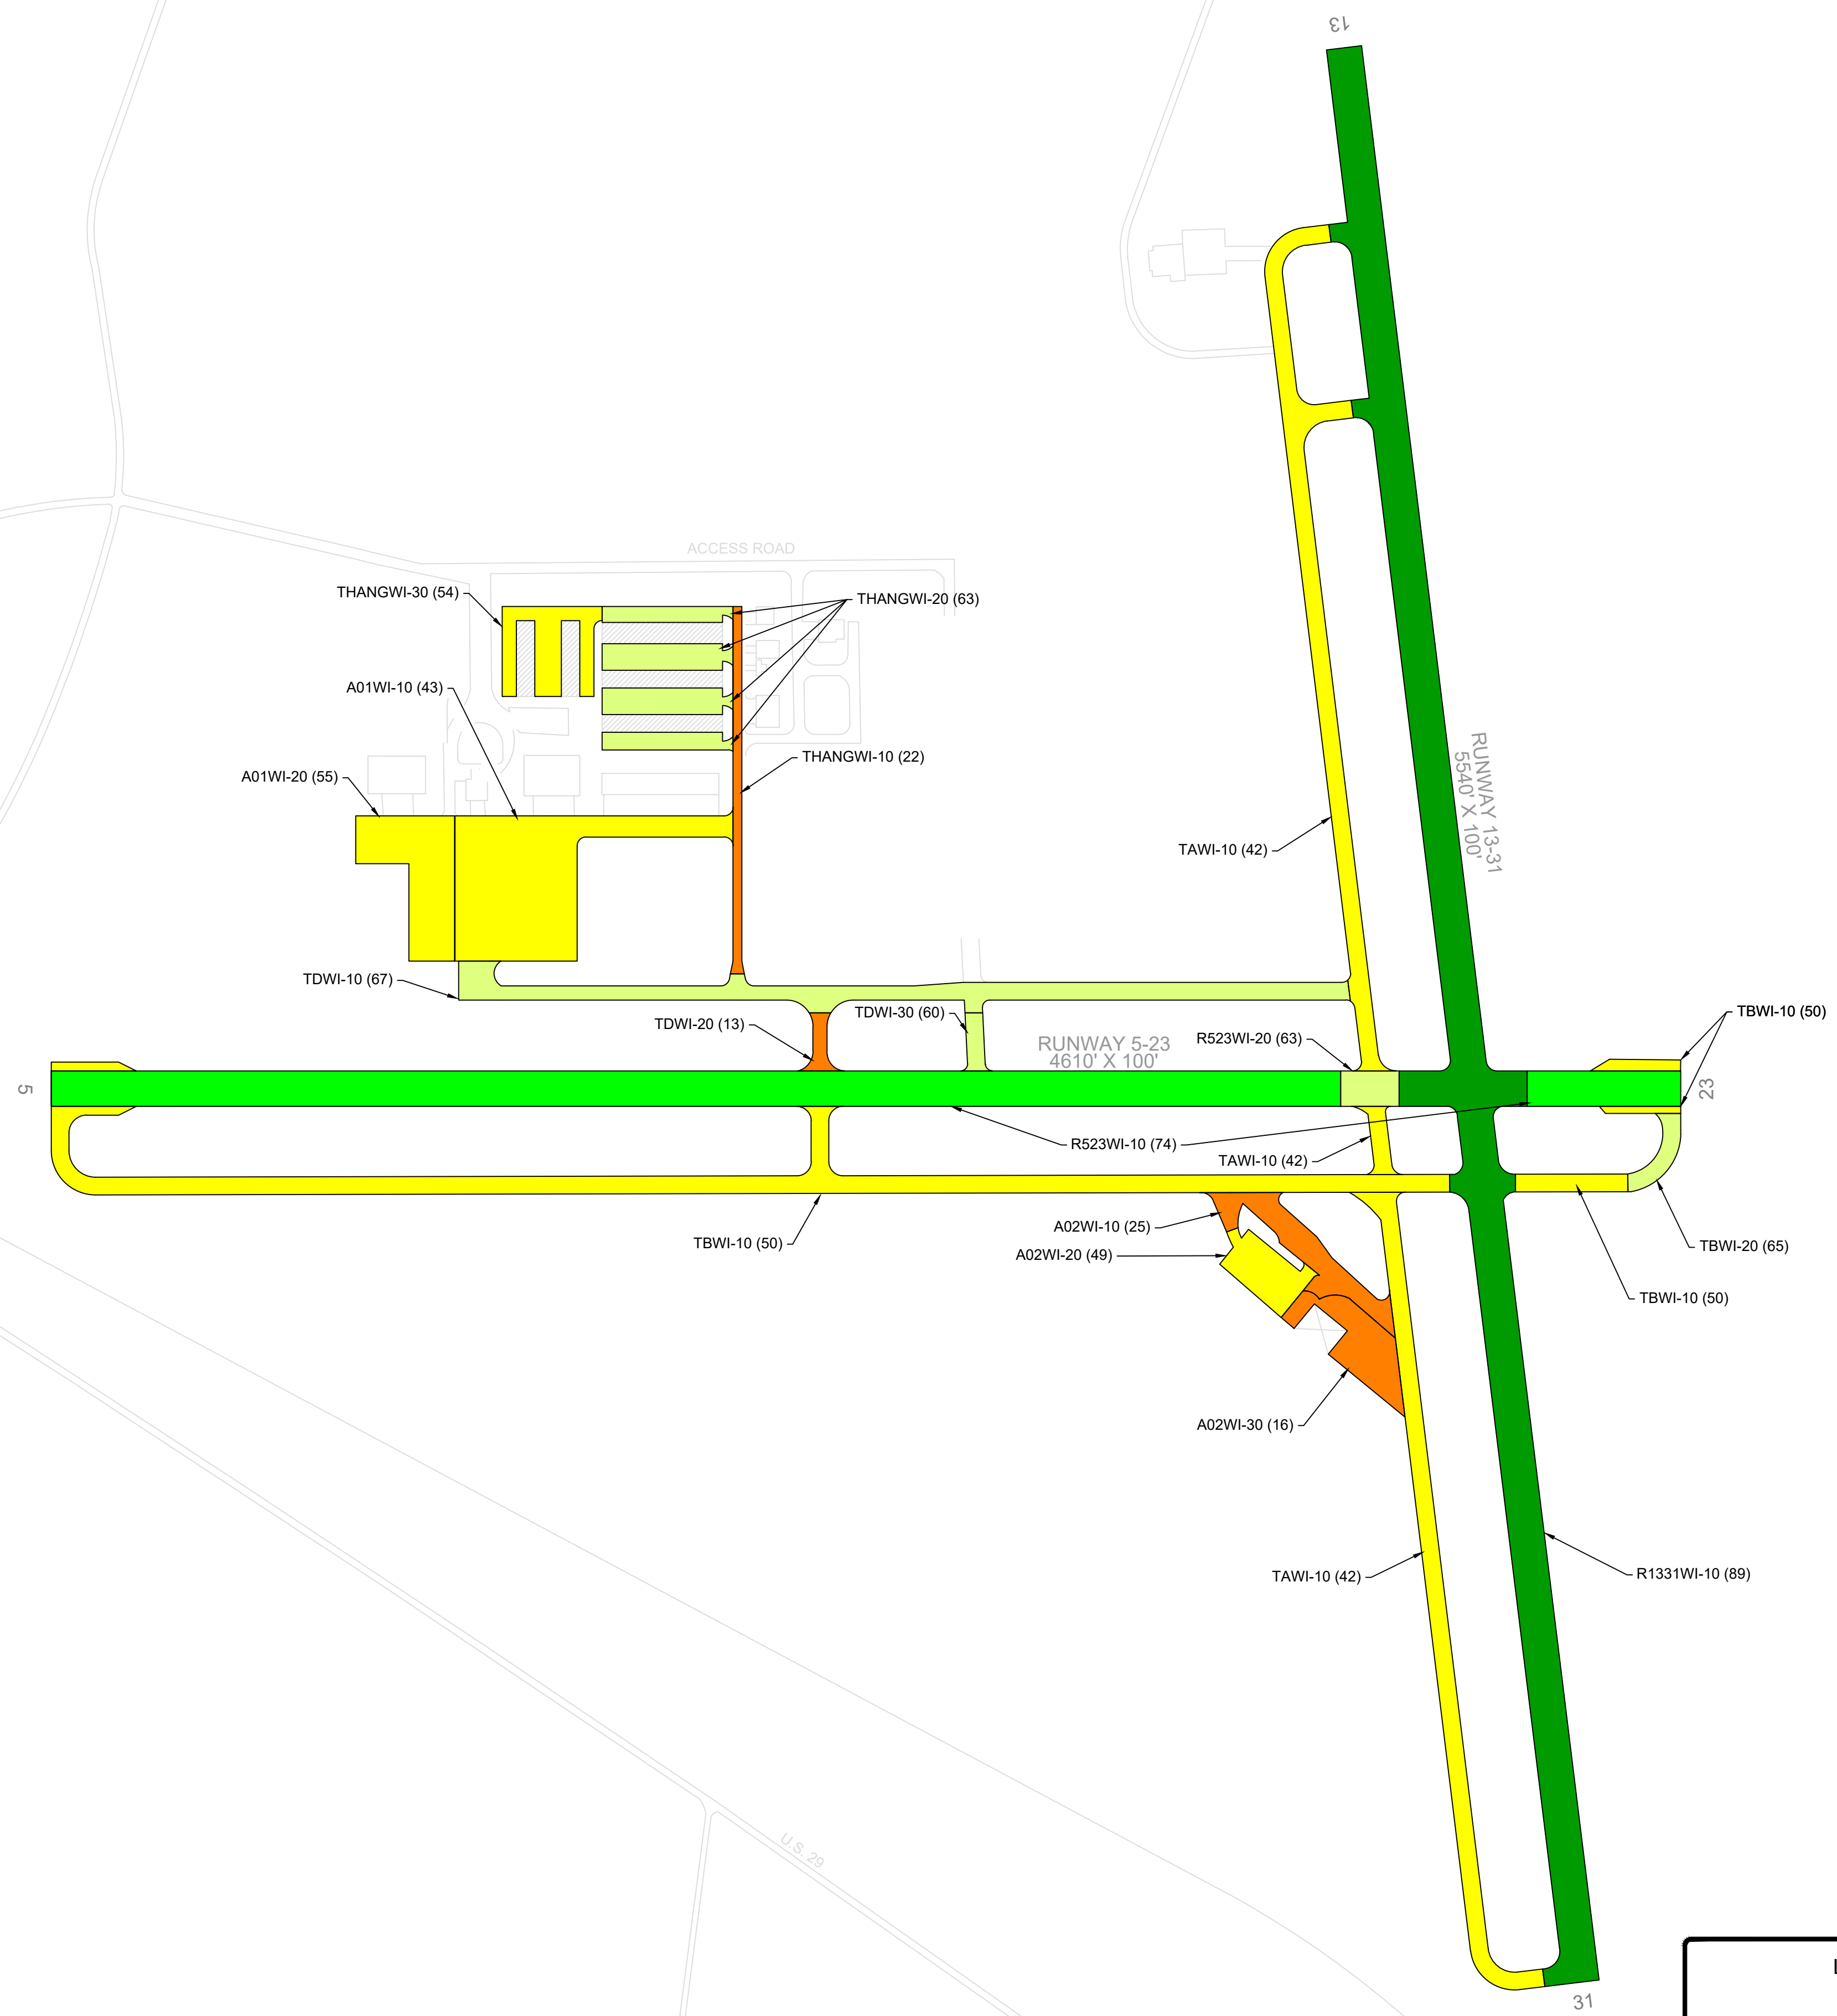
PAGE TITLE: PAVEMENT CONDITION INDEX MAP

The 2018 area-weighted condition of Barrow County Airport is 64, with conditions ranging from 13 to 89 [on a scale of 0 (failed) to 100 (excellent)]. This compares to a 2012 PCI of 66.

FIGURES 6 and 7 summarize the pavement condition distribution and overall condition of the pavements broken down by branch use, respectively, at Barrow County Airport. FIGURE 8 presents a PCI map that displays the condition of the evaluated pavements based on sectioning rules described earlier in this report. TABLE 2 summarizes the results of the pavement evaluation as well as the 2012 and 2018 PCIs.

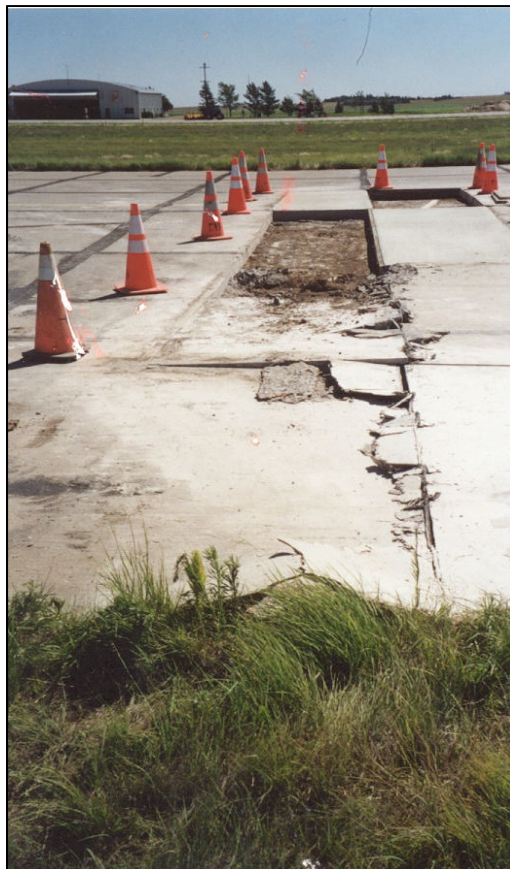
FIGURE H-10 HIGH-SEVERITY BLOWUP IN THE PROCESS OF BEING REPAIRED

Blowups occur in hot weather, usually at a transverse crack or joint that is not wide enough to permit expansion of the concrete slabs. The insufficient width is usually caused by infiltration of incompressible materials into the joint space. When expansion cannot relieve enough pressure, a localized upward movement of the slab edges (buckling) or shattering will occur in the vicinity of the joint. Blowups can also occur at utility cuts and drainage inlets. This type of distress is almost always repaired immediately because of severe damage potential to aircraft.

Depending on the situation, a full-depth patch or slab replacement will be required. An expansion joint must be provided during the repair. FIGURE H-10 shows this distress type.

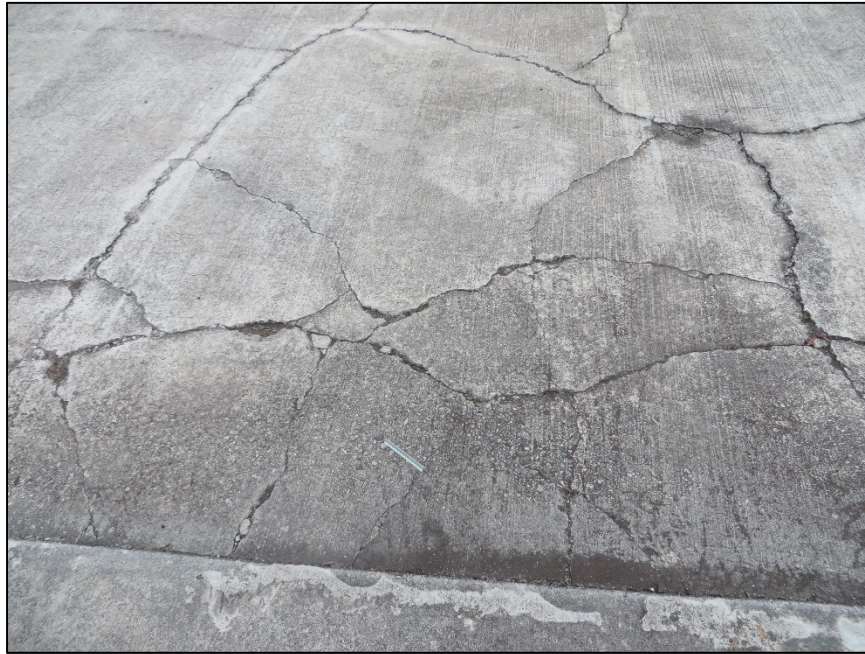
FIGURE H-17 HIGH-SEVERITY SHATTERED SLAB

A shattered slab is defined as intersecting cracks *that break a slab into four or more pieces due to overloading or inadequate support, or both*. The only option at the high-severity level is to replace the slab. An example of a high-severity shattered slab is shown in FIGURE H-17.
