# Inspection and Maintenance

Bryon Patterson, Bridge Asset Manager

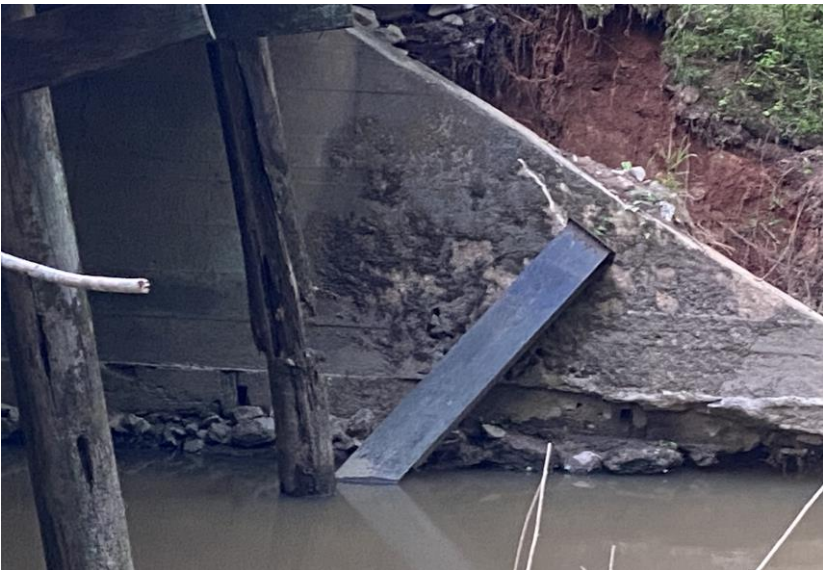
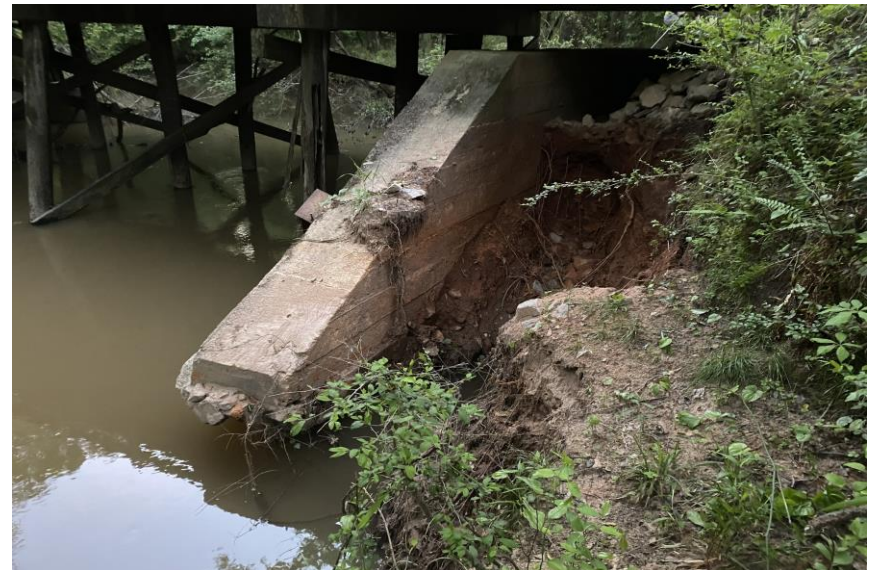
## Scour Critical

- A structure is considered Scour Critical when an abutment or pier foundations are rated unstable due to
  - observed scour at the bridge site
  - a scour potential as determined from a scour evaluation study
- One of the most common cause of a bridge failure is from floods scouring bed material from around bridge foundations

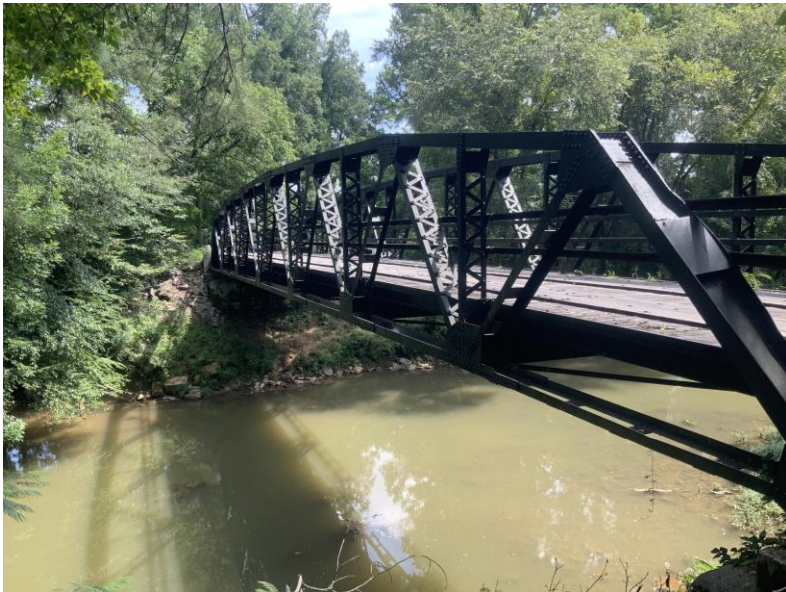
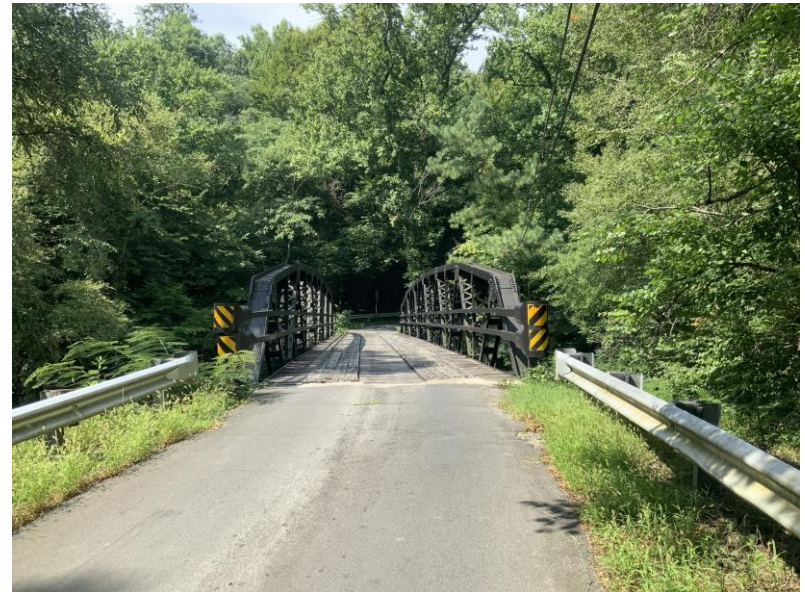
## Fracture Critical

- A bridge is considered Fracture Critical if it has non-redundant steel members (steel truss, two steel girder bridge)
  - A steel member in tension, or with a tension element, whose failure will probably cause a portion or the entire bridge to collapse

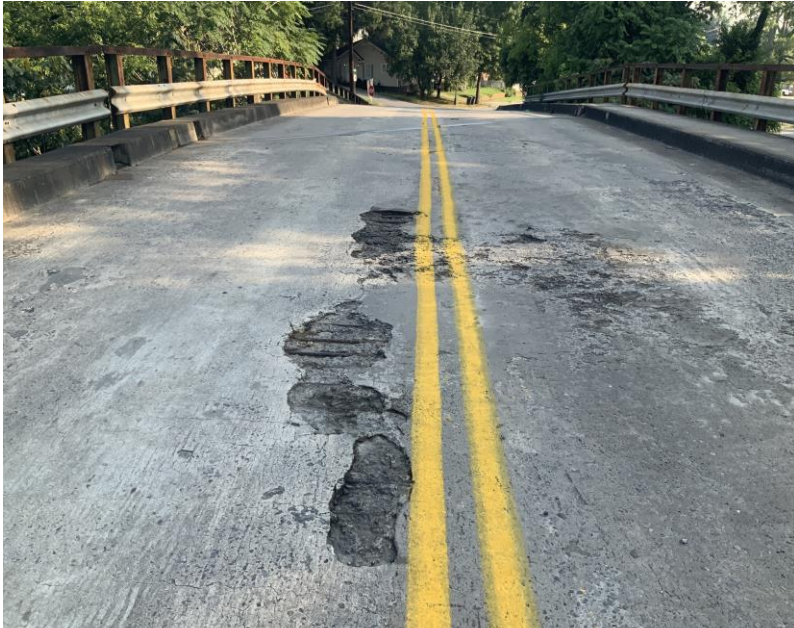
**Spalls/Delamination**

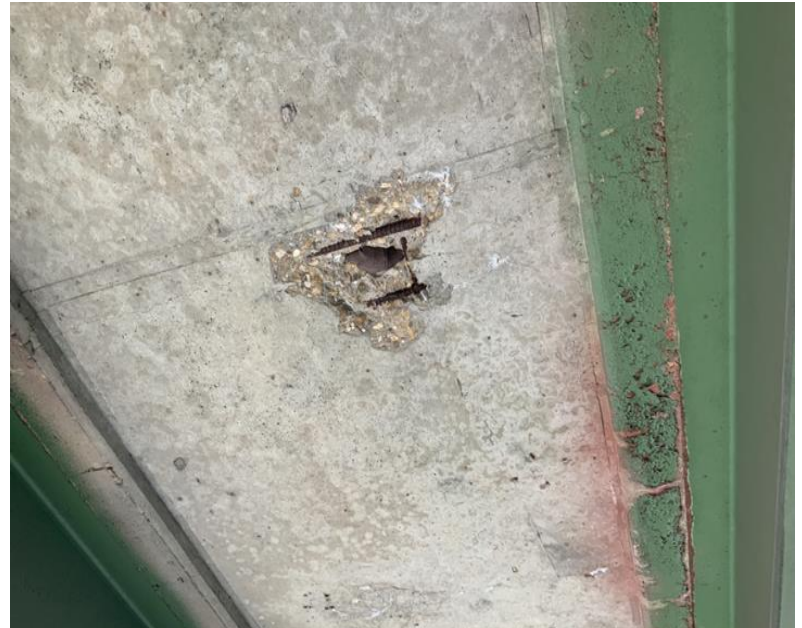
**Spall with Exposed Rebar**

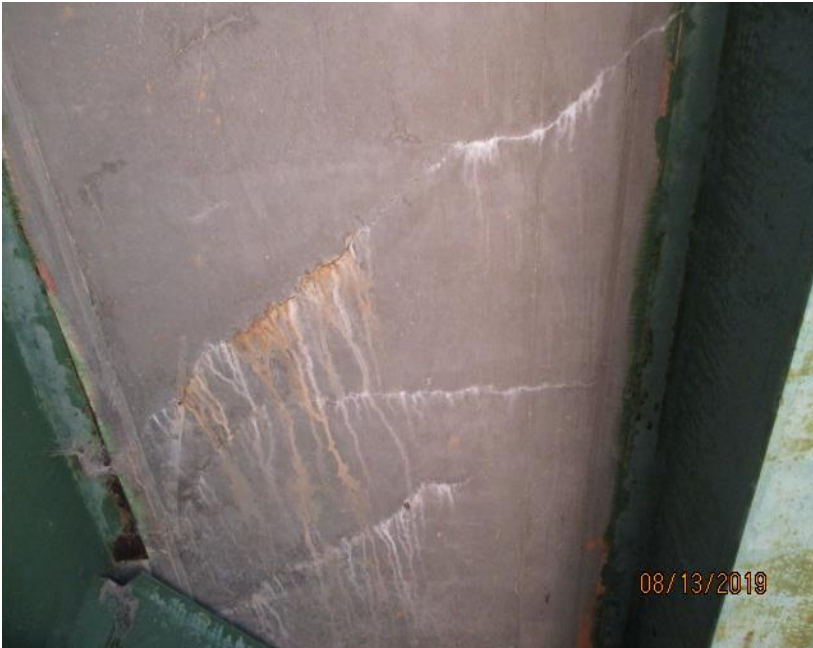
**Efflorescence**

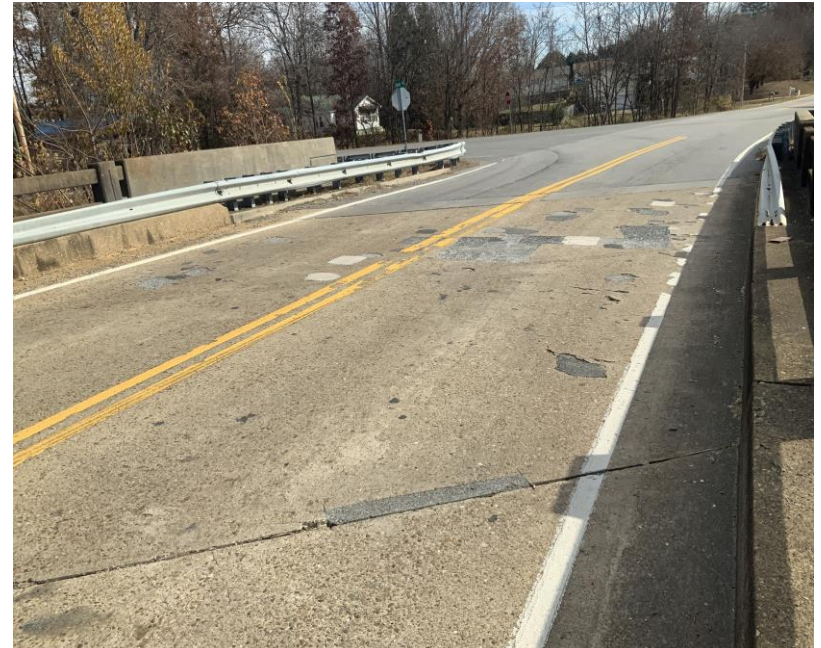
**Patched Areas**

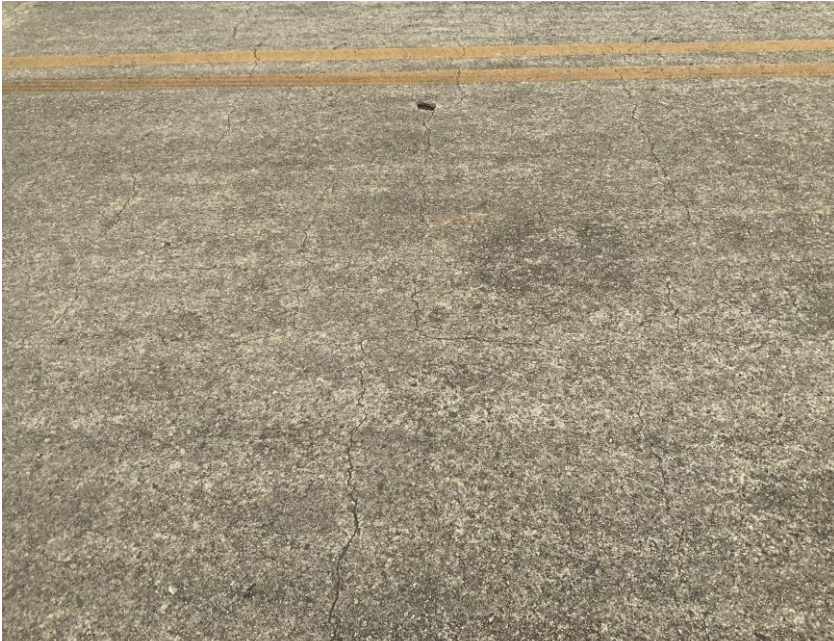
**Scaling**

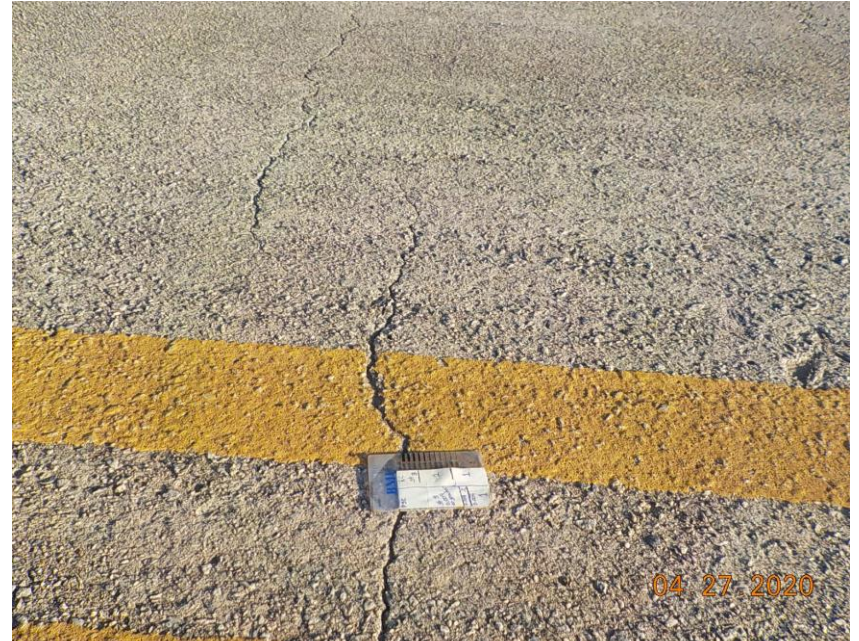
**Cracking**

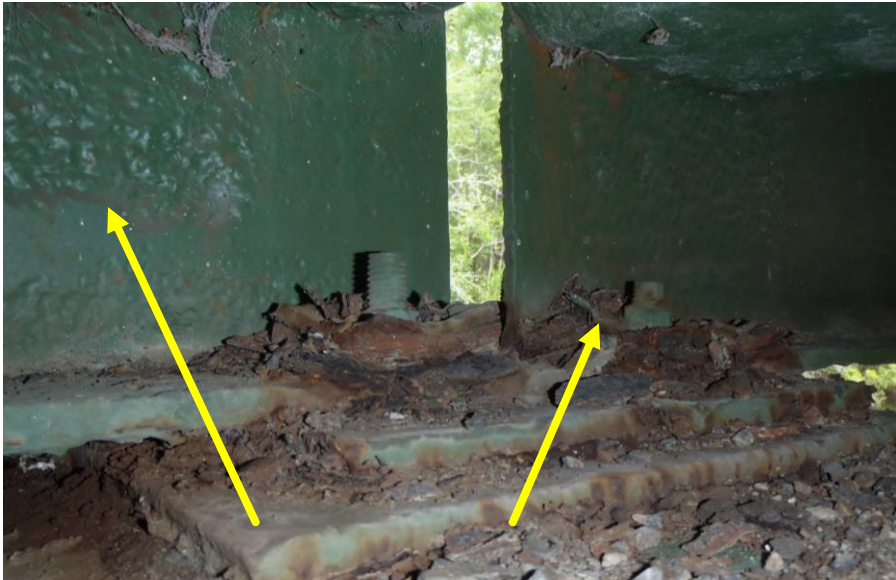
**Pitting & Pack Rust**

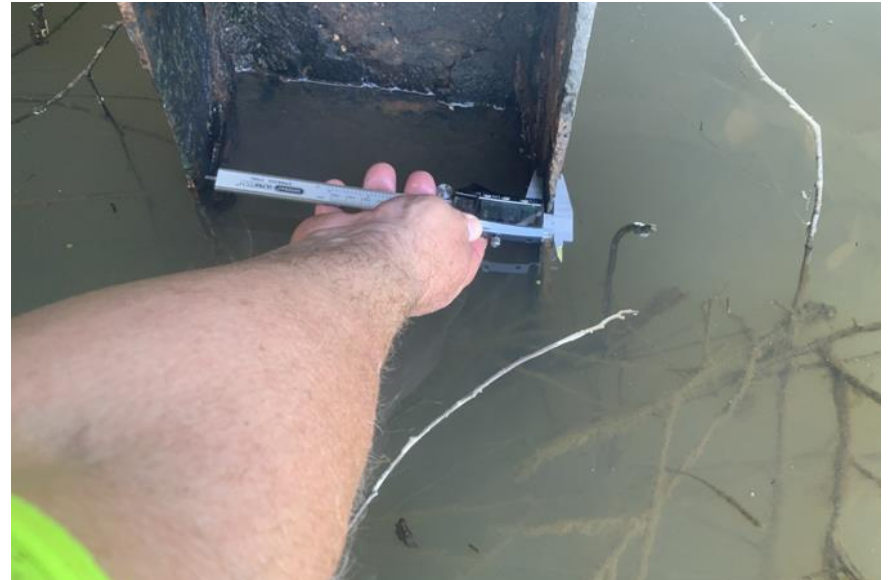
**Section Loss**

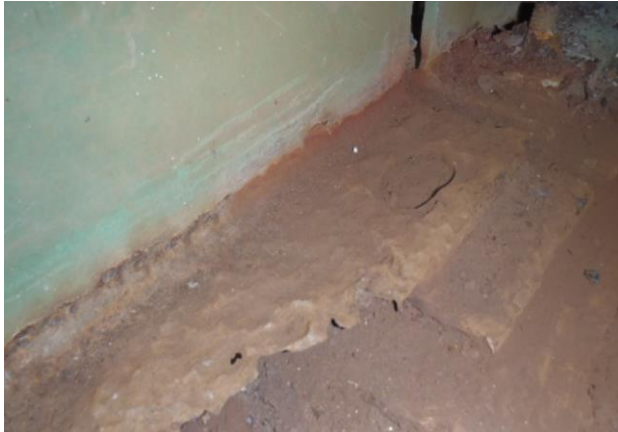
**Section Loss**

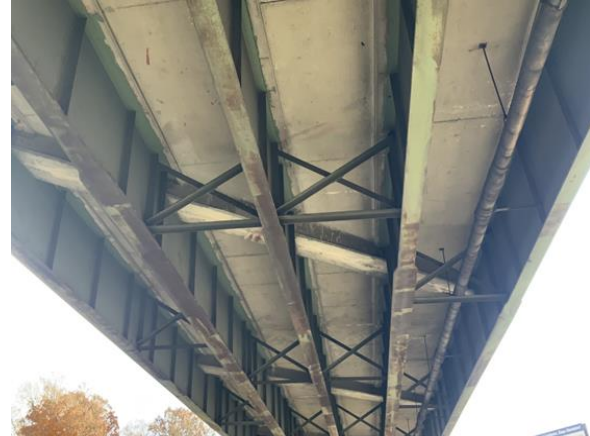
**Paint Failure**

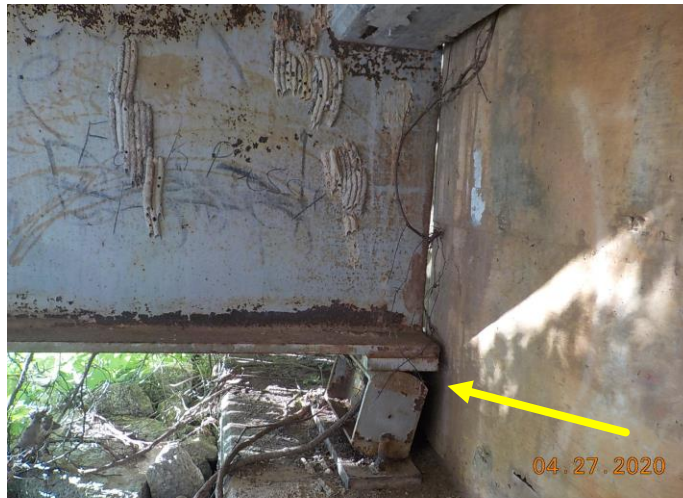
**Bearing Misalignment**

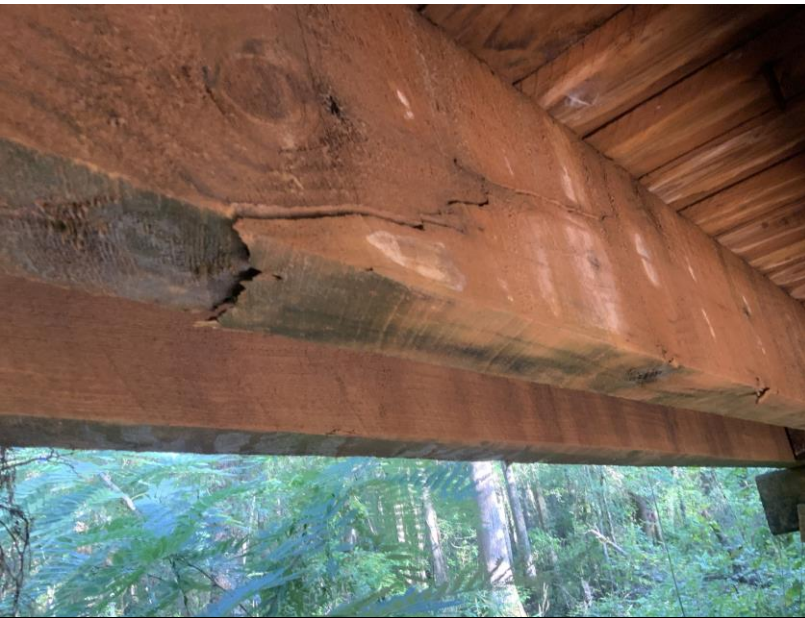
**Cracking**

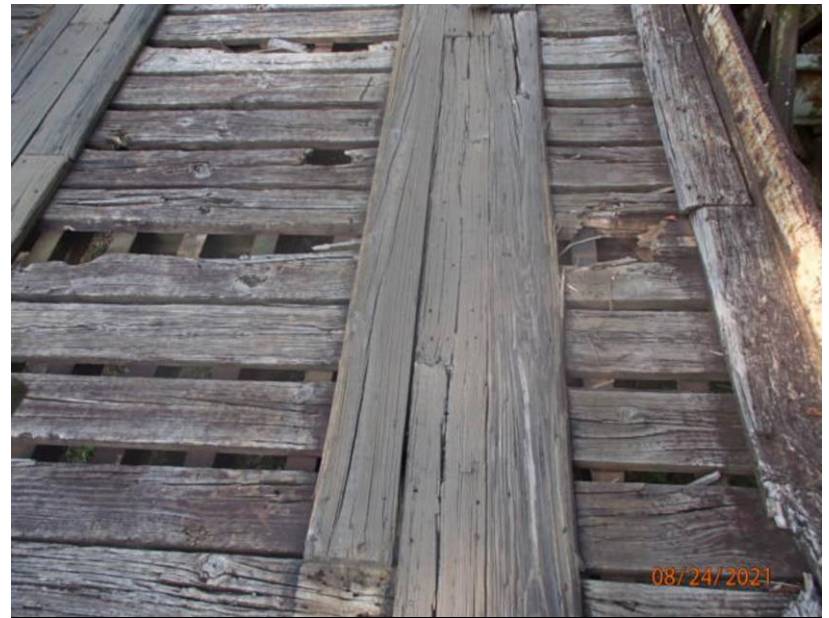
**Missing/Deteriorated Boards**

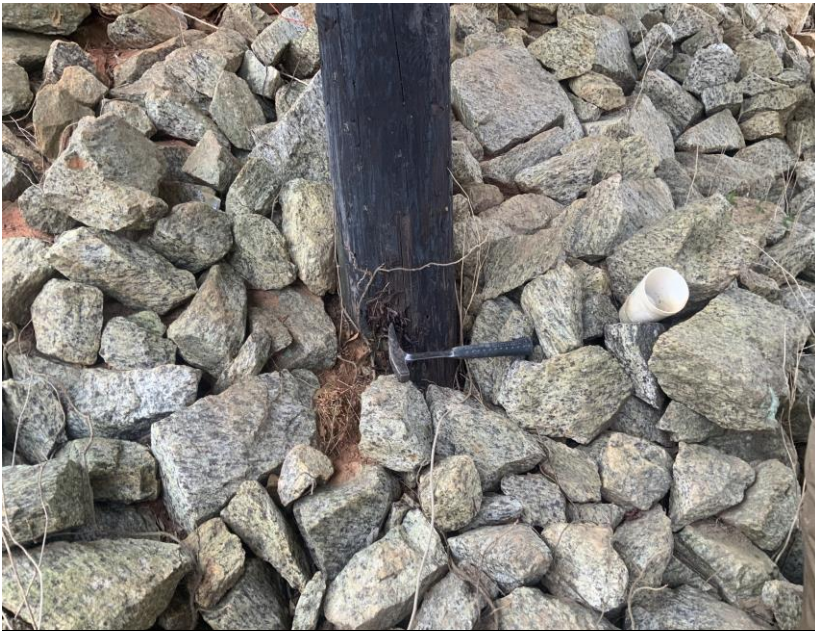
**Rotten Section**

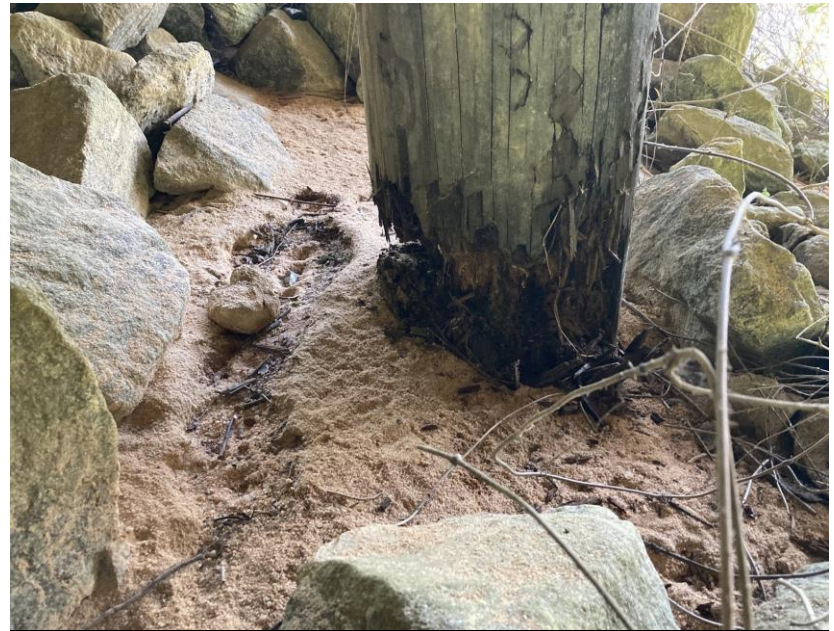
**Rotten Section**

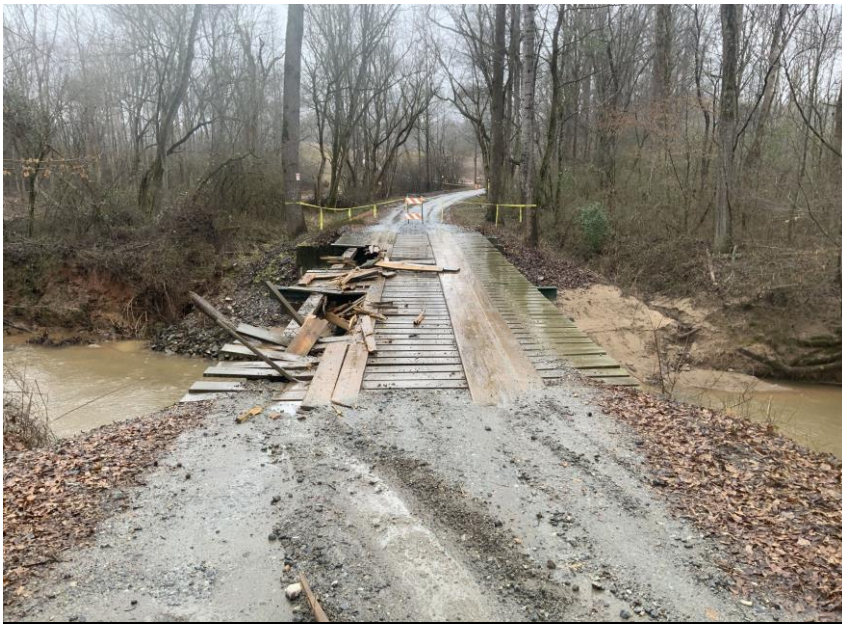
**Damage**

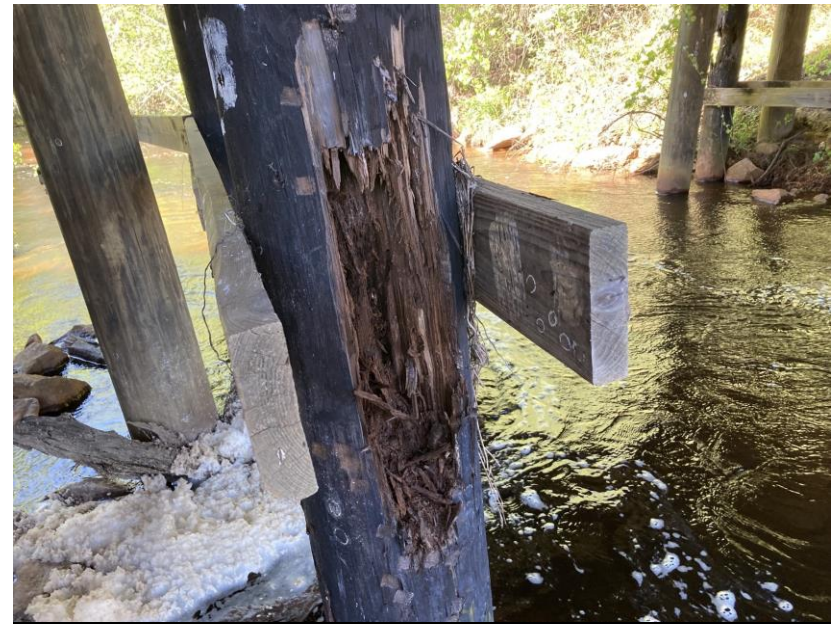
**Rotten Section**

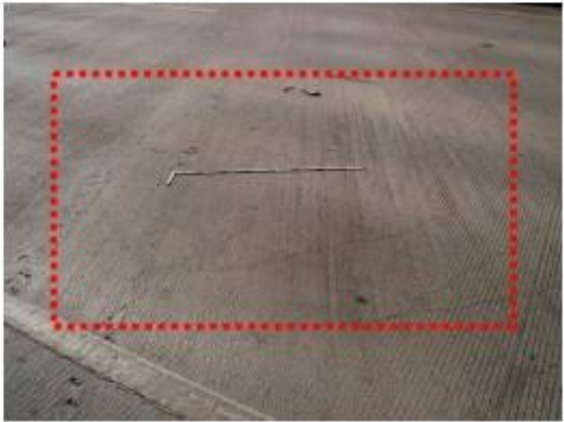
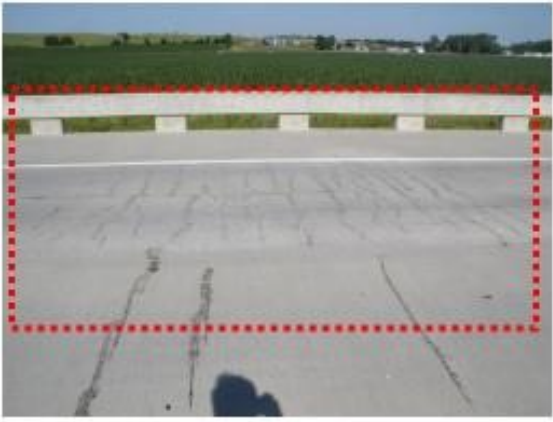
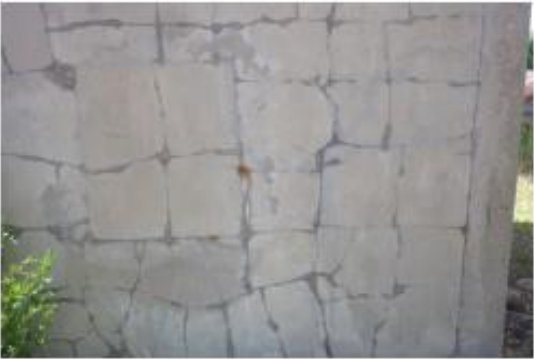
Condition State 1	Condition State 2	Condition State 3
<p>Insignificant cracks or moderate-width cracks that have been sealed.</p>	<p>Unsealed moderate width cracks or unsealed moderate pattern (map) cracking.</p>	<p>Wide cracks or heavy pattern (map) cracking.</p>
<p><i>Spacing greater than 3.0 ft.</i></p>	<p><i>Spacing of 1.0—3.0 ft.</i></p>	<p><i>Spacing of less than 1 ft.</i></p>

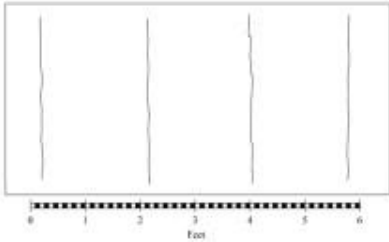
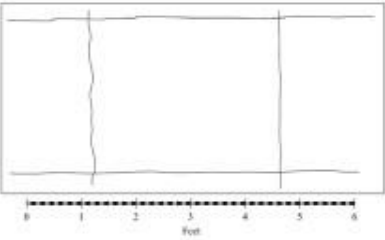
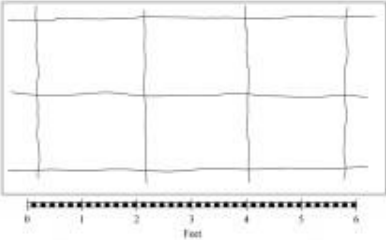
### Crack Pattern Guide

Condition State 1	Condition State 2	Condition State 3
Spacing >3 ft.	Moderate pattern (map) cracking, spacing 1–3 ft.	Heavy pattern (map) cracking, spacing less than 1 ft.

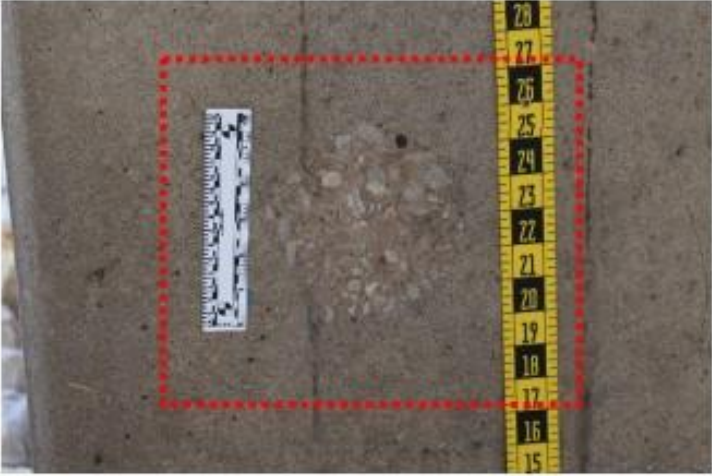
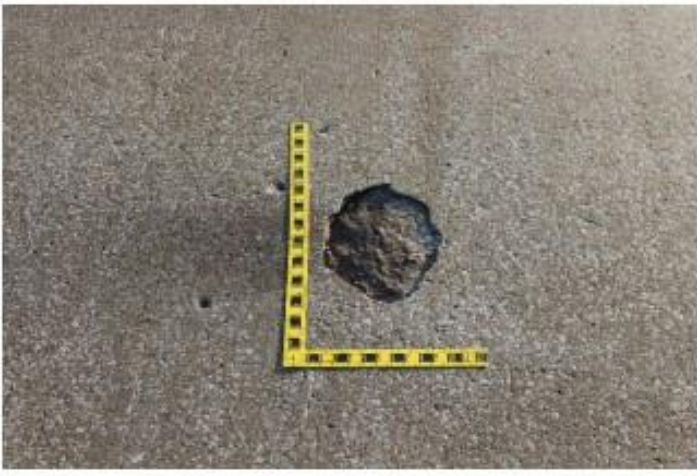
**Defect 1080—Delamination/Spall/Patched Area**

Condition State 1	Condition State 2	Condition State 3
None.	Delaminated. Spall 1 in. or less deep or 6 in. or less in diameter. Patched area that is sound.	Spall greater than 1 in. deep or greater than 6 in. diameter. Patched area that is unsound or showing distress. Does not warrant structural review.

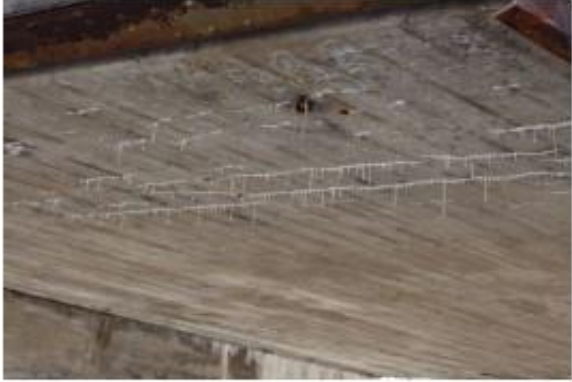
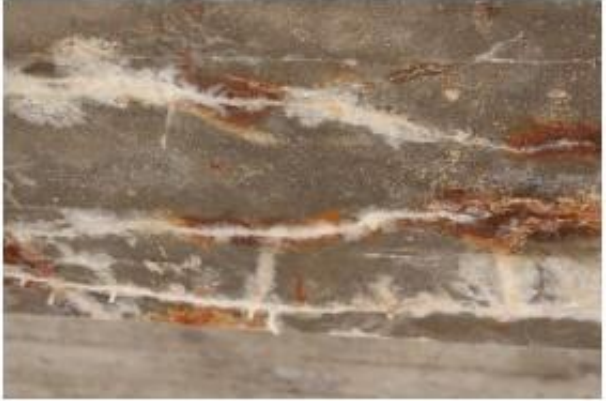
**Defect 1120—Efflorescence/Rust Staining**

Condition State 1	Condition State 2	Condition State 3
None.	Surface white without build-up or leaching without rust staining.	Heavy build-up with rust staining.

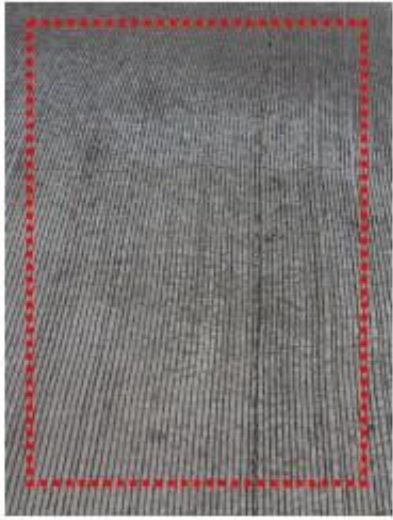
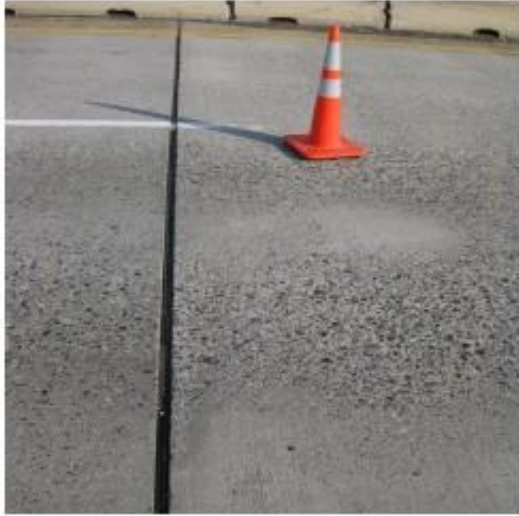
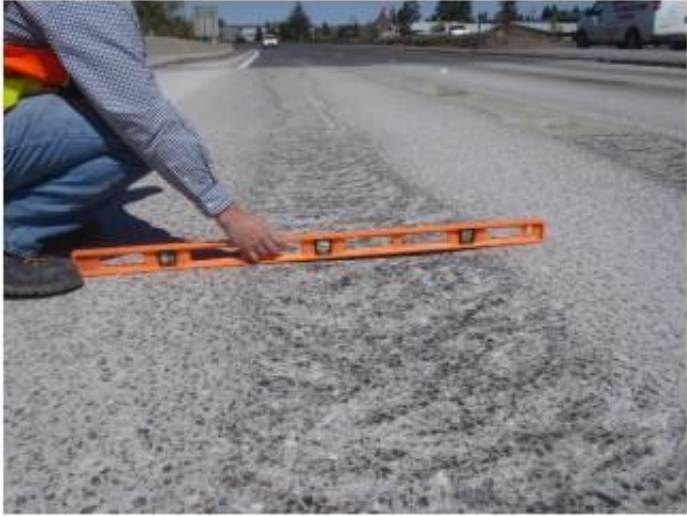
**Defect 1190—Abrasion/Wear**

Condition State 1	Condition State 2	Condition State 3
<p>No abrasion or wearing.</p>	<p>Abrasion or wearing has exposed coarse aggregate, but the aggregate remains secure in the concrete.</p>	<p>Coarse aggregate is loose or has popped out of the concrete matrix due to abrasion or wear.</p>

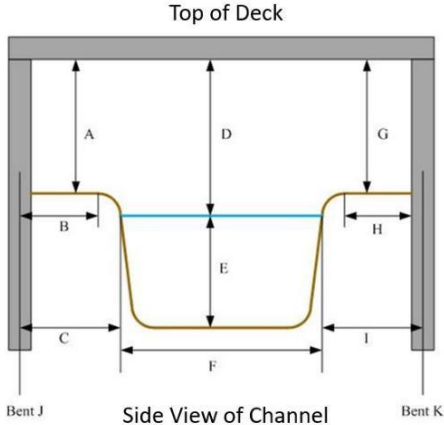
### Channel Information

**A:** 9   **B:** 16   **C:** 22   **D:** 11.5  
**E:** 14   **F:** 526   **G:** 9   **H:** 14  
**I:** 22   **J:** 1   **K:** 8

**Location of Bridge Height:** 5' forward bent 2  
**Bridge Height Taken:** 0  
**Scour Condition:** 7  
**Waterway Adequacy:** 8  
**Channel Protection:** 7  
**Channel Protection:** 7

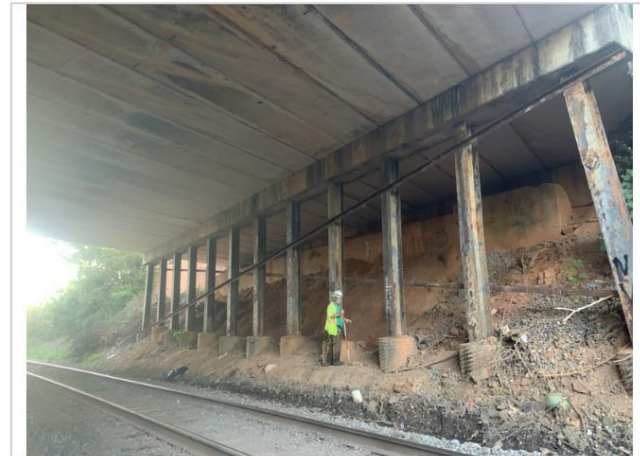
Underneath looking at bent 3. 2022

Bent 3 cap has exposed steel chairs in the bottom face.  
 Bent 3 cap has a 16" x 14" x 2" spall with no exposed steel in the forward face over pile 6; rear face has minor spalls with exposed rebar.  
 Bent 3, pile 7 has steel corrosion at the top of the pile at the cap.  
 Repair spalls

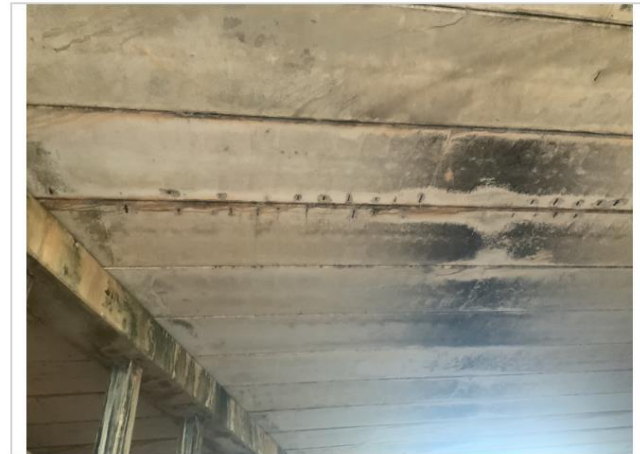
Typical exposed rebar in deck panels. 2022

Deck Underside:  
 The overhangs have spalls with exposed rebar throughout. Needs repair

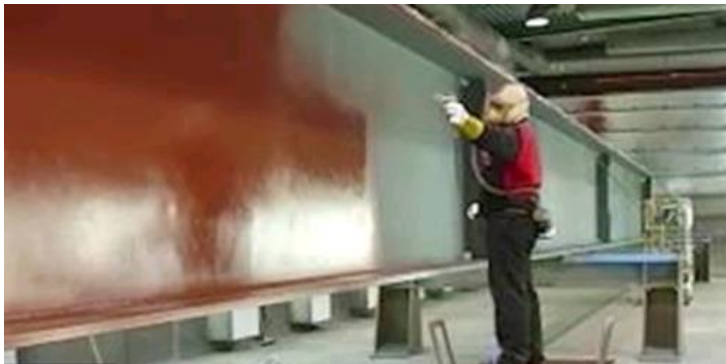
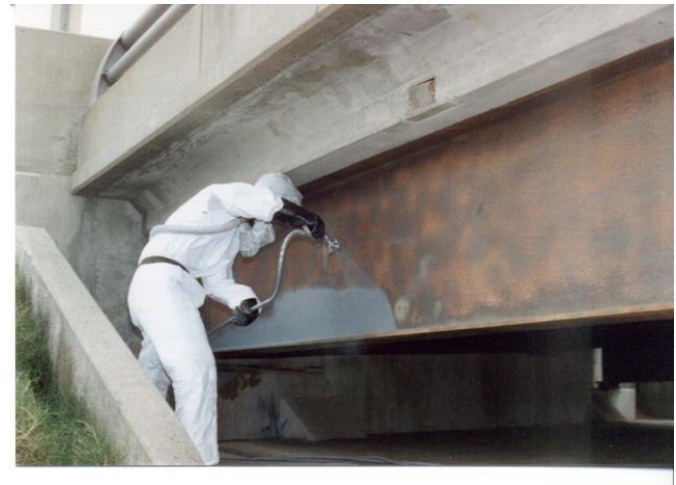
**Painting of existing steel beams  
is a preservation that can  
extend the life of a structure.**

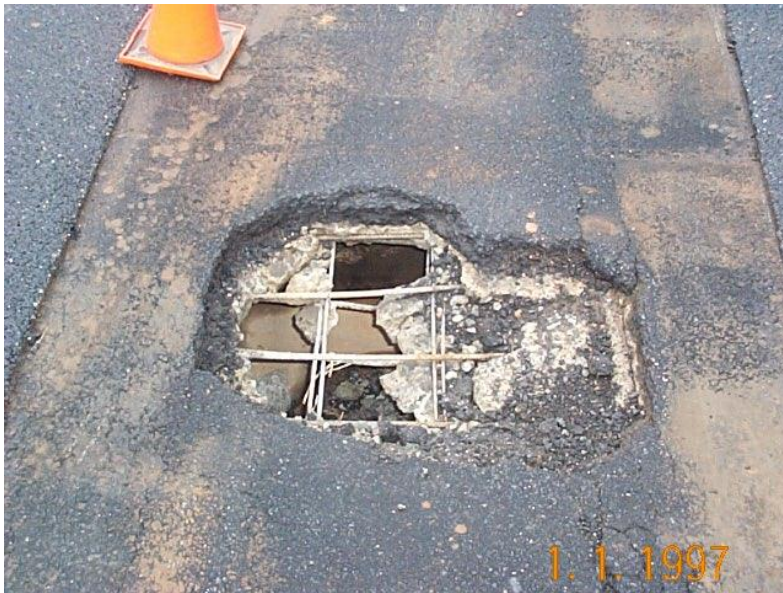
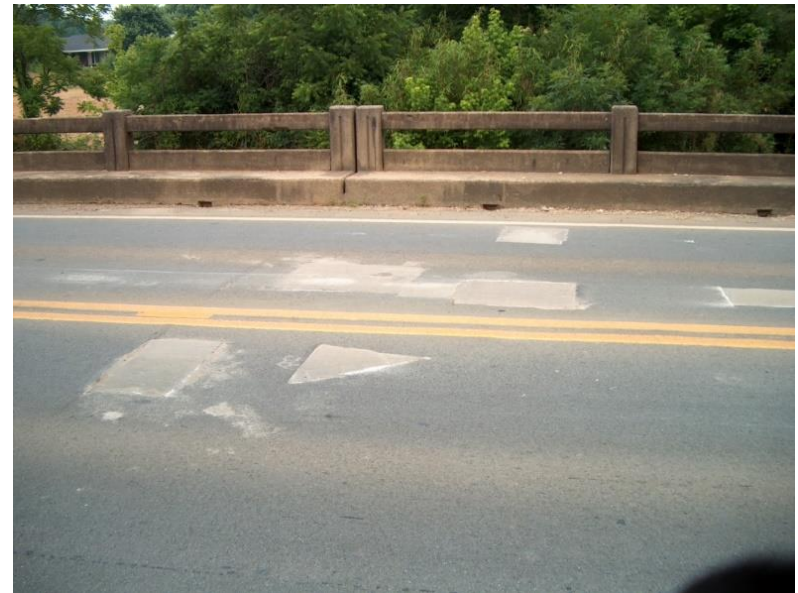
# Bridge Rehabilitation

Increased vehicle weights, pollution and limited maintenance are some of the factors that influence the deterioration of our structures.

**Before**

**After**

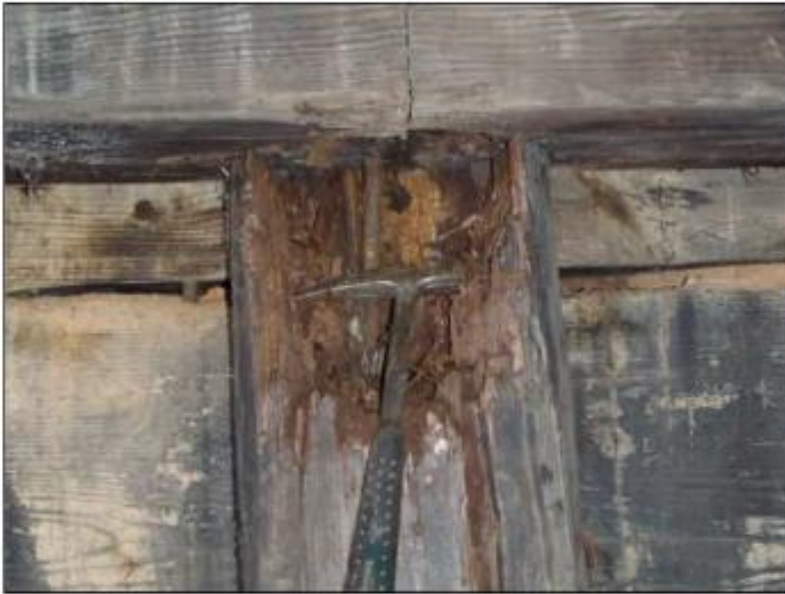
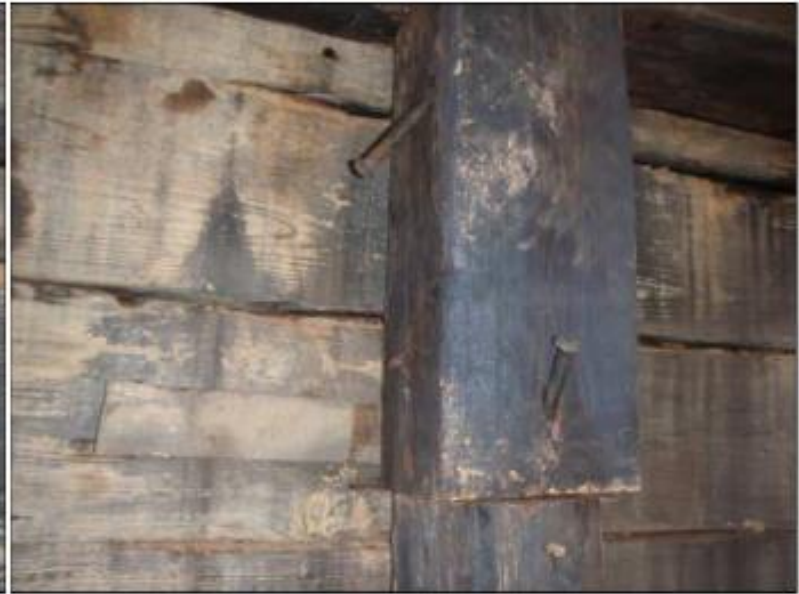
## Timber Pile – Section Loss Repair

Before Repair

After Repairs

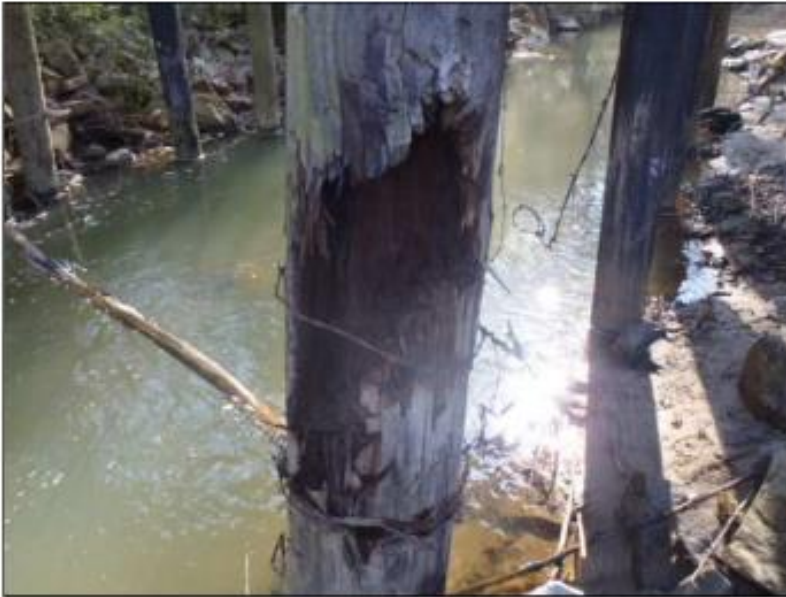
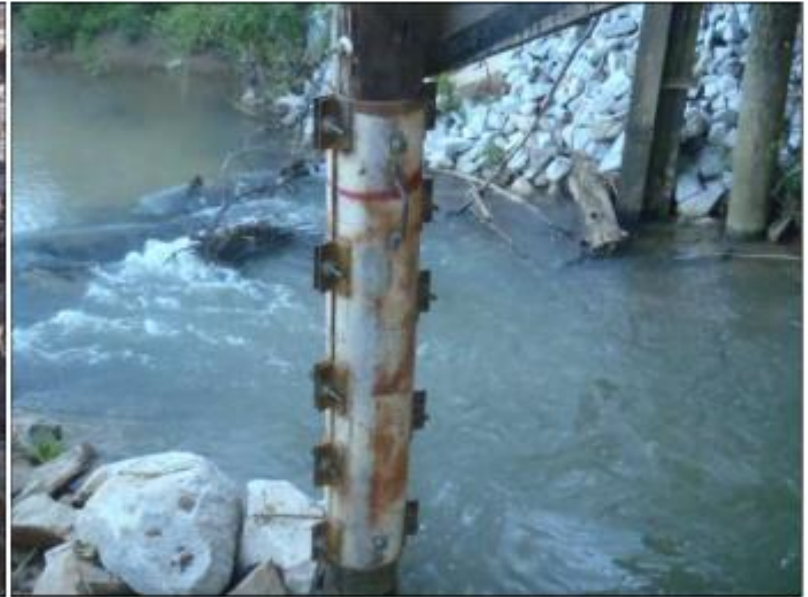
## Timber Pile – Section Loss Repair (Collar)

Before Repair

After Repairs

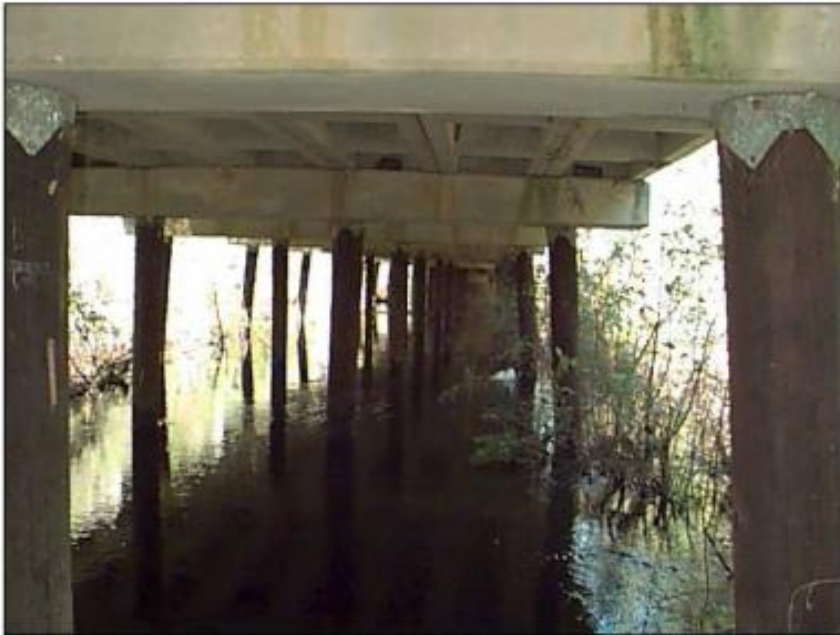
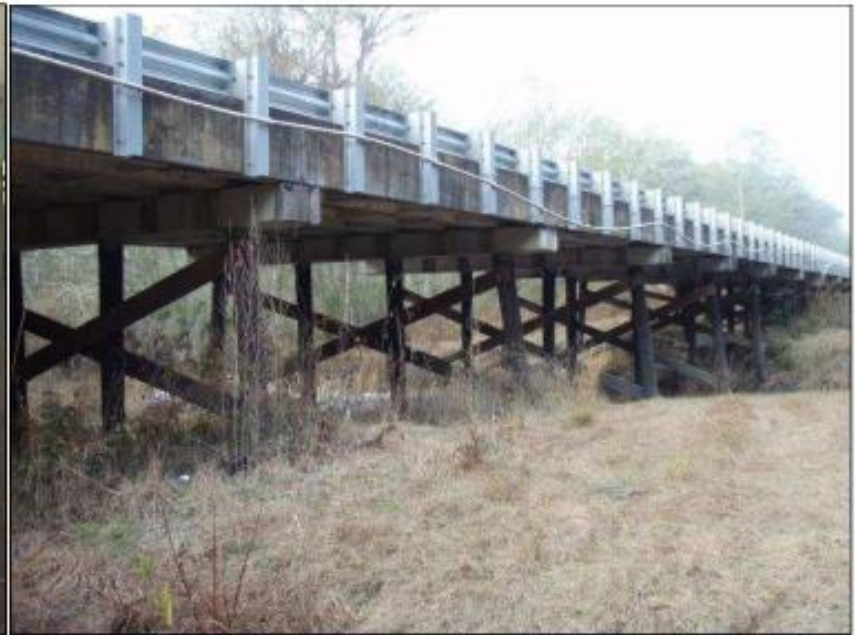
# Timber Pile – Swaybracing

Before Repair

After Repairs

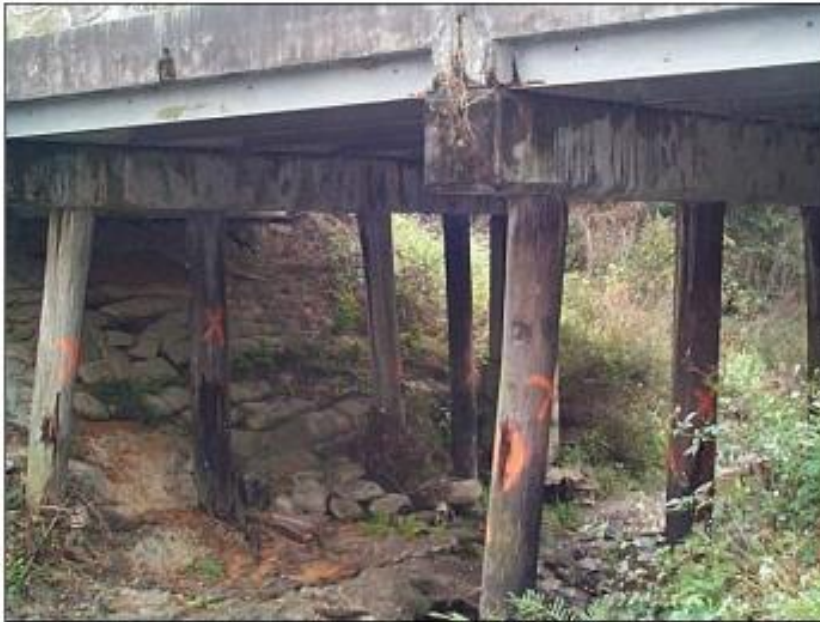
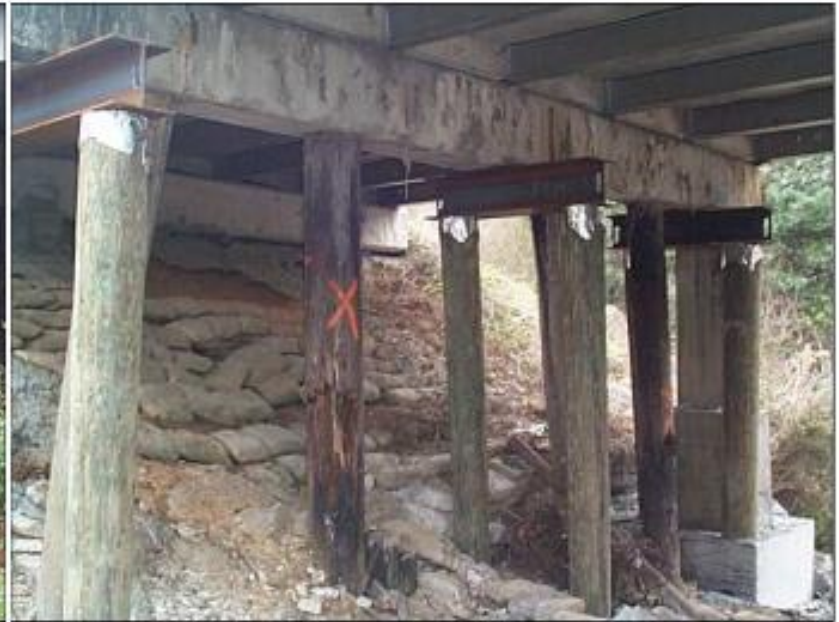
## Helper Bent (Temporary Repair)

Before Repair

After Repairs

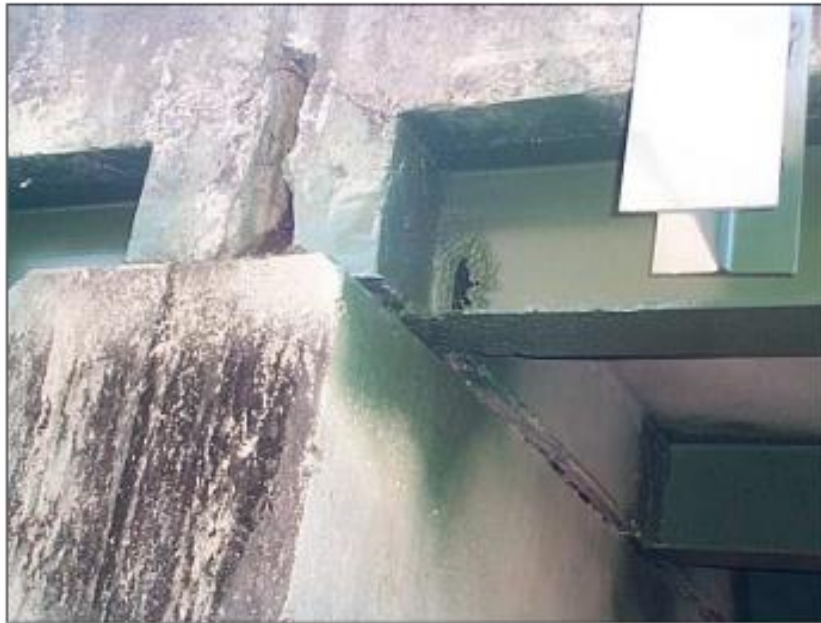
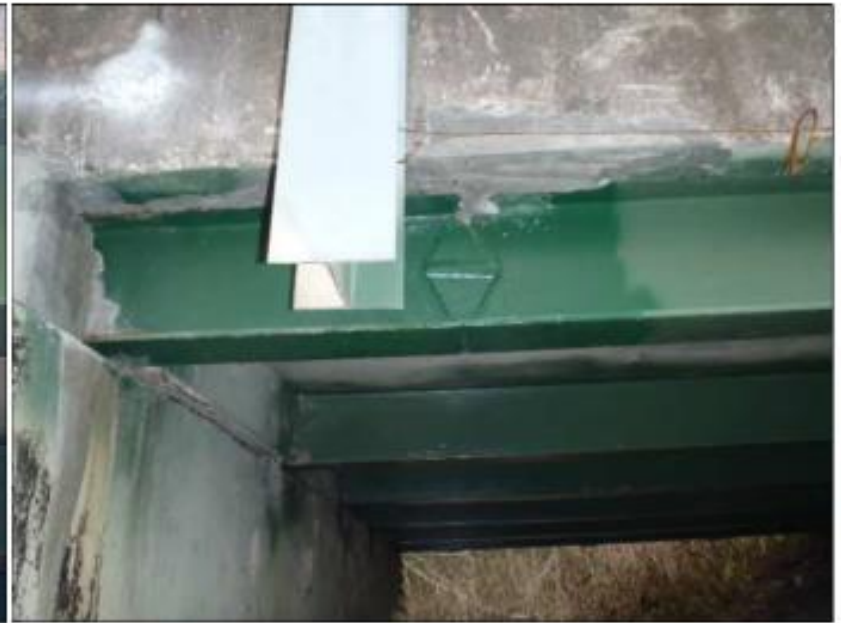
# Beam Web Section Loss Repair

Before Repair

After Repairs

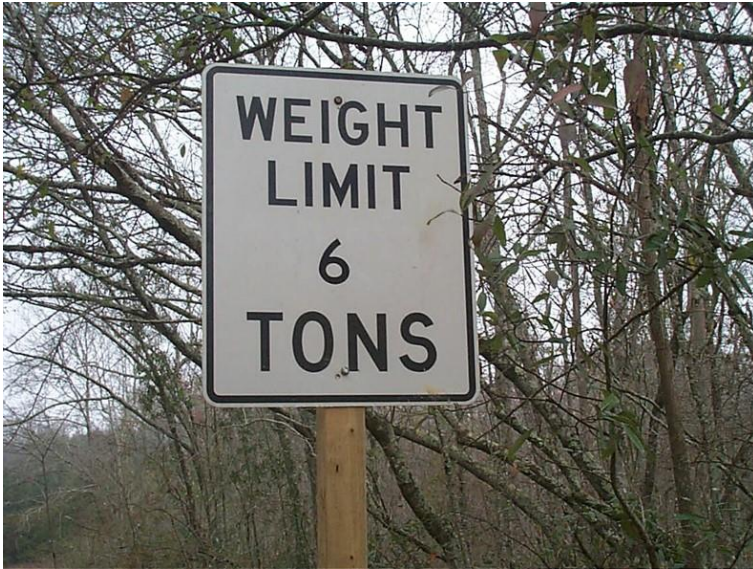
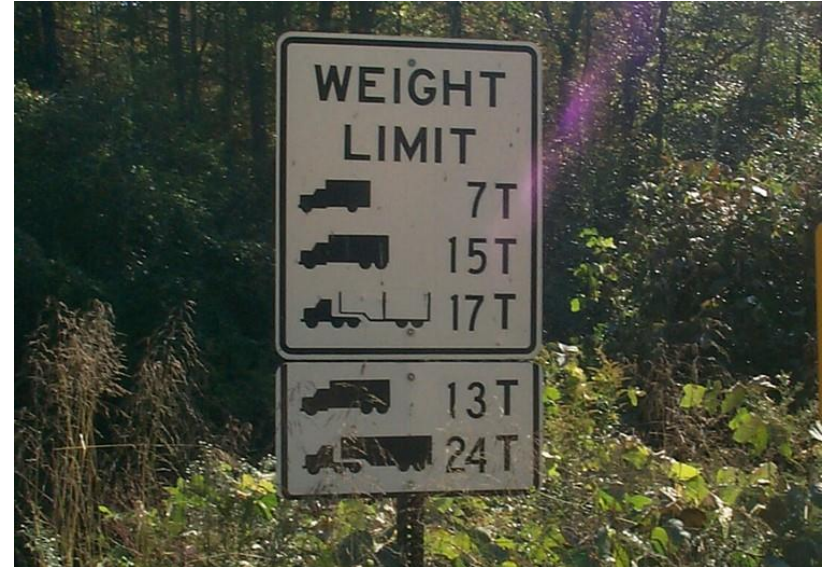
# Types of Posting Signs

R12-1  
GROSS WEIGHT LIMIT SIGN  
(Type A.)

## Type A

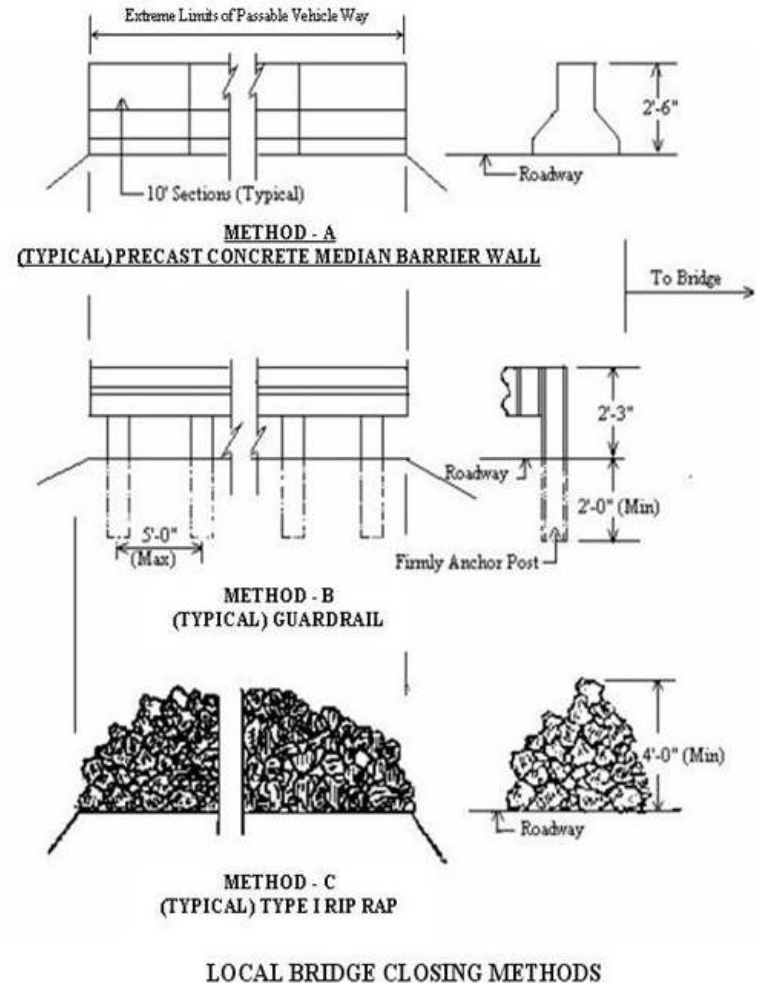
- Why do we close structures?
  - If the load rating calculates less than 5 tons of carrying capacity
  - Any bridge below 5 tons **MUST** be closed according to GDOT Methods
- Different Methods of Closures
  - Method A
  - Method B
  - Method C
