# Inspection and Maintenance

Bryon Patterson, Bridge Asset Manager

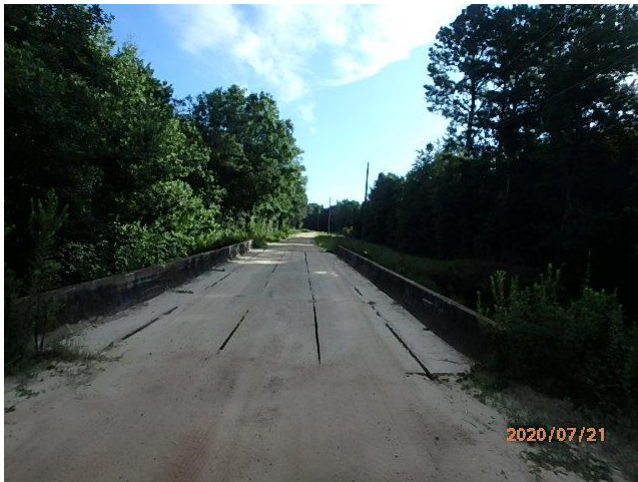
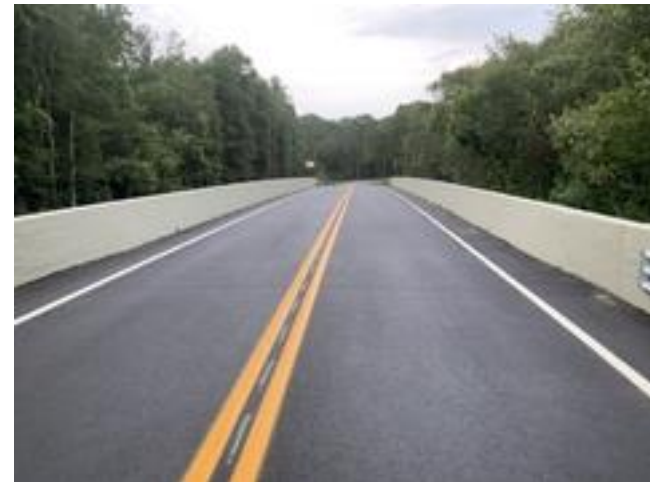
# Bridge Replacement

- Total replacement of an existing bridge with a new facility constructed in the same general location.
- The replacement structure will meet current standards to better serve the highway's current and future traffic needs.
- Bridges are replaced when it is no longer economically feasible to repair or rehabilitate them to fully functional structures.
