# Post Design-Build Evaluation Report

**Project Description: I-24 at SR 299 Bridge Replacement  
(Accelerated Bridge Construction)**

**P.I. Number: 0011682  
County: Dade  
GDOT District: District 6**

**Date Conducted: August 1, 2017**

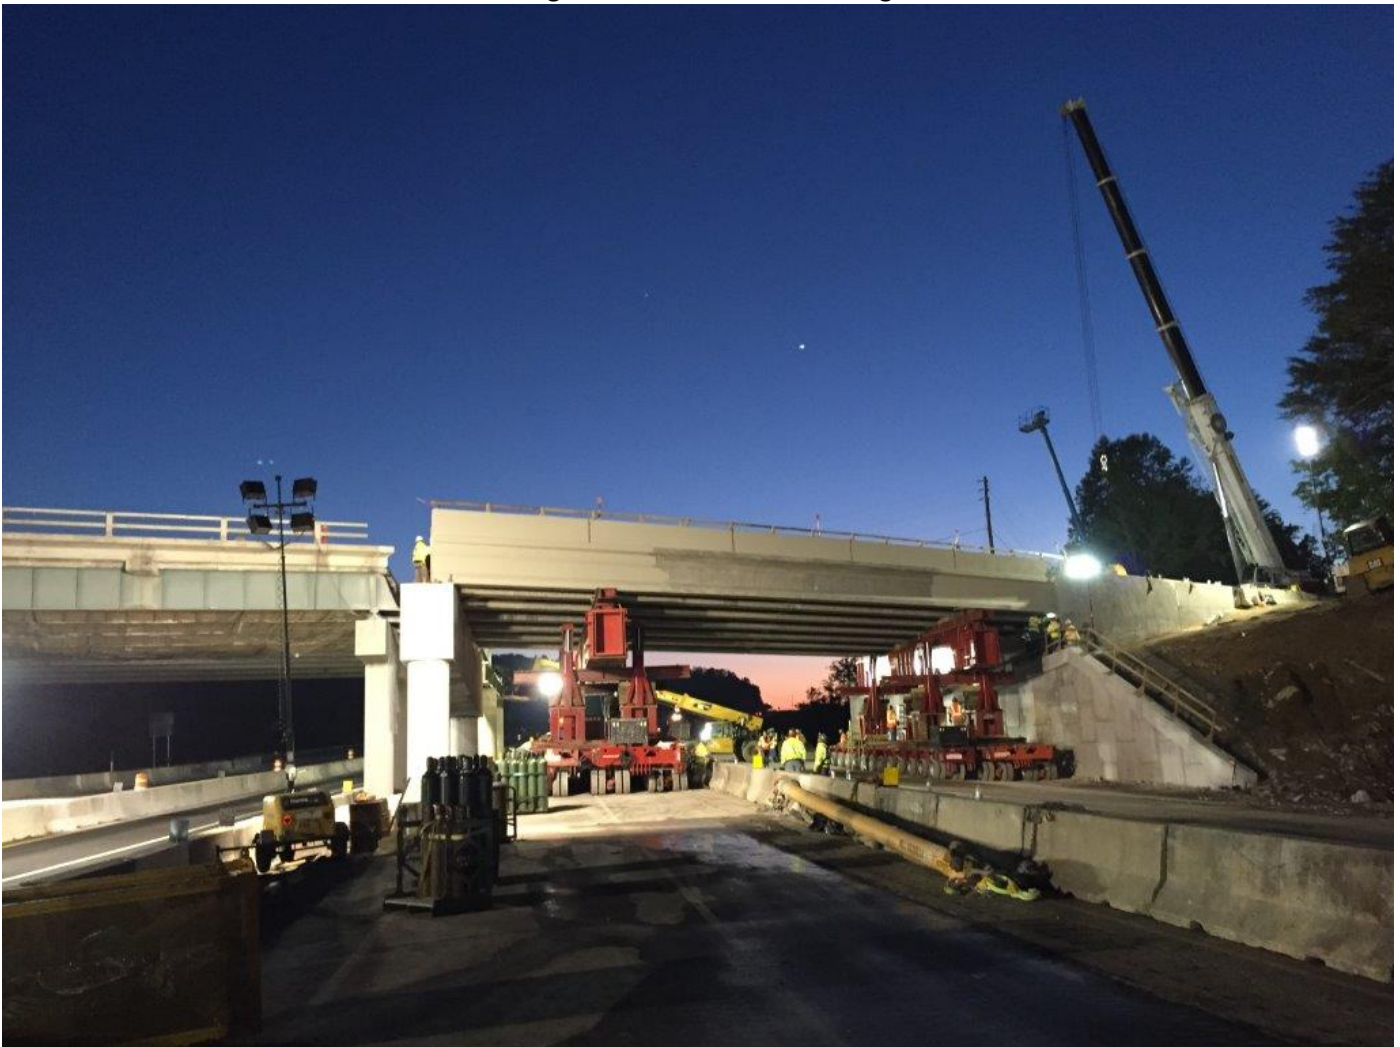
I-24 at SR 299 Bridge under construction during 56 hour move

- o Self-Propelled Modular Transport for Bridge Move during 56 hour weekend
- o Pre-Cast Approach Slabs and Pedestals
- o Use of #57 Crushed Stone to backfill approaches prior to the move as opposed to dirt.
- o Only known project in the country to move two spans over live traffic in one-weekend, which may have been overly aggressive.
- o Maintaining traffic flow on interstate I-24 went very smoothly.
