2012 Southwest Georgia Regional Airport Pavement Management Plan

SOUTHWEST GEORGIA REGIONAL AIRPORT

PAVEMENT MANAGEMENT REPORT

DECEMBER 2012

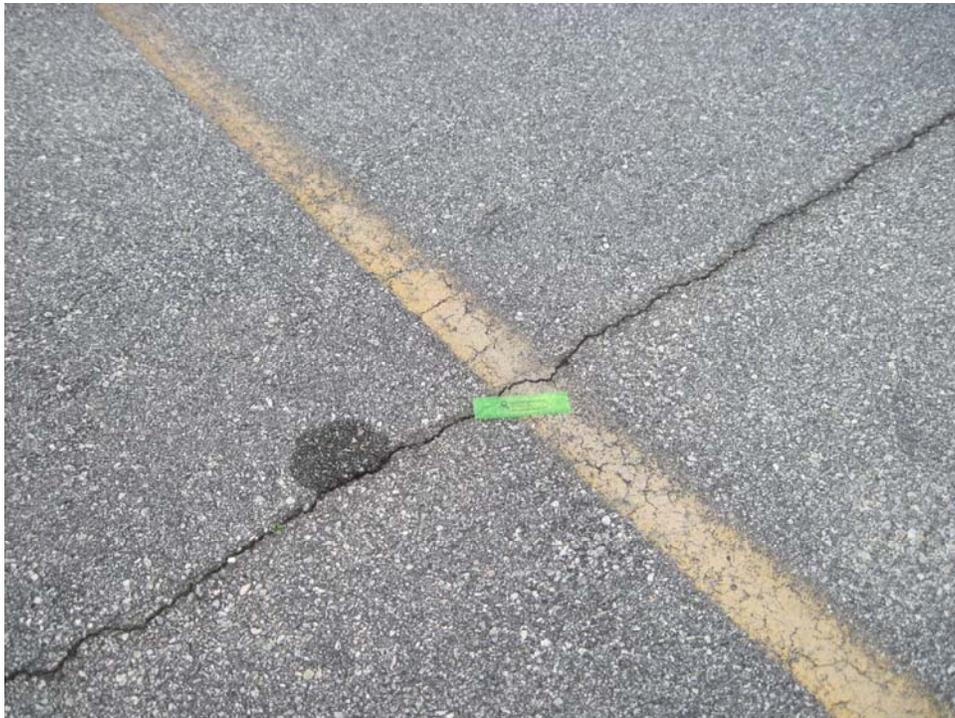
A02AY-10. Satisfactory Paint.

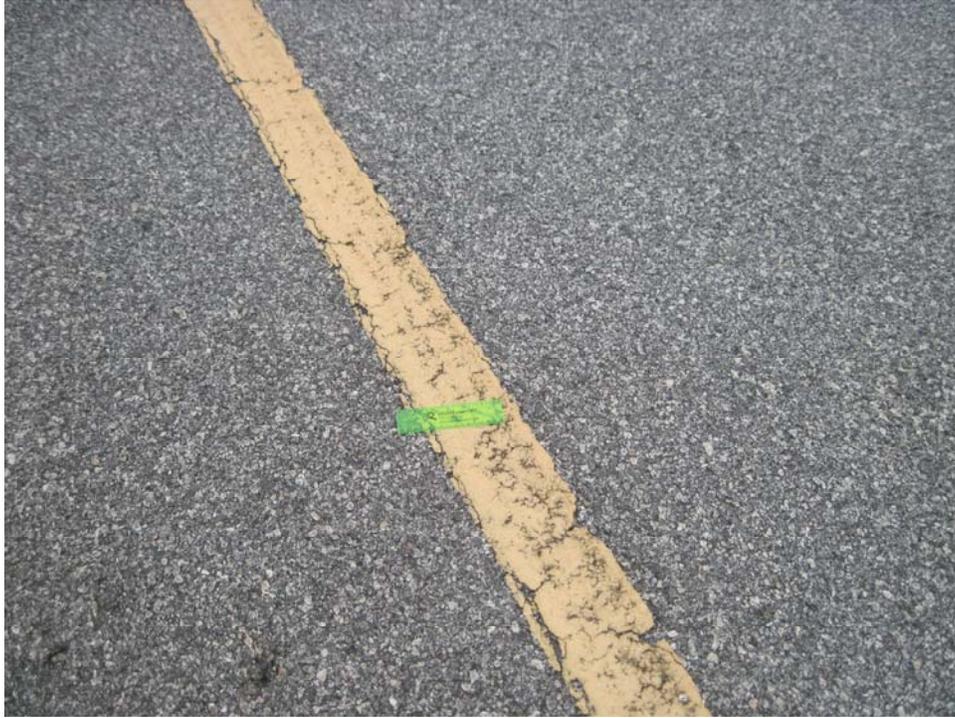
ACARGOAY-30. Satisfactory Paint.

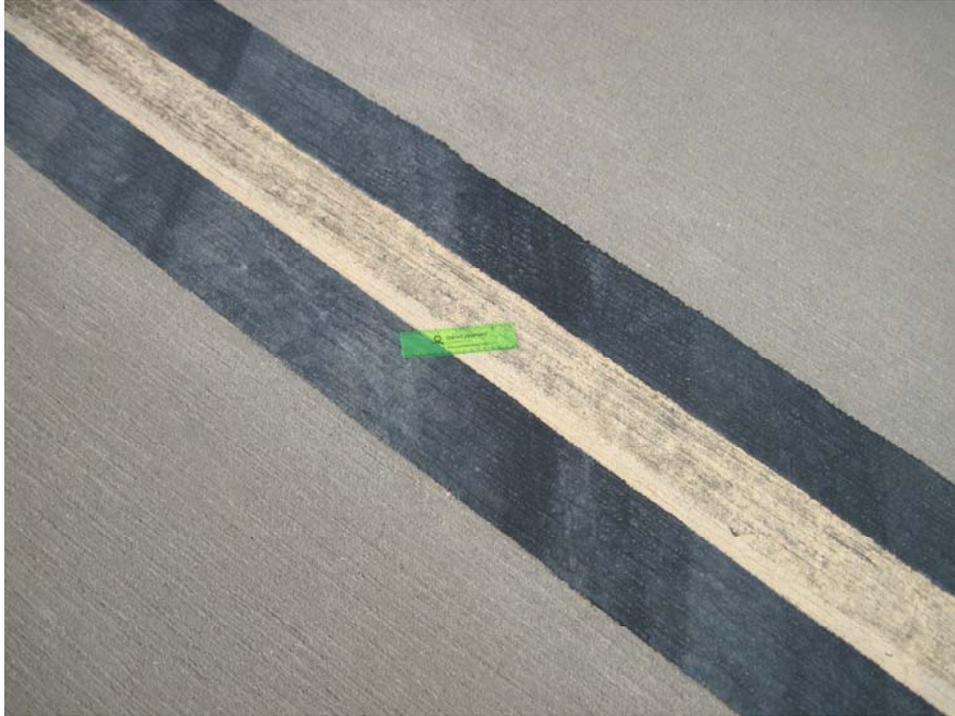
ACARGOAY-40. Satisfactory Paint.

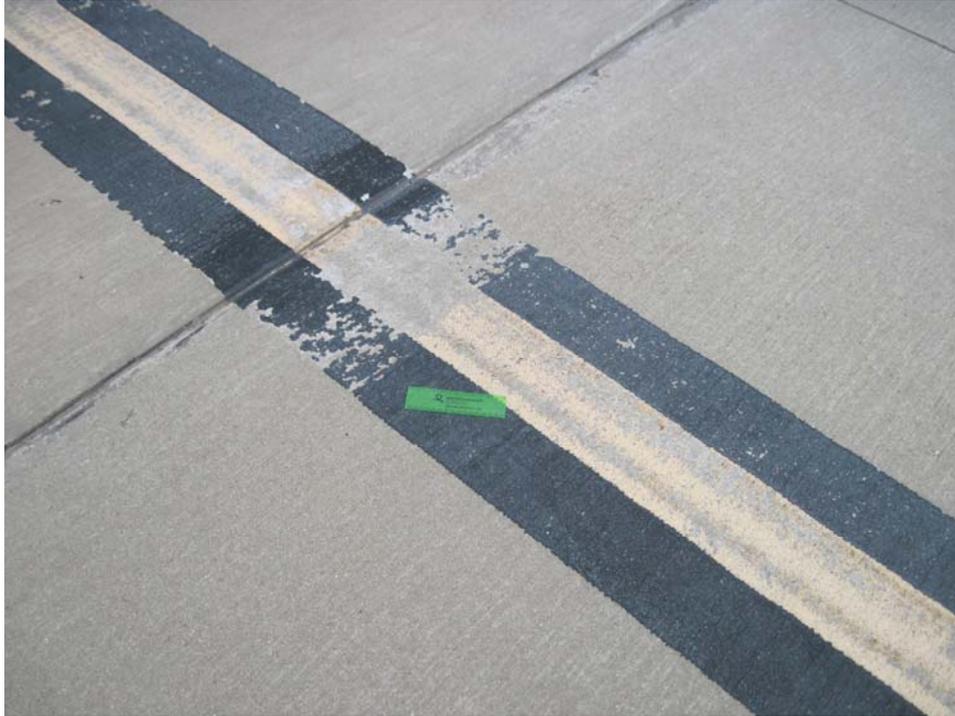
ACARGOAY-50. Satisfactory Paint.

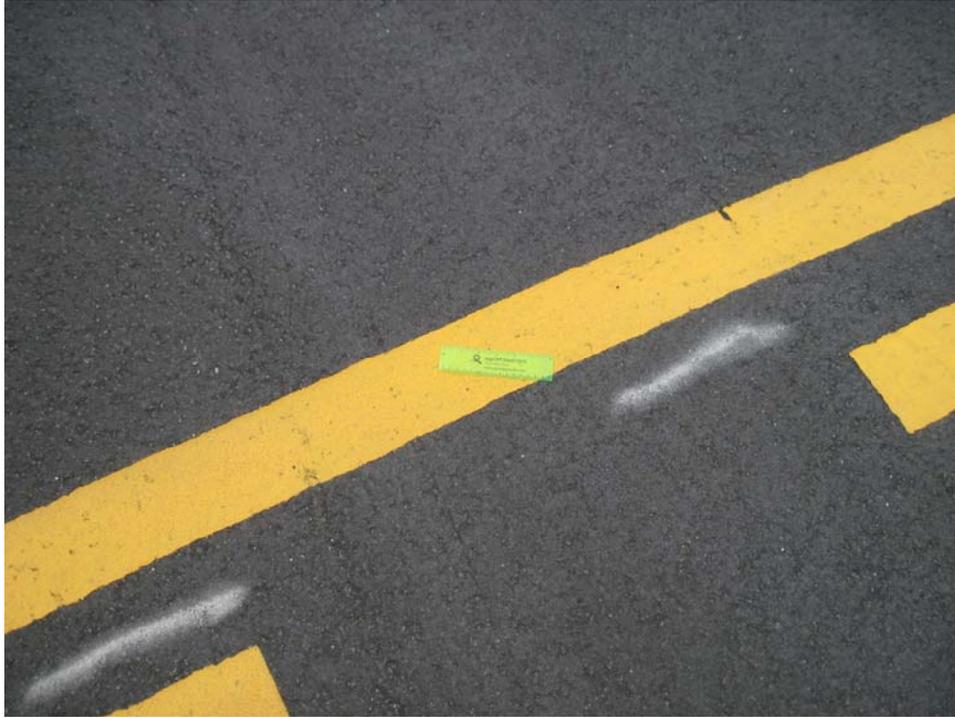
ATERMAY-20. Satisfactory Paint.

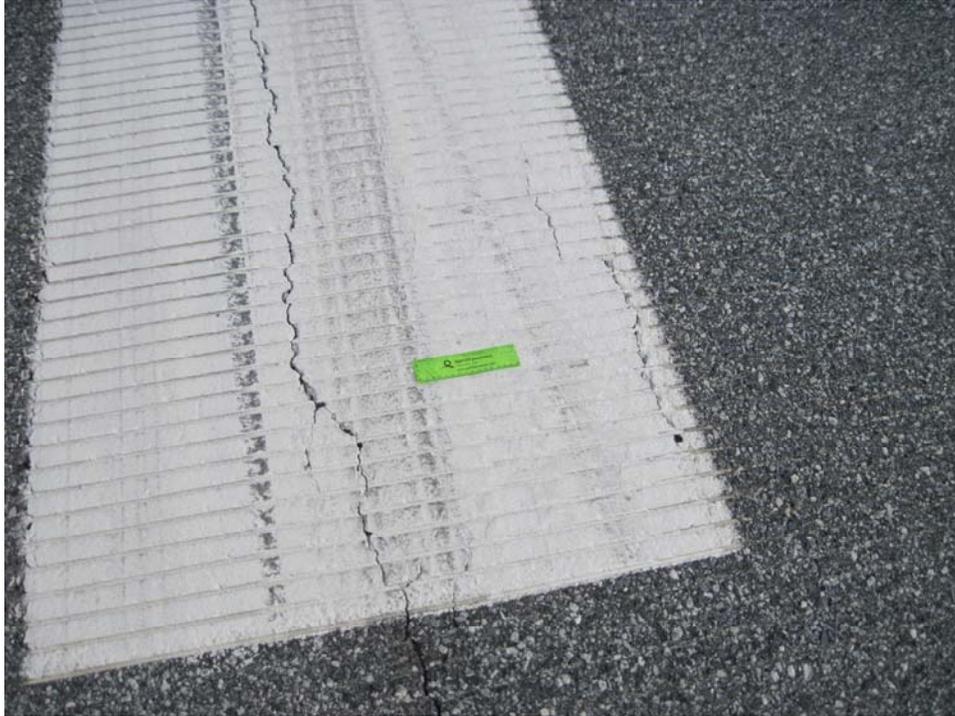
R422AY-10. Satisfactory Paint.

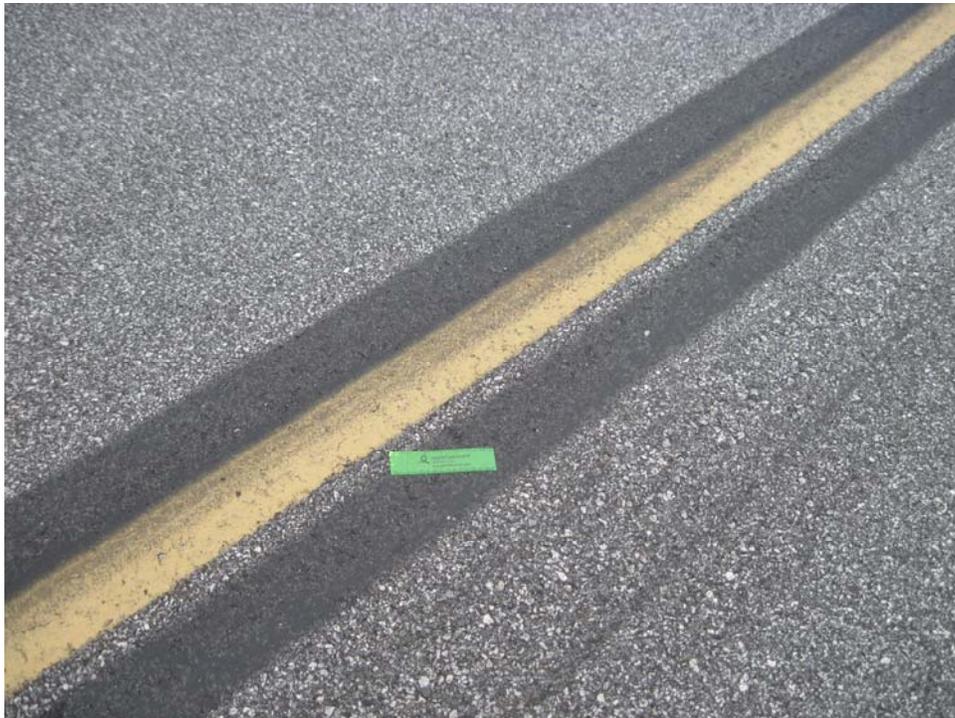
TAAY-10. Satisfactory Paint.

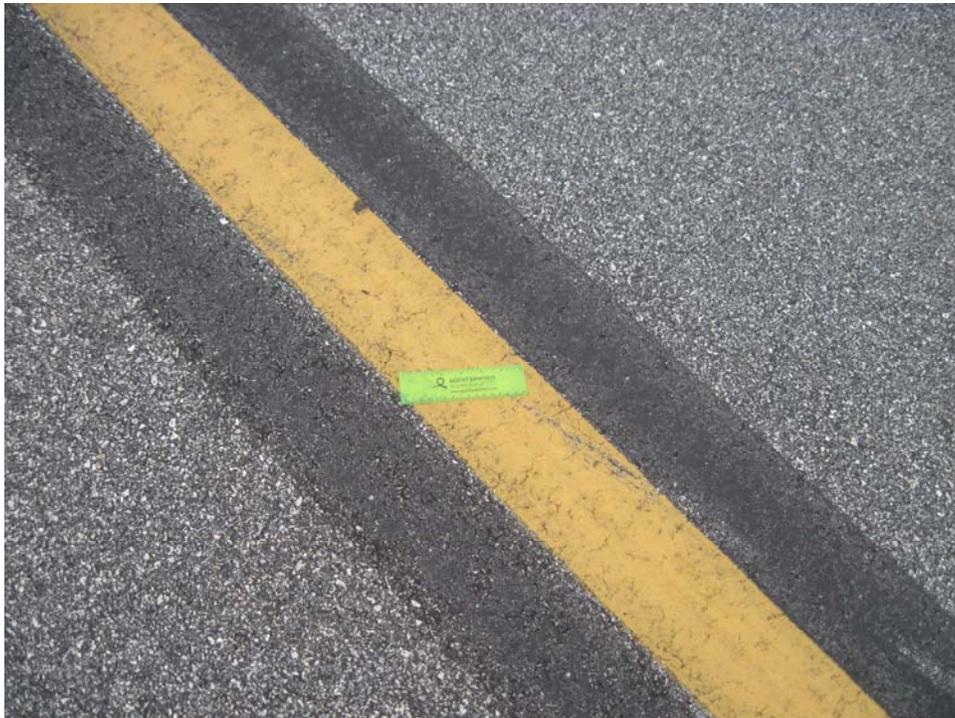
TAA-20. Satisfactory Paint.

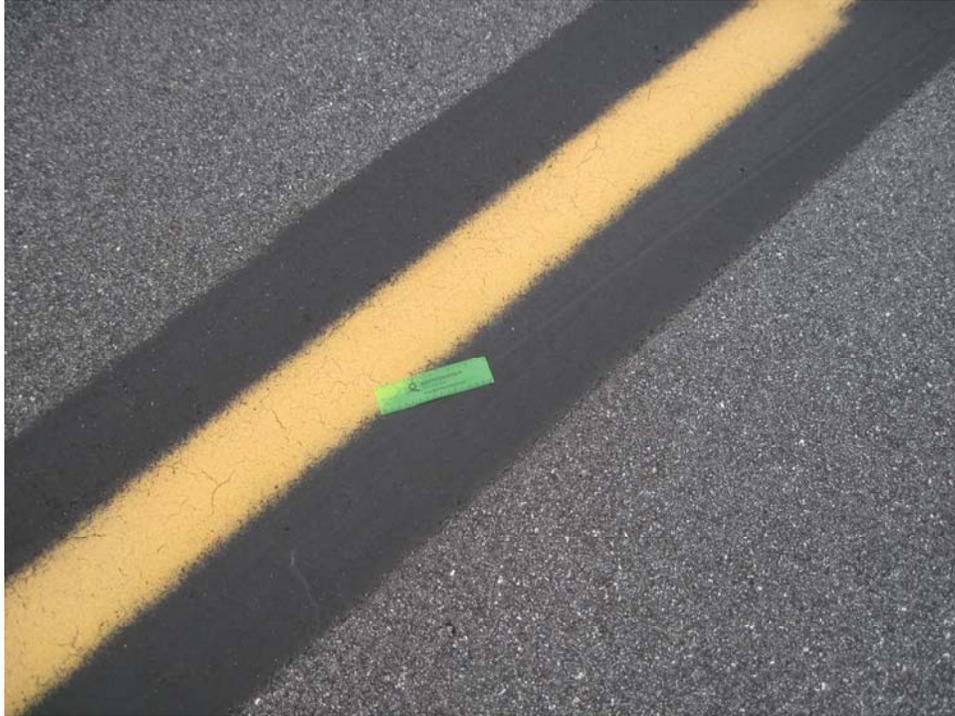
TBAY-10. Satisfactory Paint.

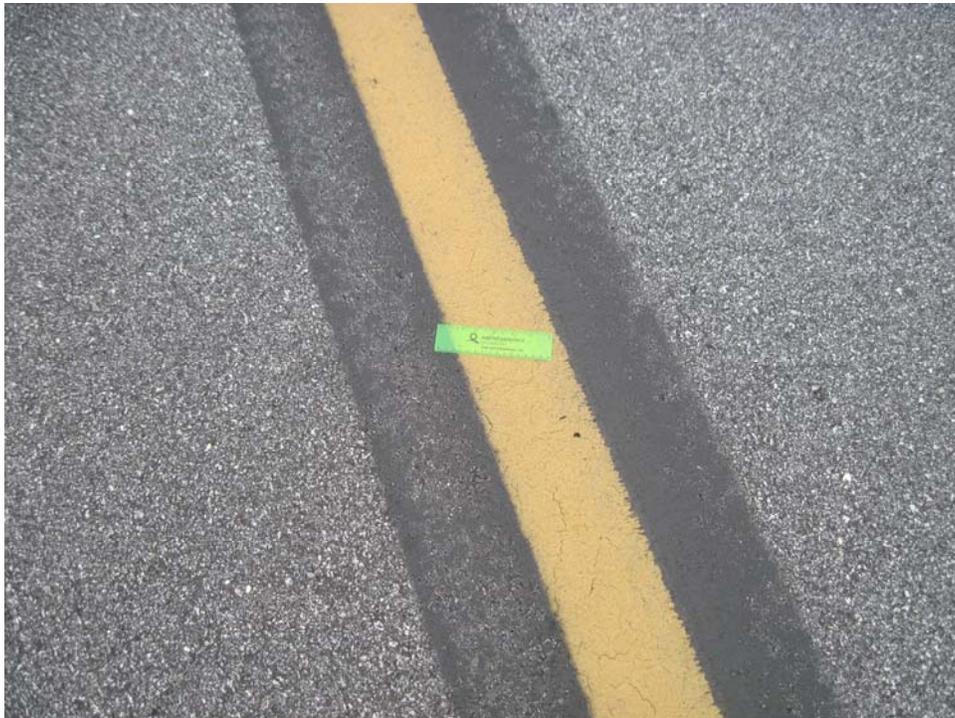
TCAY-10. Satisfactory Paint.

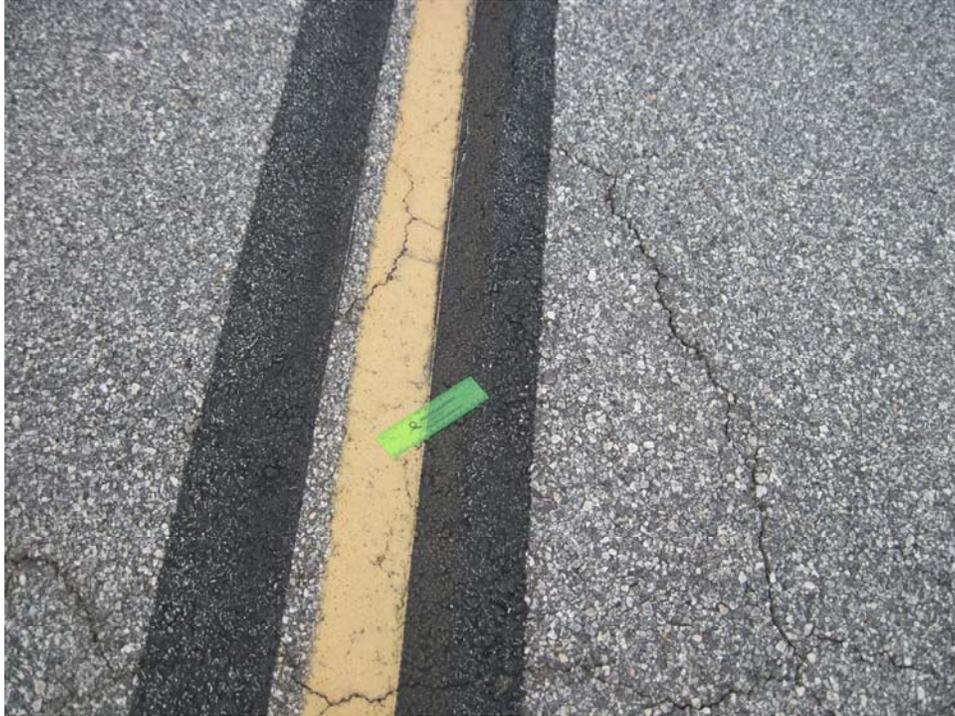
TCAY-20. Satisfactory Paint.

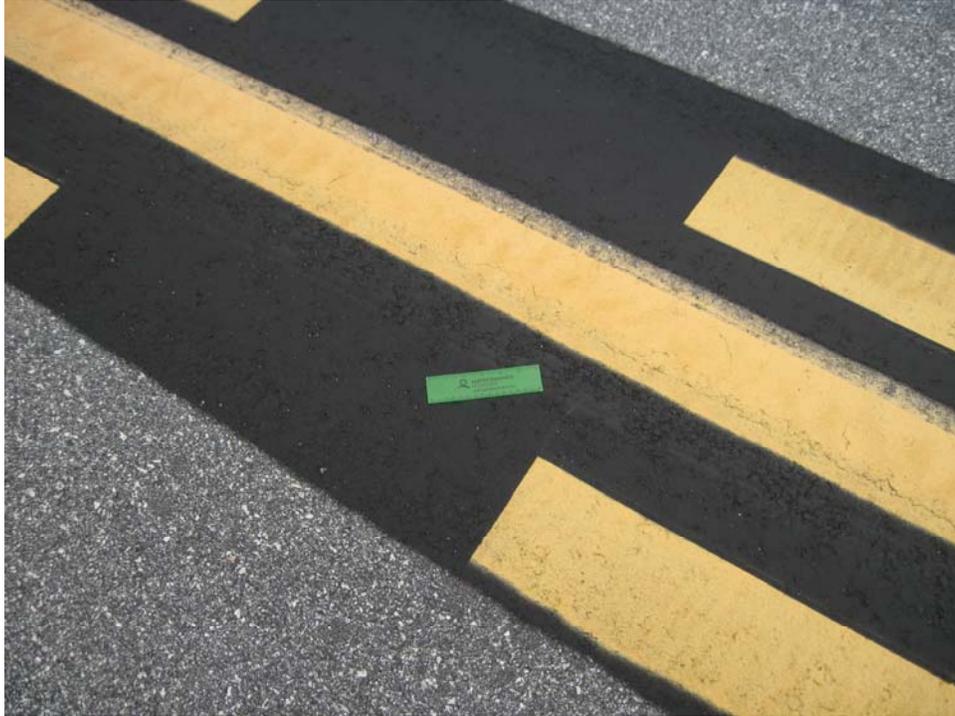
Taxiway D was comprised of one section. Section 10 is in excellent condition with a PCI of 99. The only distress identified was a small amount of low-severity L&T cracking.

TDAY-10. Satisfactory Paint.

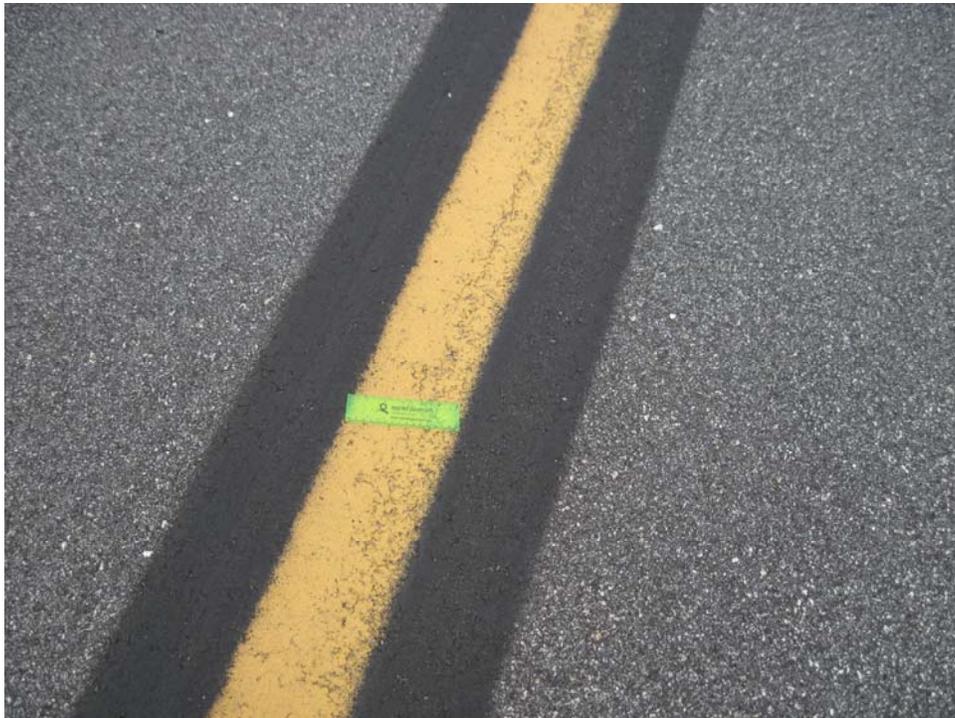
TEAY-10. Satisfactory Paint.

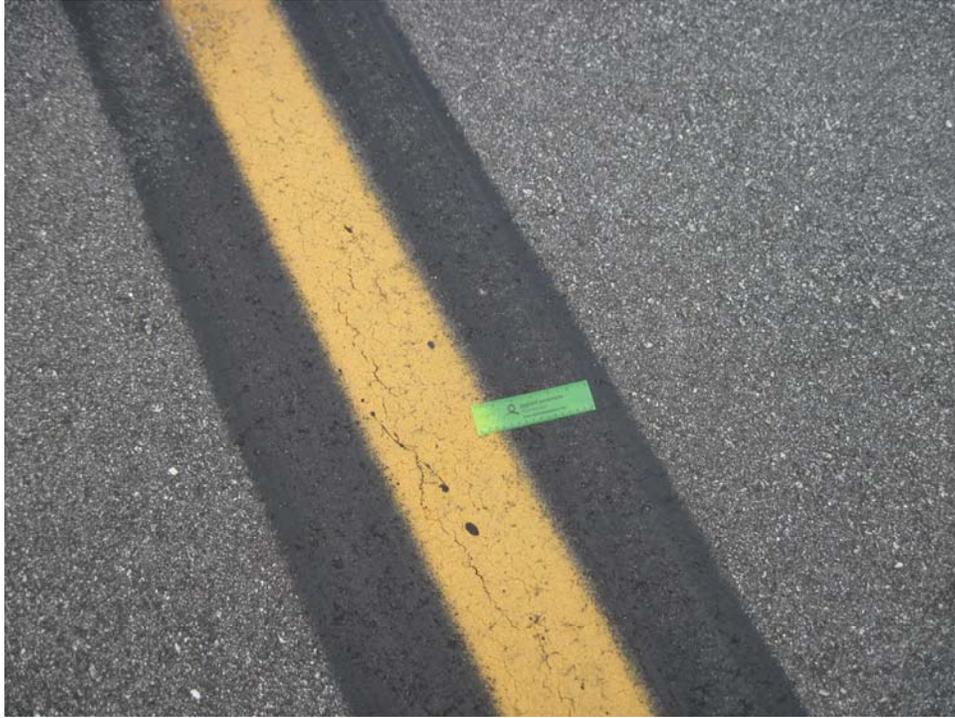
TEAY-20. Satisfactory Paint.

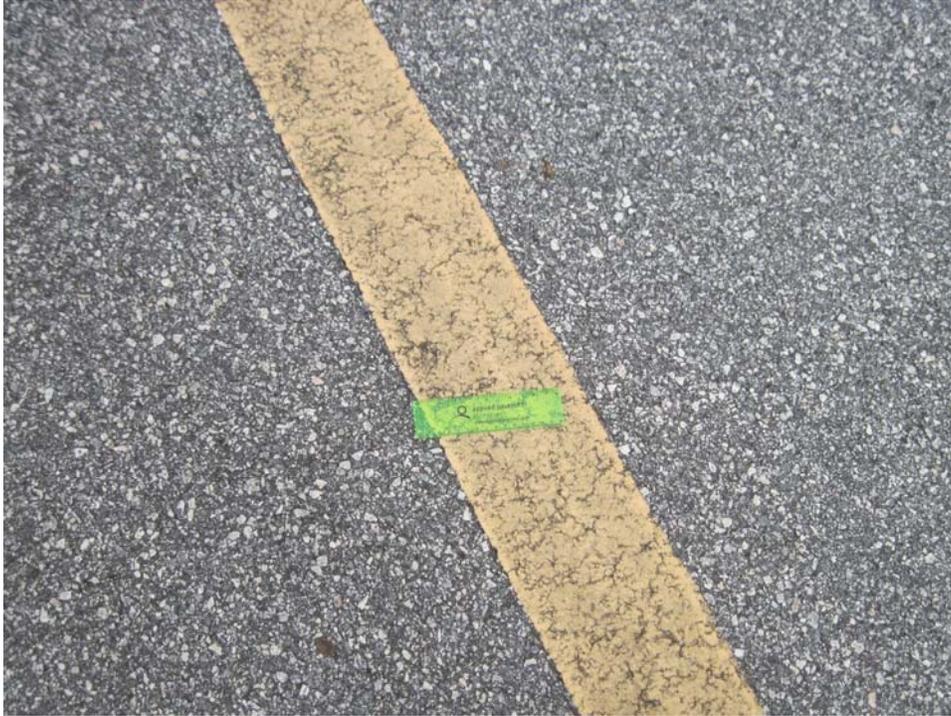
TEAY-30. Satisfactory Paint.

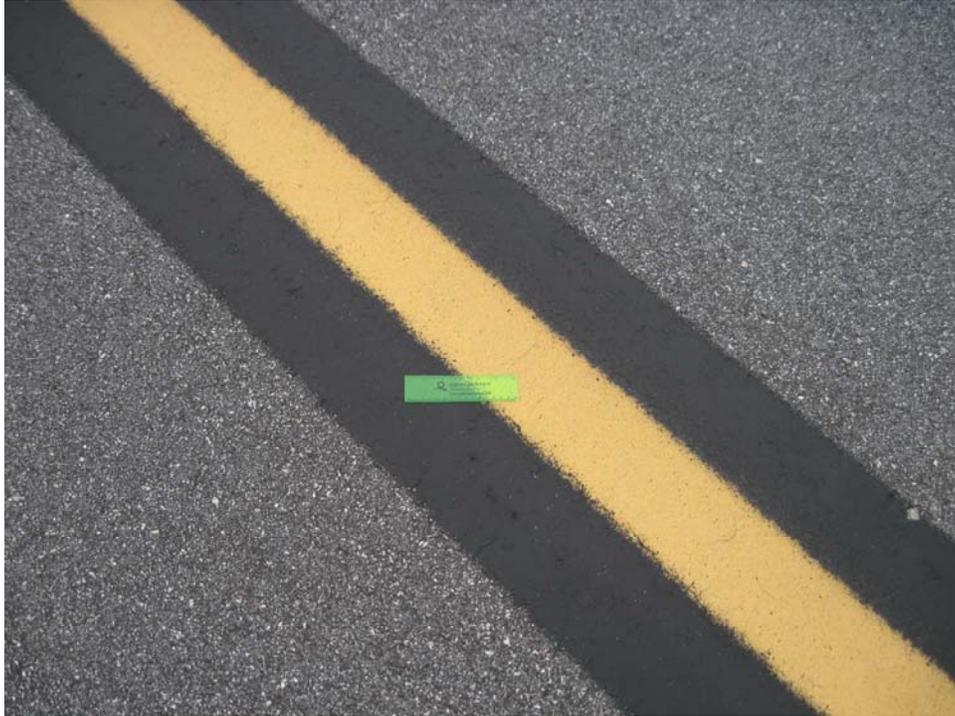
TEAY-40. Satisfactory Paint.

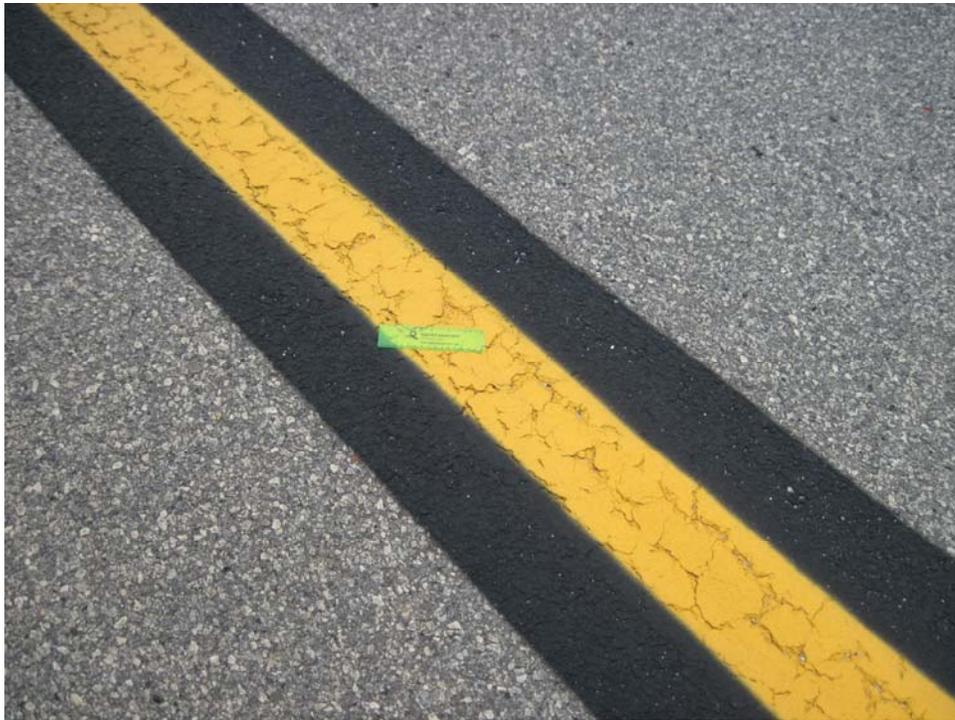
TSAY-10. Satisfactory Paint.
