2012 Daniel Field Pavement Management Plan

DANIEL FIELD

PAVEMENT MANAGEMENT REPORT

DECEMBER 2012

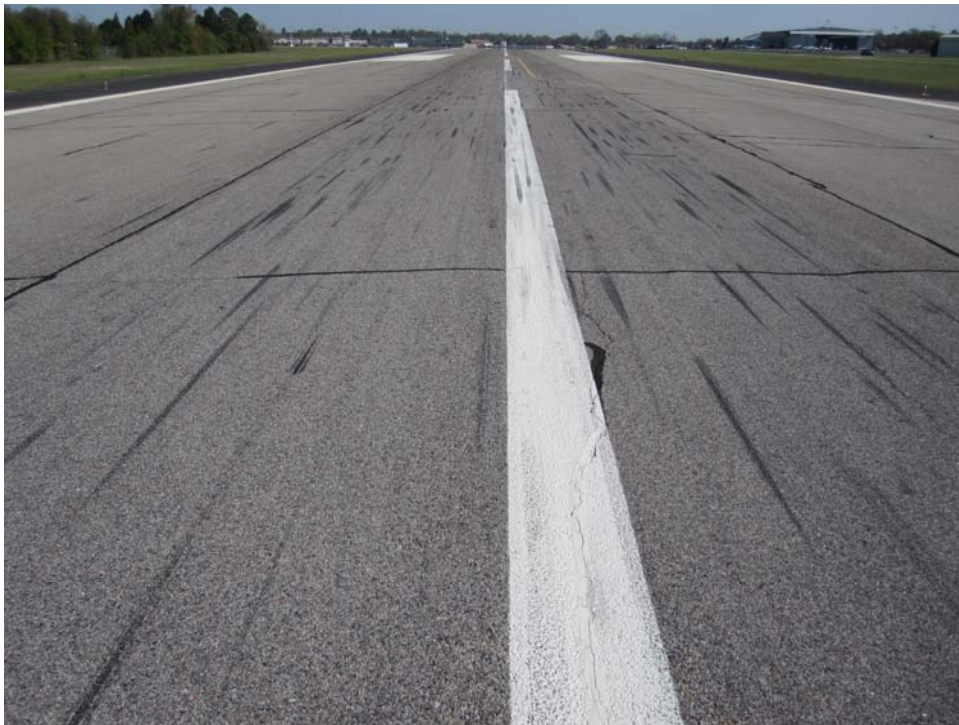
R0523AG-10. Overview.

Runway 5-23 consisted of two sections. Section 10 had a PCI value of 52. The only distresses identified in this section were low- and medium-severity L&T cracking and low-severity weathering along with smaller quantities of medium-severity weathering. All low-severity cracking was unsealed, and medium-severity cracking was due to unsatisfactory crack sealant. An additional sample unit that included several areas of low- and medium-severity patching unique to that location of the runway was recorded in accordance with ASTM D5340. Section 20 consisted of the intersection of both runways and had a PCI value of 91. Moderate amounts of low-severity weathering were observed in this section along with low-severity, unsealed L&T cracking.

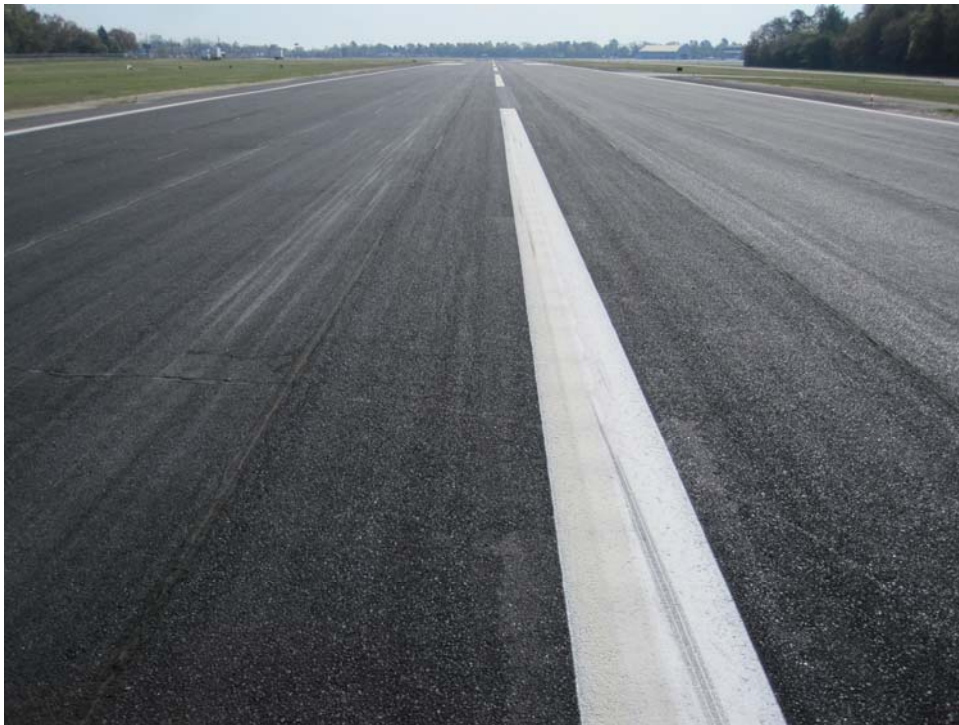
R1129AG-10. Overview.

Runway 11-29 was comprised of one section with a PCI value of 70. A surface treatment project was completed on this runway in 2010. Substantial amounts of low- and medium-severity longitudinal and transverse (L&T) cracking were observed throughout this section. The low-severity cracking was both sealed and unsealed, and the medium-severity cracking was due to unsatisfactory crack sealant.

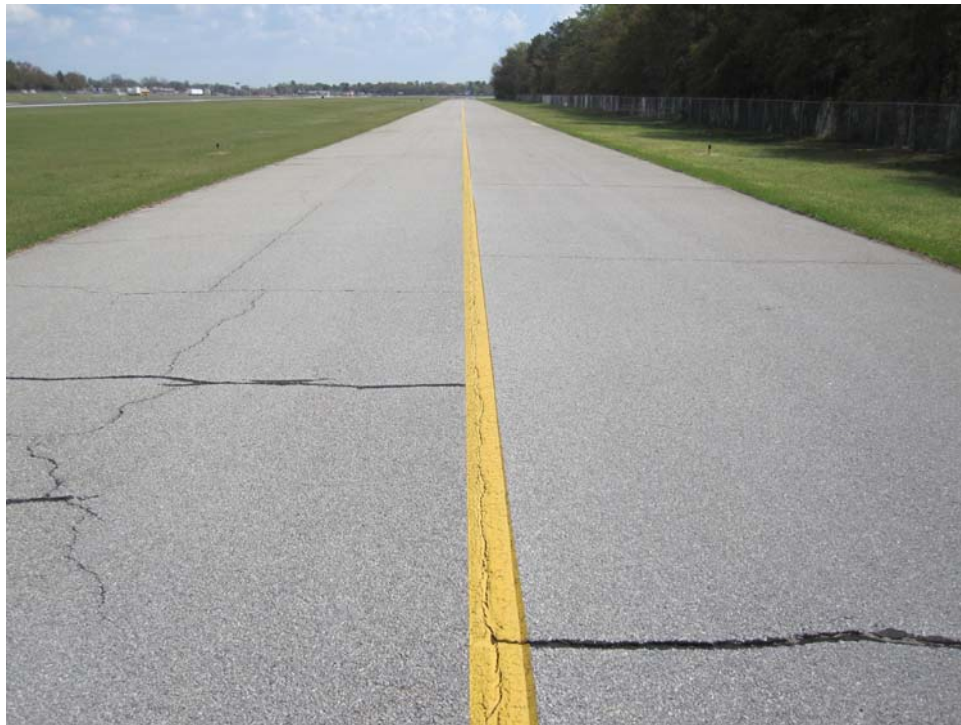
TAAG-10. Overview.

Taxiway A was defined by one section with a PCI value of 52. The primary distresses identified in Section 10 were medium-severity L&T cracking and low-severity weathering. In addition, moderate amounts of low-severity L&T cracking, medium-severity alligator cracking, and medium-severity weathering were also observed. All low-severity cracking was unsealed and medium-severity cracking was due to unsatisfactory crack sealant.

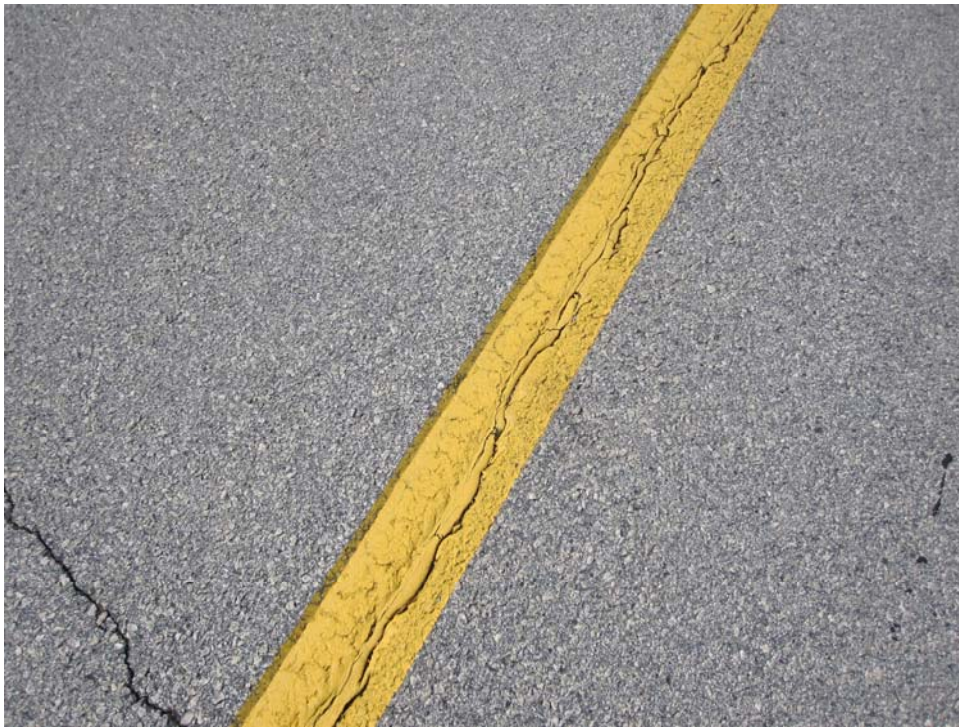
TAAG-10. Satisfactory Paint.

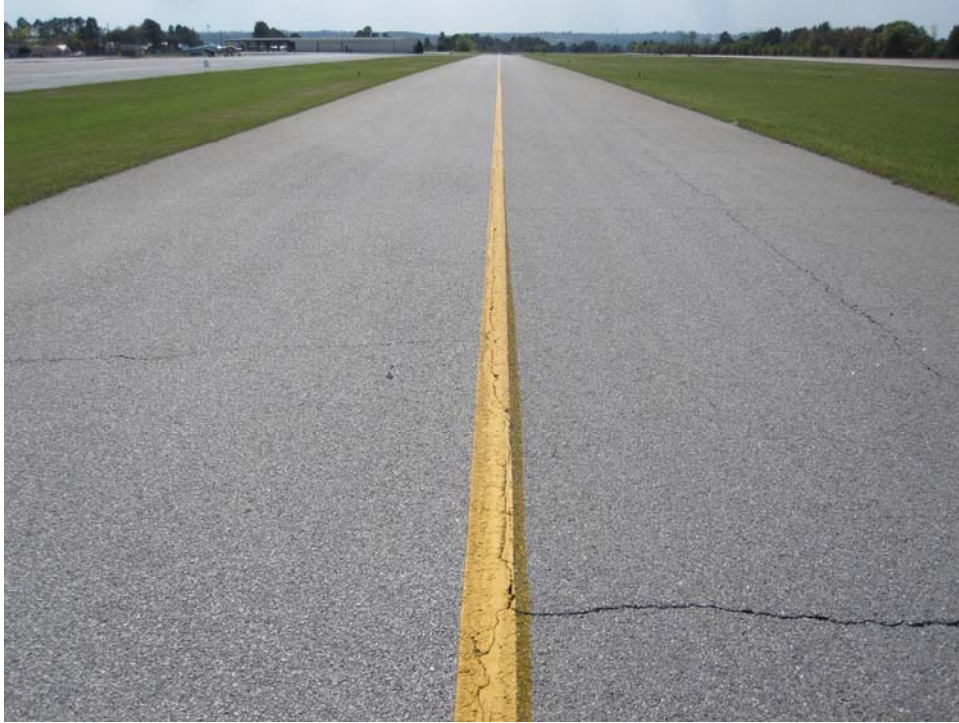
TDAG-10. Overview.

Taxiway D was comprised of one section with a PCI value of 76. Substantial quantities of low-severity weathering were recorded throughout Section 10 along with moderate amounts of low- and medium-severity L&T cracking and medium-severity weathering. All low-severity cracking was unsealed and medium-severity cracking was due to unsatisfactory crack sealant.
