2012 Columbus Airport Pavement Management Plan

COLUMBUS AIRPORT

PAVEMENT MANAGEMENT REPORT

DECEMBER 2012

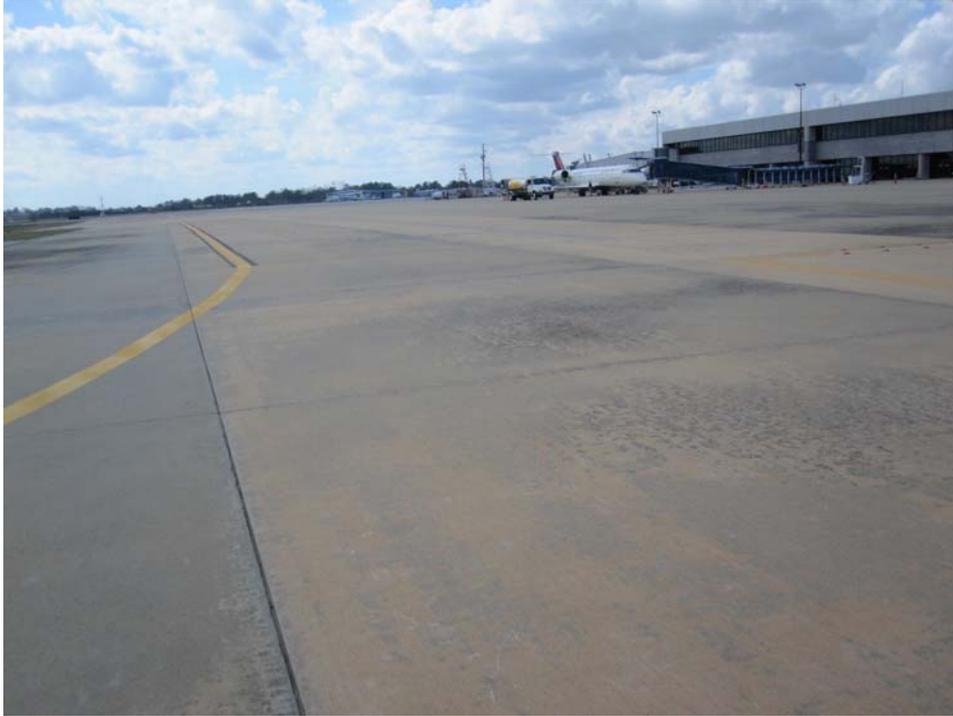
ATERMCS-10. Overview.

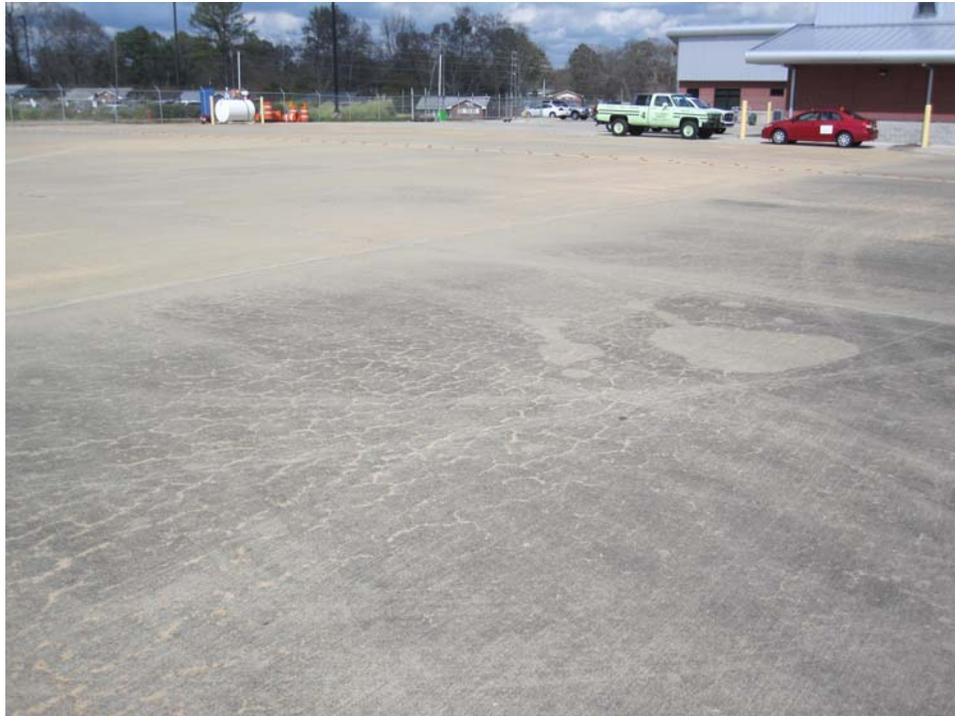
ATERMCS-10. ASR (Sample Unit #10).

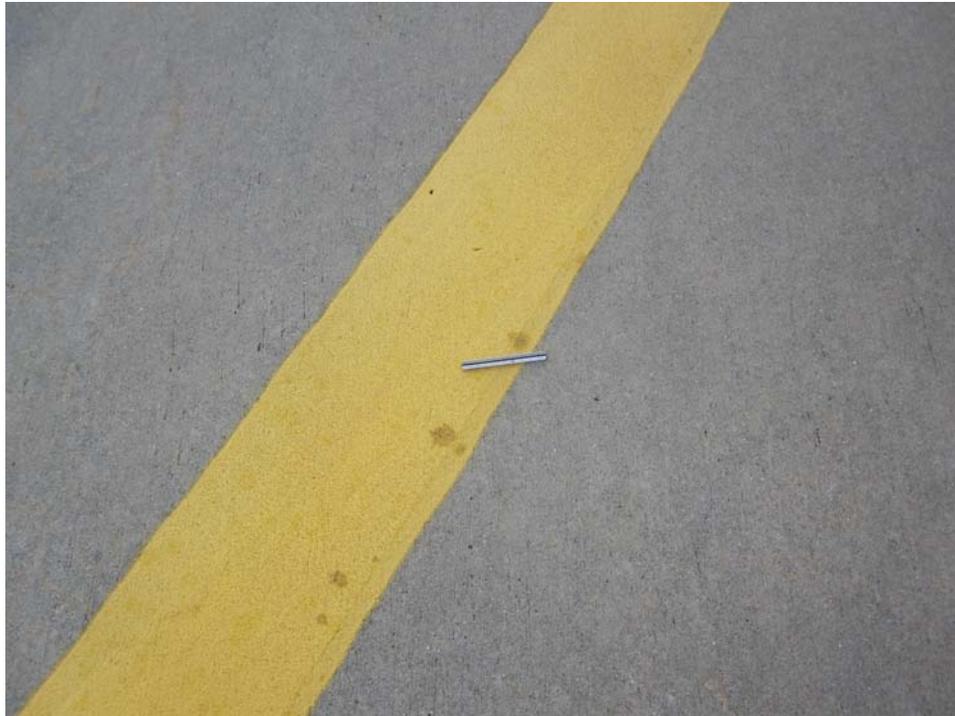
ATERMCS-10. Satisfactory Paint.

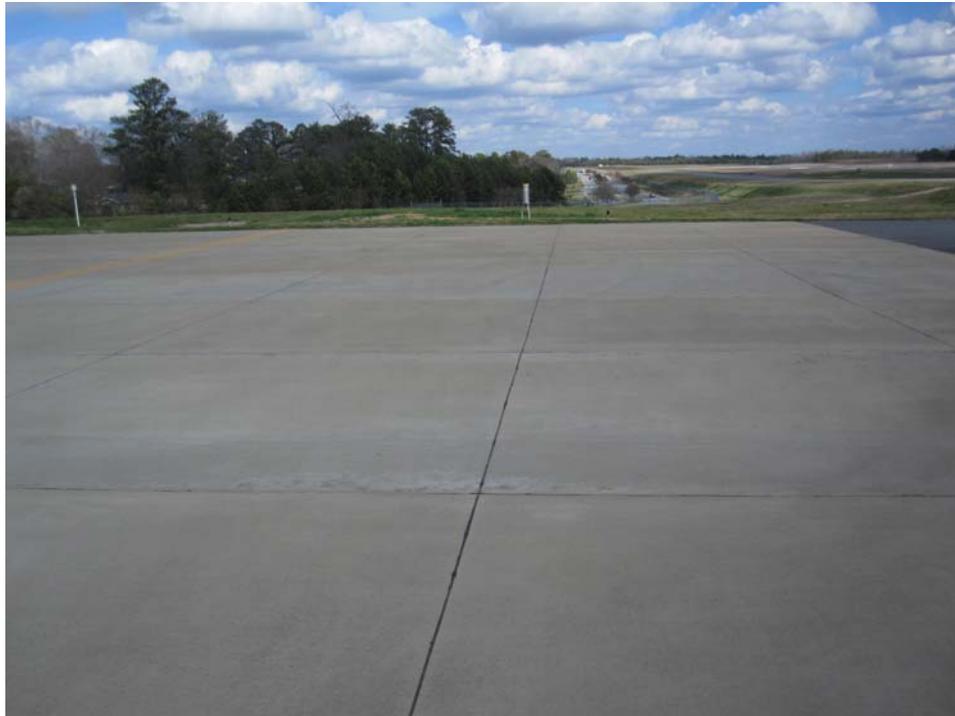
ATERMCS-20. Overview.

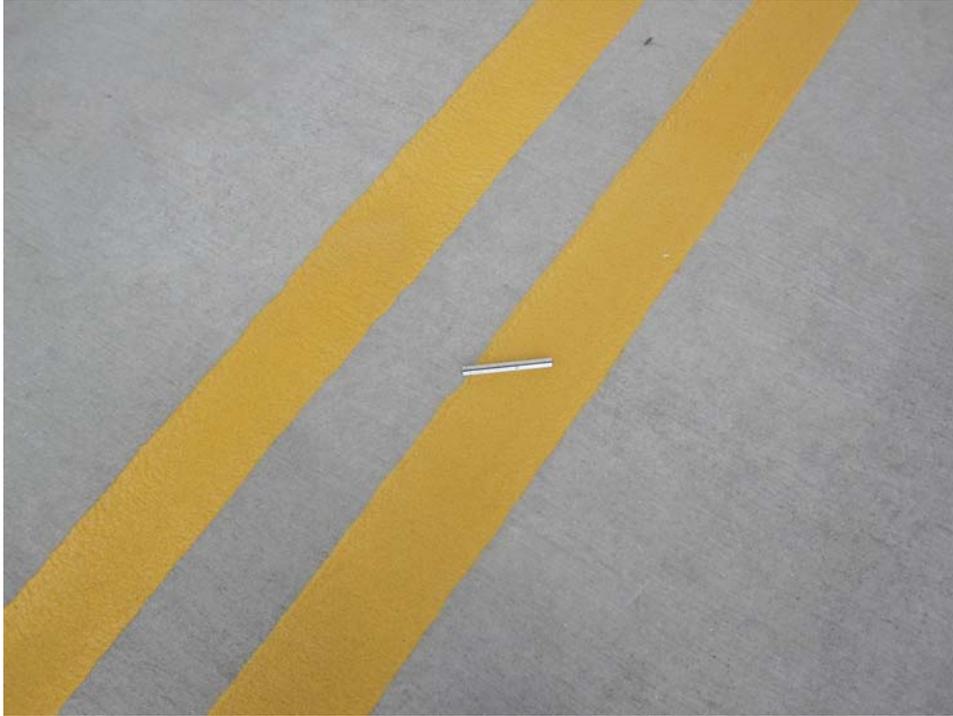
ATERMCS-20. Satisfactory Paint.

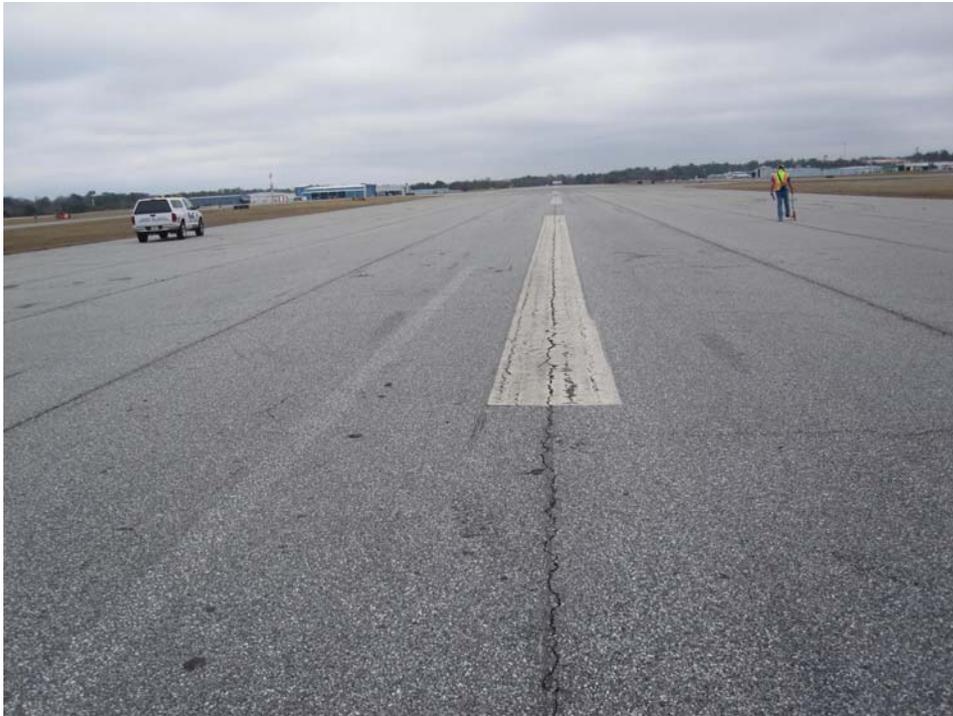
R1331CS-10C. Overview.

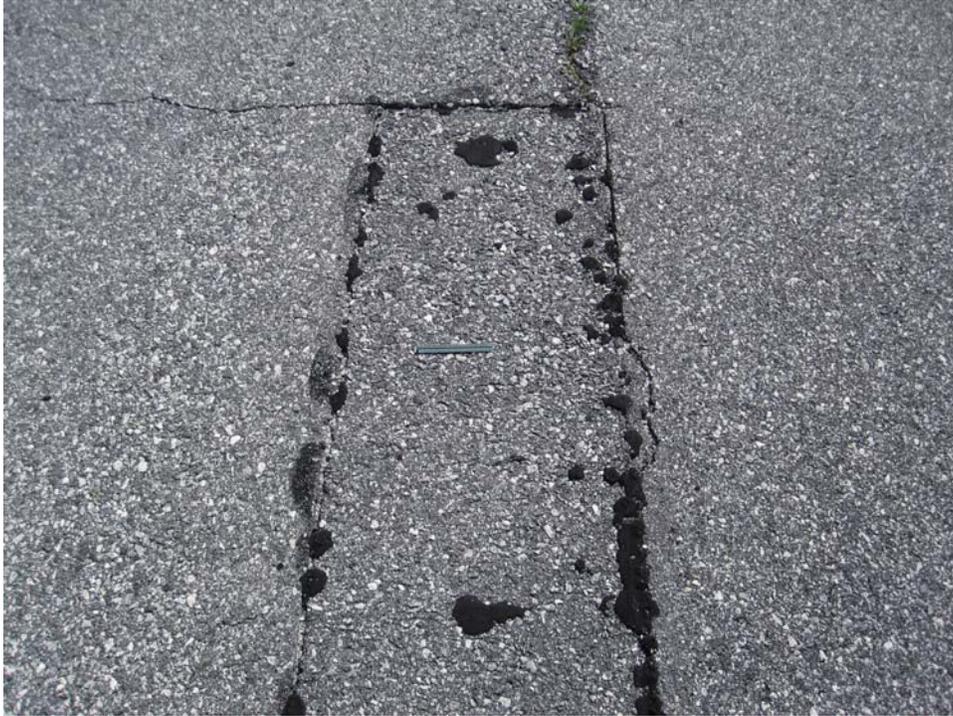
R1331CS-10C. Patching (Sample Unit #10).

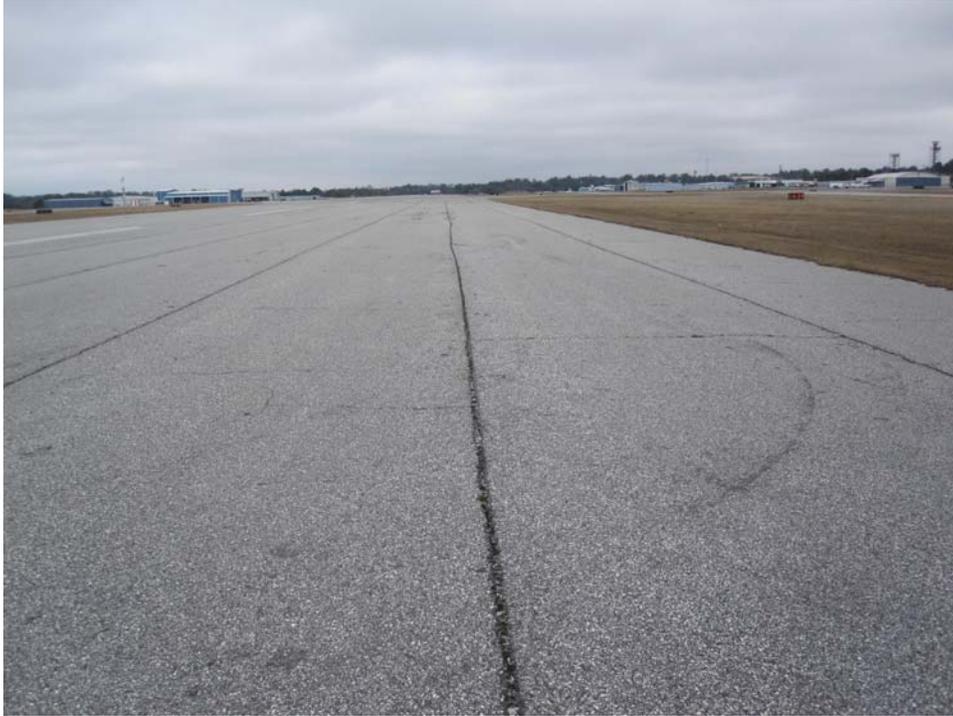
R1331CS-10N. Overview.

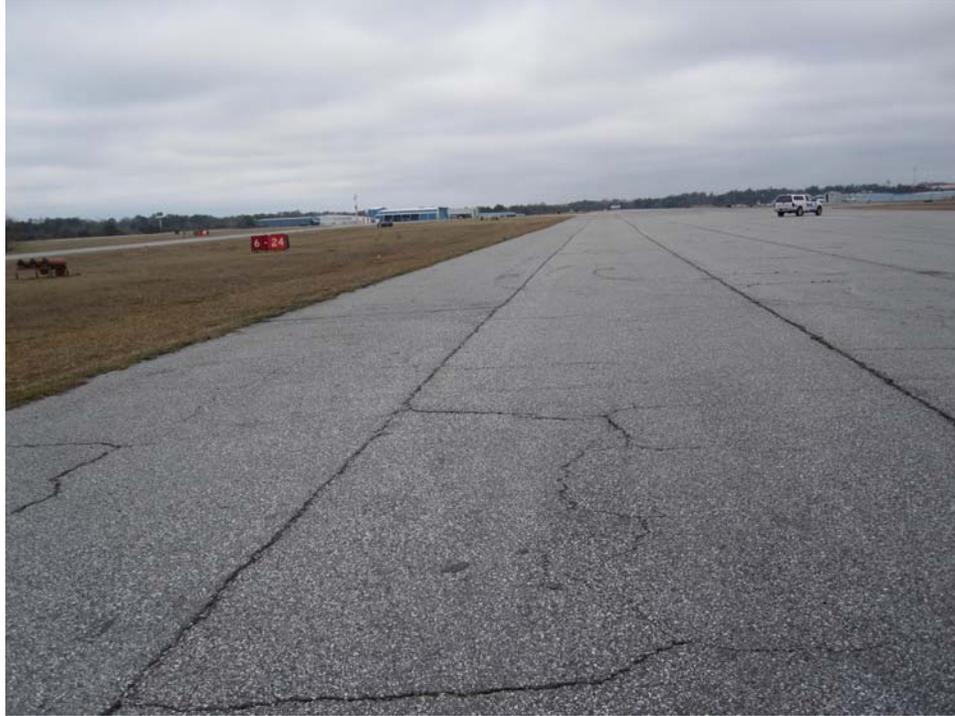
R1331CS-10S. Overview.

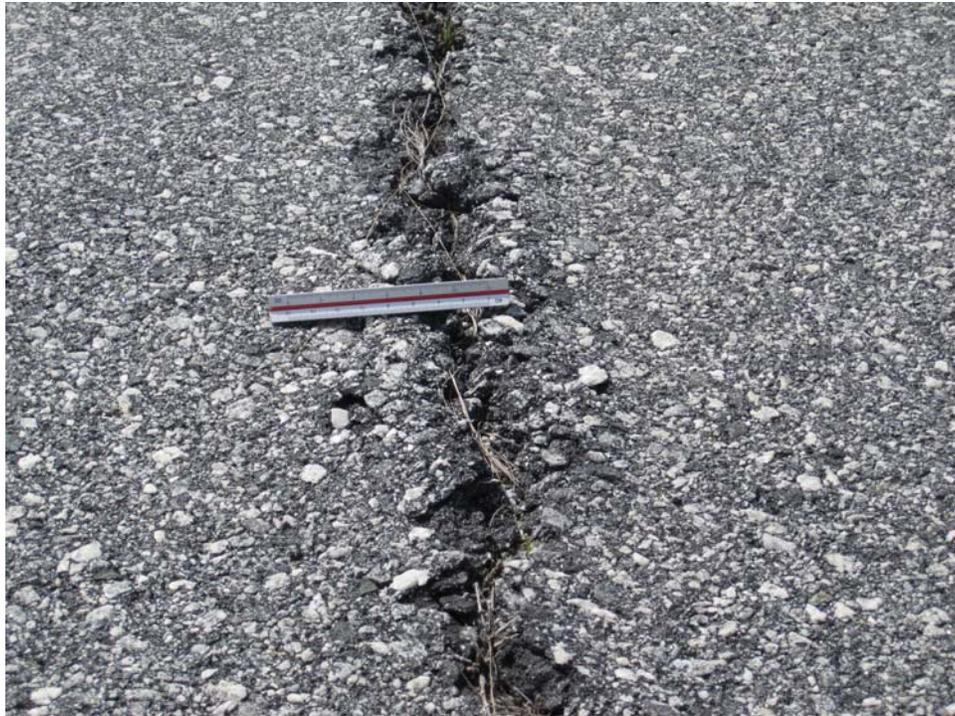
R1331CS-10S. Swelling (Sample Unit #21).

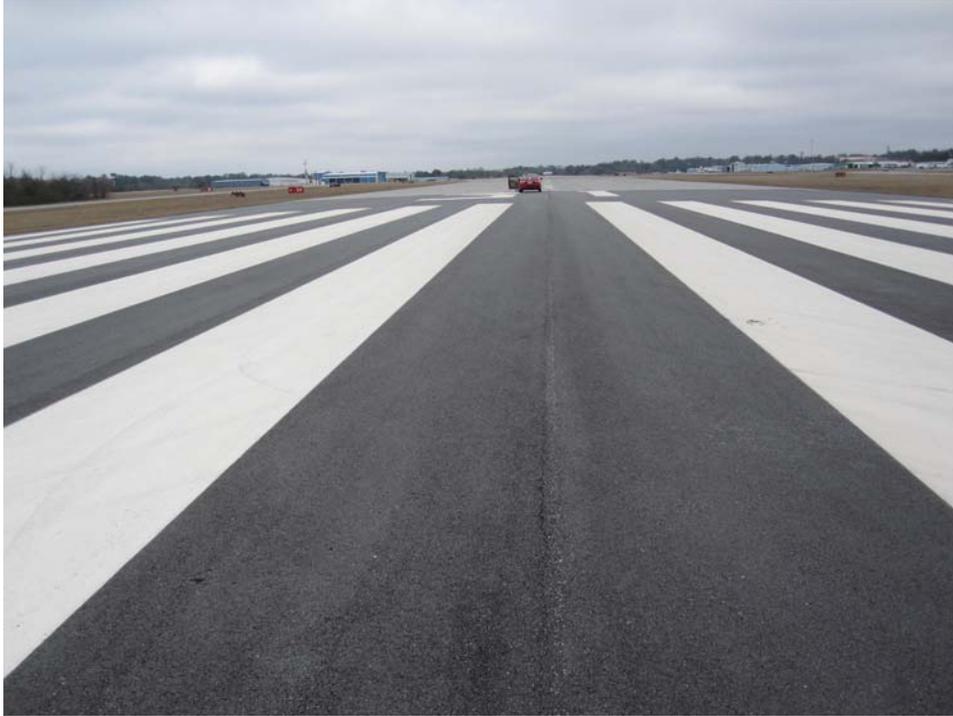
R1331CS-20C. Overview.

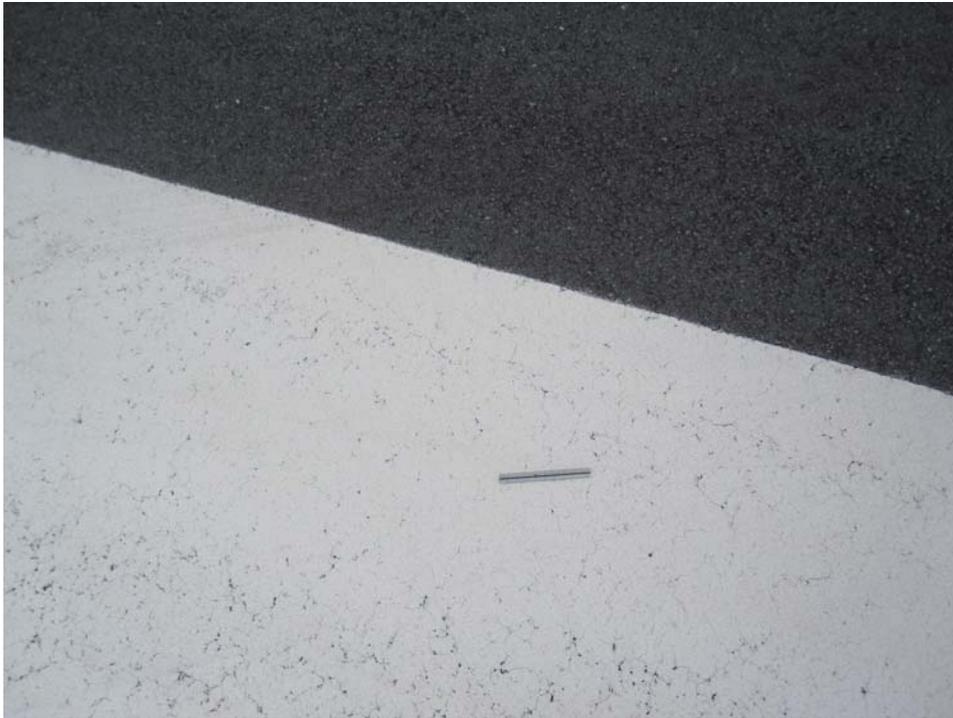
R1331CS-20C. Satisfactory Paint.

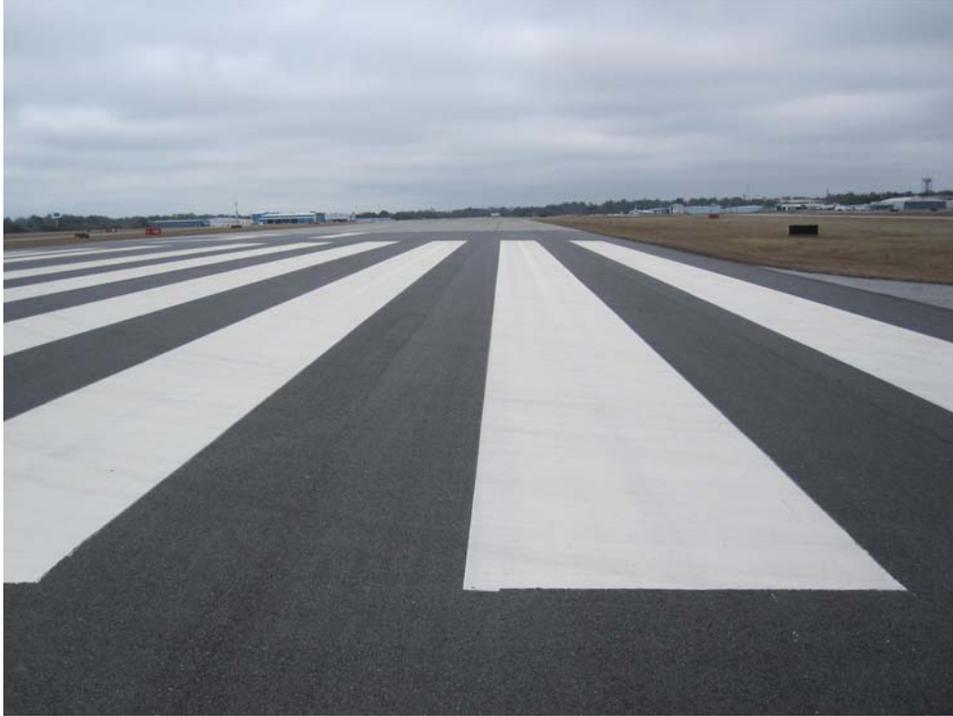
R1331CS-20N. Overview.

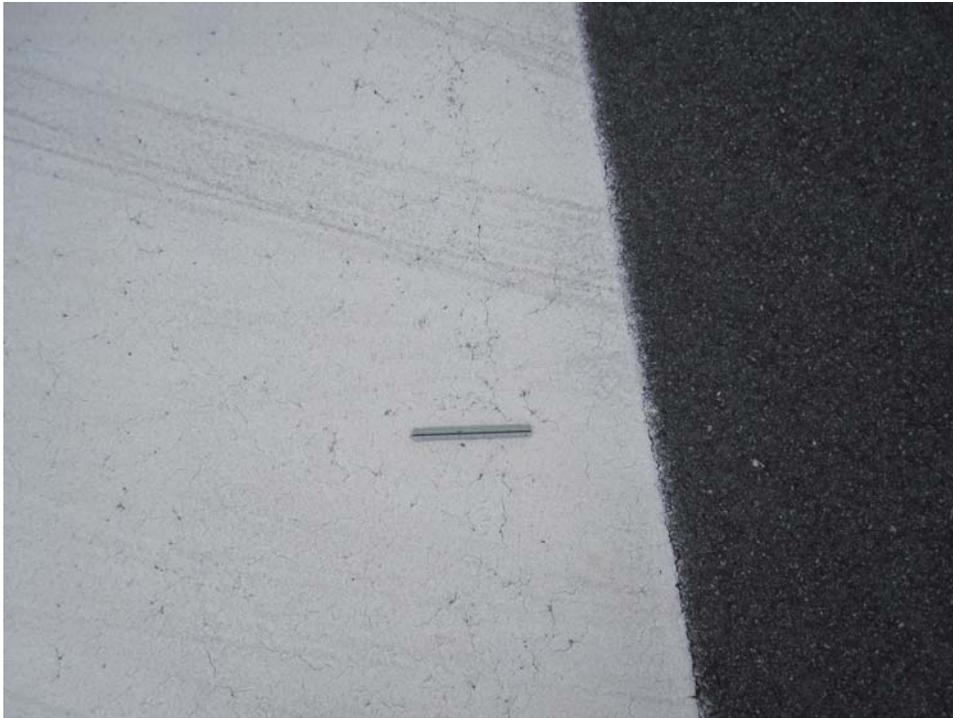
R1331CS-20N. Satisfactory Paint.

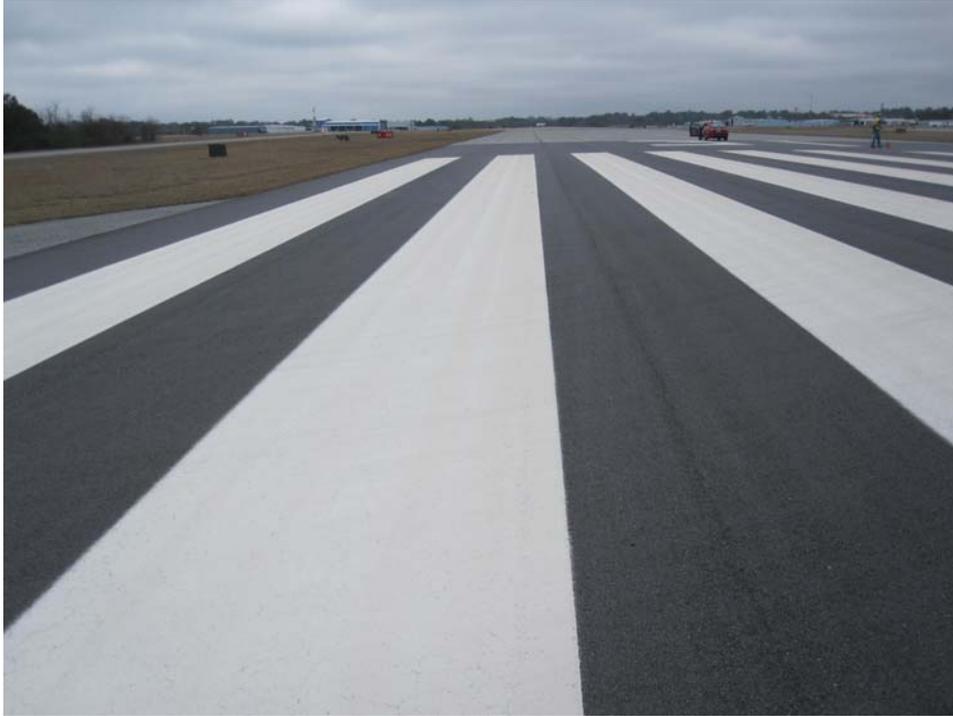
R1331CS-20S. Overview.

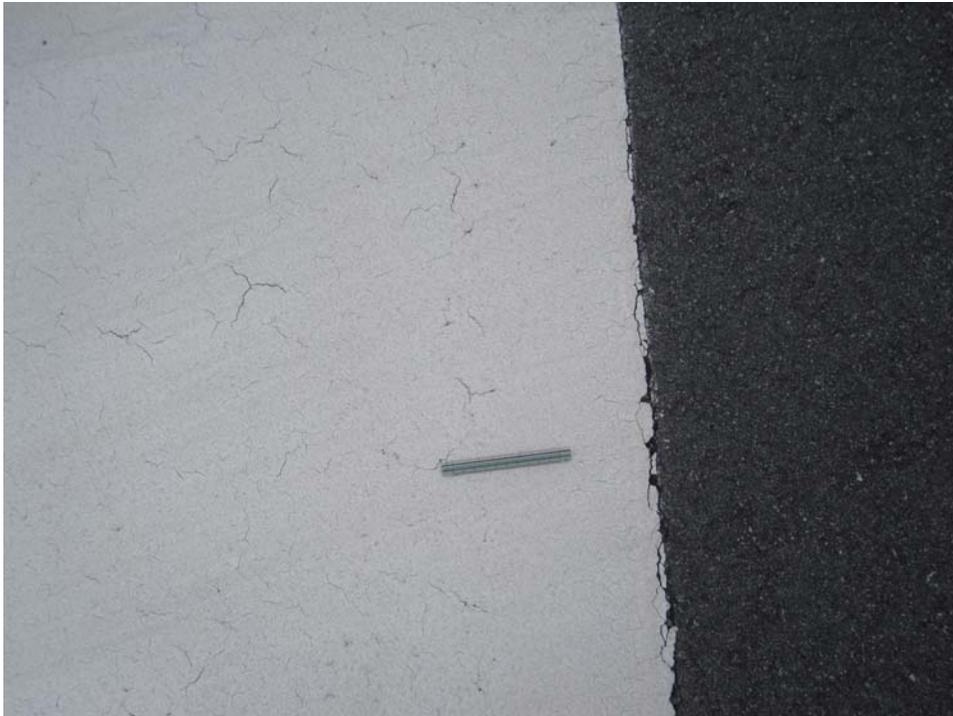
R1331CS-20S. Satisfactory Paint.

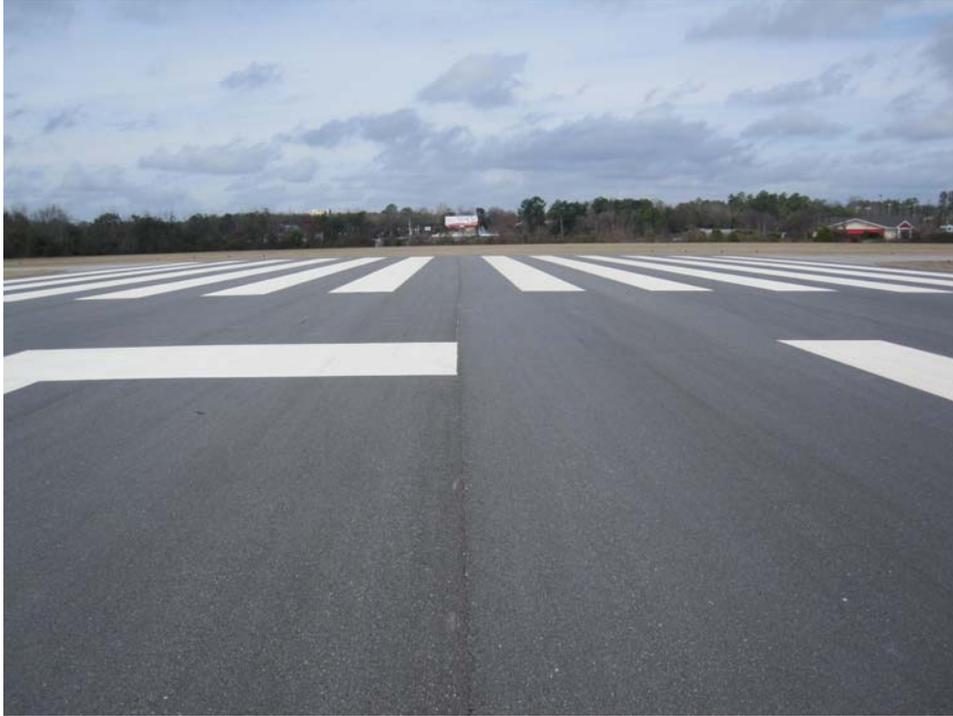
R1331CS-30C. Overview.

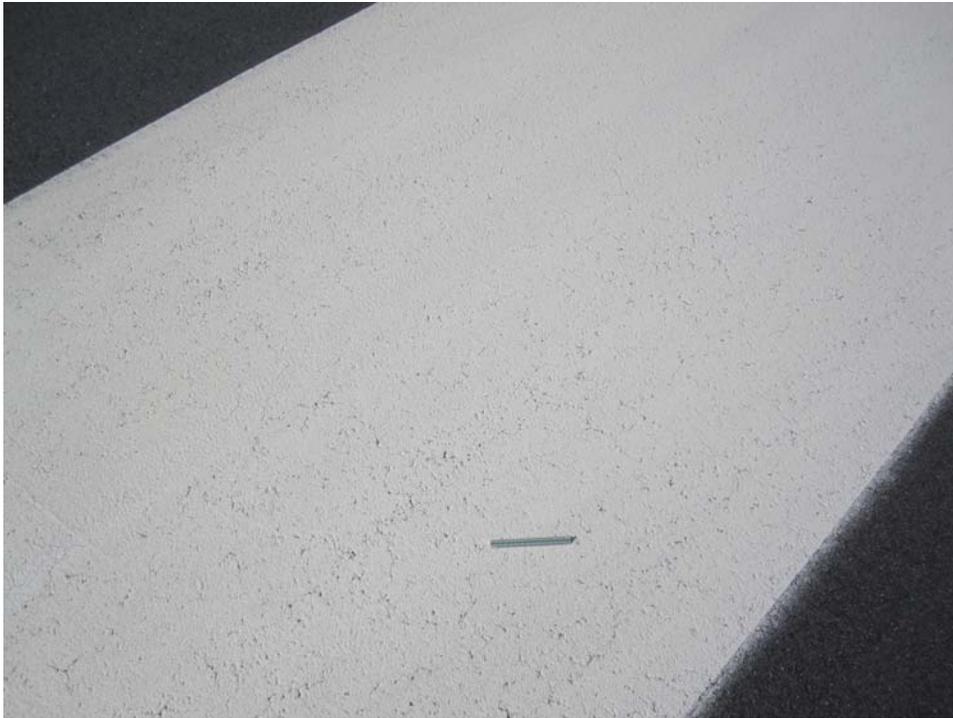
R1331CS-30C. Satisfactory Paint.

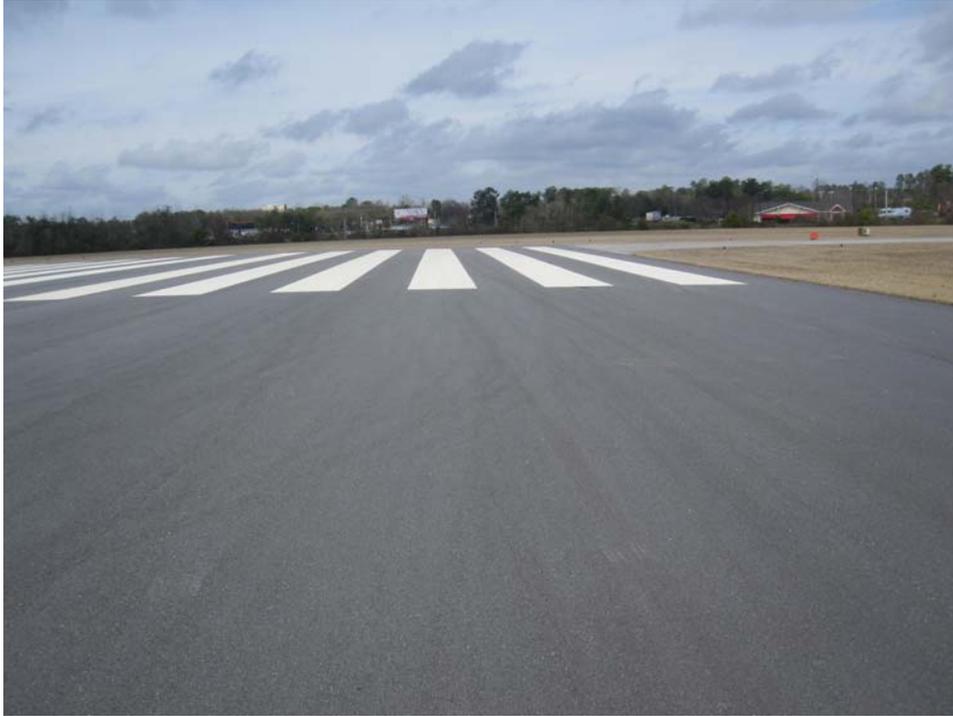
R1331CS-30N. Overview.

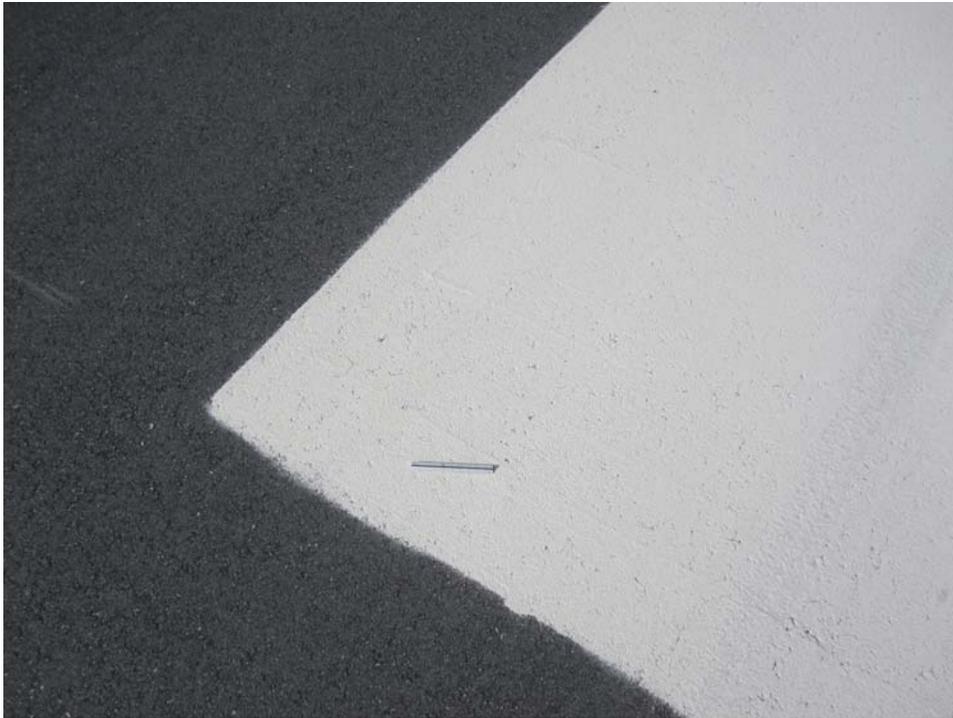
R1331CS-30N. Satisfactory Paint.

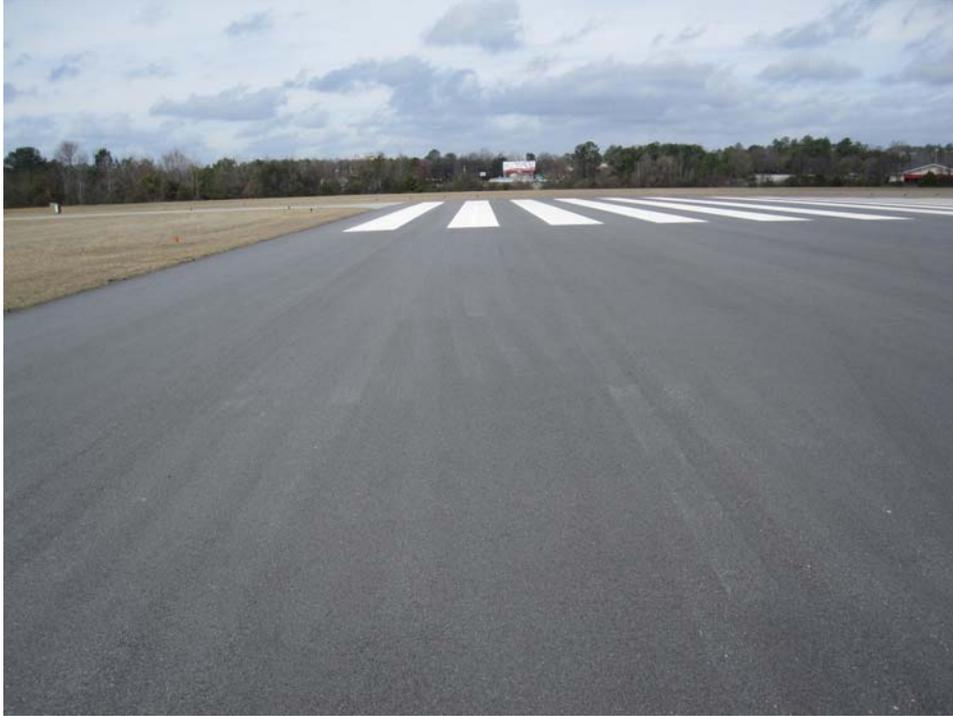
R1331CS-30S. Overview.

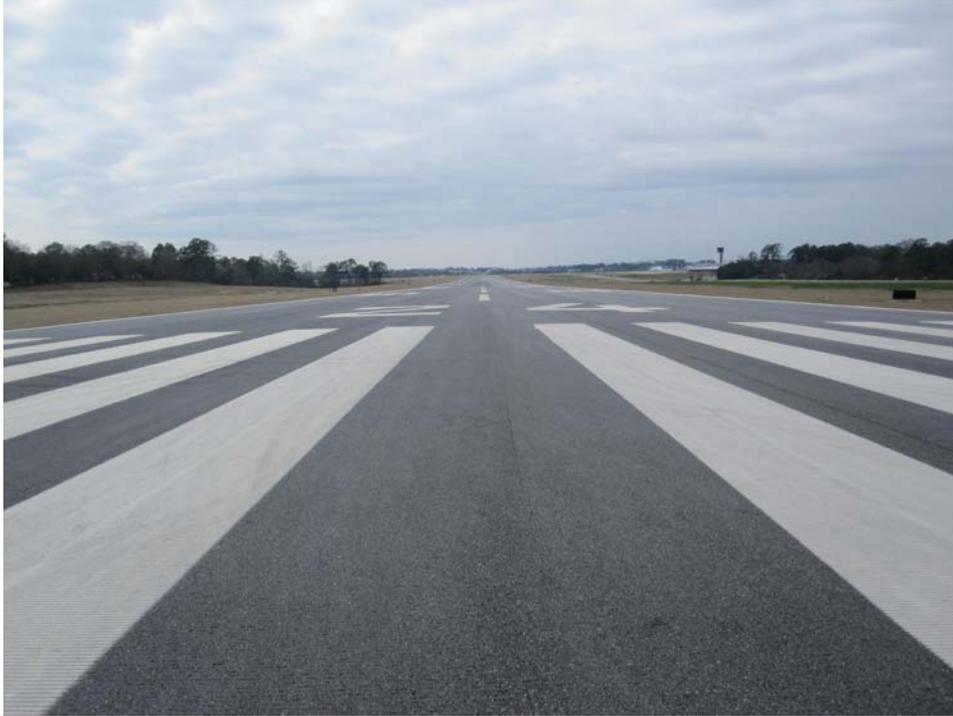
R624CS-10C. Overview.

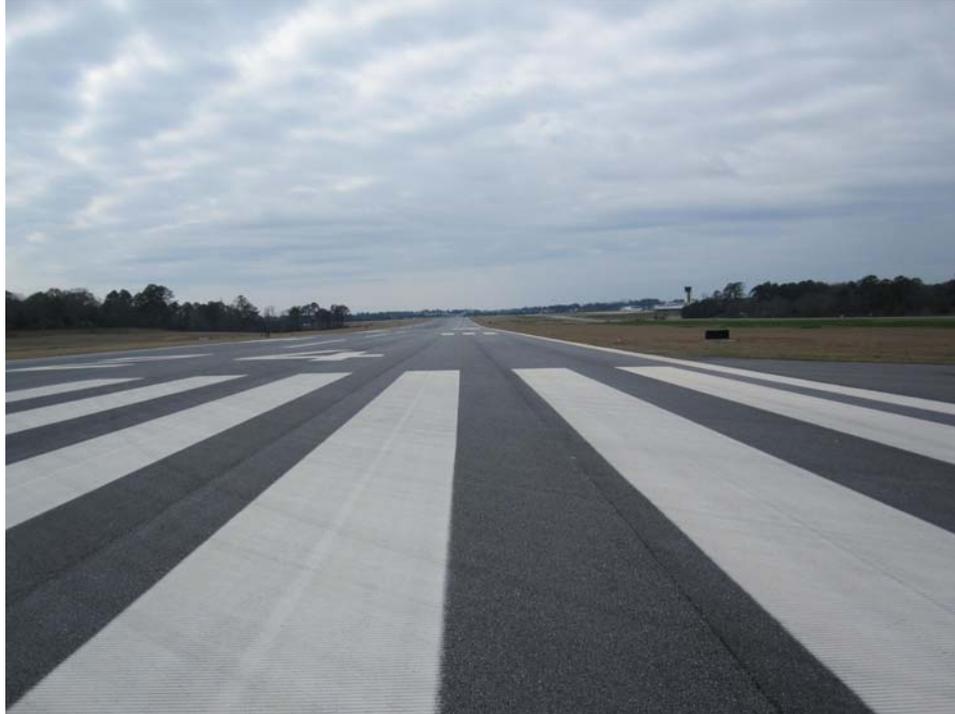
R624CS-10W. Overview.

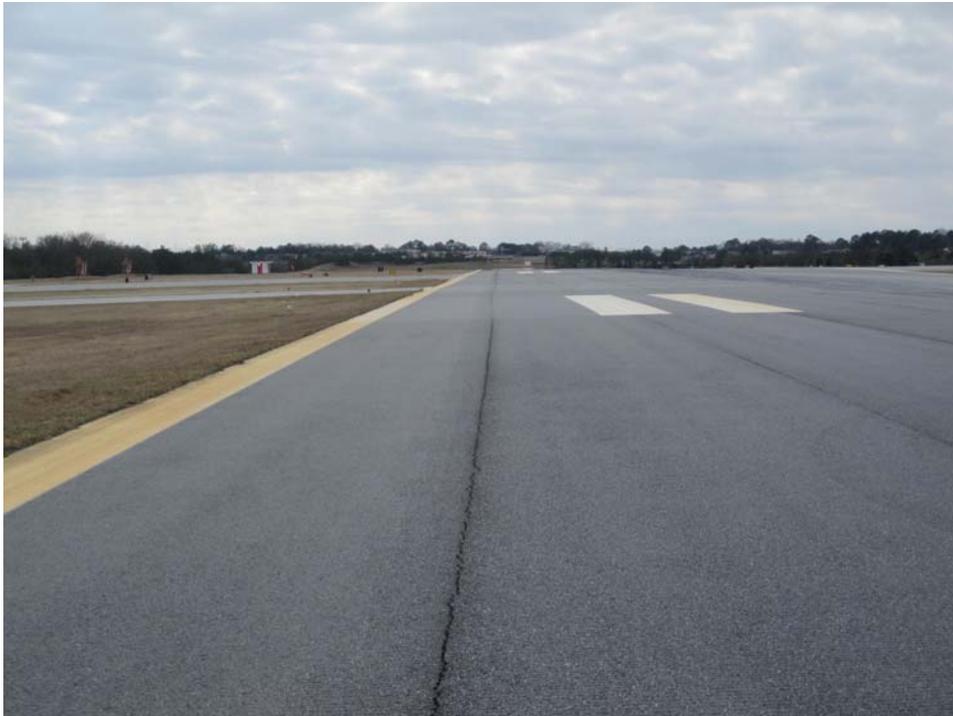
R624CS-20E. Overview.

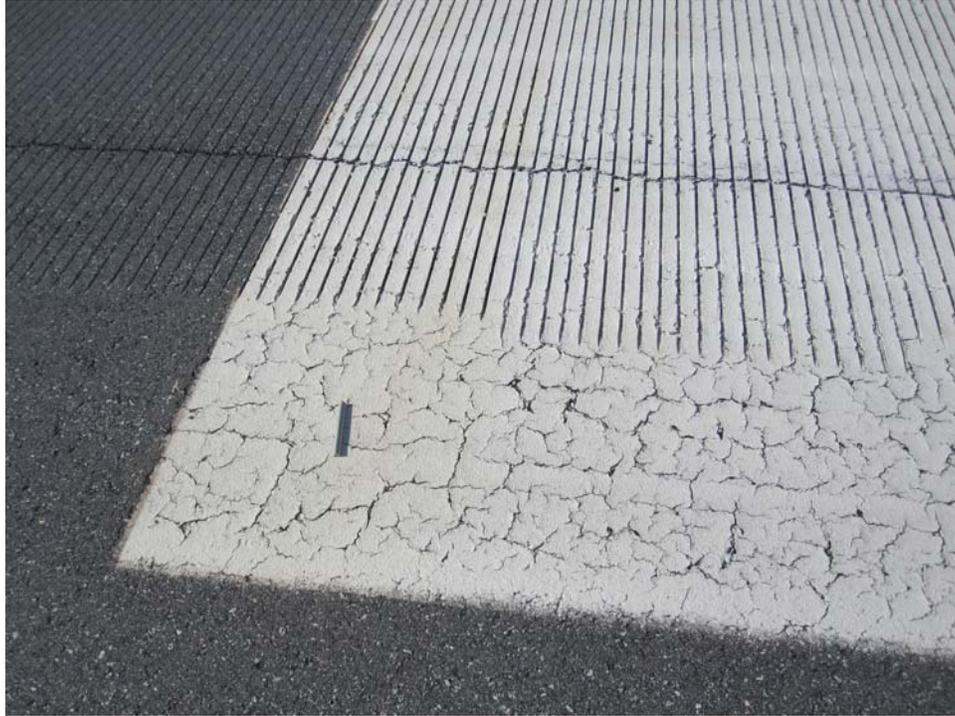
R624CS-20E. Unsatisfactory Paint.

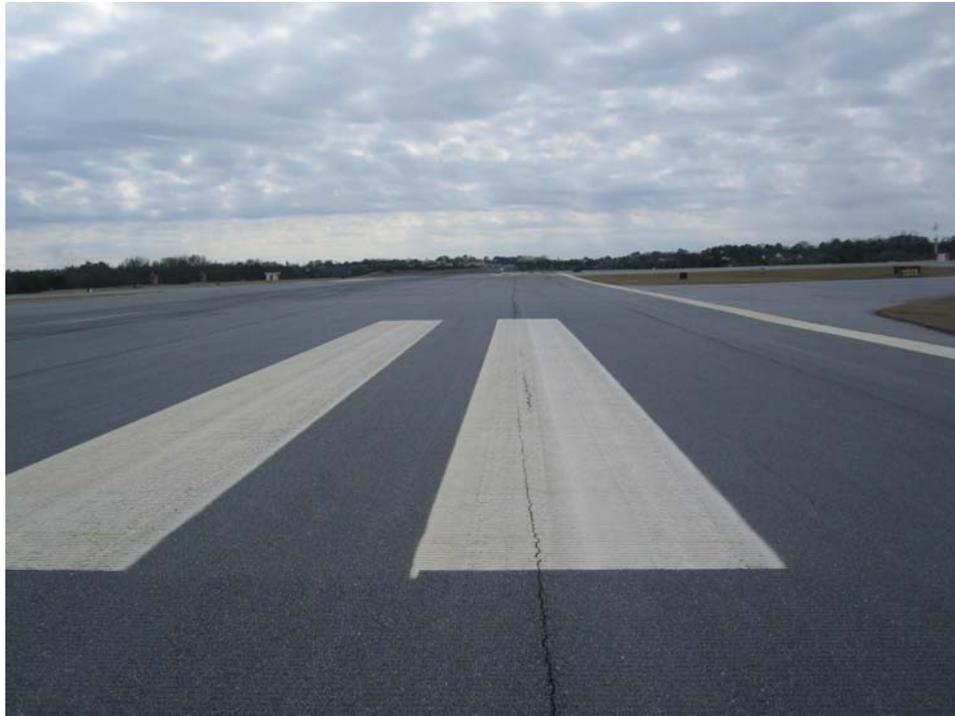
R624CS-20W. Overview.

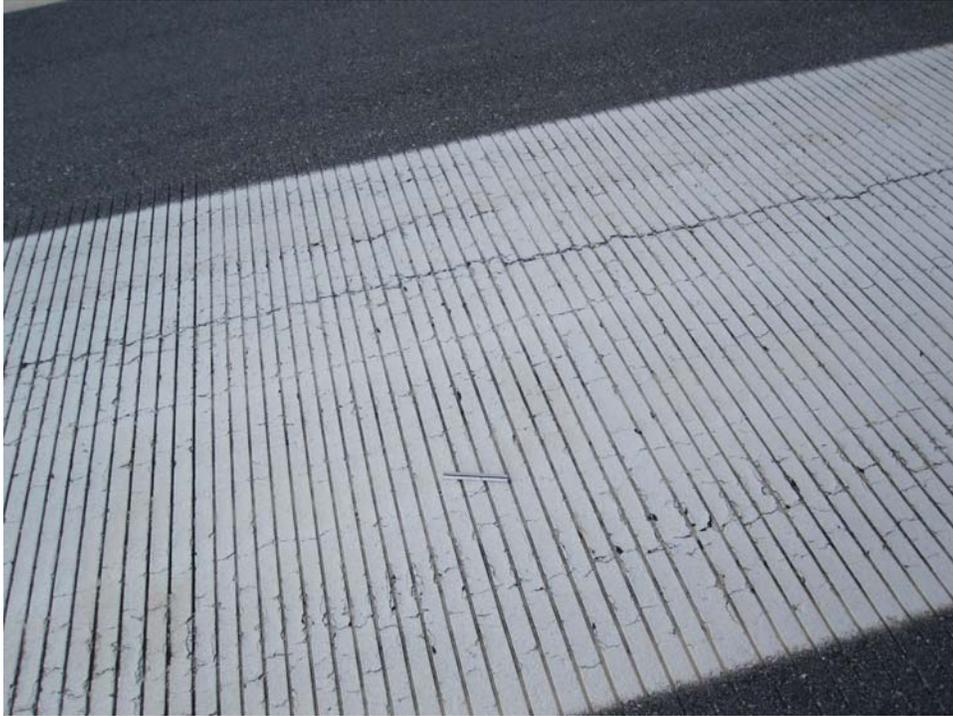
R624CS-20W. Unsatisfactory Paint.

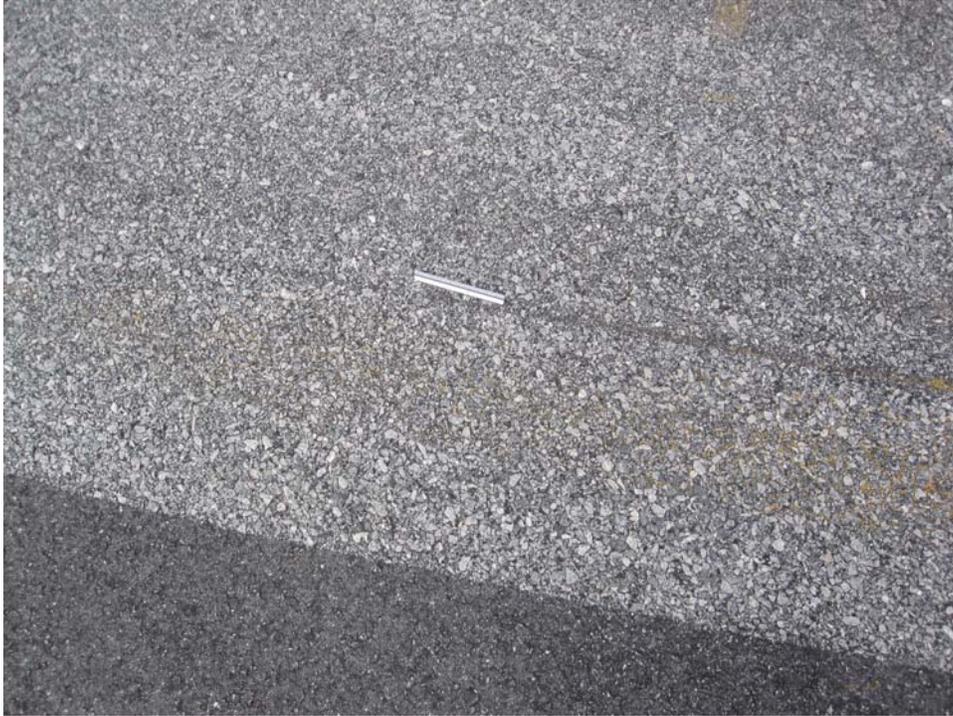
TCCS-20. Raveling (Additional Sample Unit #01).

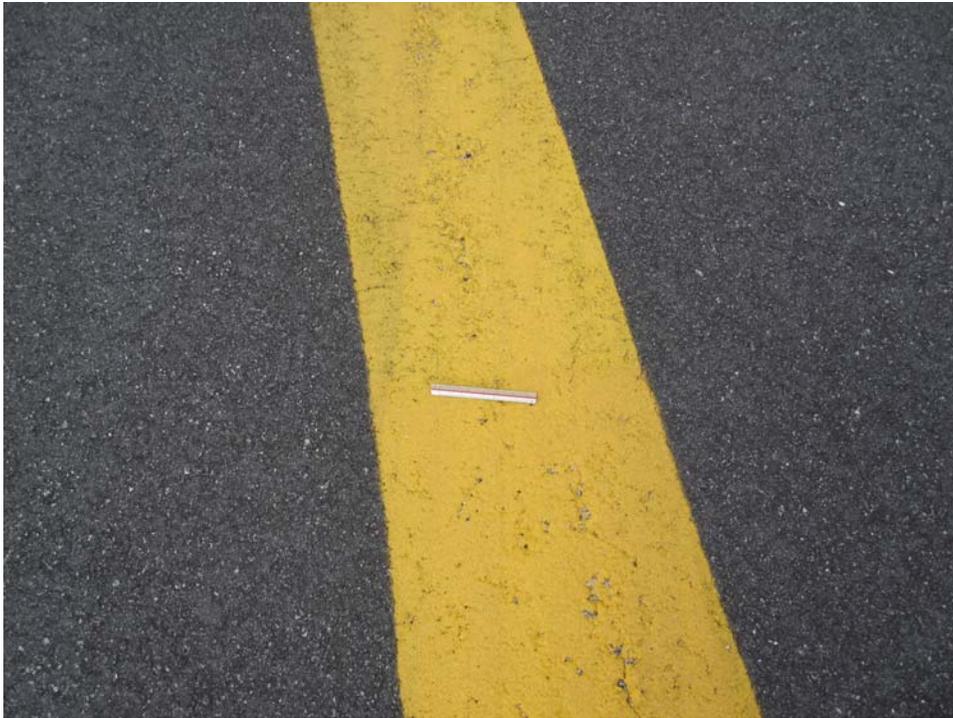
TCCS-20. Satisfactory Paint.

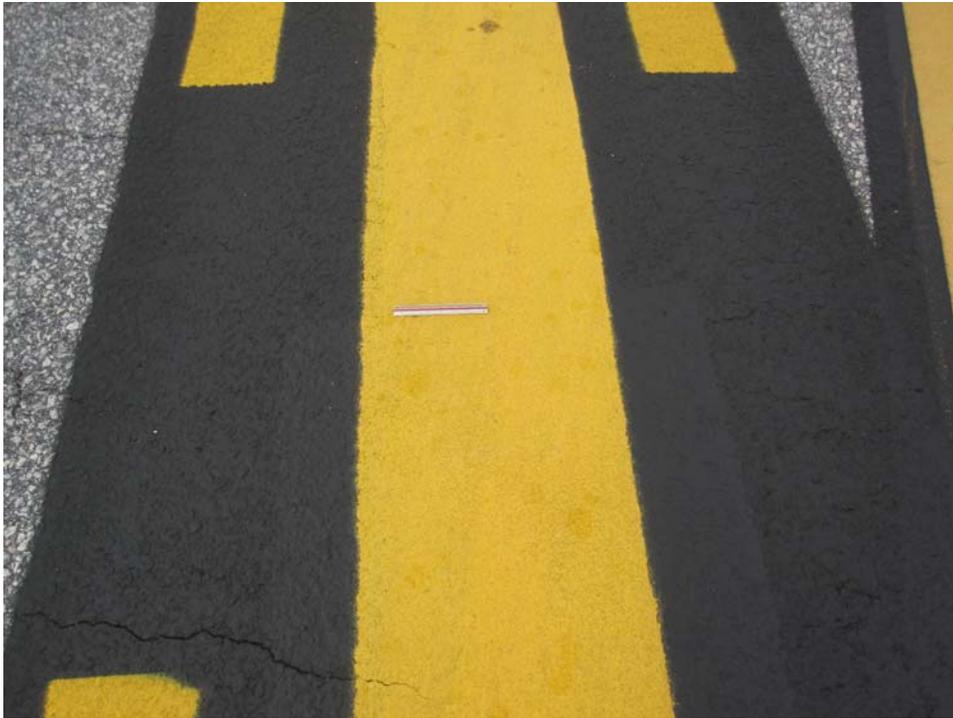
TCCS-40. Satisfactory Paint.

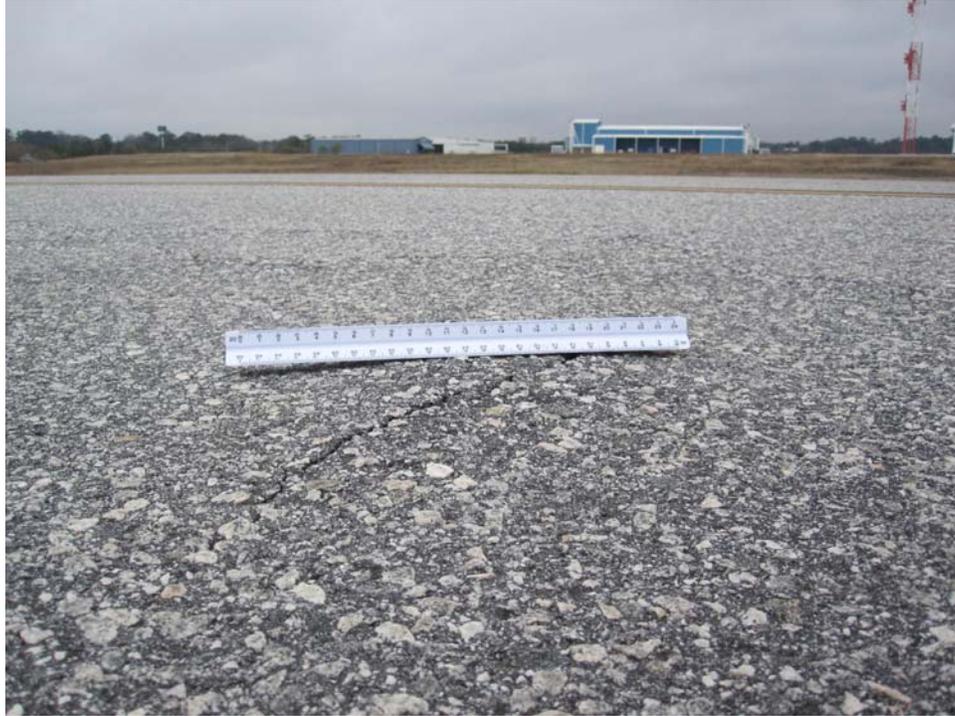
TCCS-40. Swelling (Sample Unit #05).

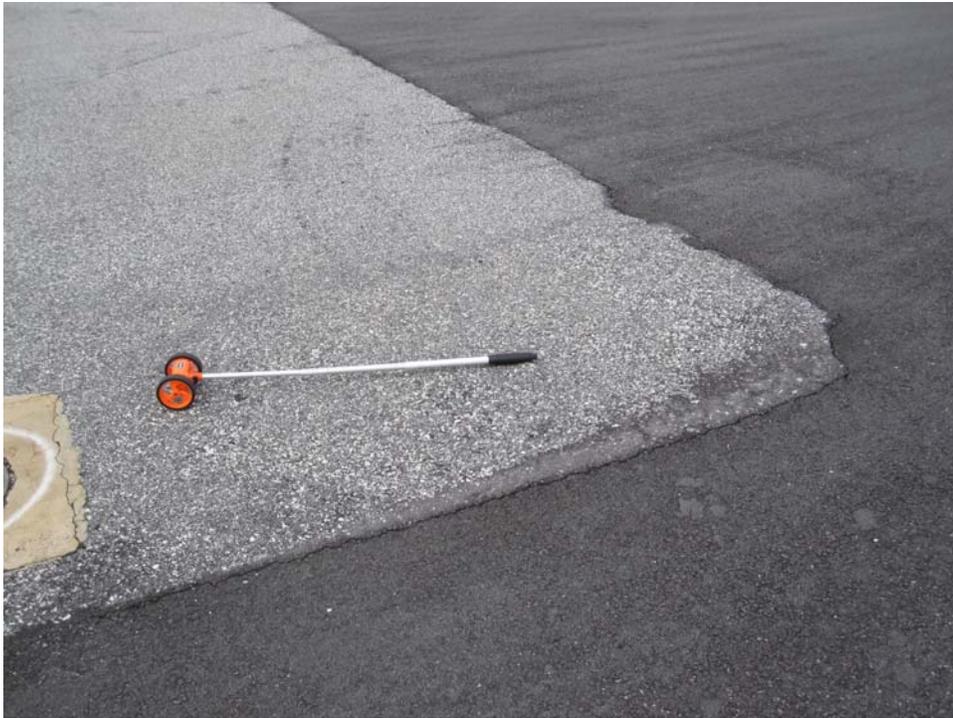
TFCS-30. Patching (Sample Unit #02).

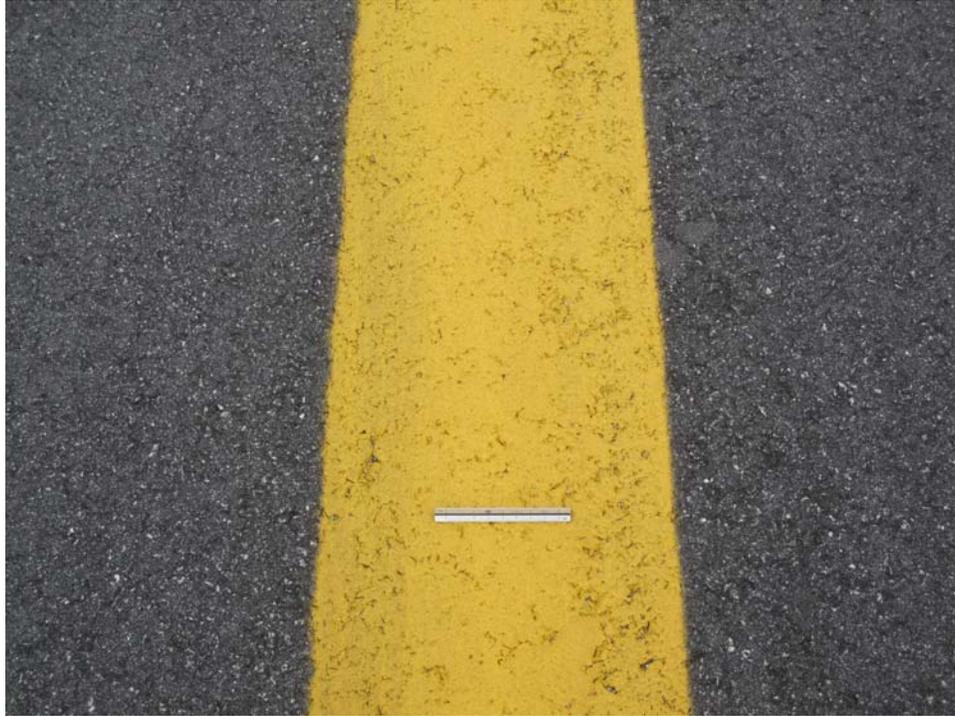
TFCS-30. Satisfactory Paint.
