2012 Columbus Airport Pavement Management Plan

COLUMBUS AIRPORT

PAVEMENT MANAGEMENT REPORT

DECEMBER 2012

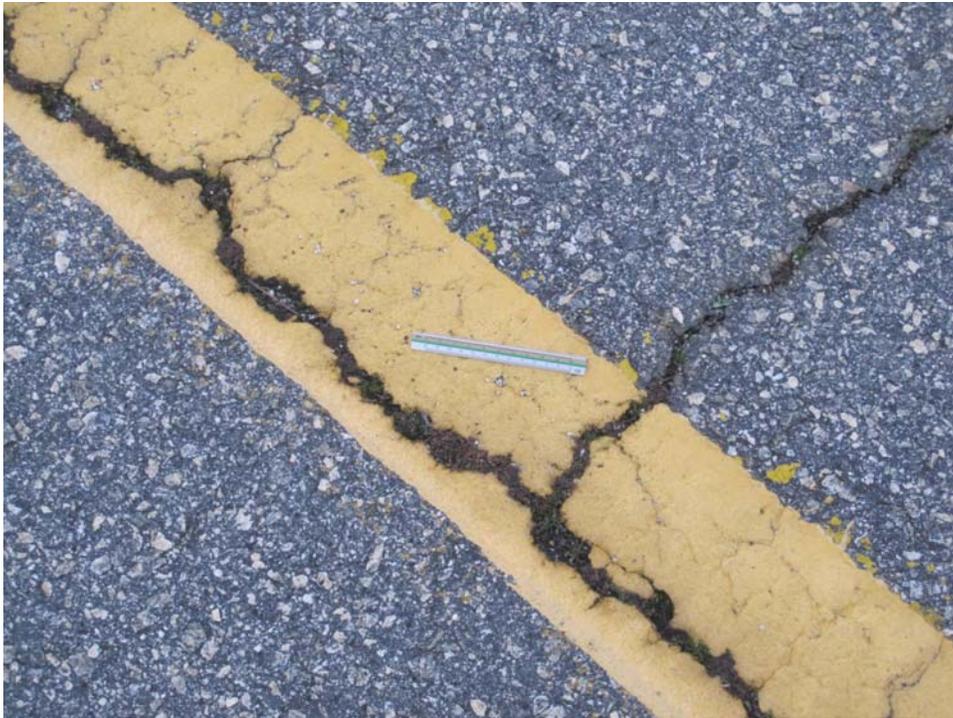
THANGCS-10. Satisfactory Paint. (1)

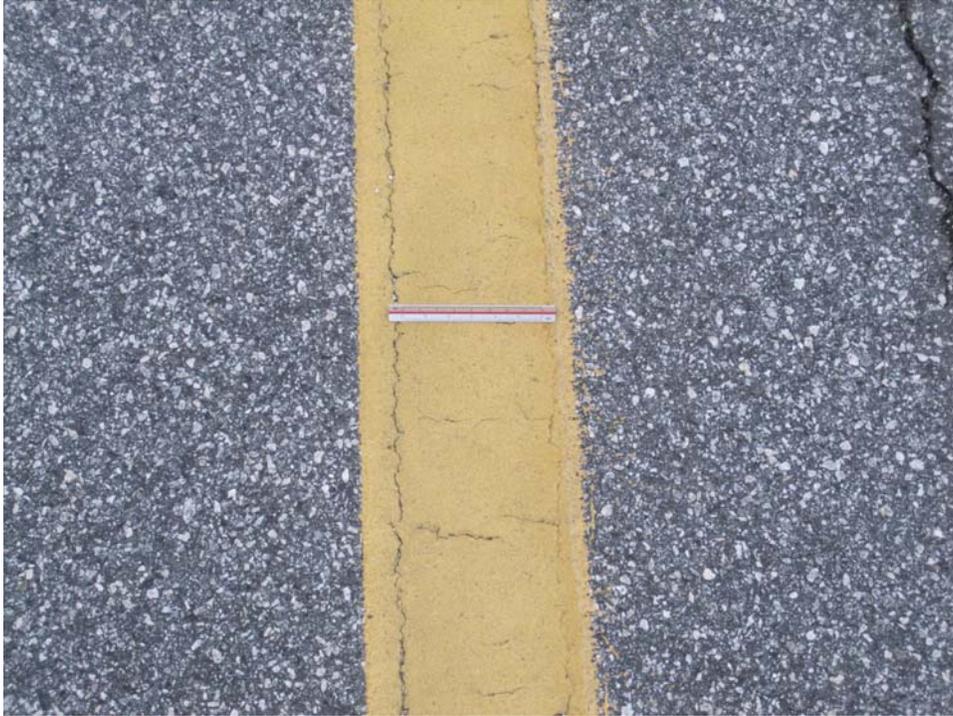
THANGCS-10. Satisfactory Paint. (2)
