2012 Gwinnett County- Briscoe Field Pavement Management Plan

GWINNETT COUNTY-BRISCOE FIELD

PAVEMENT MANAGEMENT REPORT

DECEMBER 2012

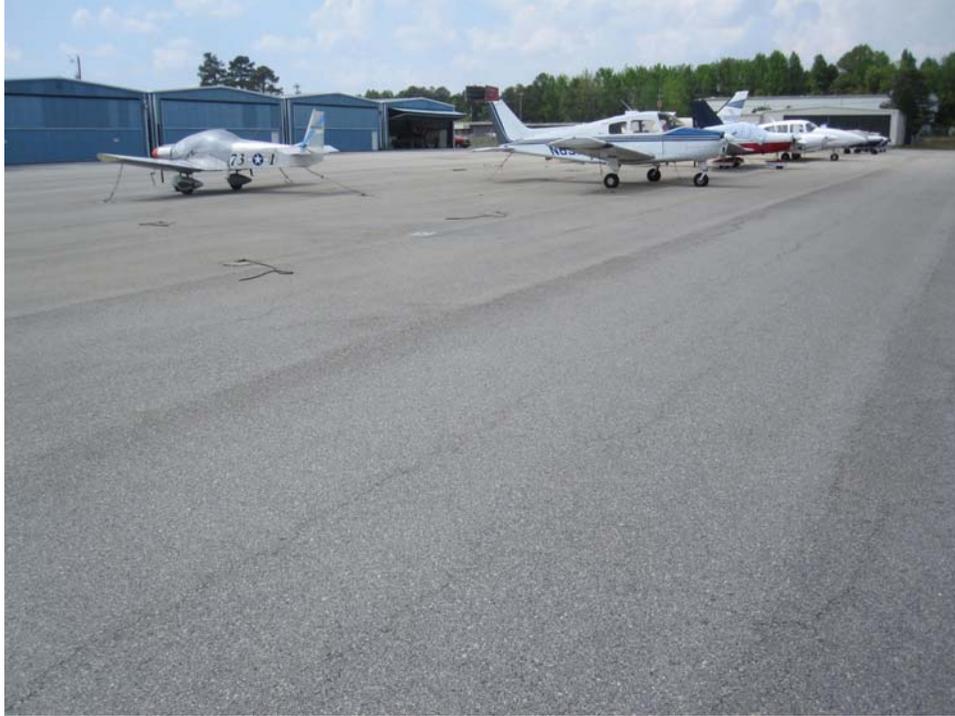
A01LW-10. Overview.

Runway 7-25 was comprised of one section. Section 10 had a PCI value of 73 with the majority of the distresses observed being low-severity weathering and low- and medium-severity longitudinal and transverse cracking (L&T) cracking. The low-severity cracking was unsealed, and the medium-severity cracking was in the unsealed condition with crack widths greater than ¼ in. Low-severity patching was also observed.

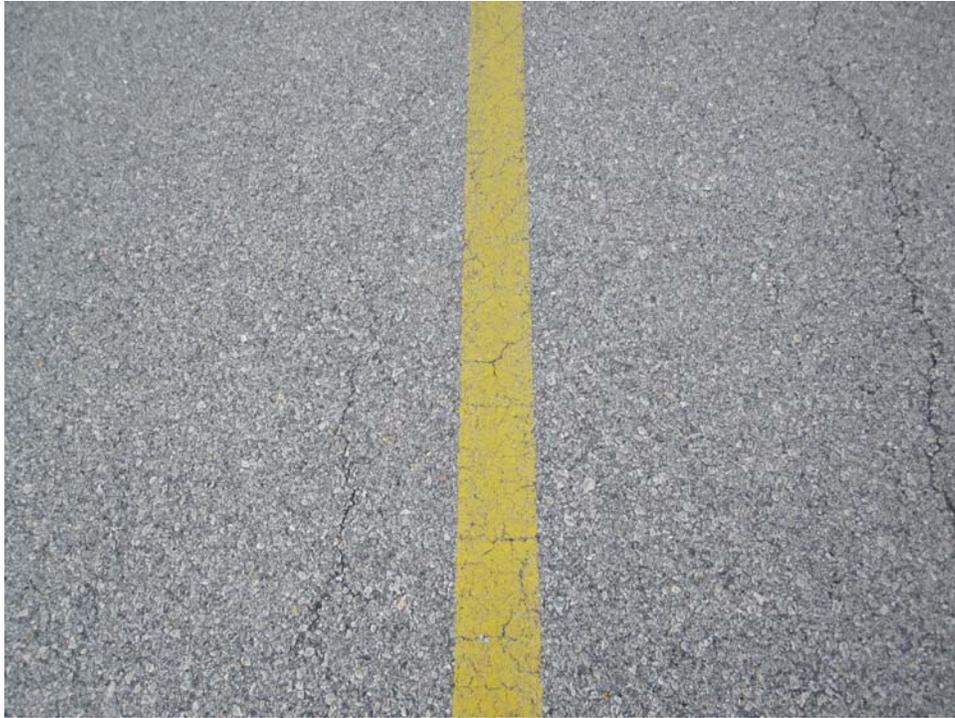
A01LW-10. Satisfactory Paint.

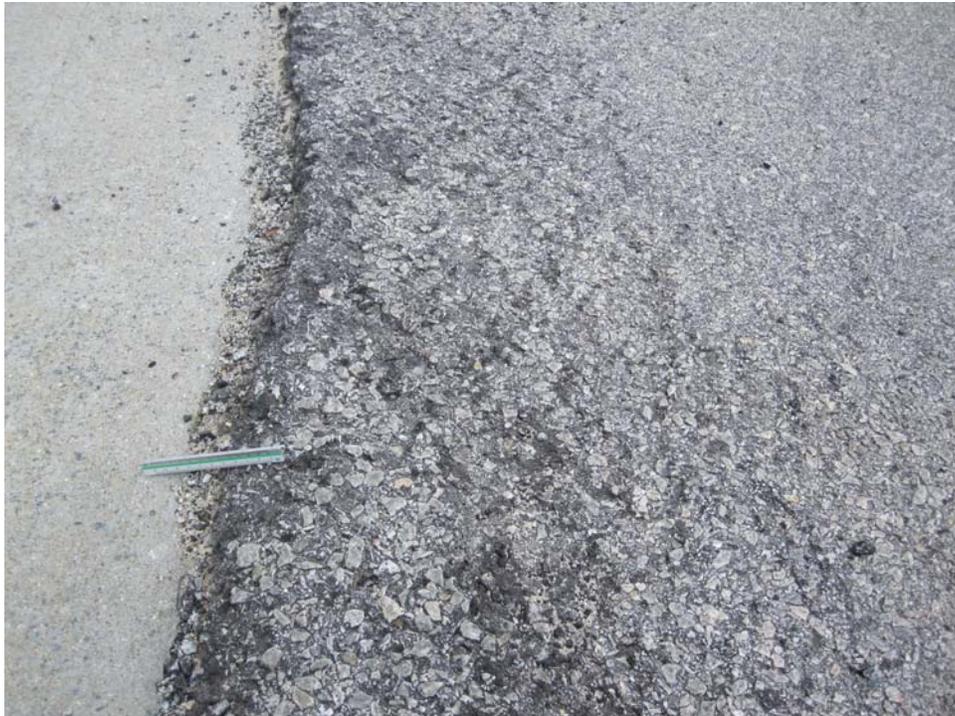
A01LW-10. Shoving (Sample Unit #12).

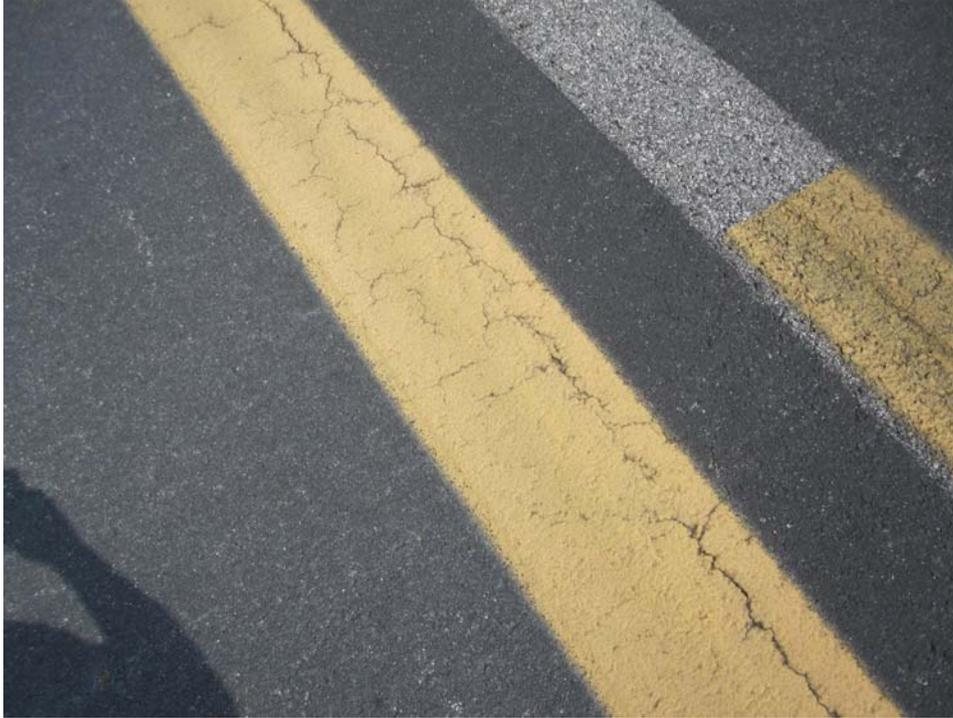
A01LW-20. Satisfactory Paint.

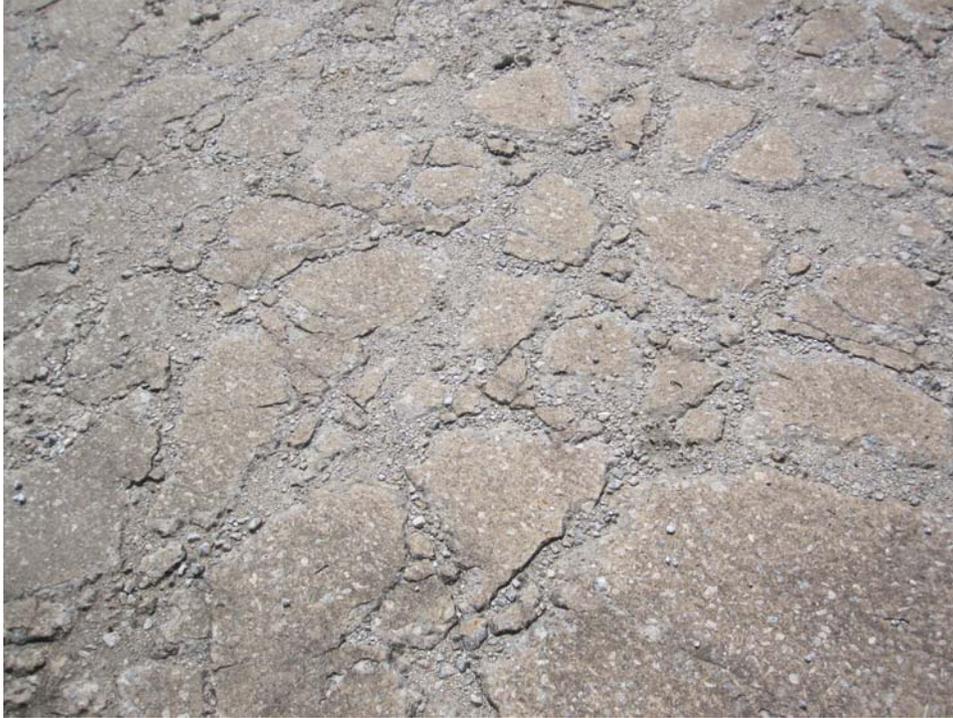
A01LW-40. Shattered Slab (Sample Unit #04).

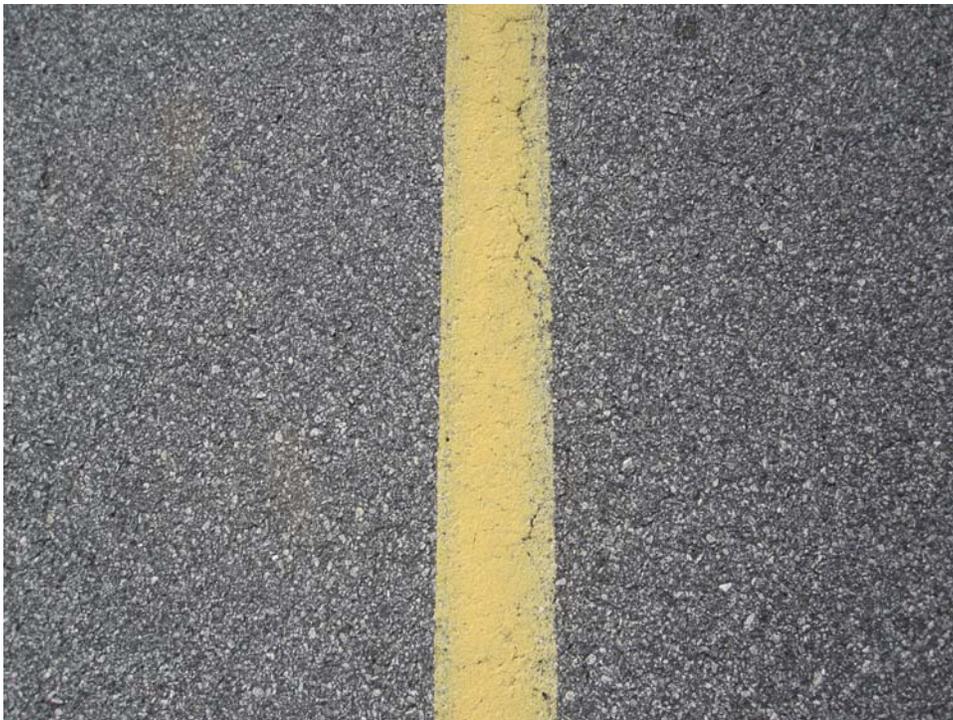
A04LW-20. Satisfactory Paint.

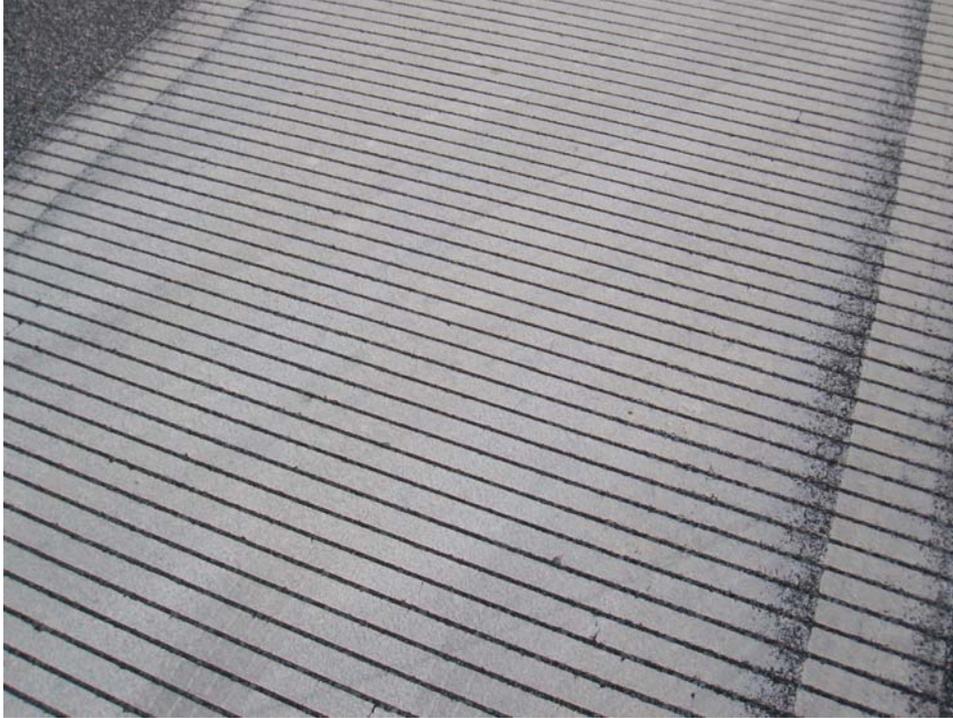
R725LW-10. Satisfactory Paint.

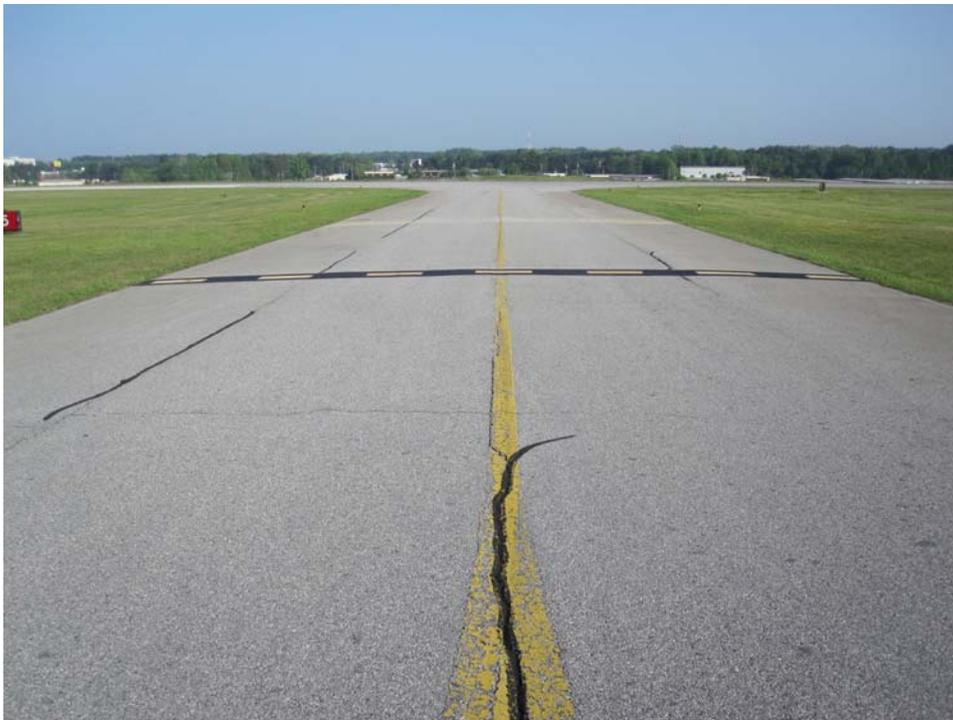
TBLW-10. Overview.

Taxiway B was defined by one section with a PCI value of 53. Low-severity weathering was observed throughout the majority of the pavement surface with small areas of low- and medium-severity raveling also observed. Large quantities of low- and medium-severity L&T cracking were observed in both sealed and unsealed conditions. Additionally, small amounts of medium- and high-severity alligator cracking were observed.

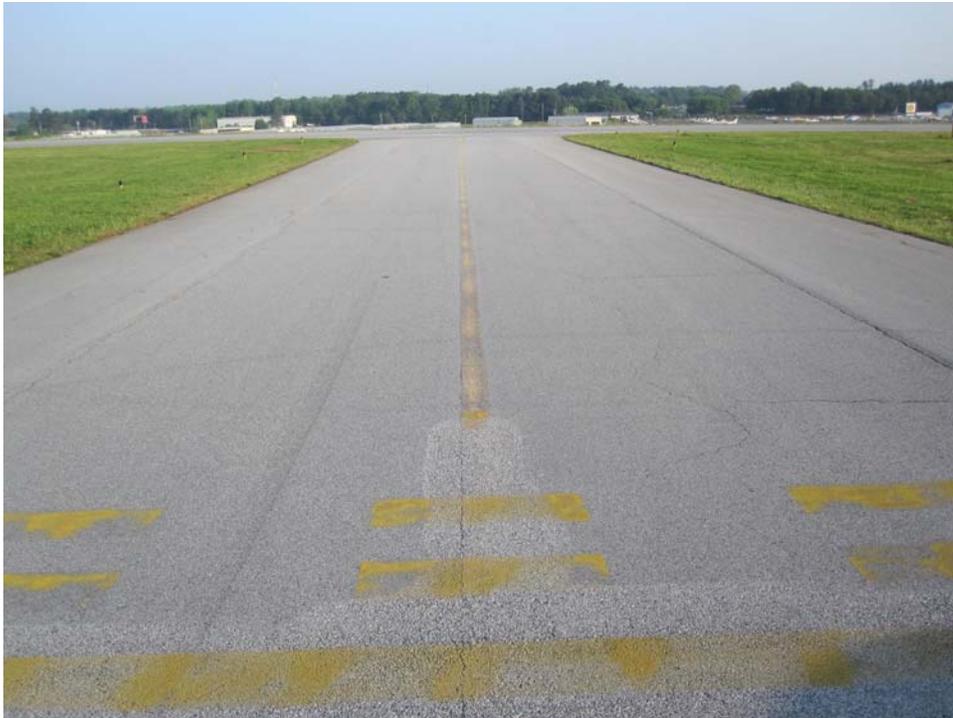
TCLW-10. Overview.

Taxiway C contained one section with a PCI value of 63. The primary distresses identified in this section were unsealed, low- and medium severity L&T cracking and low-severity weathering. The medium-severity cracking was recorded where crack widths were greater than ¼ in. A small amount of medium-severity alligator cracking was also noted.

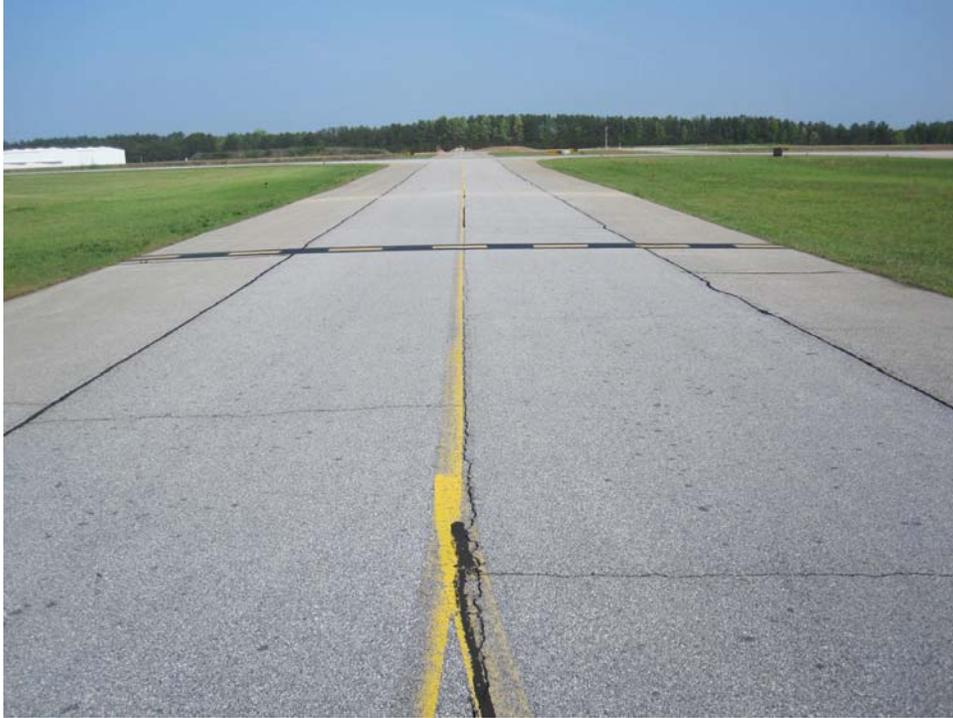
TFLW-10. Overview.

Taxiway F was comprised of one section with a PCI value of 54. Large amounts of low- and medium-severity L&T cracking and low-severity weathering were the primary distresses

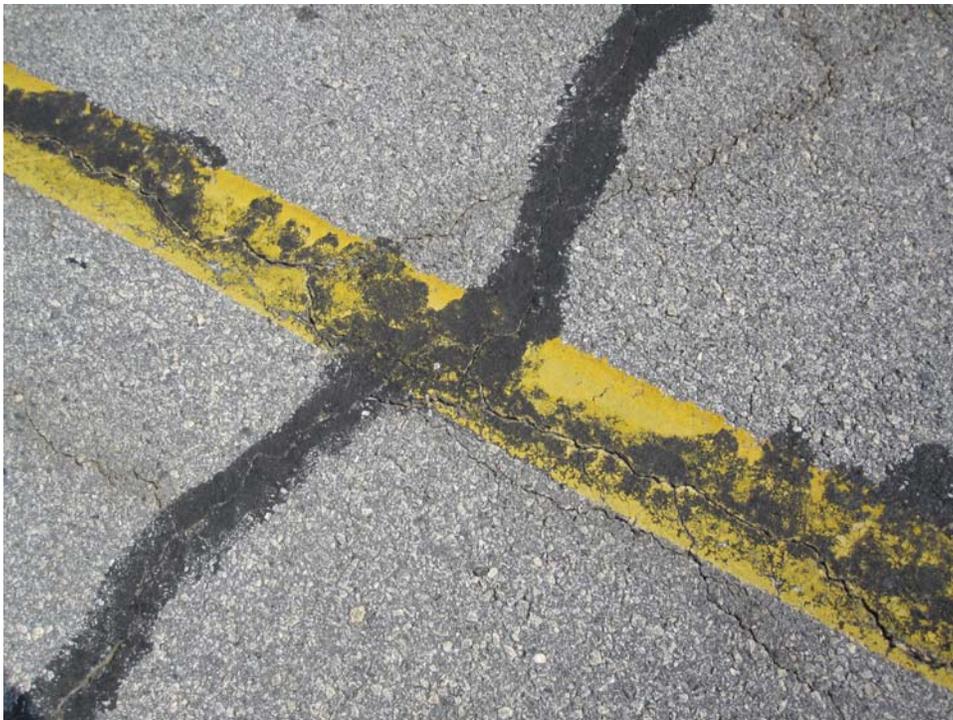
THLW-10. Unsatisfactory Paint.

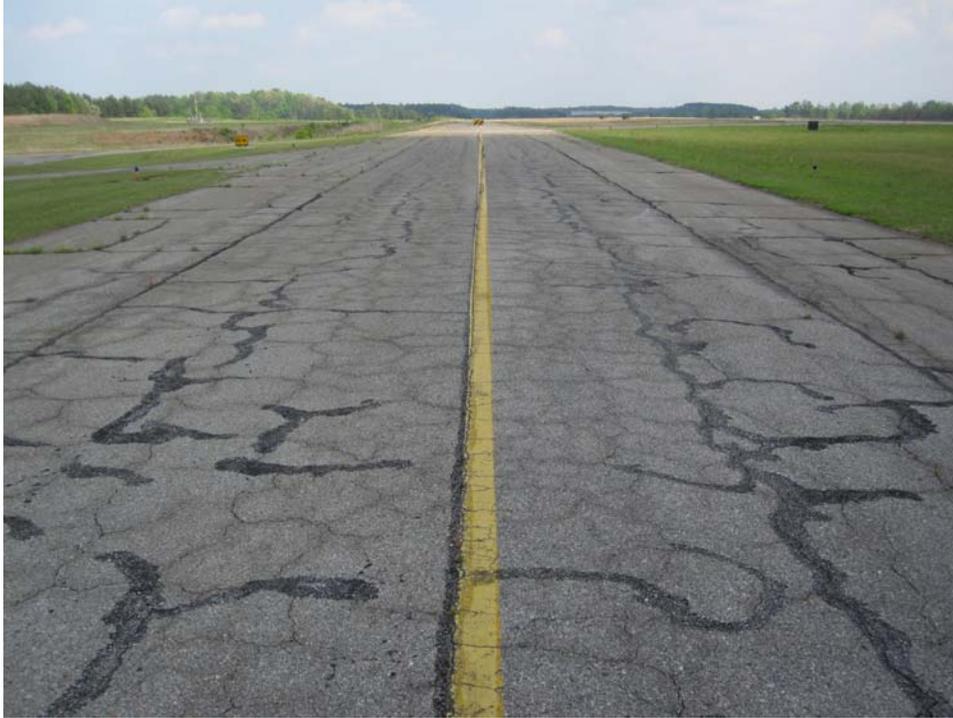
THLW-20. Overview.

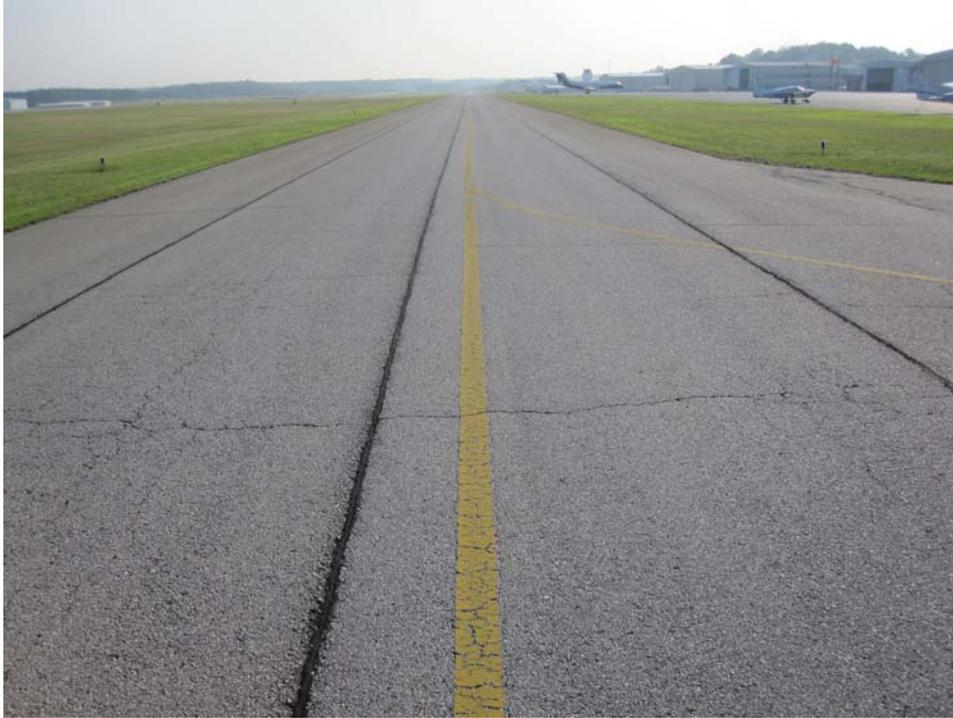
TWLW-10. Overview.

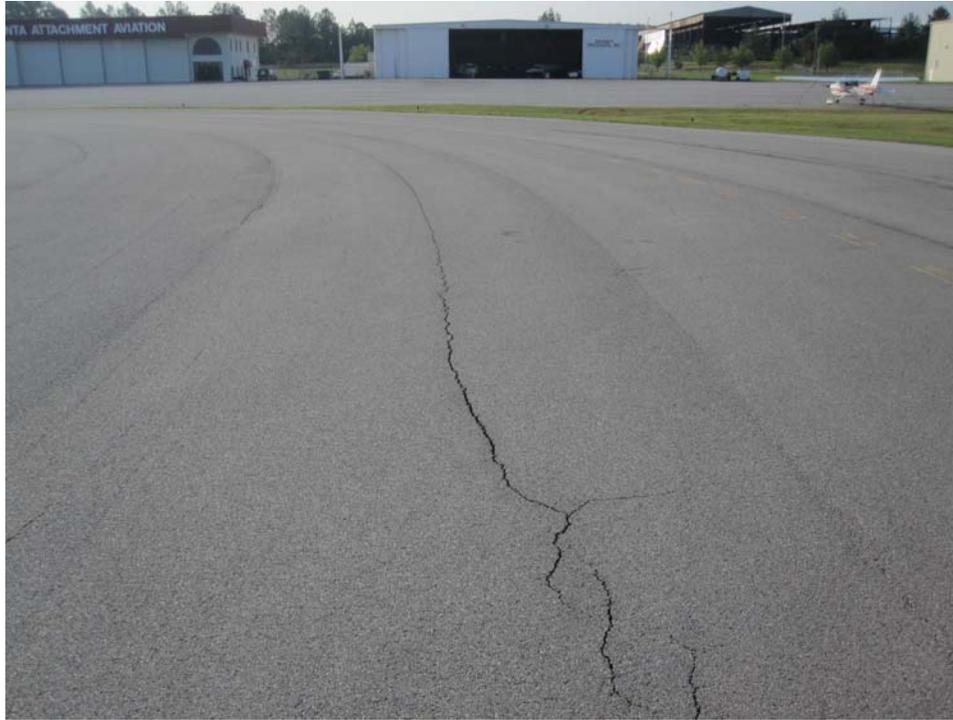
TWLW-20. Overview.

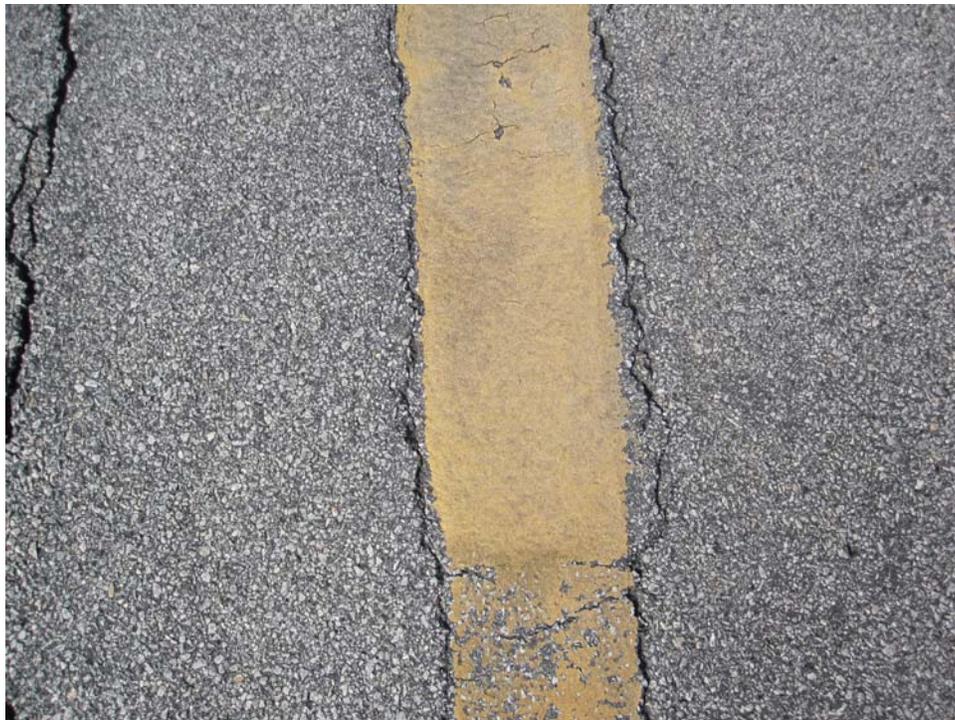
TWLW-30. Satisfactory Paint.

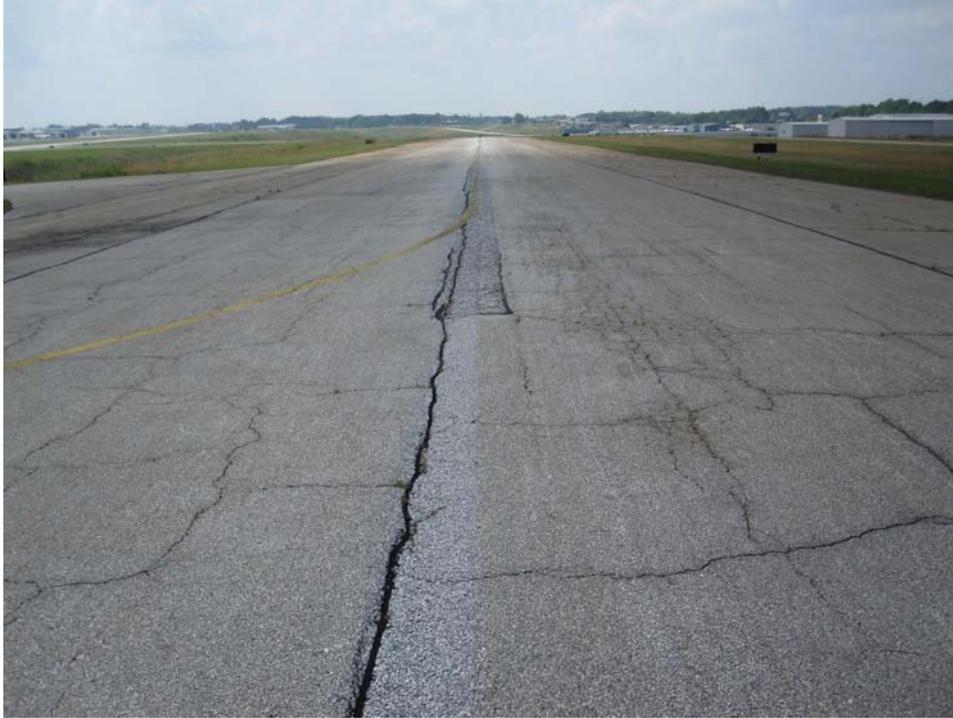
TYLW-10. Overview.

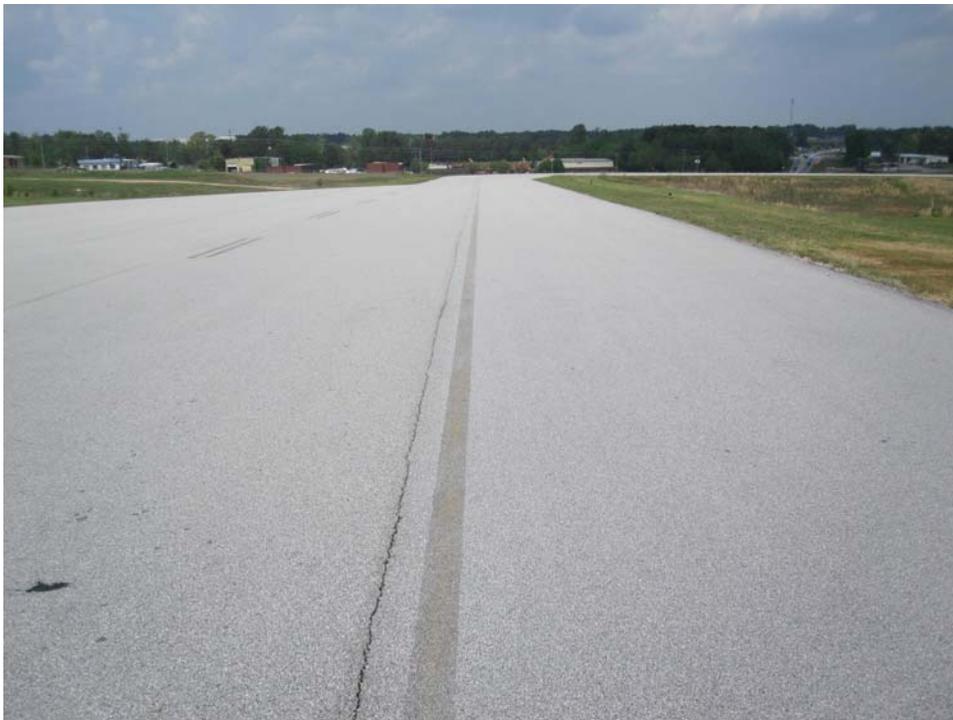
TZLW-10. Overview.

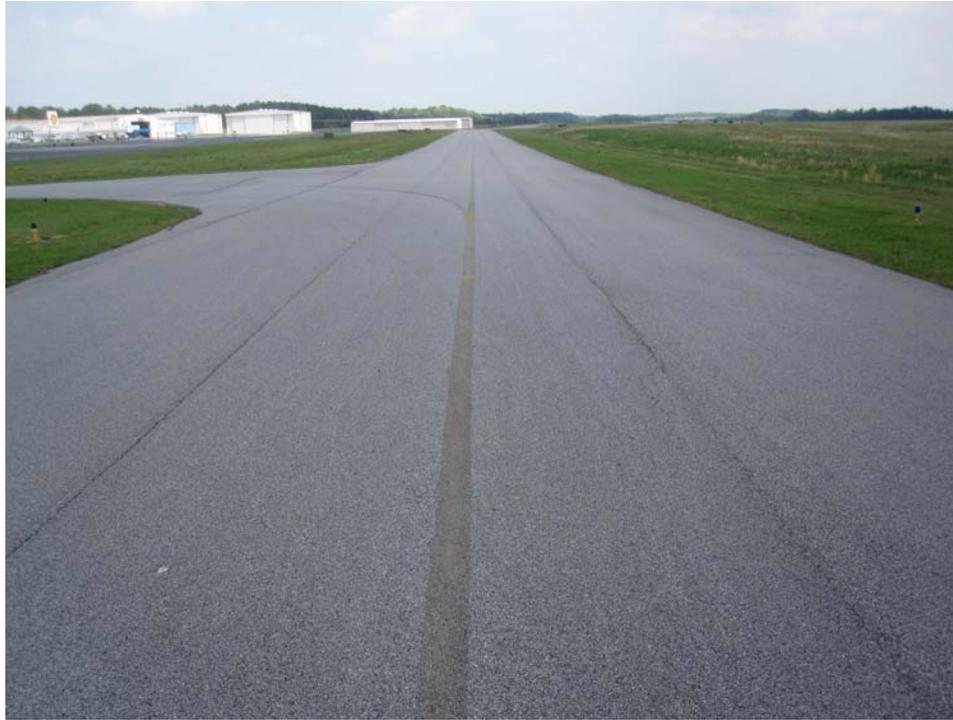
TZLW-20. Overview.

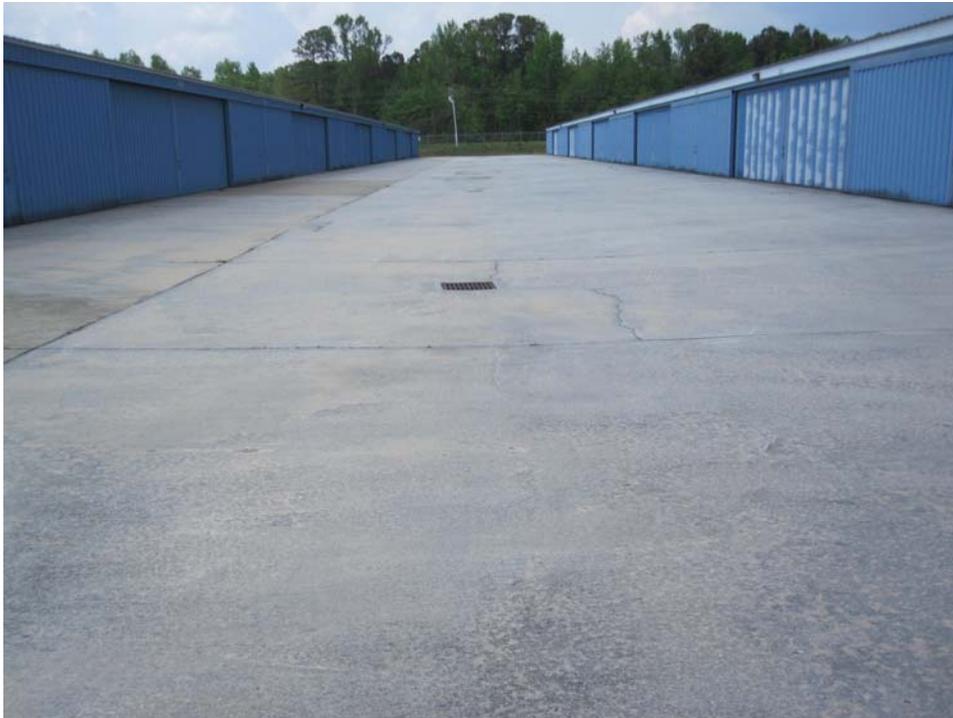
THANGLW-10. Overview.

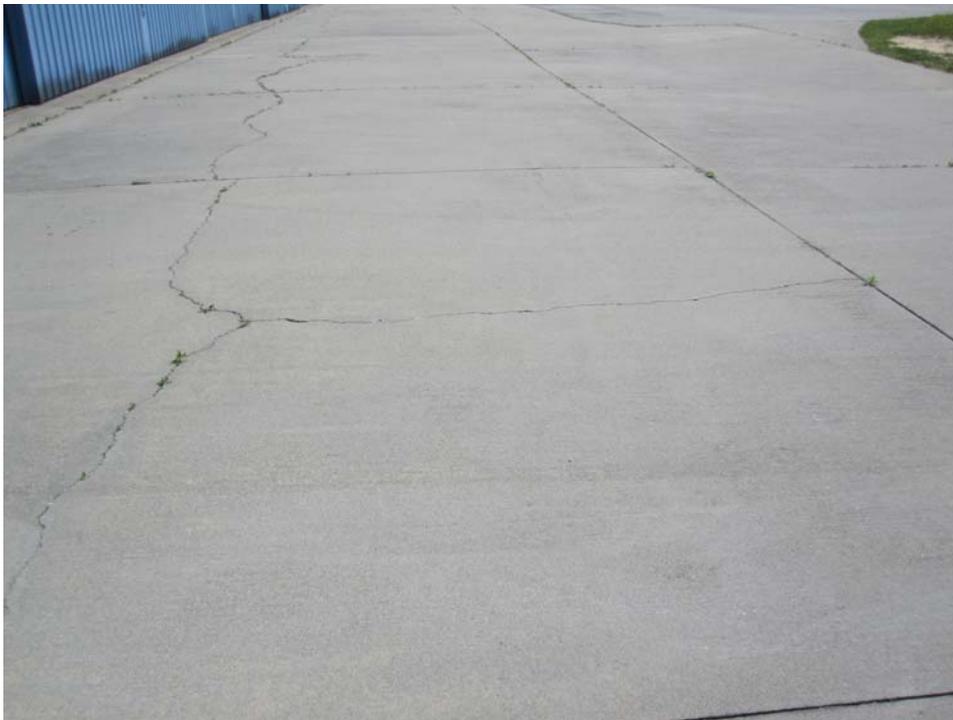
THANGLW-20. Overview.
