# 2012 Savannah-Hilton Head International Airport Pavement Management Plan

# SAVANNAH-HILTON HEAD INTERNATIONAL AIRPORT

## PAVEMENT MANAGEMENT REPORT

**DECEMBER 2012**

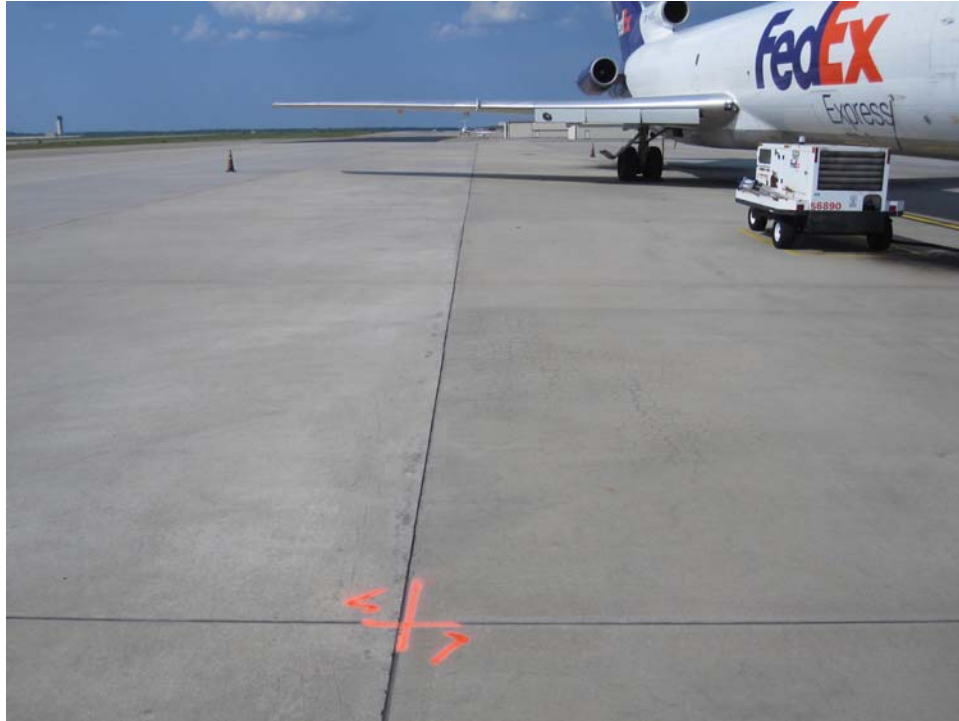
ACARGOSV-10. Overview.

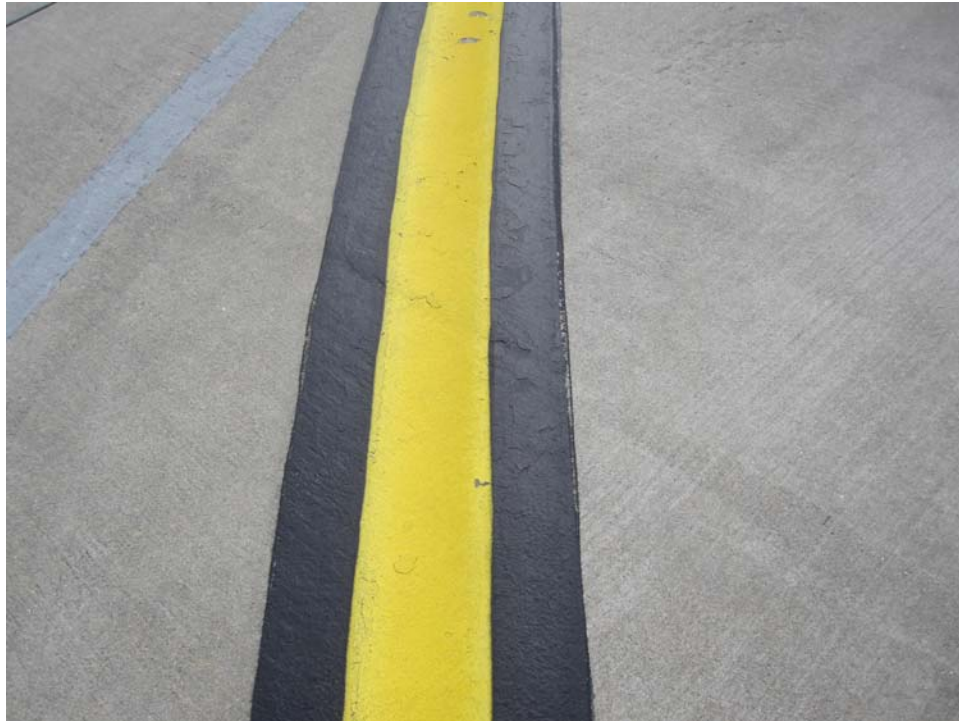
ACARGOSV-10. Satisfactory Paint.

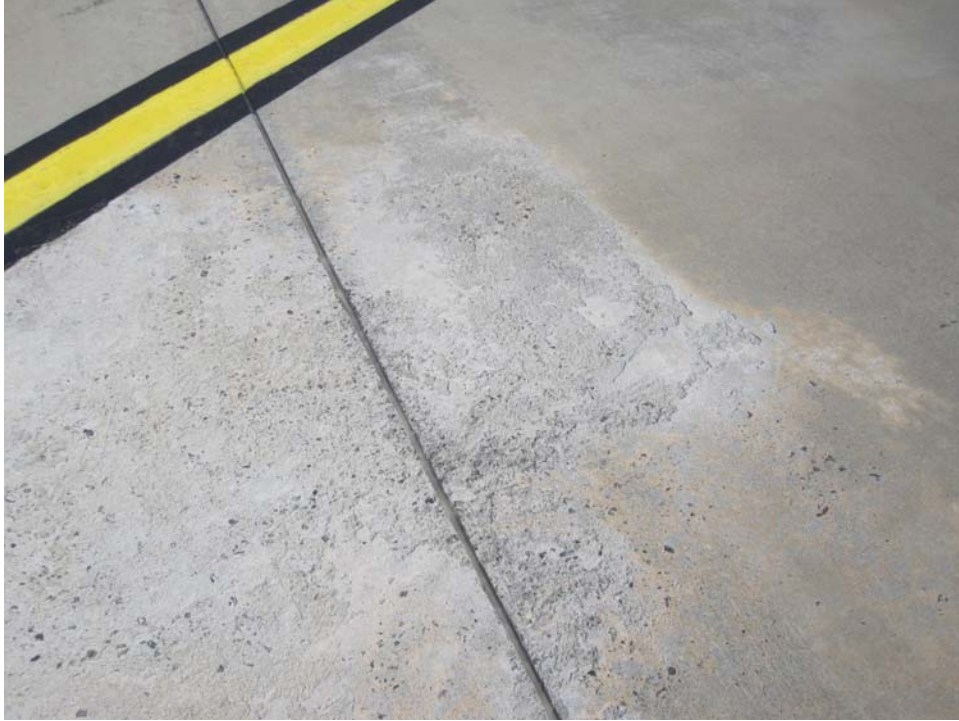
ACARGOSV-10. Scaling (Sample Unit #03).

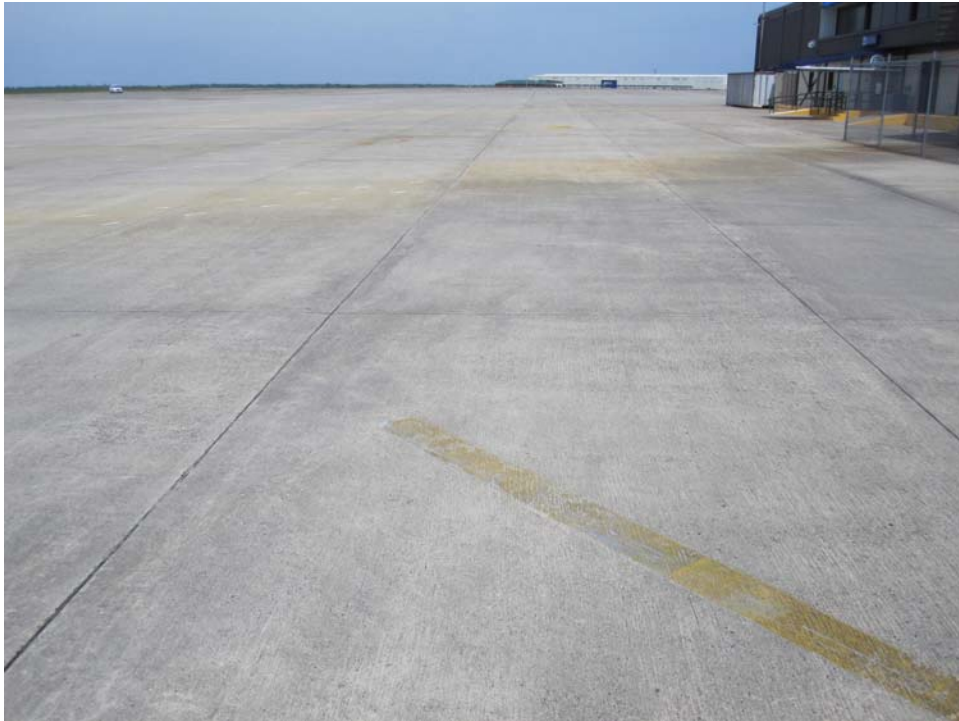
AOLDTERMSV-10. Overview.

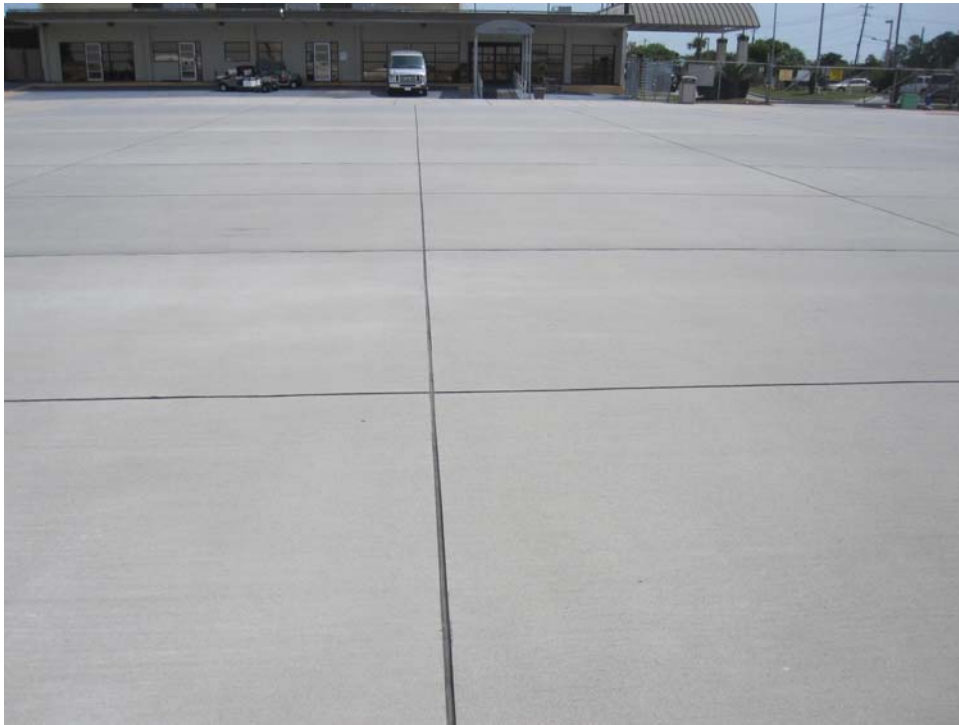
AOLDTERMSV-20. Overview.

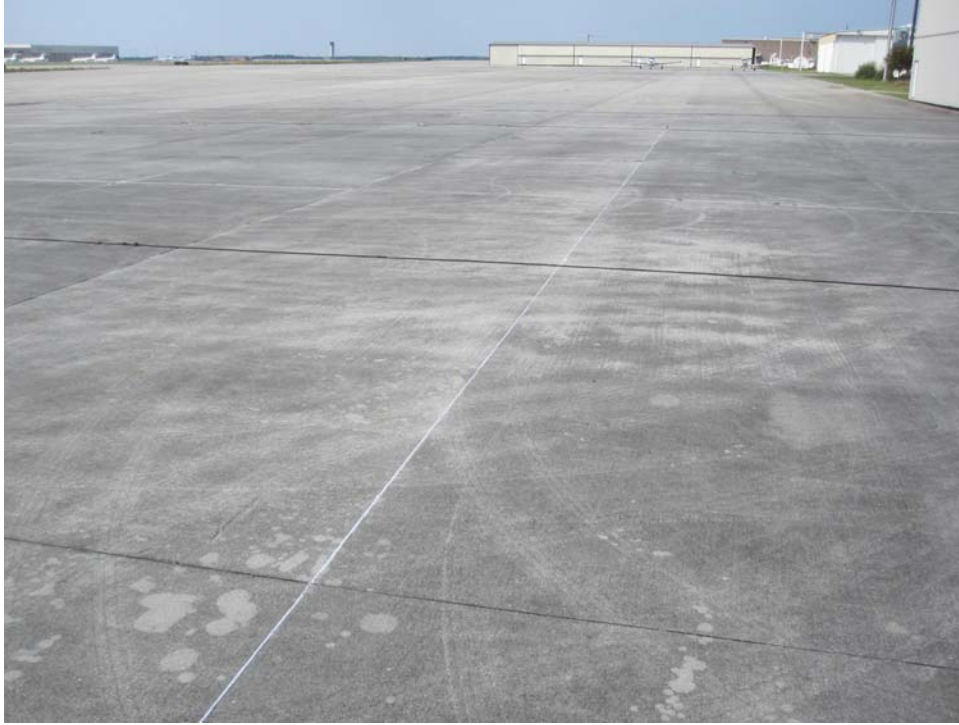
ASAVAIRSV-10. Overview.

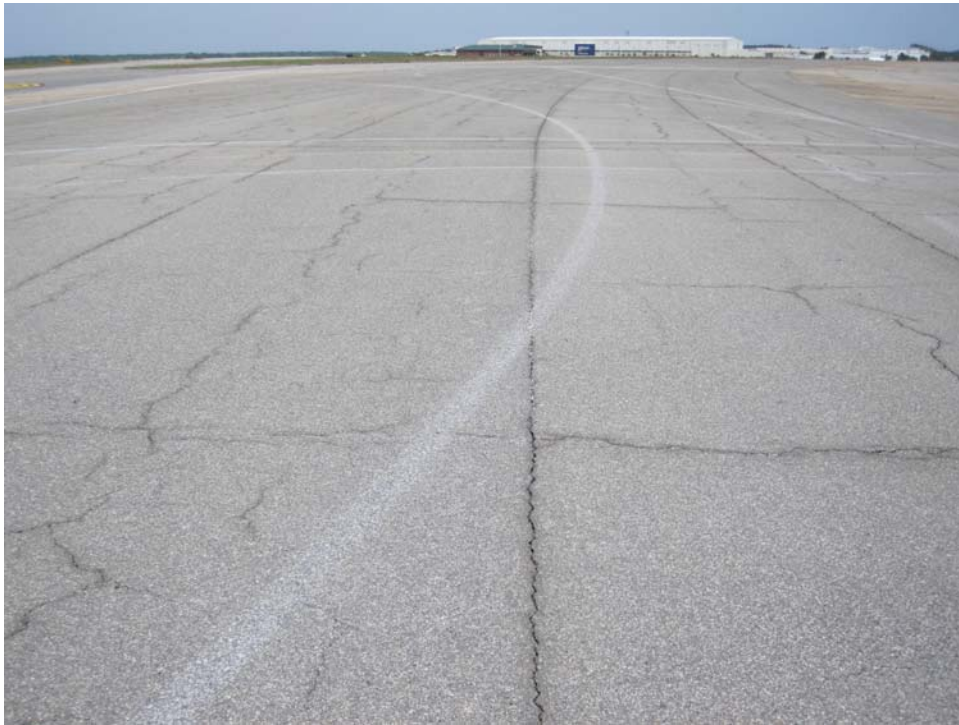
ASIGNORSV-10. Overview.

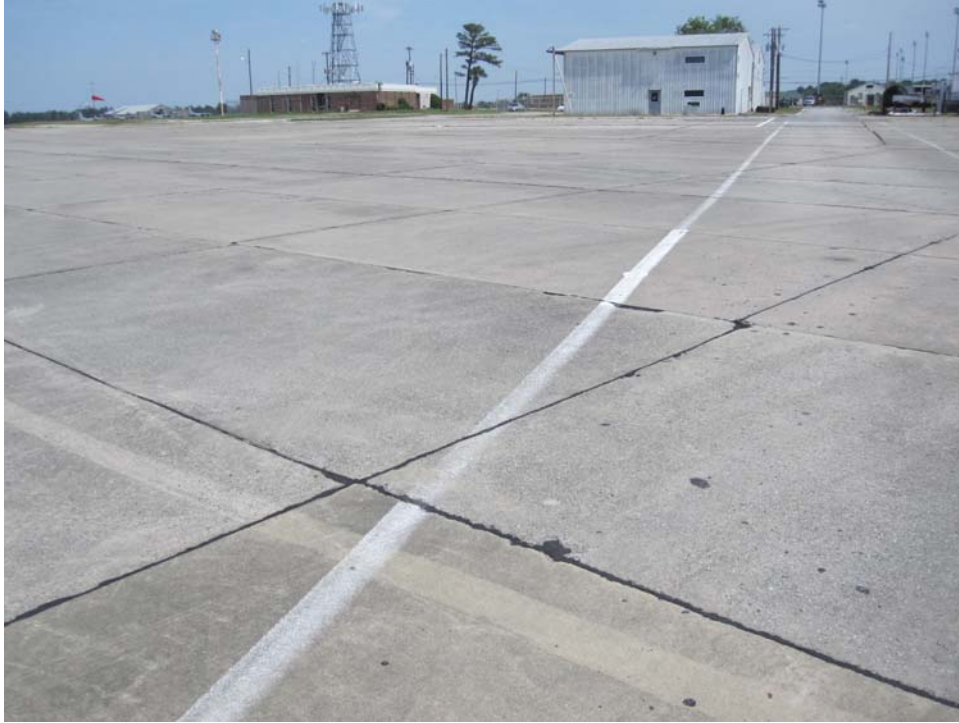
ASIGNORSV-20. Overview.

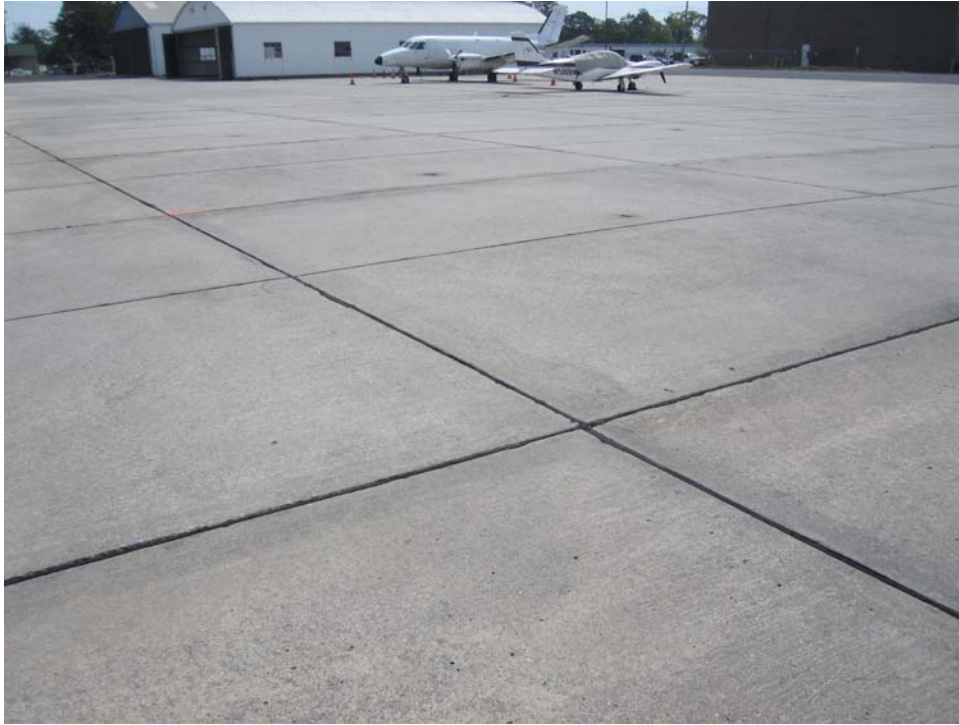
ASIGSTHSV-10. Overview.

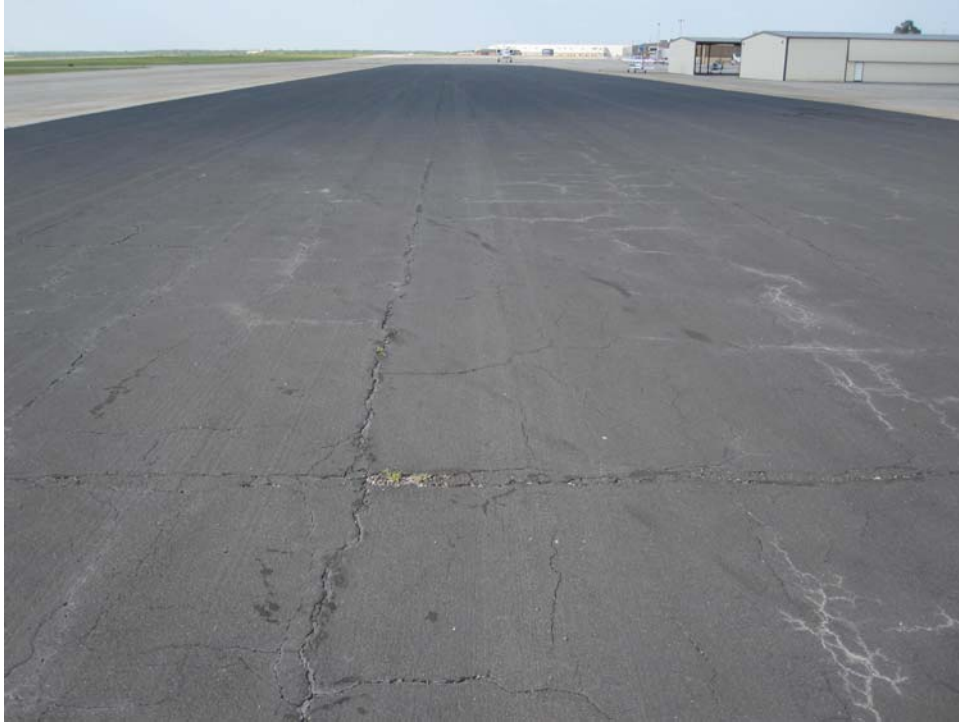
ASIGSTHSV-20. Overview.

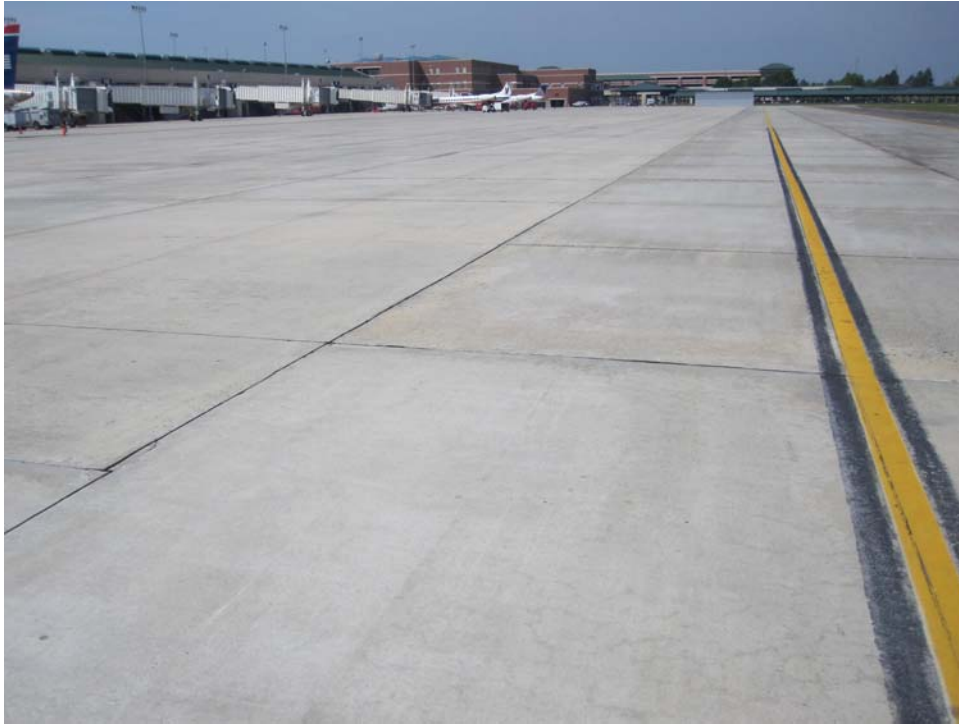
ATERMSV-10. Overview.

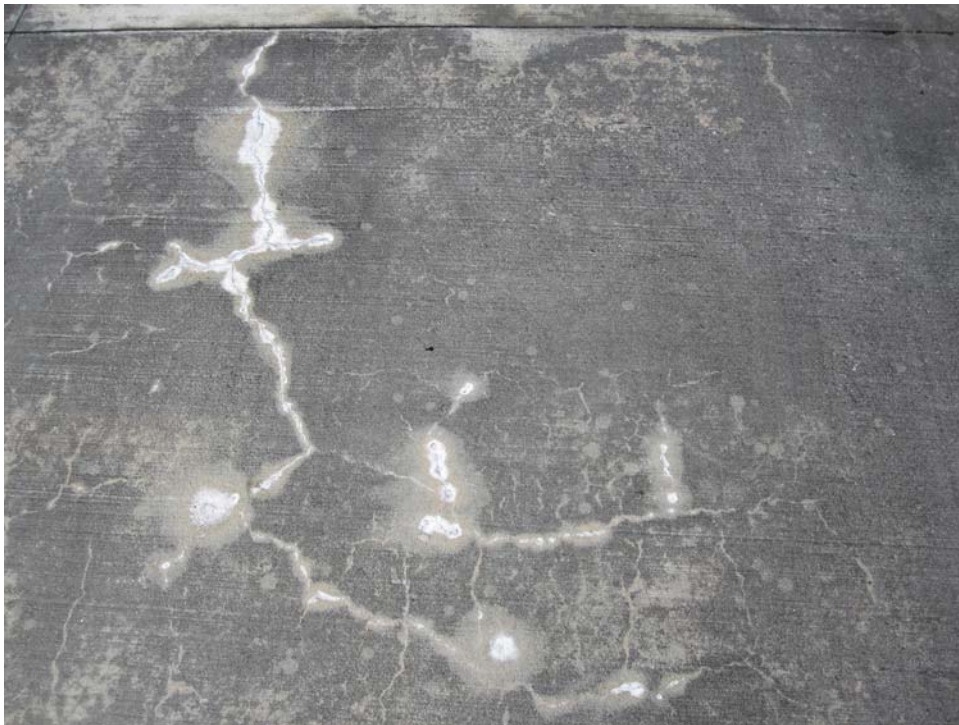
Seventy-two pavement sections were defined during the inspection. In several pavement areas, alkali silica reactivity (ASR) was recorded according to PCI procedure. The ASR was recorded where evidence of a precipitate was observed within some of the cracking in the PCC surface. It should be noted that laboratory testing and analysis is the only definitive way to validate the presence of ASR; however, the formation of a precipitate is evidence of a reaction consistent with this type of materials-related distress.

ATERMSV-10. ASR (Sample Unit #11).

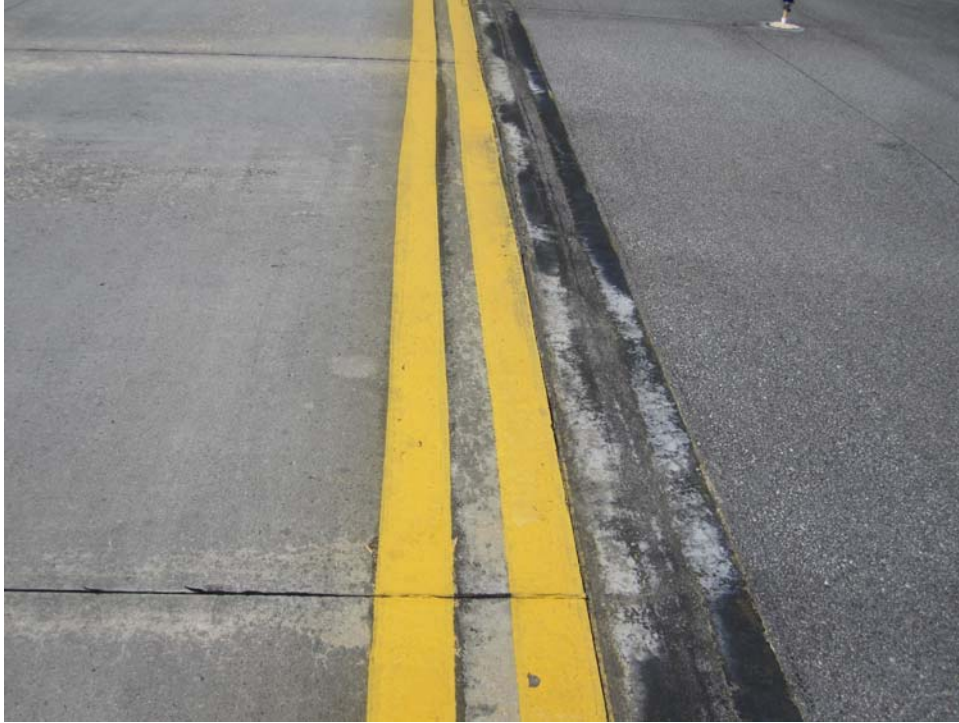
ATERMSV-10. Satisfactory Paint.

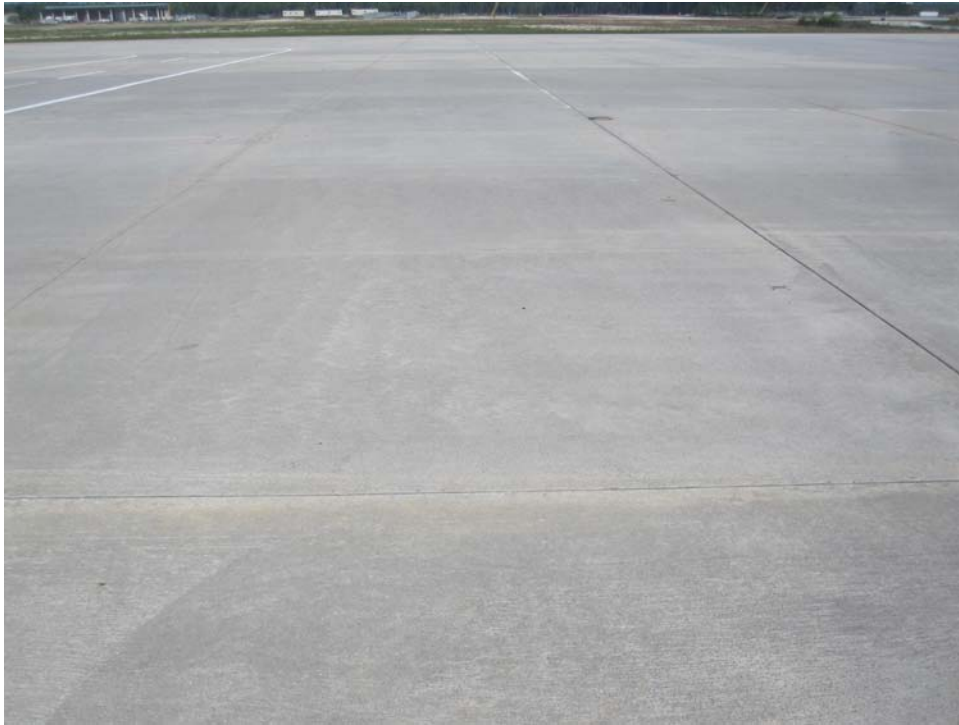
ATERMSV-20. Overview.

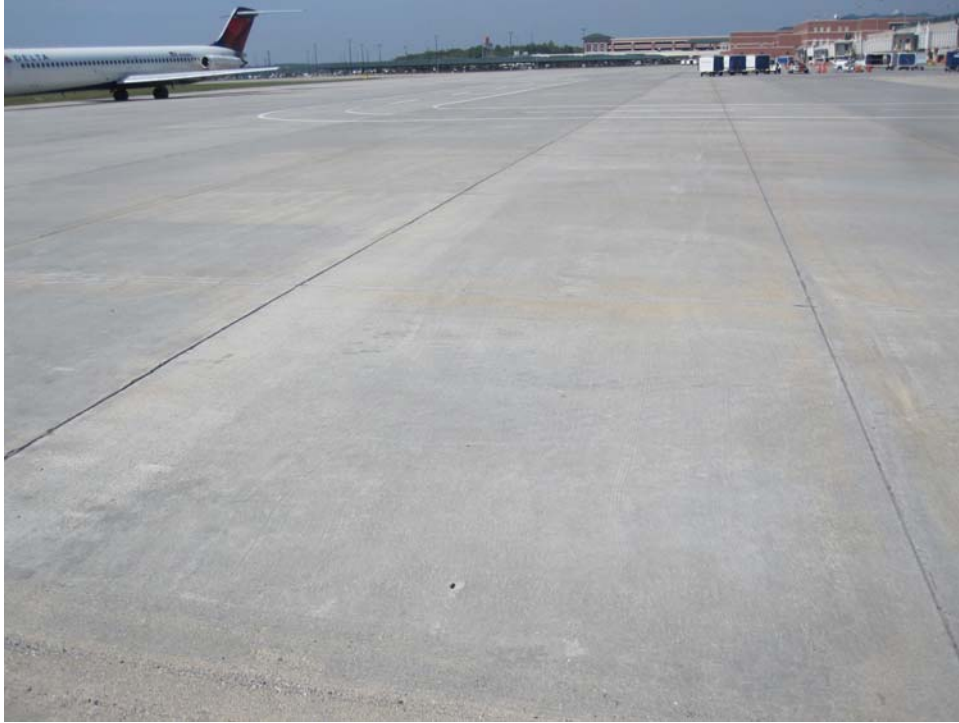
ATERMSV-30. Overview.

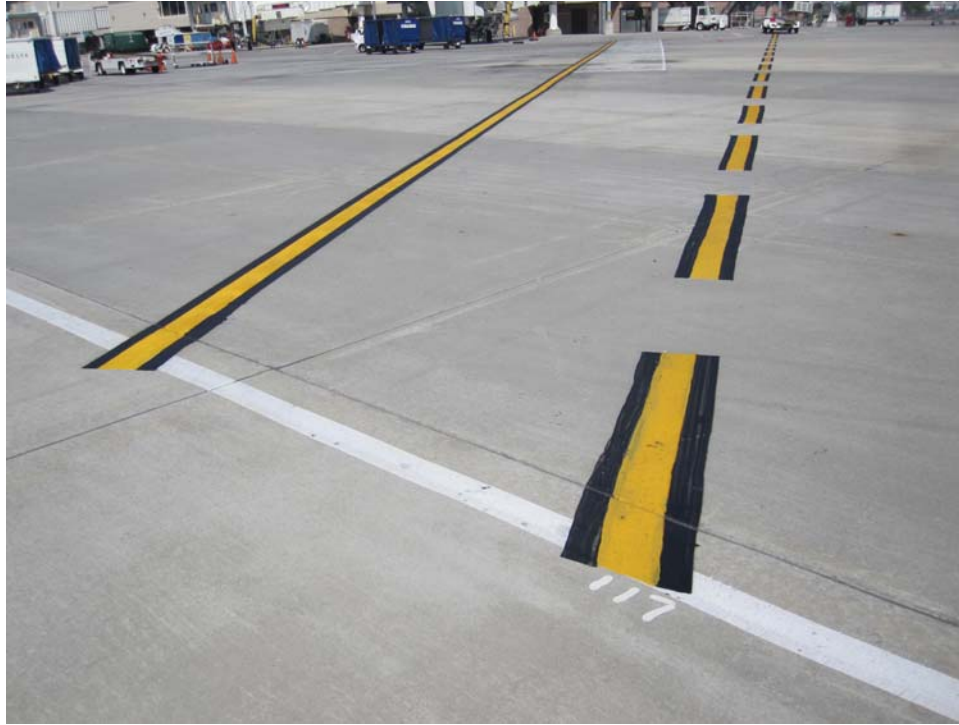
ATERMSV-30. Satisfactory Paint.

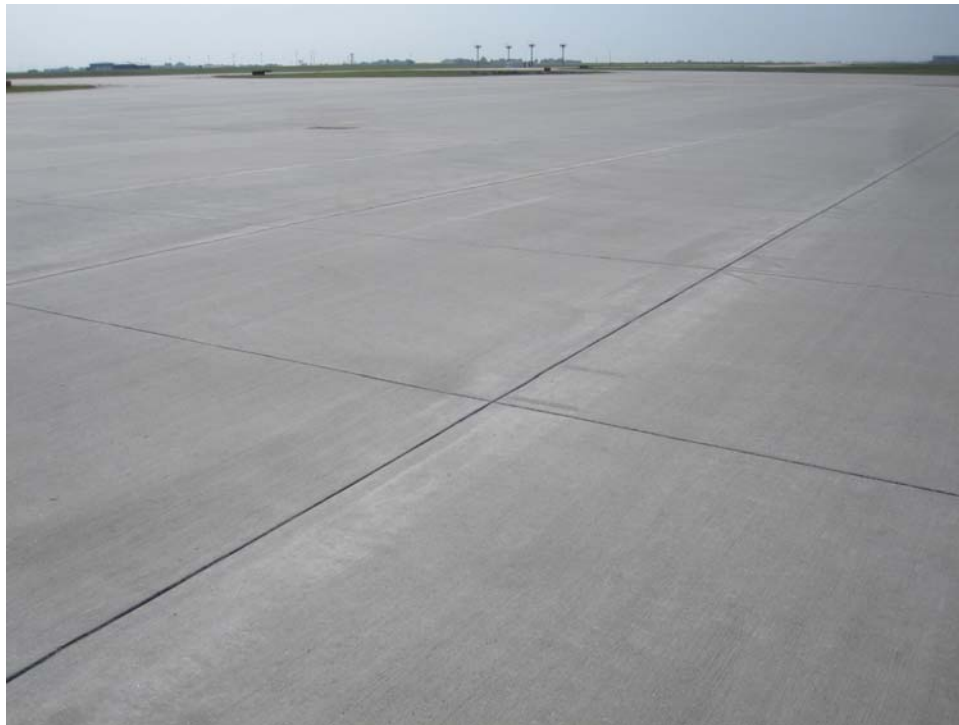
ATERMSV-40. Overview.

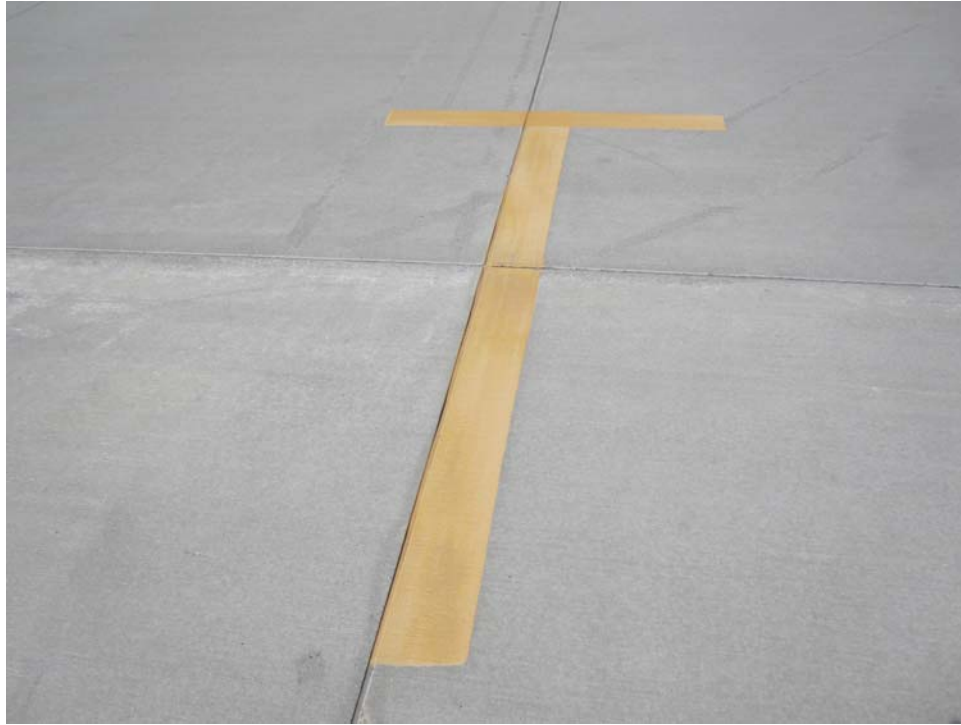
ATERMSV-40. Satisfactory Paint.

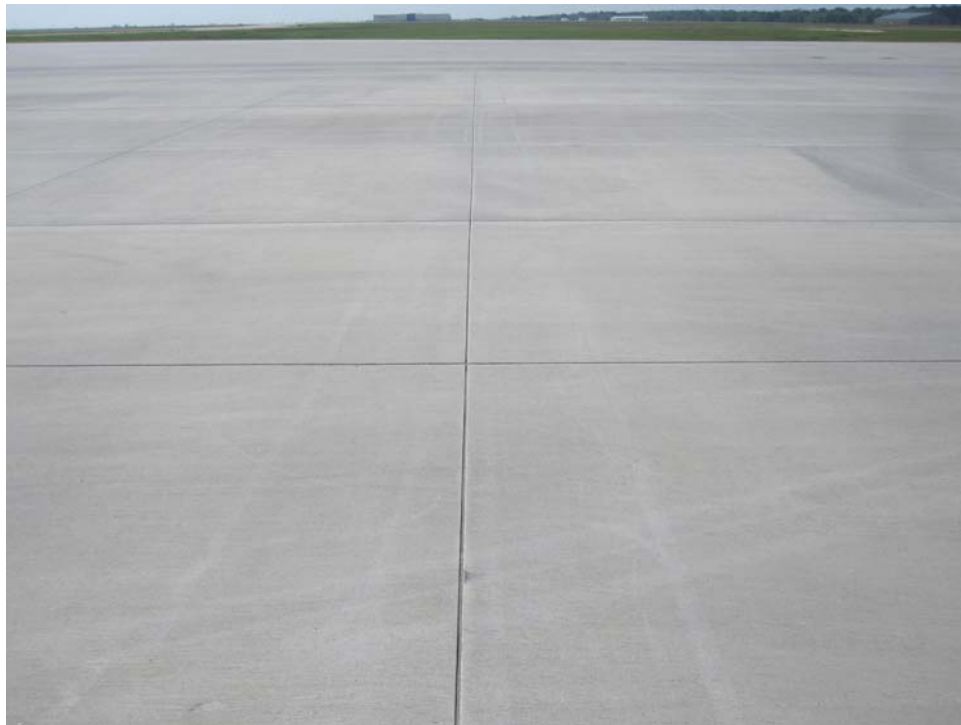
ATERMSV-50. Overview.

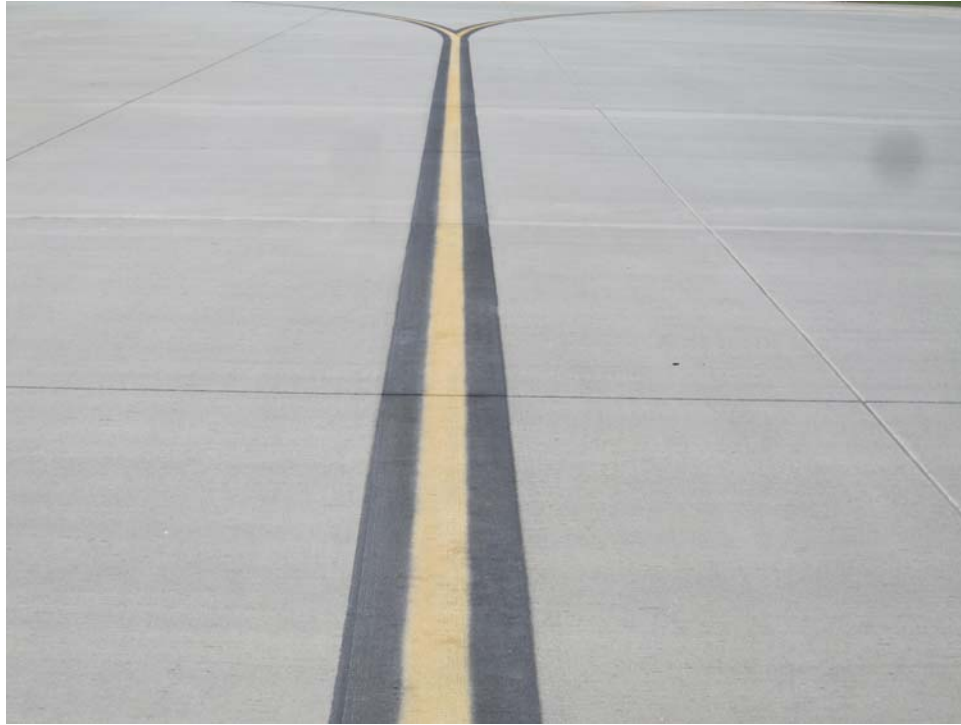
ATERMSV-50. Satisfactory Paint.

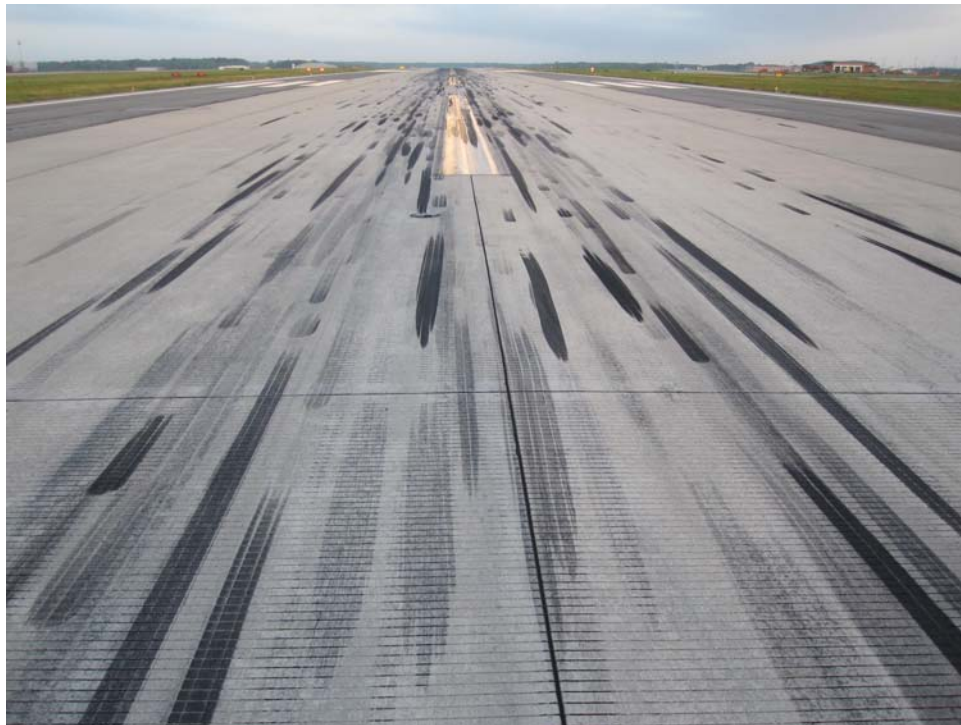
Runway 10-28 was defined by three sections. Section 10C consisted of the center PCC pavement and had a PCI value of 94. The majority of the joint sealant was in good condition. Small amounts of various severity small patching, low-severity large patching, shrinkage cracking, medium-severity joint spalling, and medium-severity corner spalling were also observed. An area with medium-severity joint seal damage and low-severity faulting was inspected as an additional sample unit according to PCI procedure. It was also noted that the intersection with Runway 1-19 had slightly higher deterioration with more patching and some high-severity joint seal damage.

R1028SV-10C. Overview.

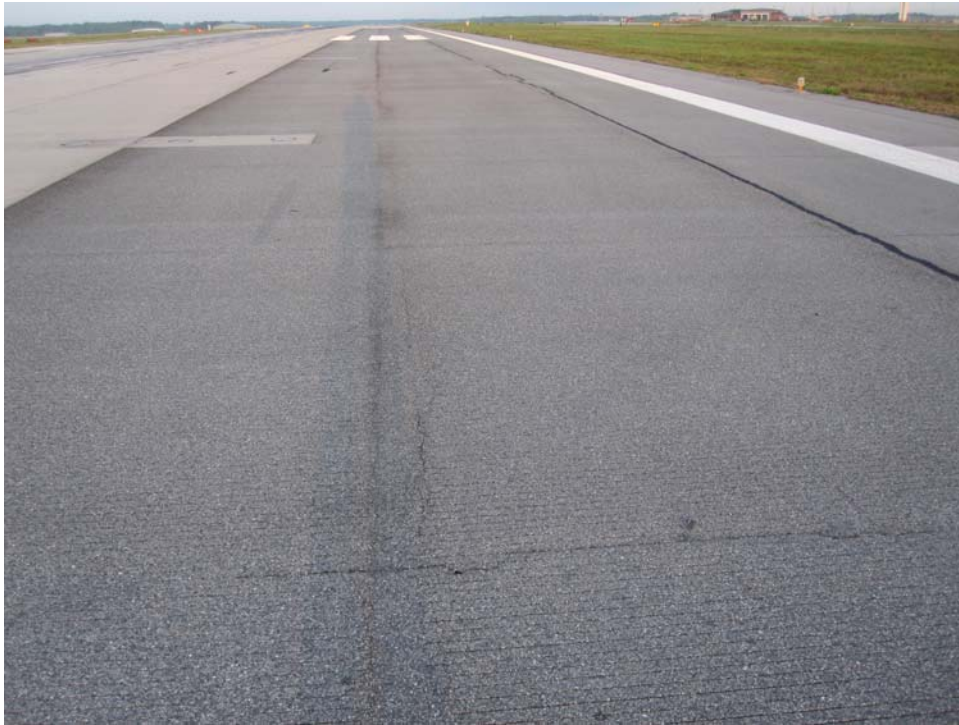
R1028SV-10N. Overview.

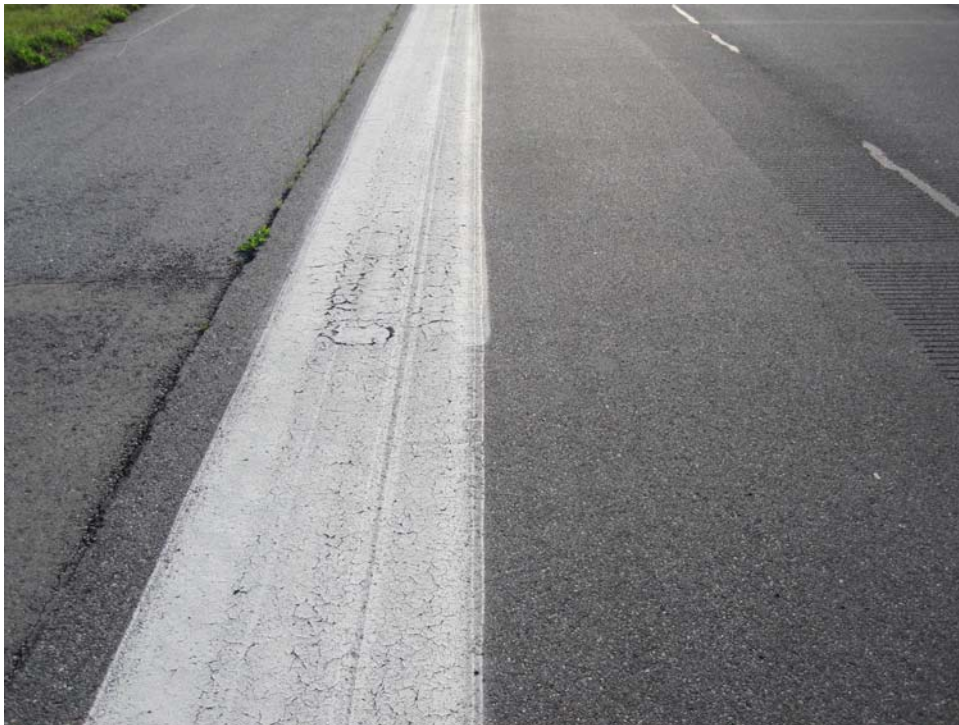
R1028SV-10N. Satisfactory Paint.

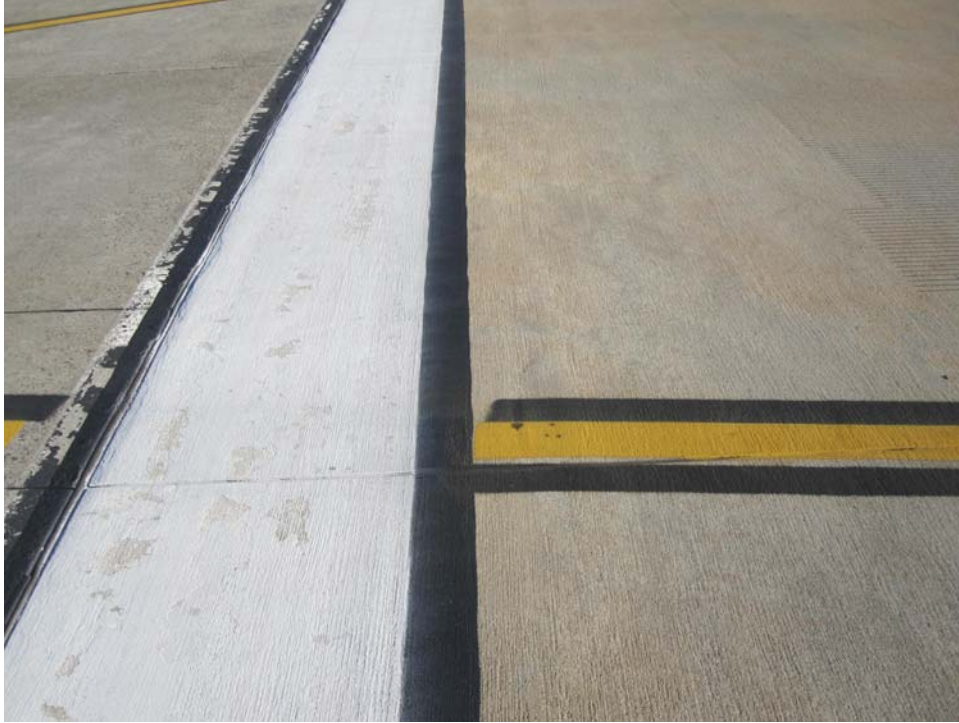
R119SV-20W. Joint Seal Damage (Sample Unit #01).

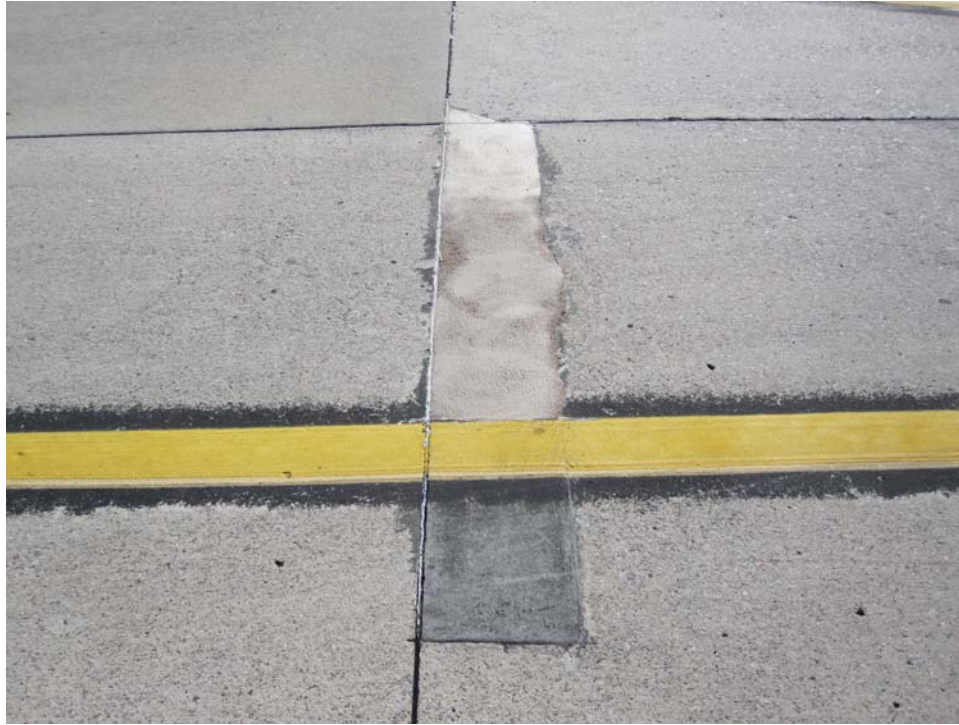
TASV-40. Large Patching (Sample Unit #09).

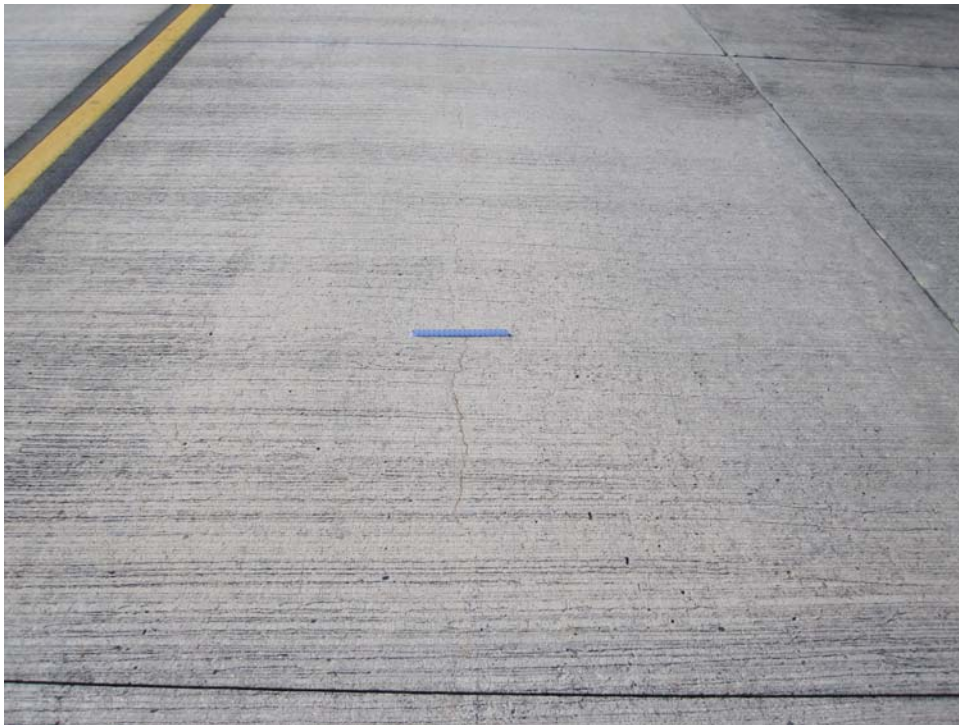
TBSV-20. ASR (Sample Unit #02).

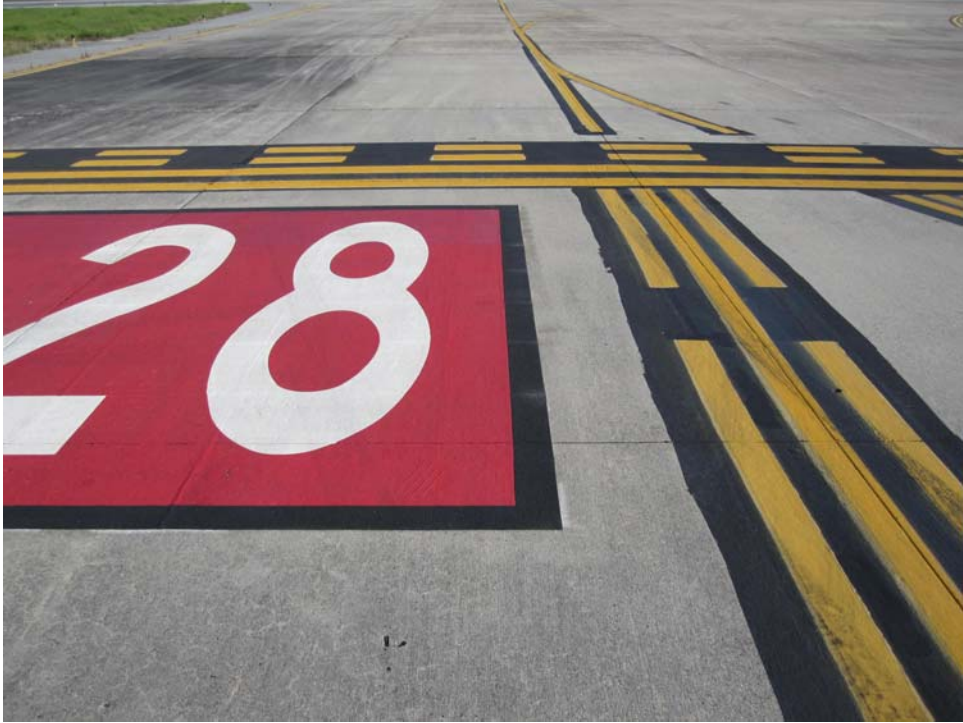
TC1SV-10. Longitudinal and Transverse Cracking (Sample Unit #25).

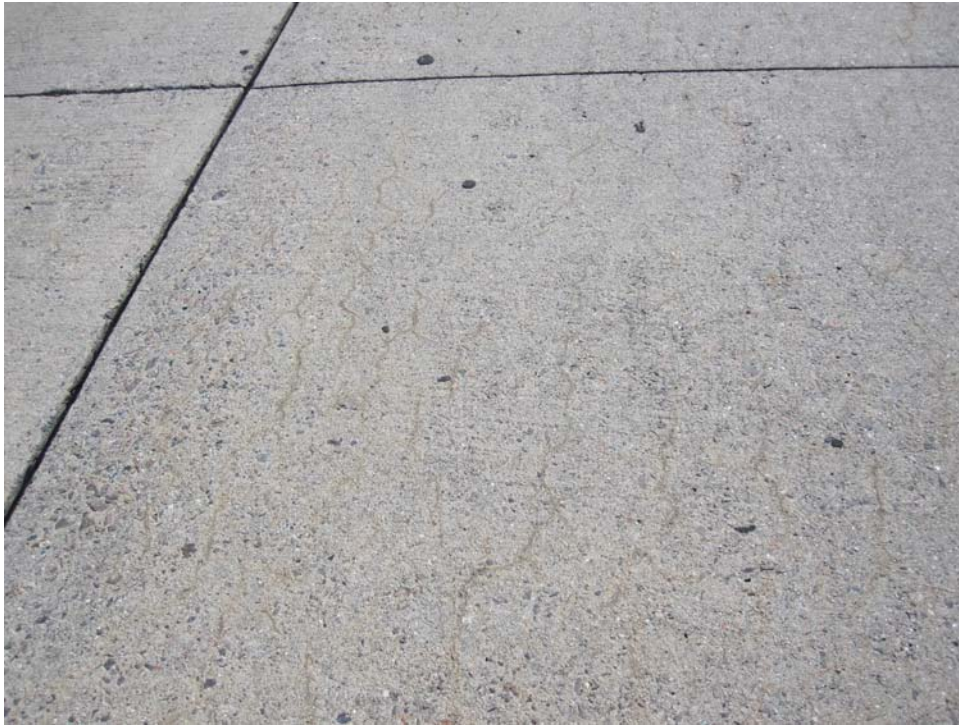
TCSV-40. ASR (Sample Unit #15).

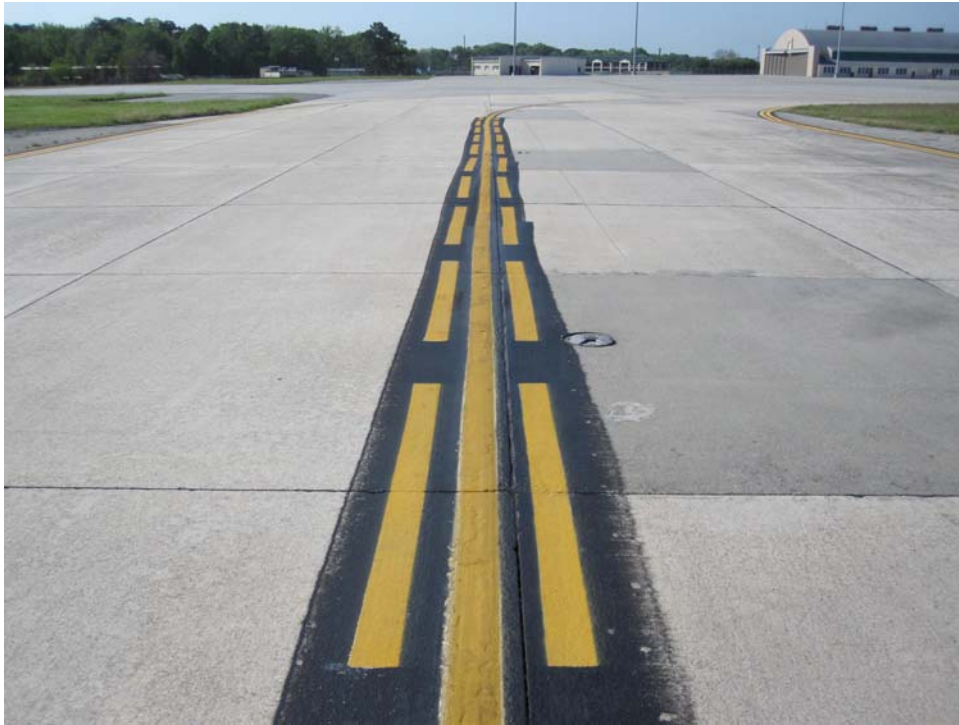
TCSV-60. Overview.

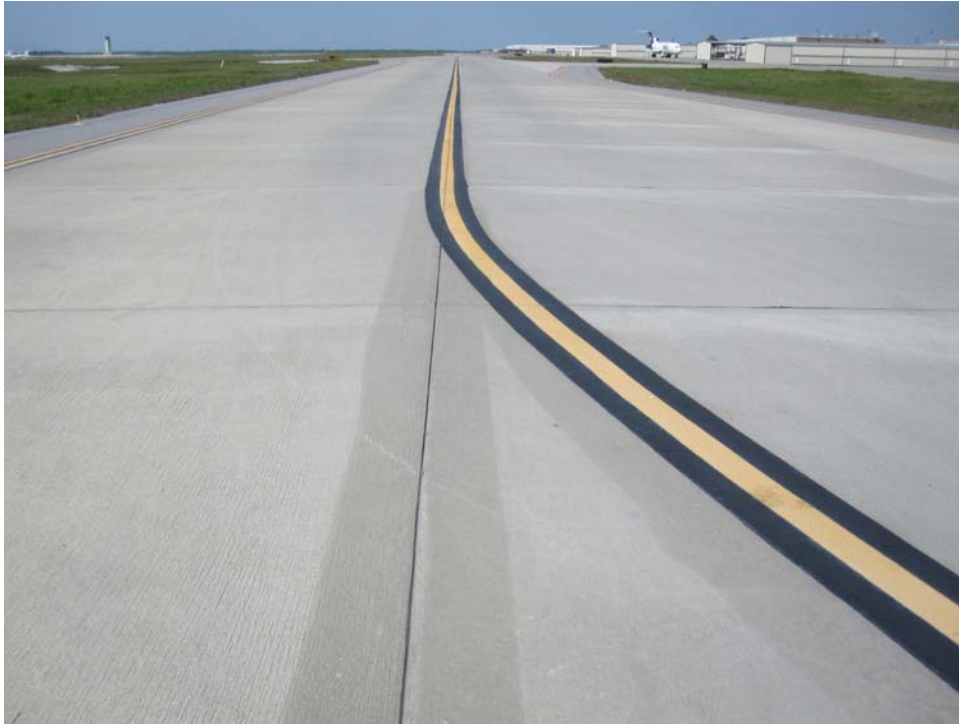
TDSV-10. Overview.

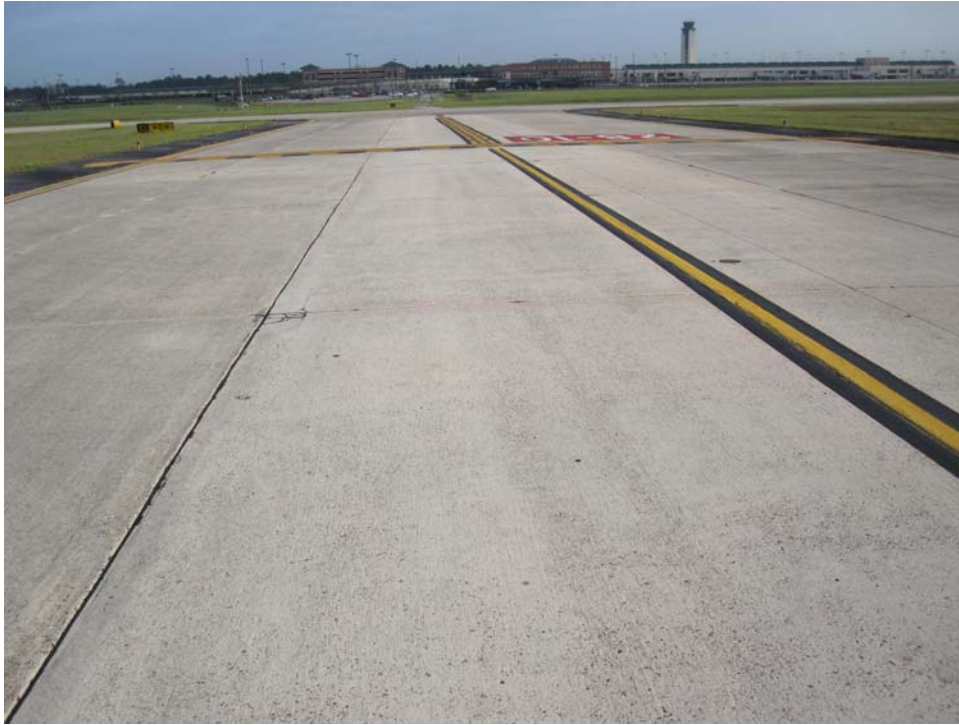
TE1SV-10. Overview (1).

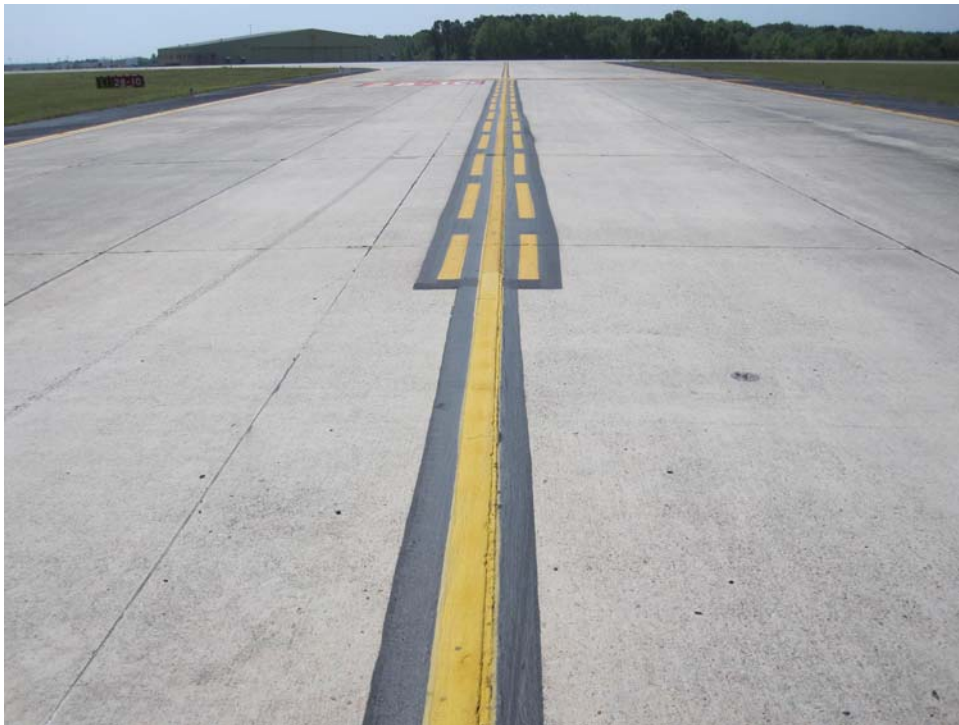
TE1SV-10. Overview (2).
