# 2012 Savannah-Hilton Head International Airport Pavement Management Plan

# SAVANNAH-HILTON HEAD INTERNATIONAL AIRPORT

## PAVEMENT MANAGEMENT REPORT

**DECEMBER 2012**

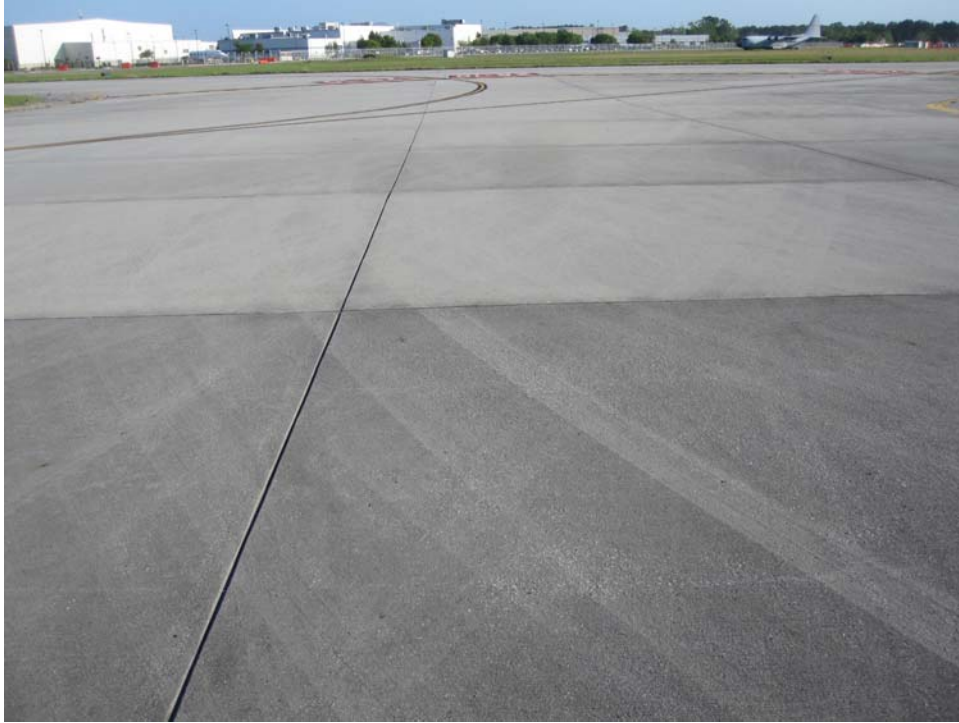
TE2SV-10. Overview.

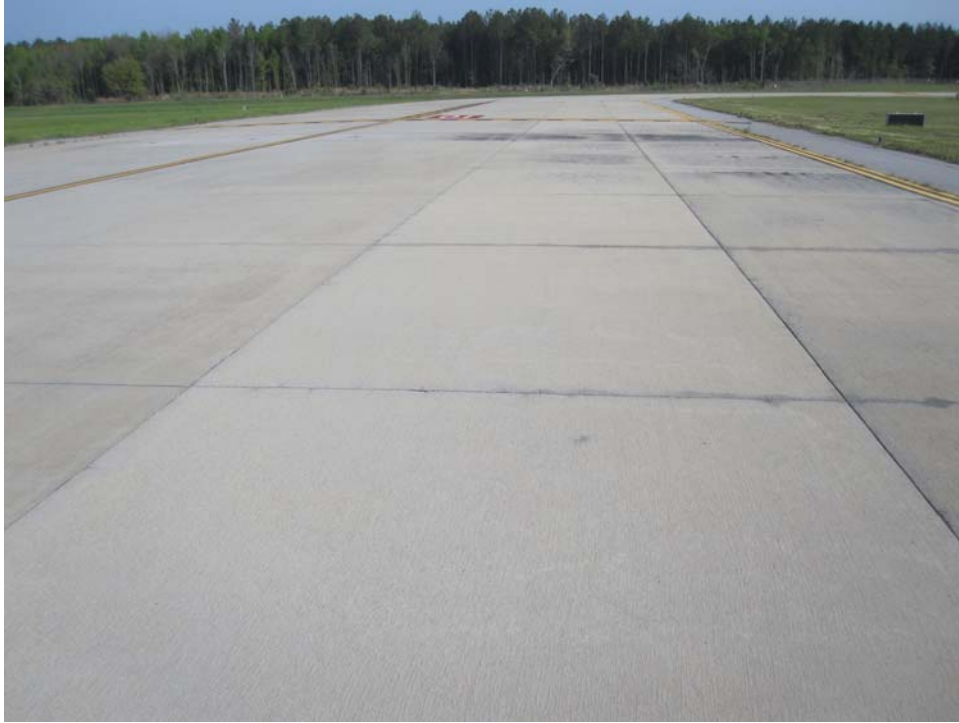
TESV-10. Overview (1).

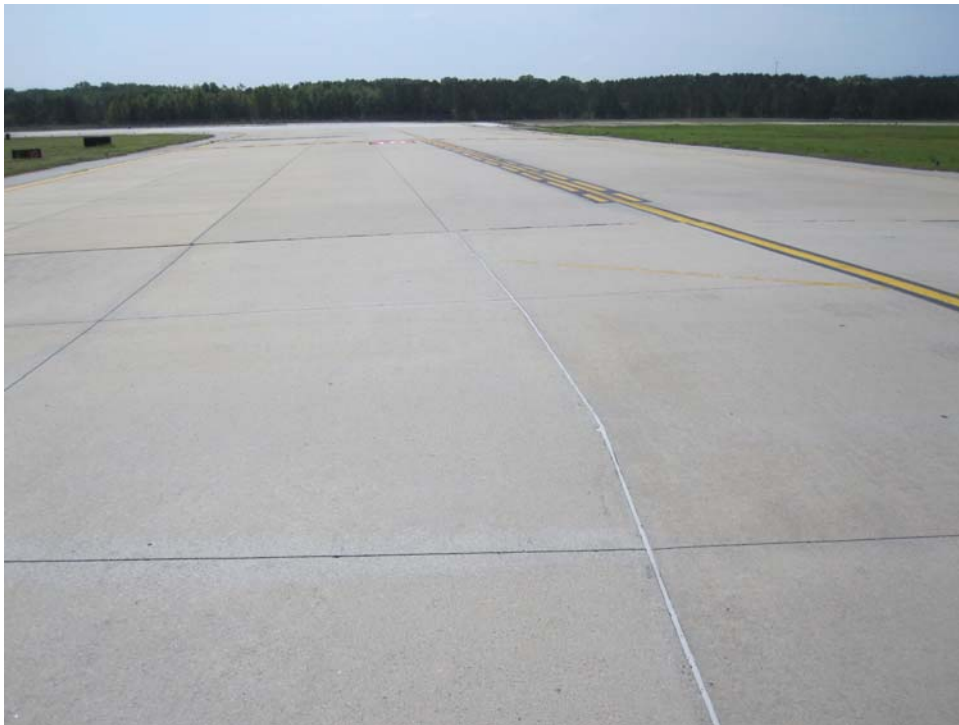
TESV-10. Overview (2).

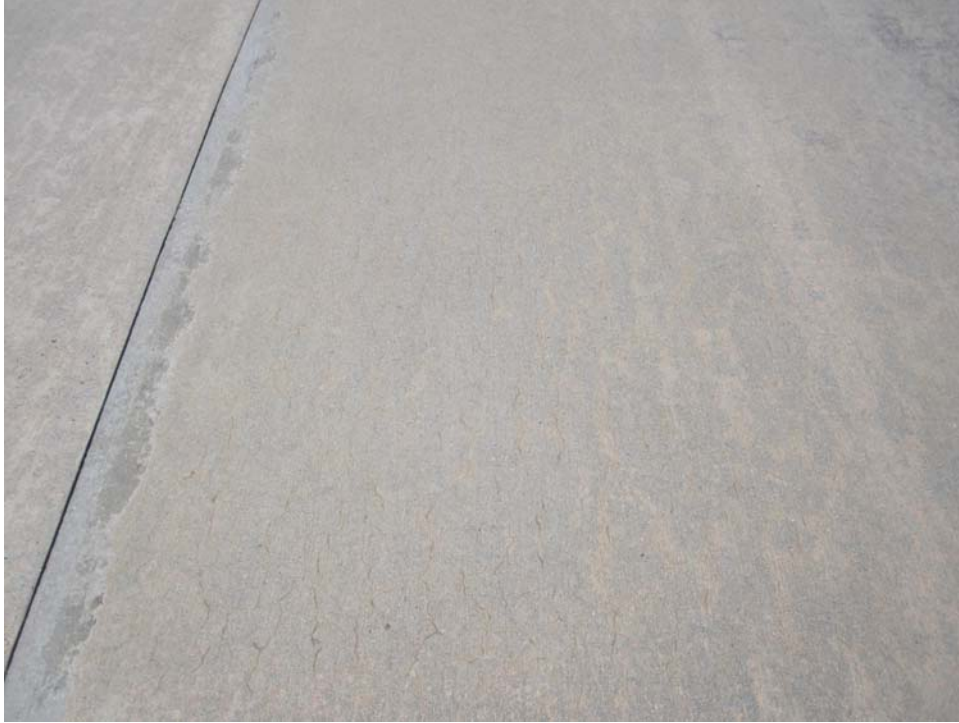
TESV-10. ASR (Sample Unit #39).

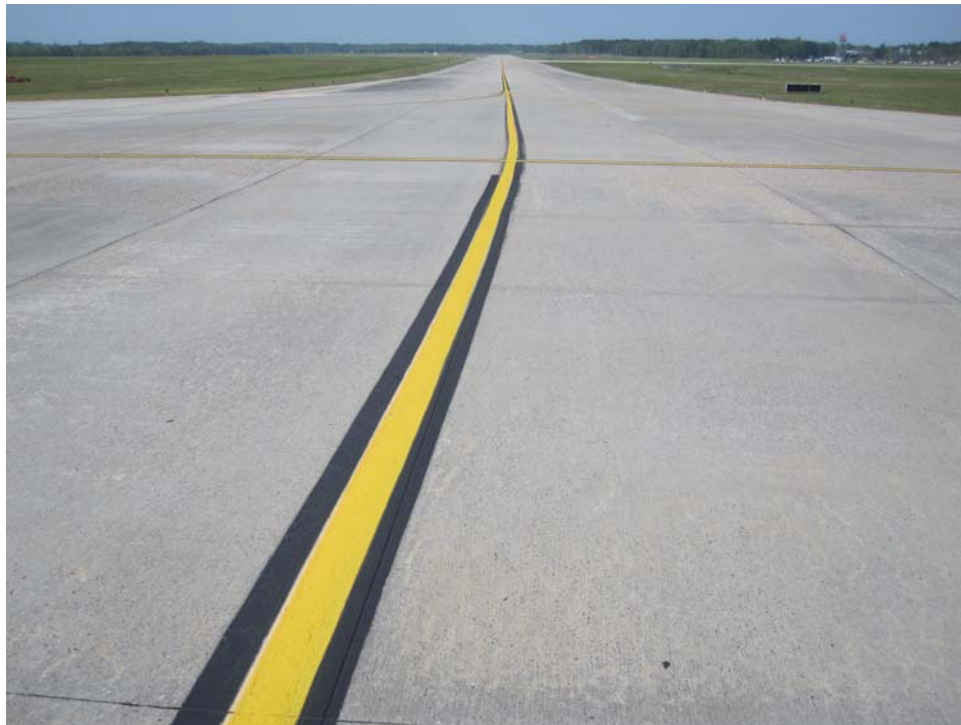
TESV-20. Overview.

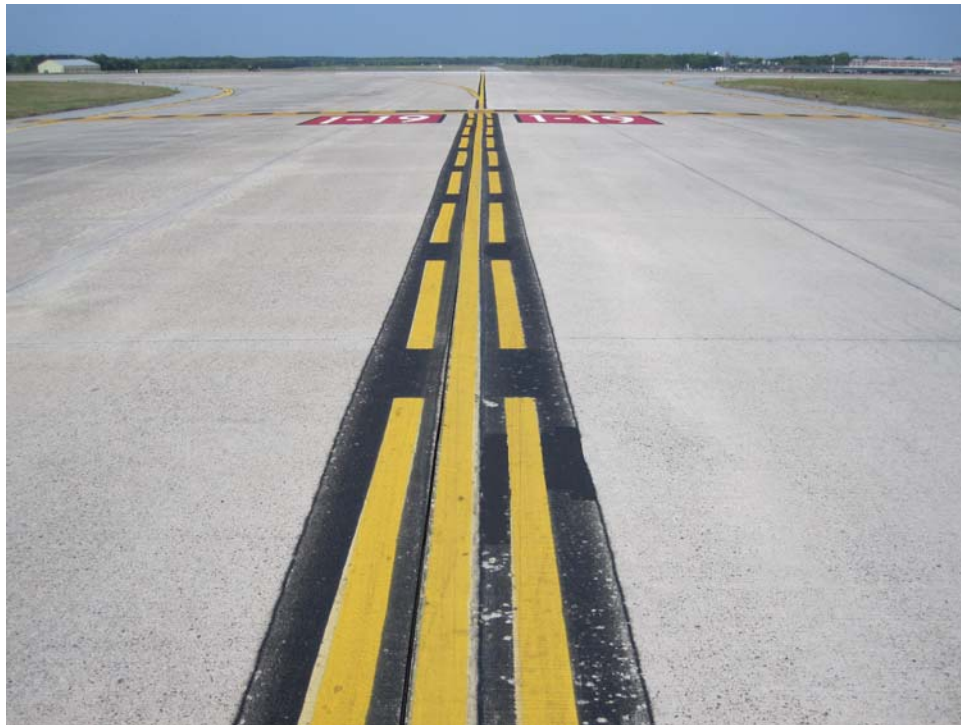
TESV-30. Overview.

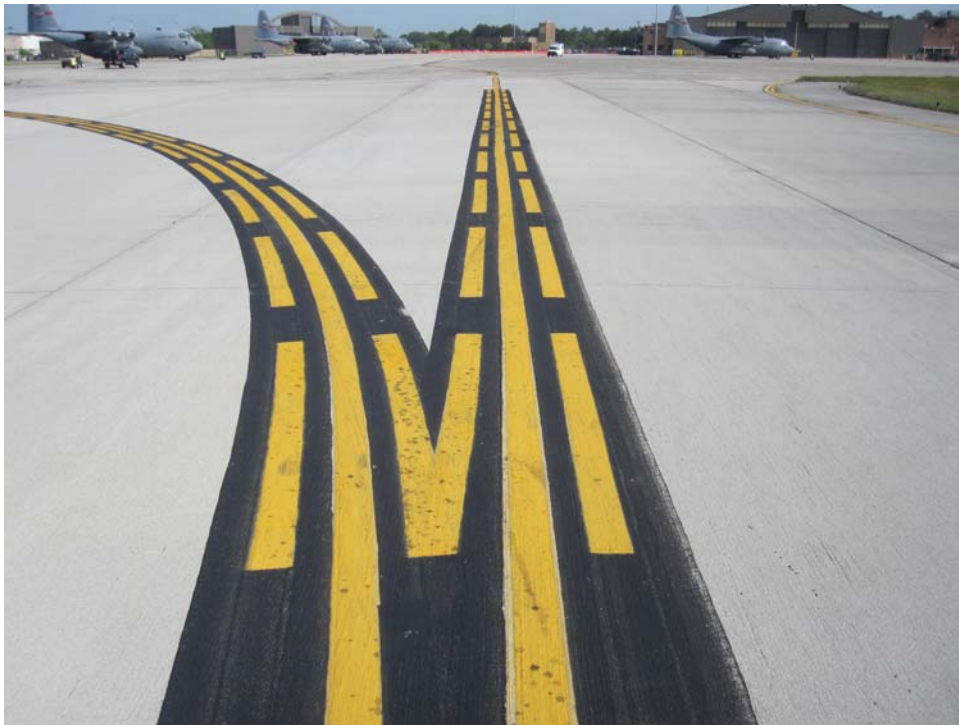
TESV-40. Overview.

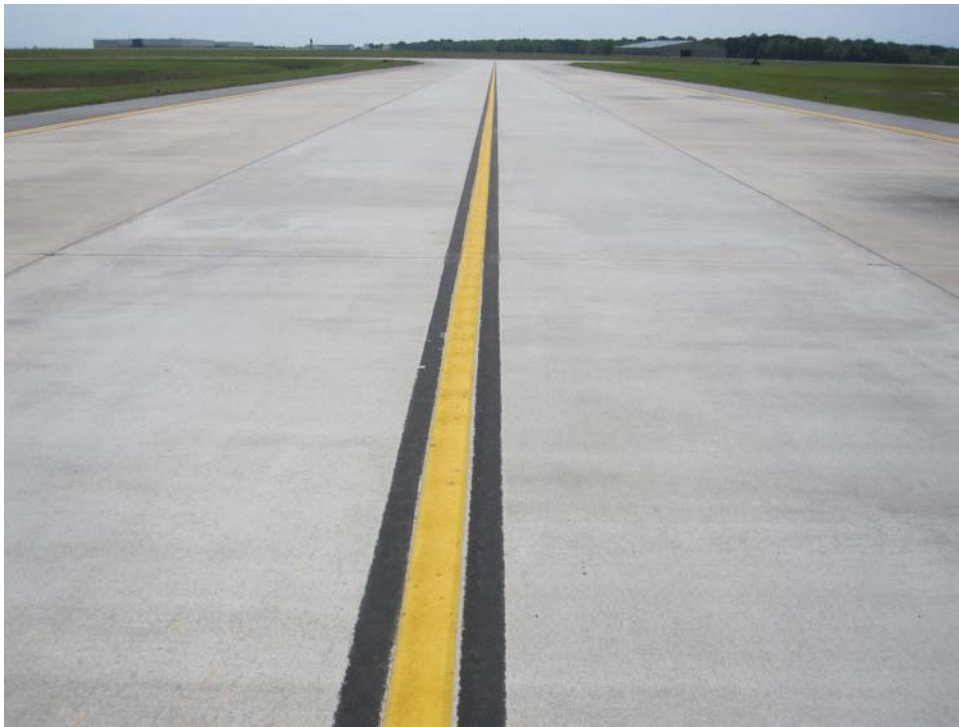
TFSV-10. Overview.

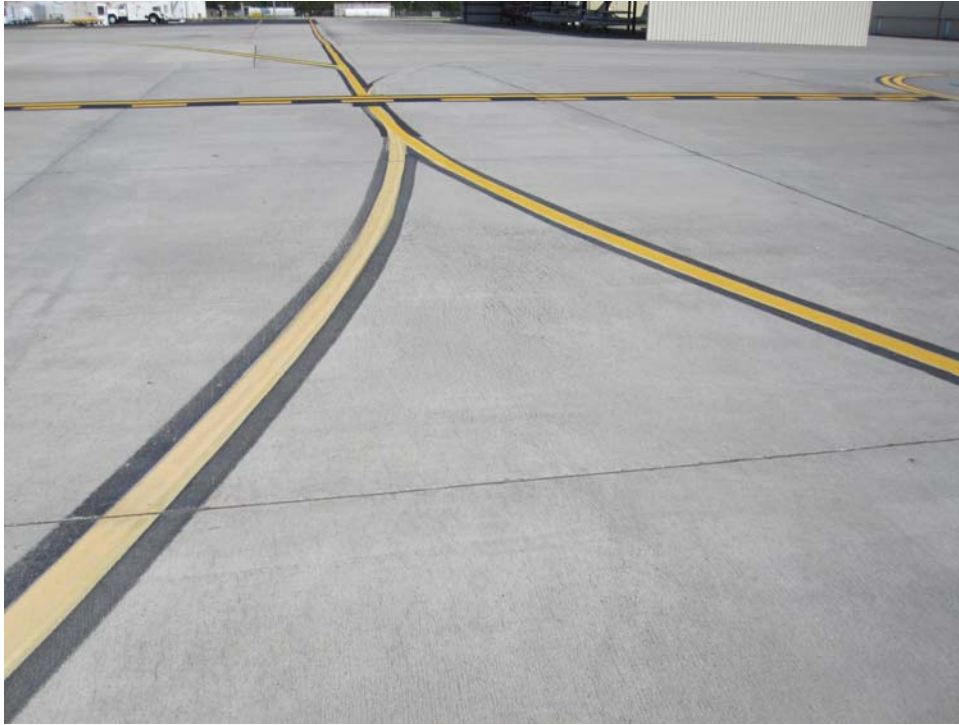
TGA1SV-10. Overview.

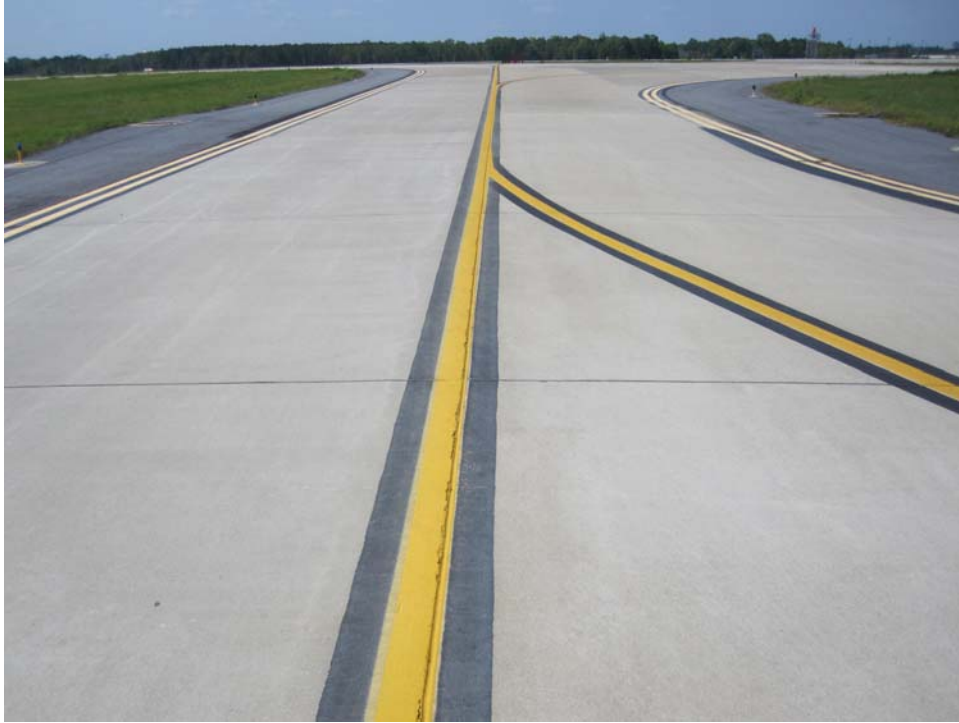
TGA4SV-10. Overview.

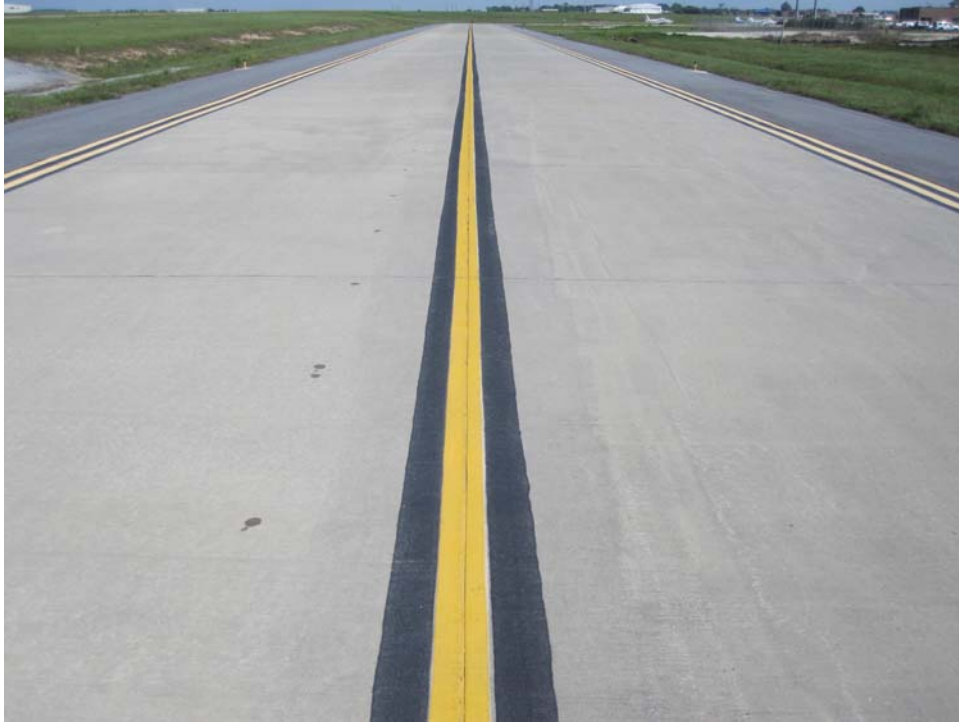
TGA4SV-20. Overview.

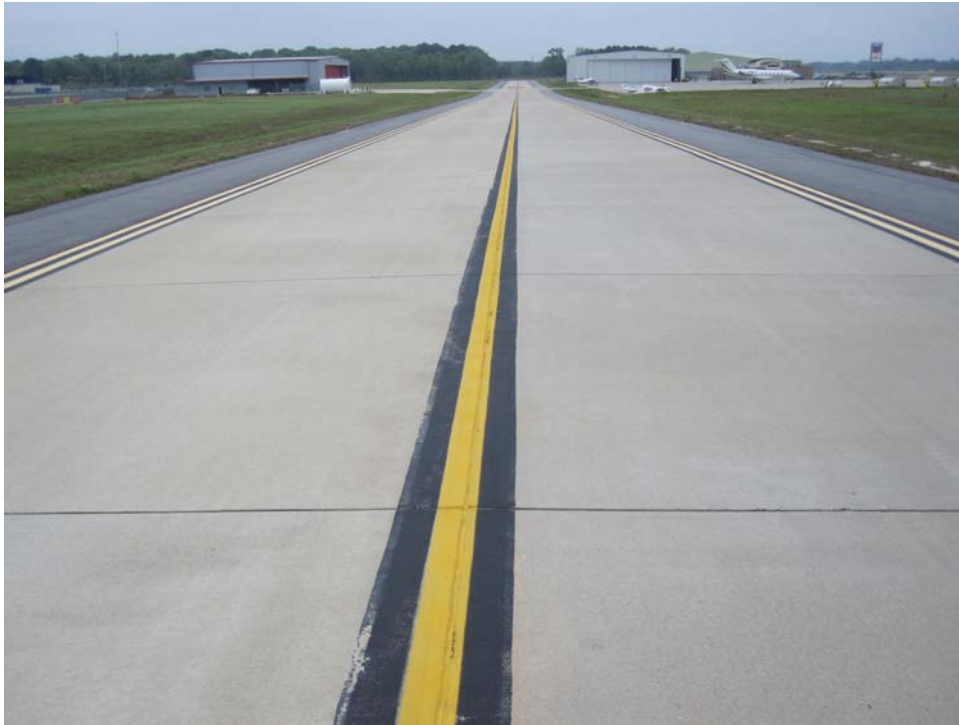
TGA5SV-10. Overview.

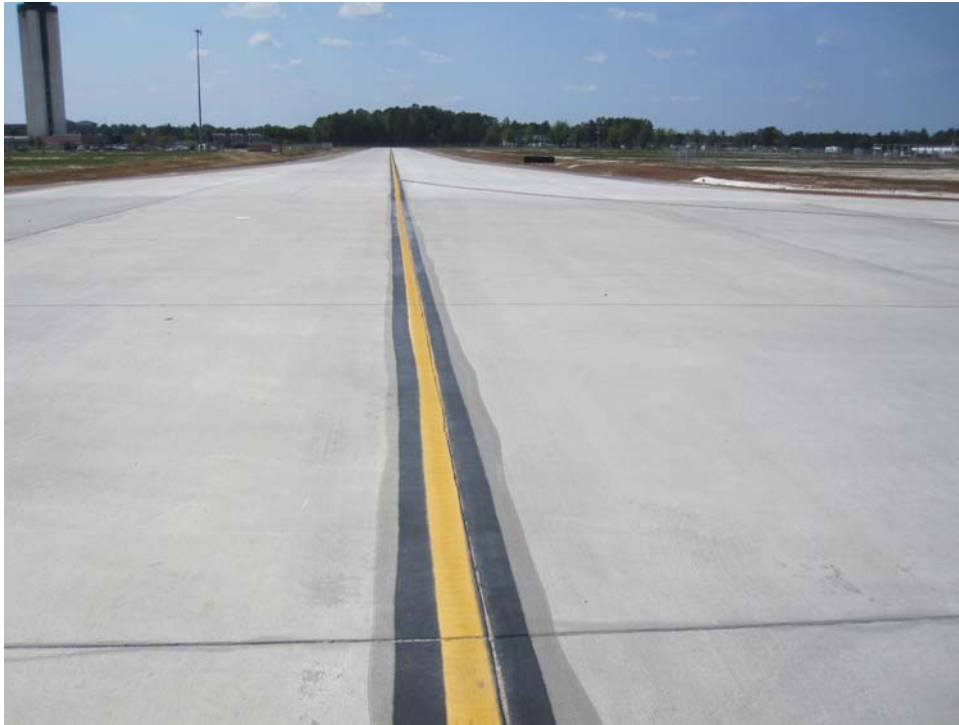
TGA6SV-10. Overview.
