# 2012 Valdosta Regional Airport Pavement Management Plan

# VALDOSTA REGIONAL AIRPORT

## PAVEMENT MANAGEMENT REPORT

**DECEMBER 2012**

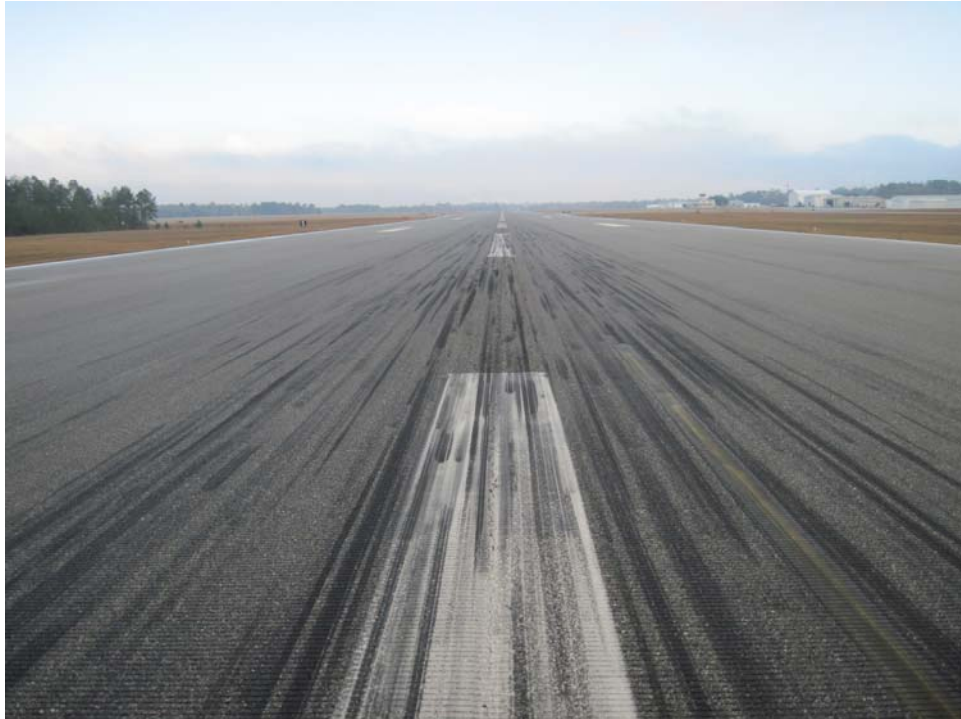
R1735VL-10. Overview.

Runway 17-35 was defined by two sections. Section 10 had a PCI of 84 with moderate quantities of low-severity L&T cracking and a small amount of medium-severity L&T cracking observed. Small amounts of low- and medium-severity weathering were also identified. In accordance with ASTM D5340, two additional sample units were recorded that contained low-severity patching. Section 20 was in excellent condition with a PCI of 97. Only a small amount of low-severity L&T cracking was noted. In both sections on this runway, most of the L&T cracking was observed at the paving lane joints.

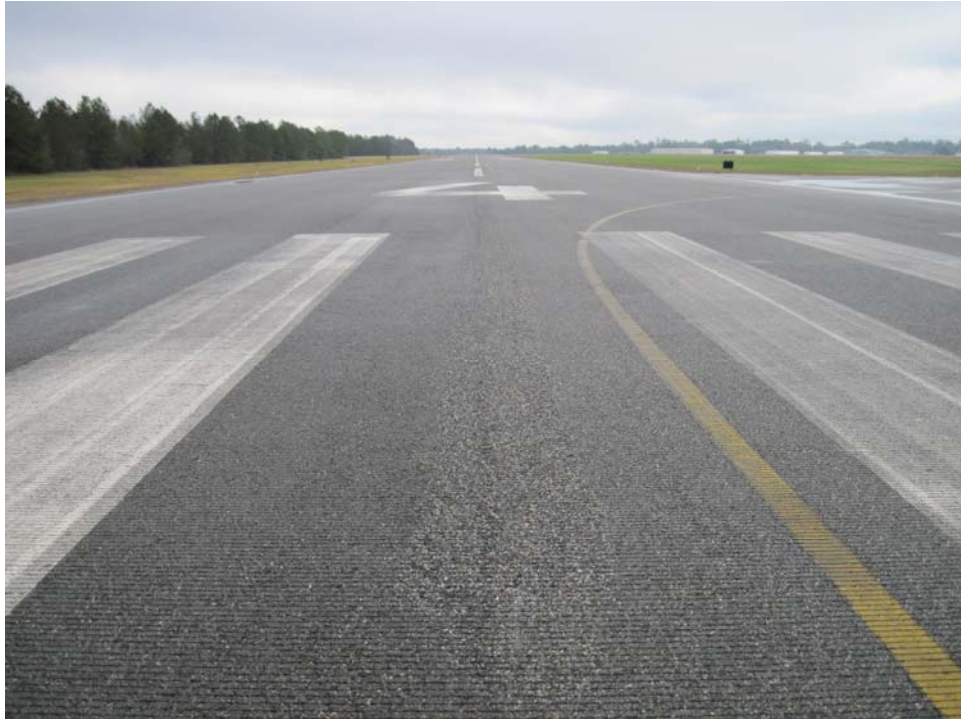
R422VL-10. Overview.

Runway 4-22 contained one section with a PCI value of 92. Moderate amounts of low-severity L&T cracking and weathering were recorded along with small amounts of bleeding and medium-severity weathering. At the south end of the runway, an area of depression was noted which was not deep enough to be recorded.

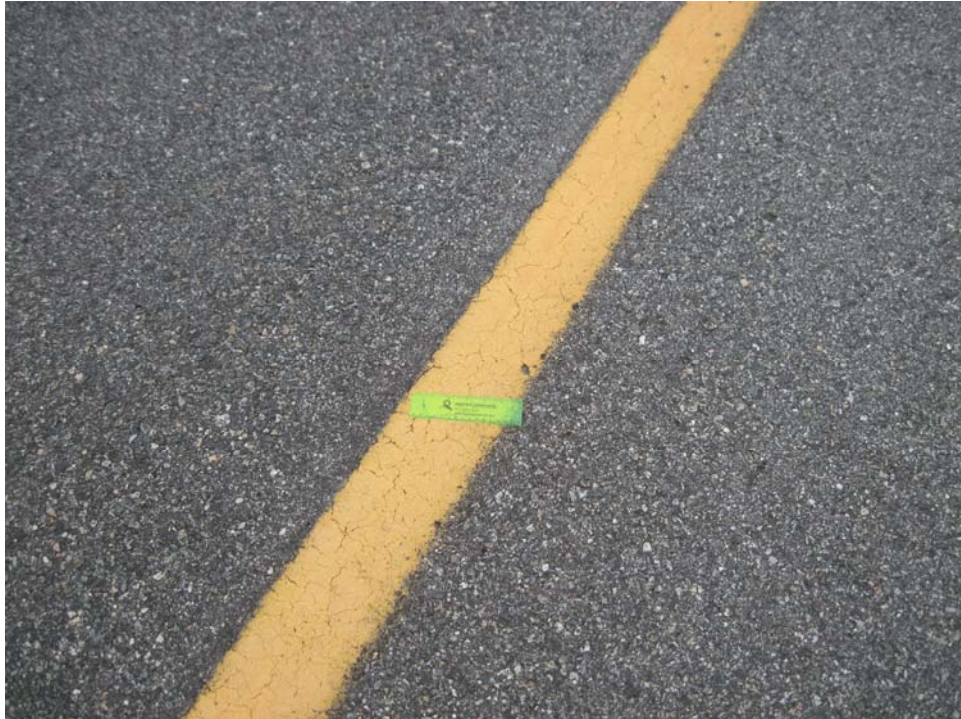
TAVL-10. Satisfactory Paint.

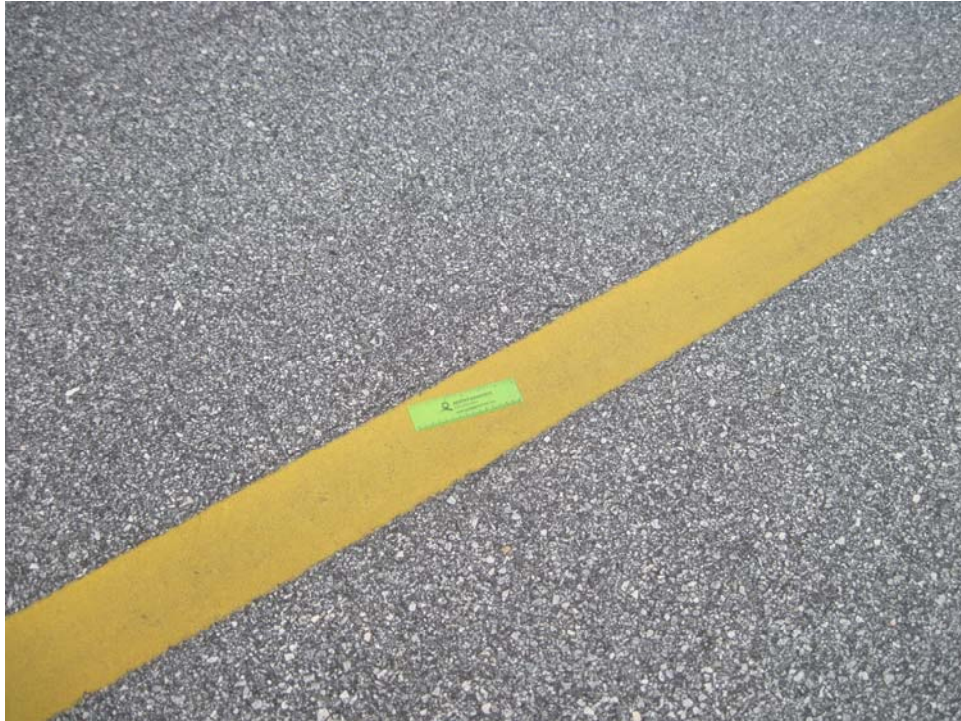
TAVL-20. Satisfactory Paint.

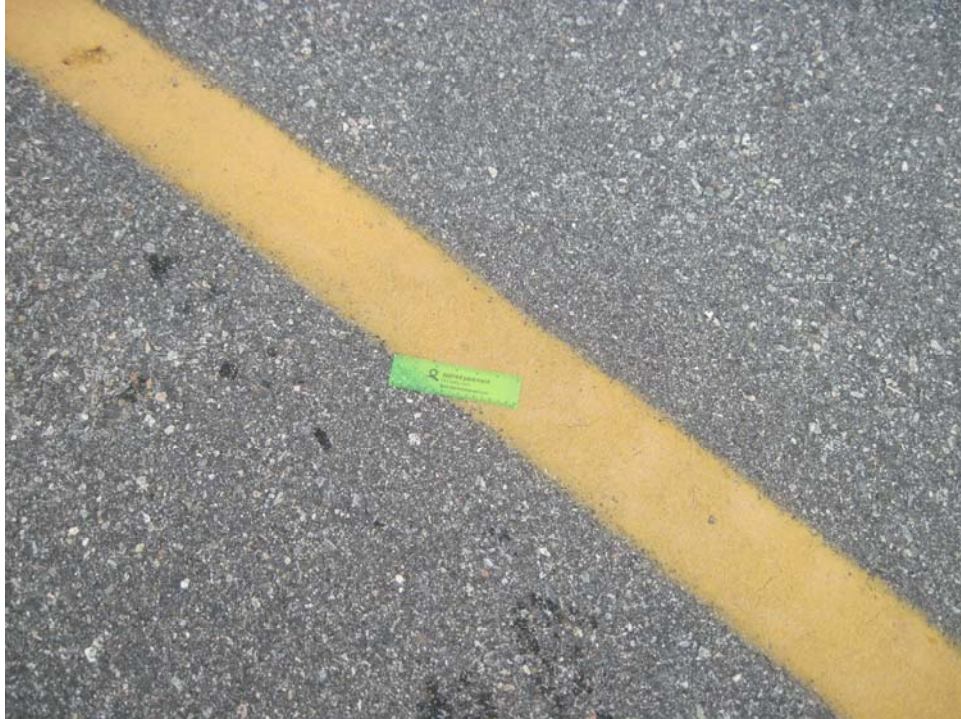
TLVL-10. Satisfactory Paint.
