2012 Athens-Ben Epps Field Pavement Management Plan

ATHENS-BEN EPPS FIELD

PAVEMENT MANAGEMENT REPORT

DECEMBER 2012

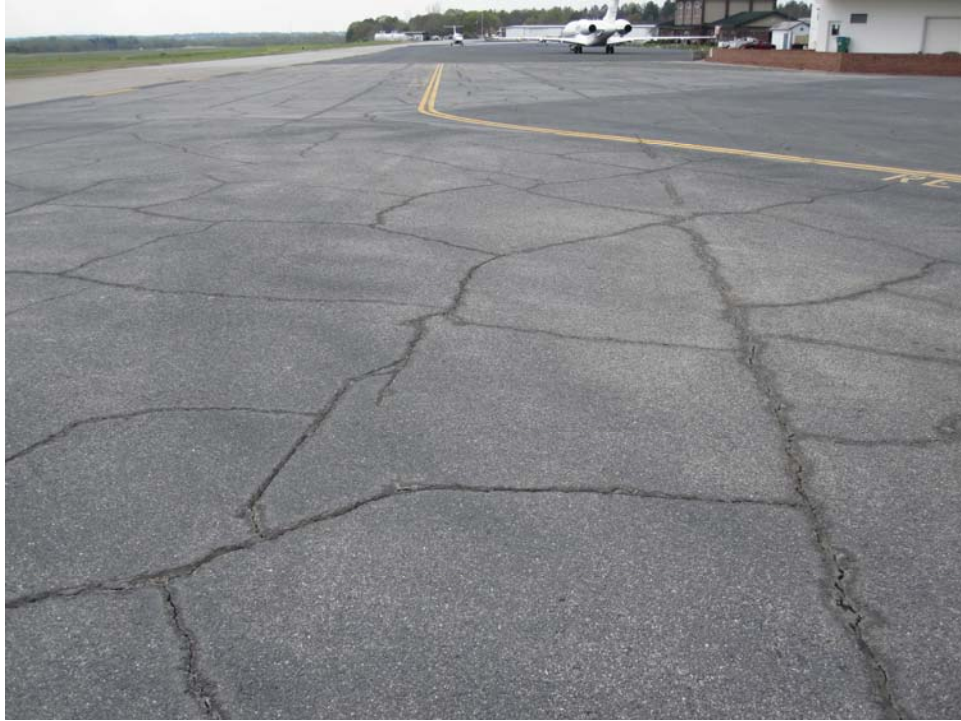
A01AT-10. Overview.

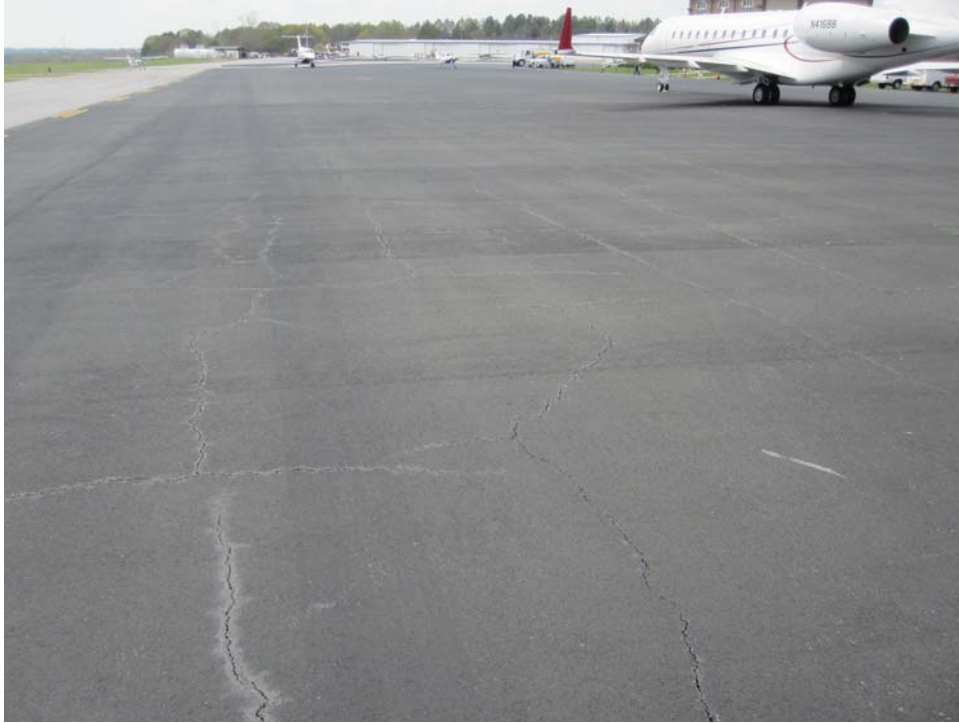
A01AT-20. Overview.

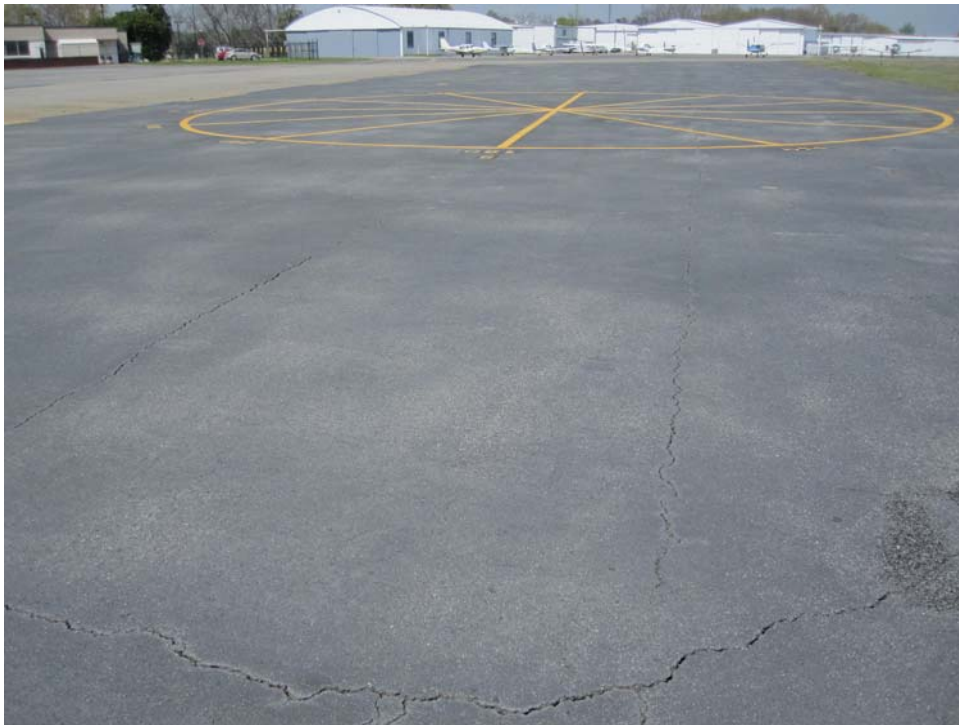
A01AT-30. Overview.

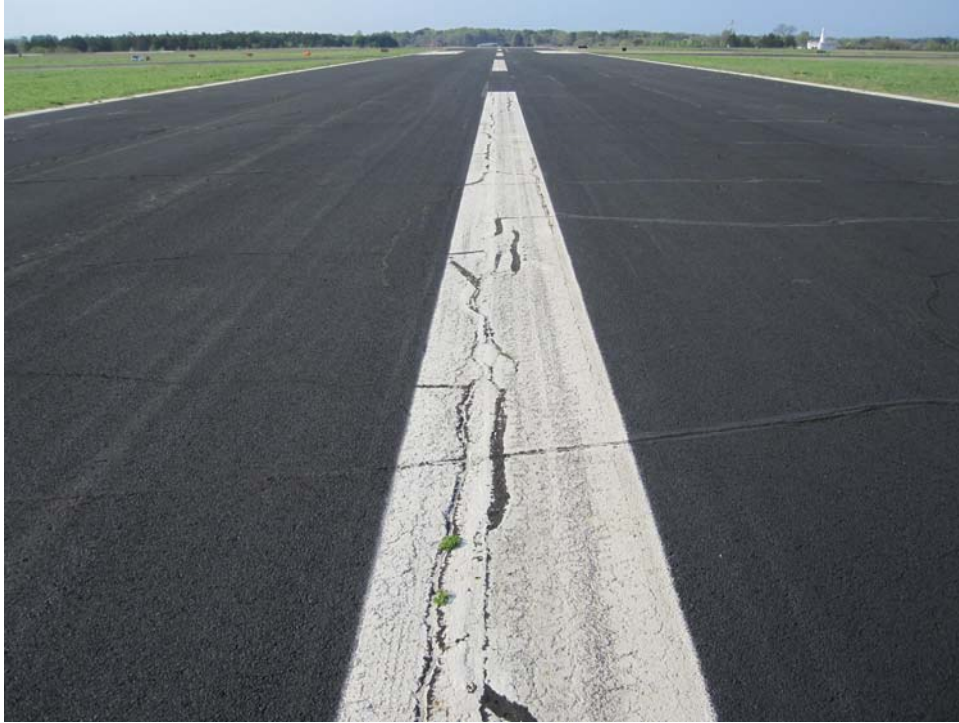
R220AT-10. Overview.

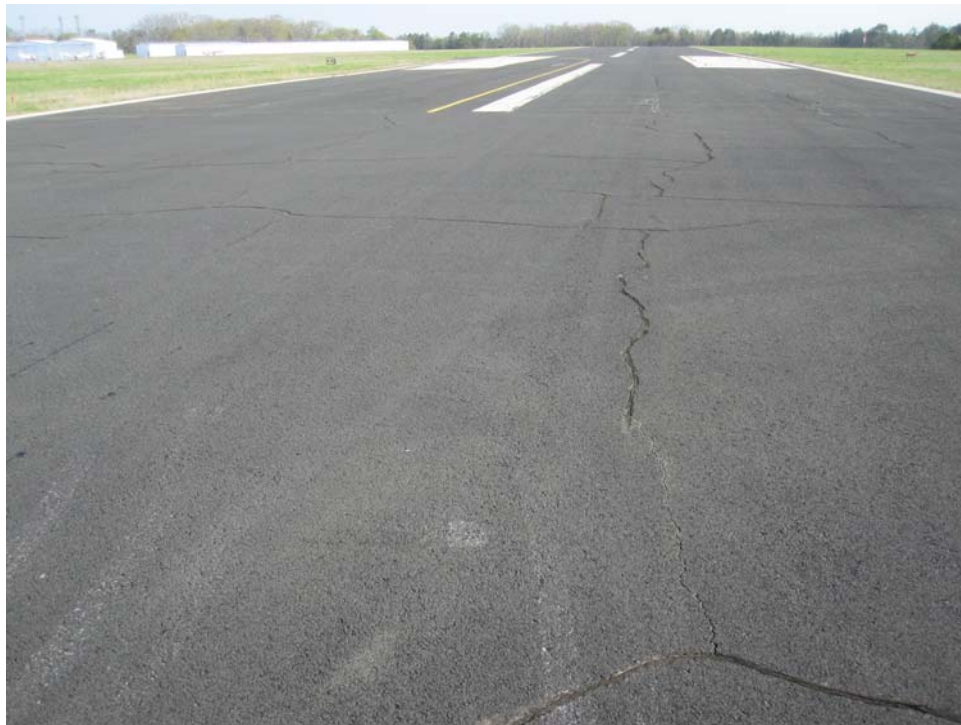
R220AT-20. Overview.

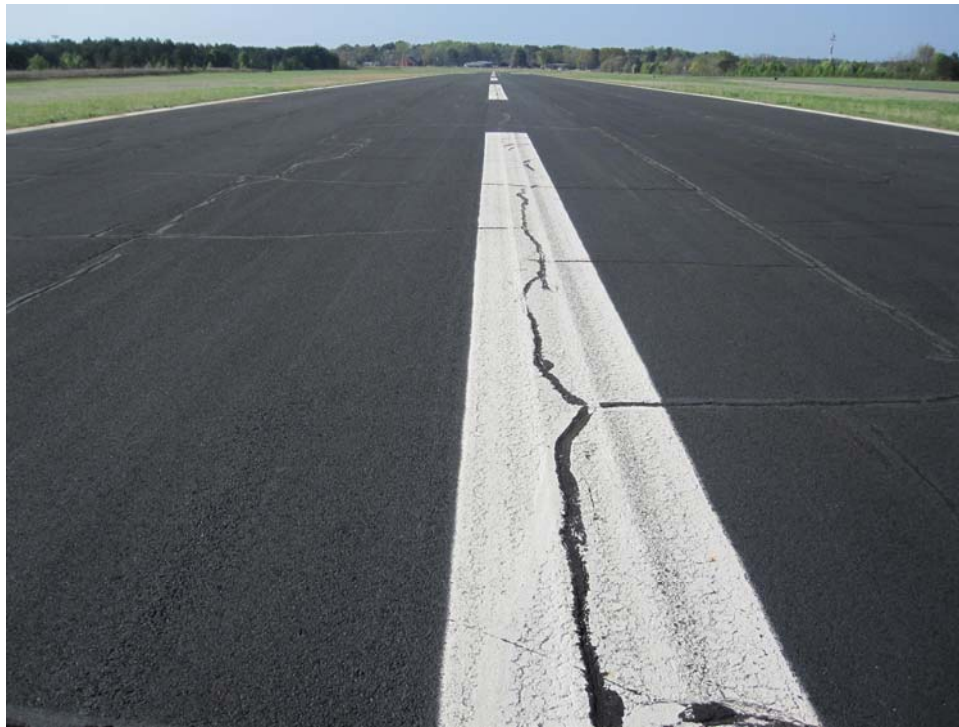
R220AT-30. Overview.

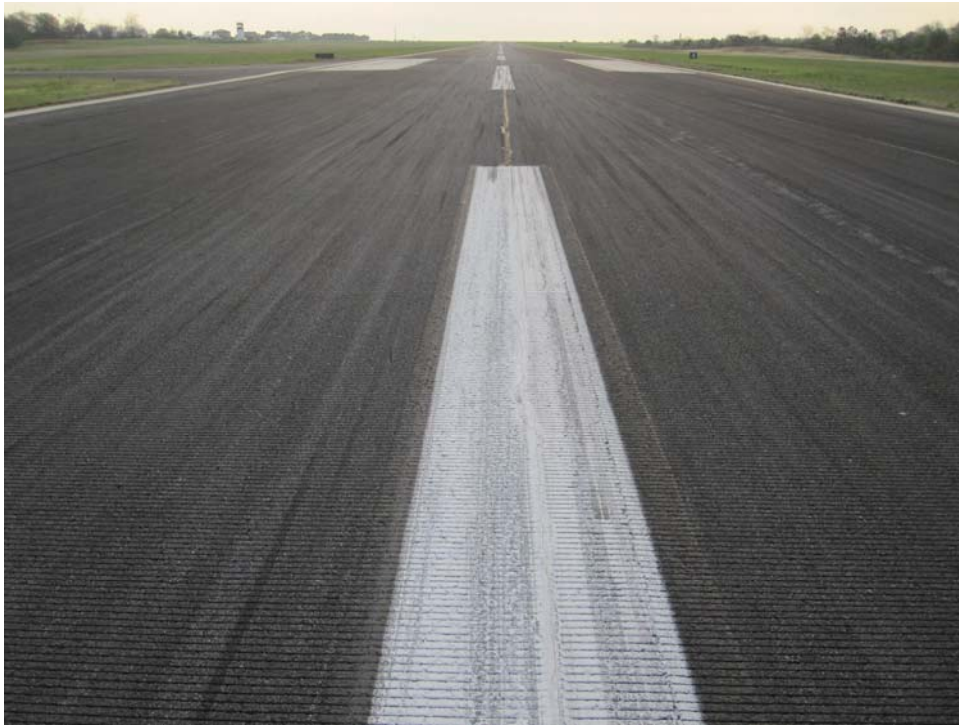
Runway 9-27 consisted of two sections. Section 10 had a PCI value of 60. The primary distress identified in this section was medium-severity L&T cracking along with smaller quantities of low-severity L&T cracking and alligator cracking. Section 20 had a PCI value of 80. Low- and medium-severity L&T cracking were recorded throughout this section.

R927AT-10. Overview.

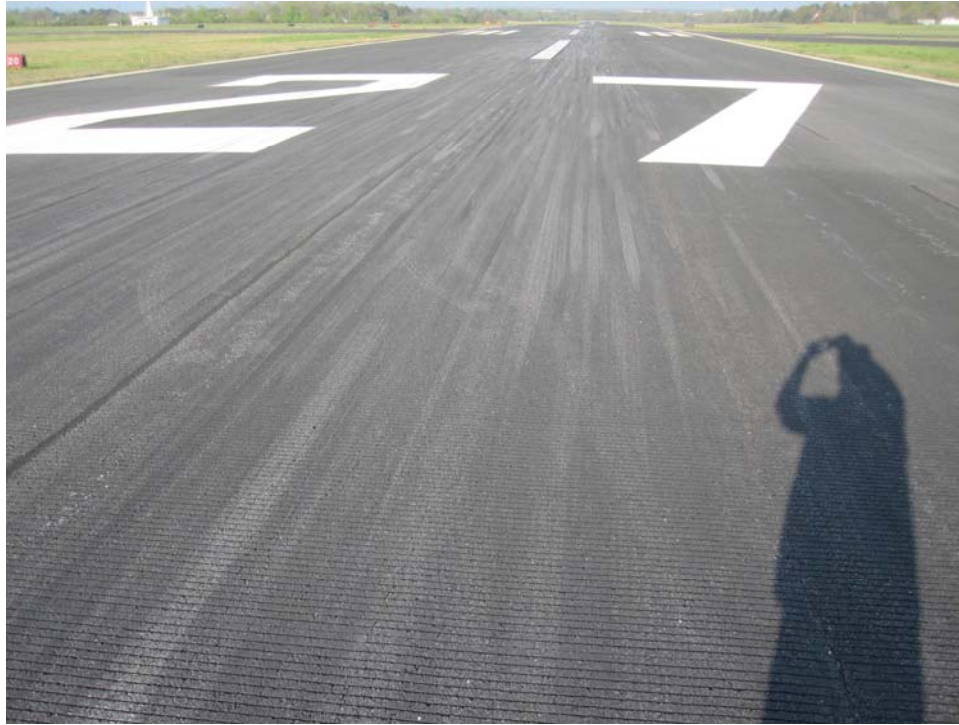
R927AT-20. Overview.

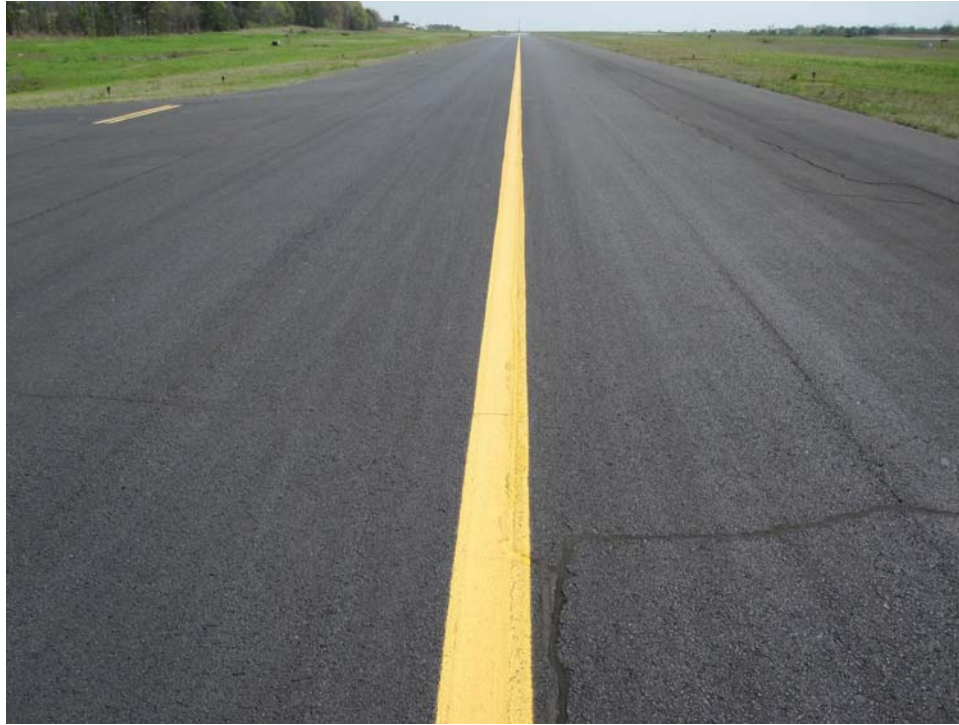
TAAT-10. Overview.

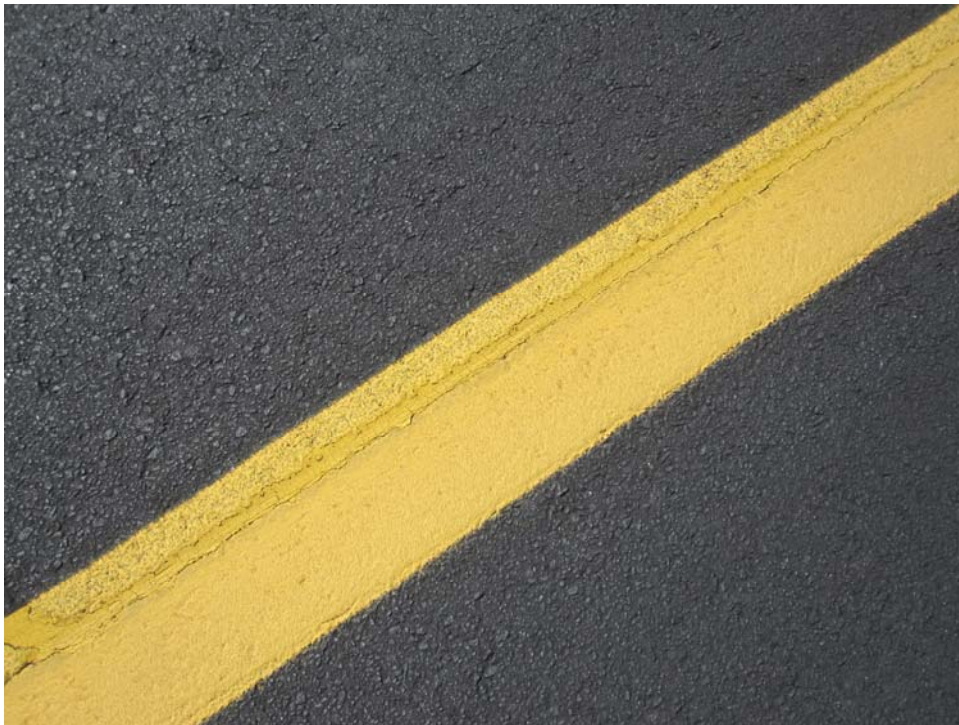
TAAT-10. Satisfactory Paint.

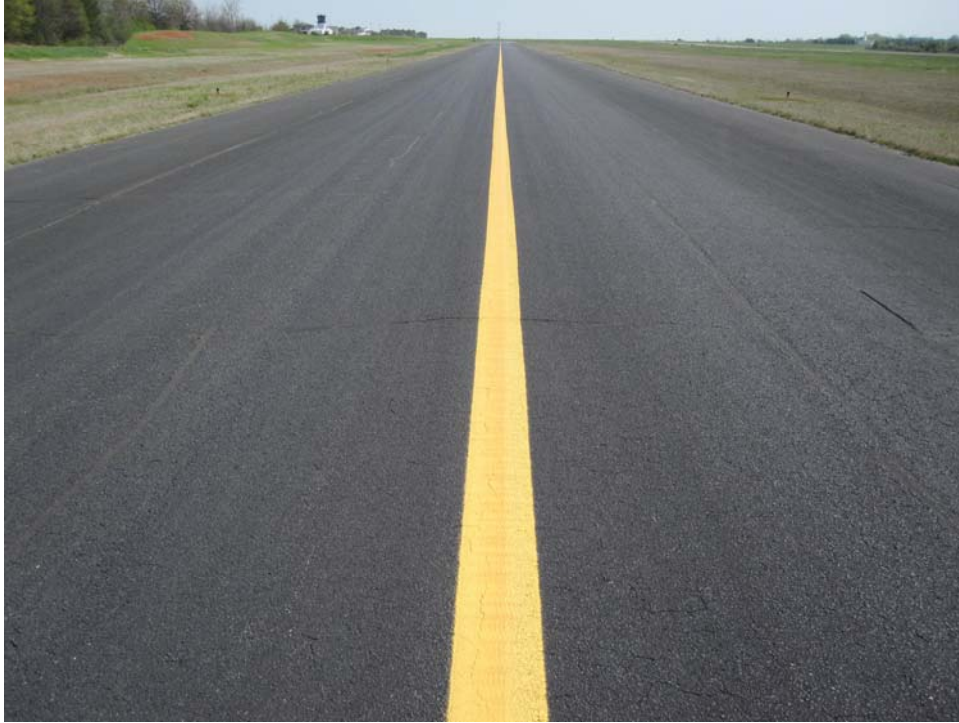
TAAT-20. Overview.

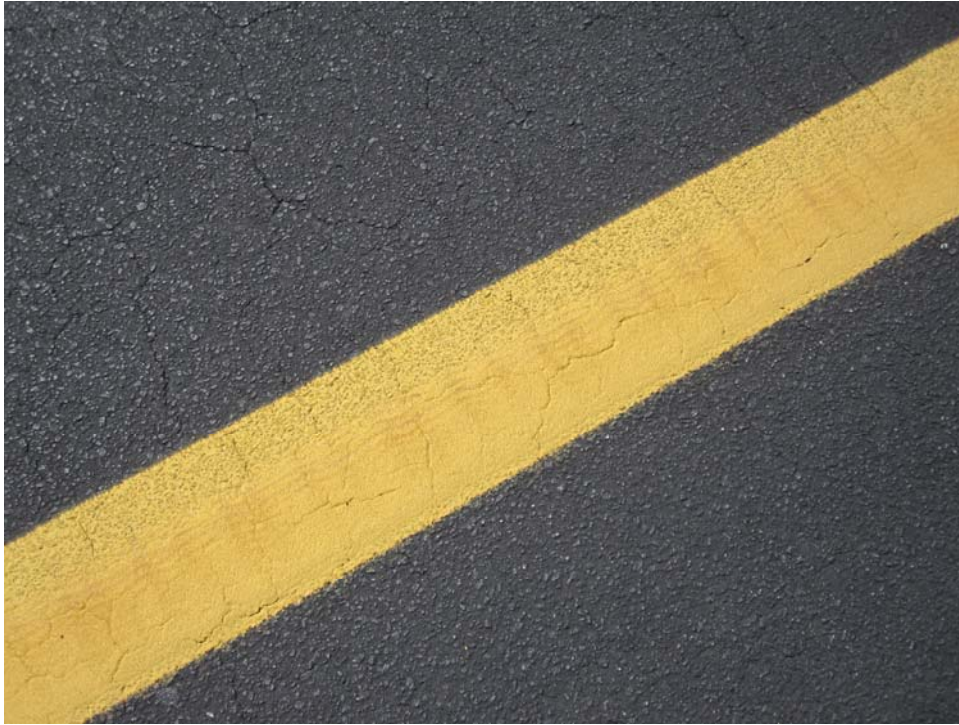
TAAT-20. Satisfactory Paint.

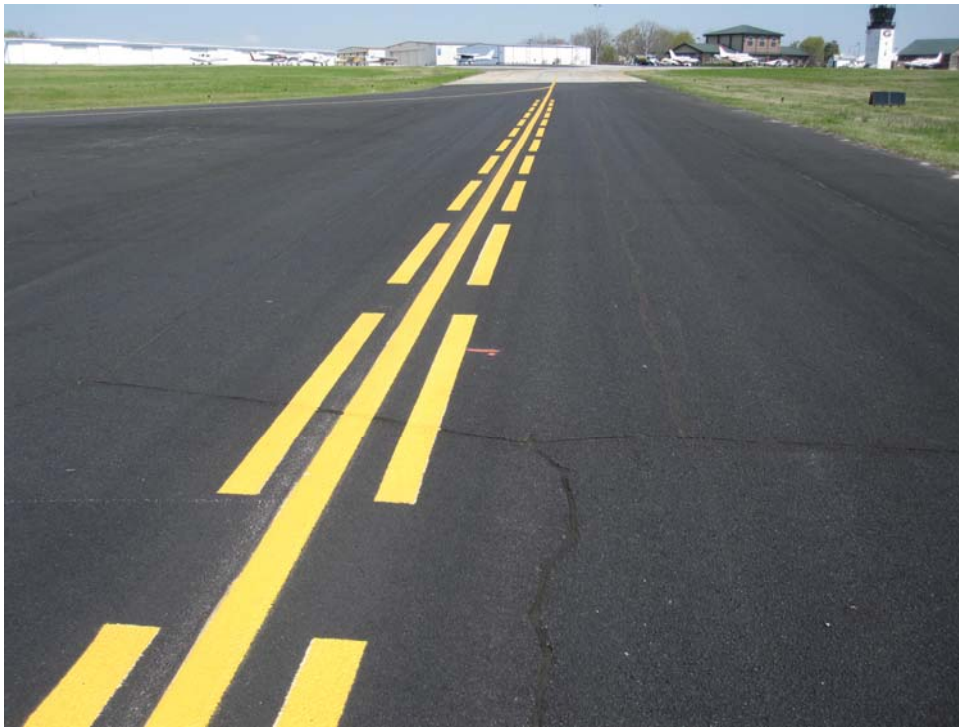
TAAT-30. Overview.

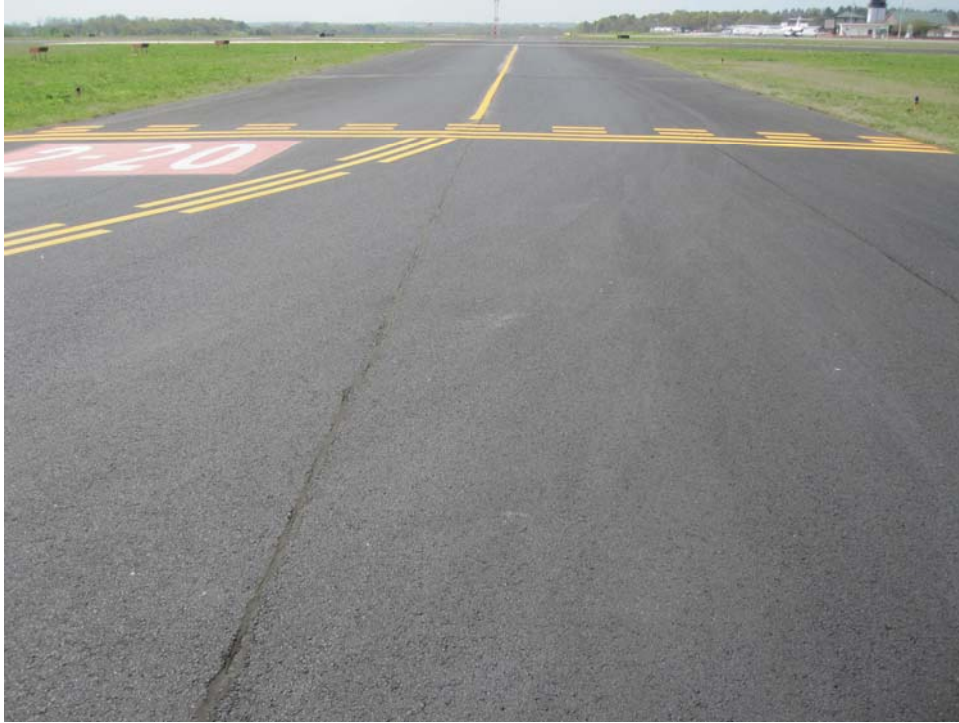
TAAT-40. Overview.

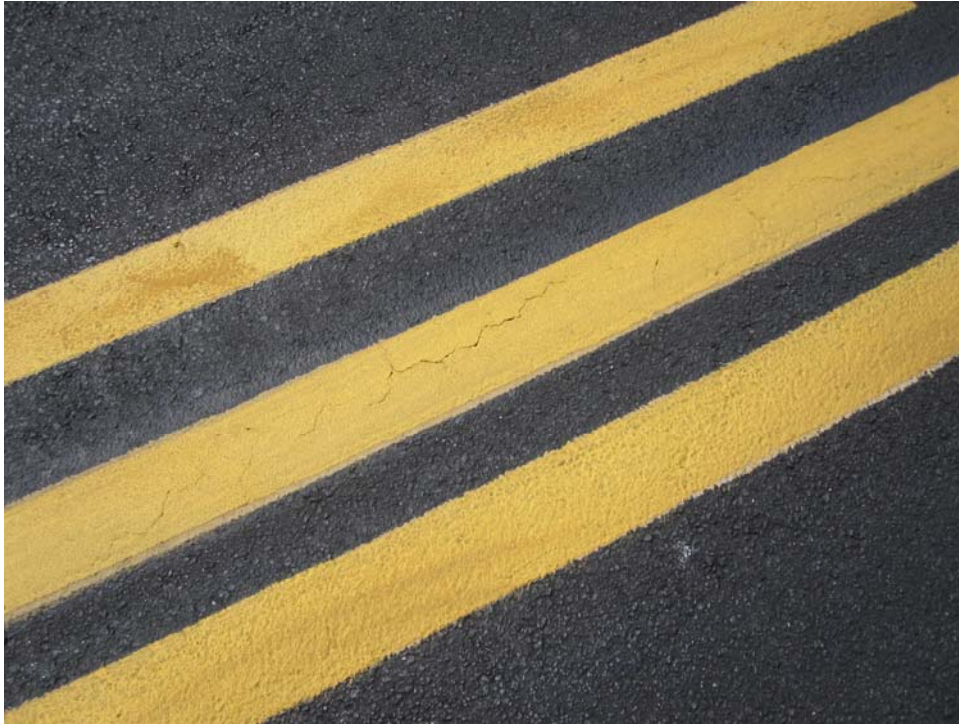
TAAT-40. Satisfactory Paint.

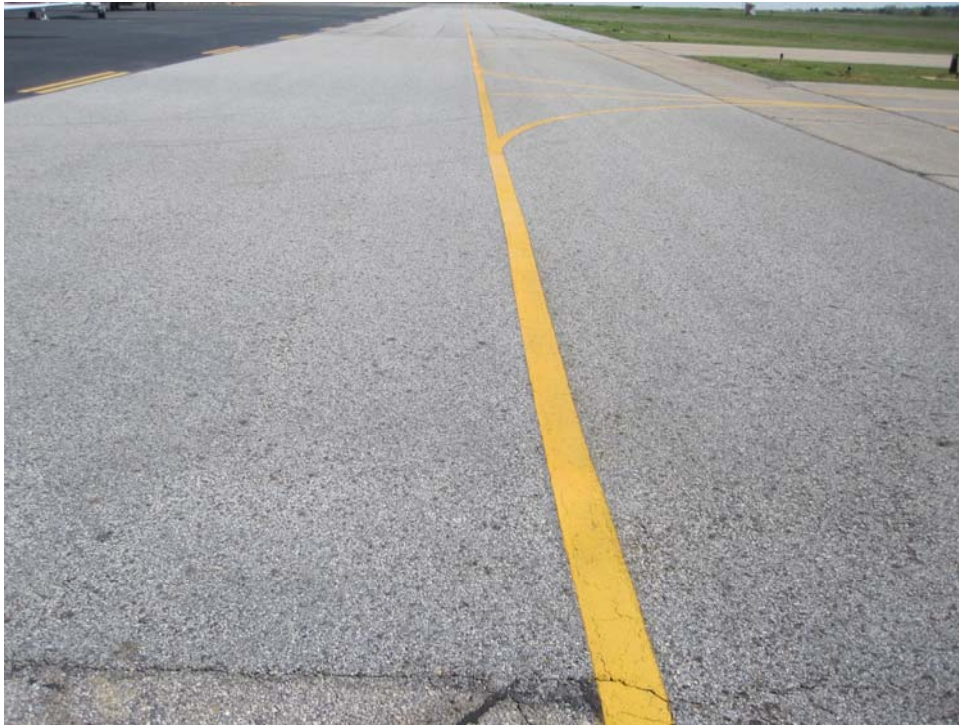
TAAT-50. Overview.

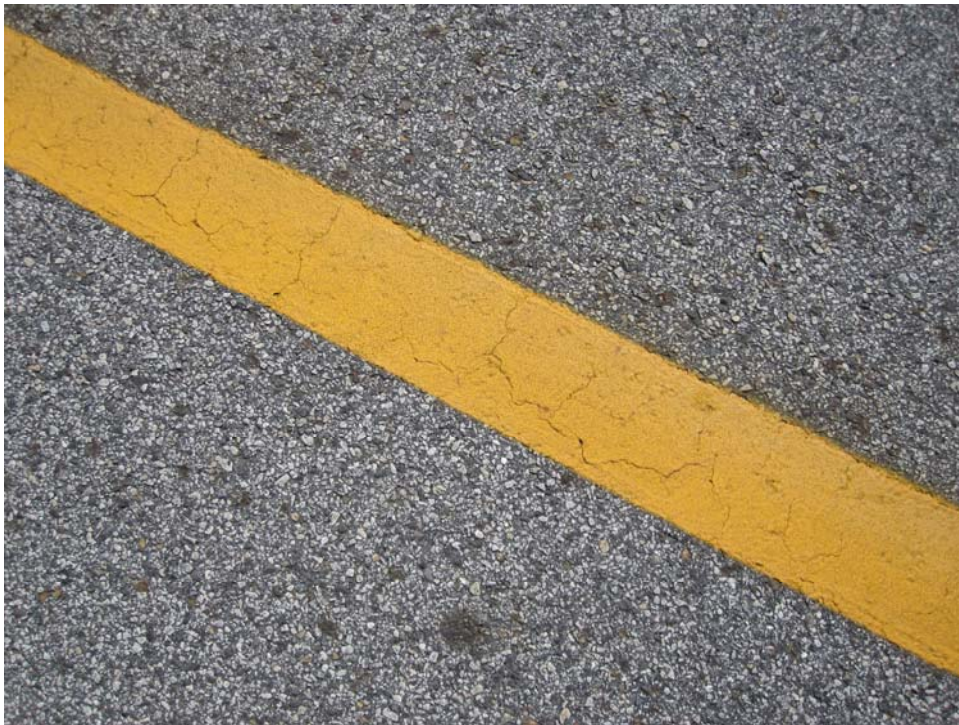
TAAT-50. Satisfactory Paint.

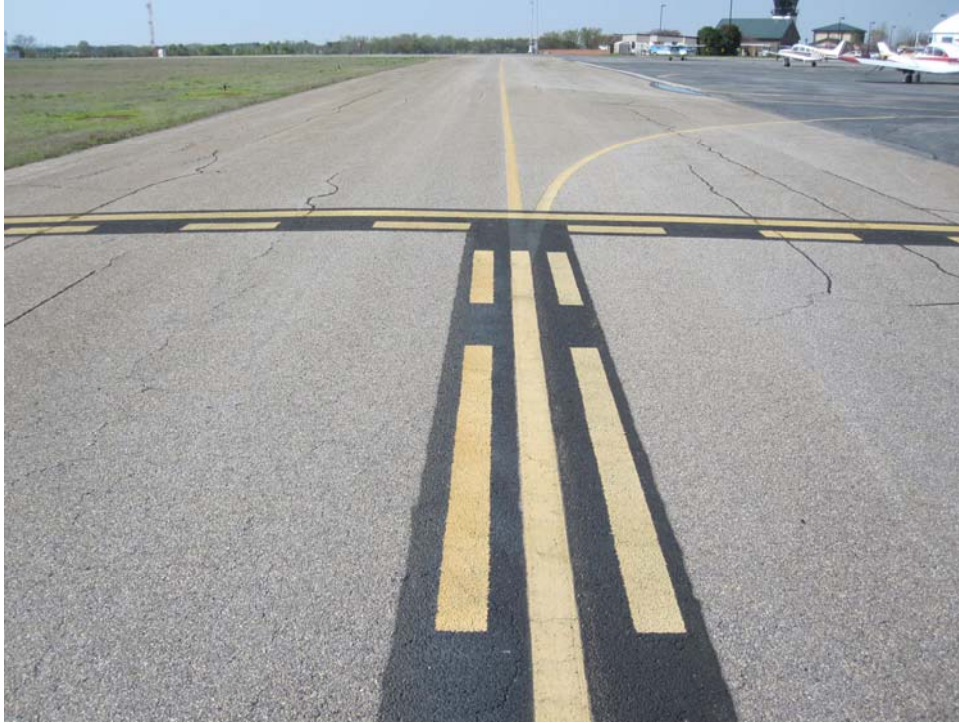
TBAT-10. Overview.

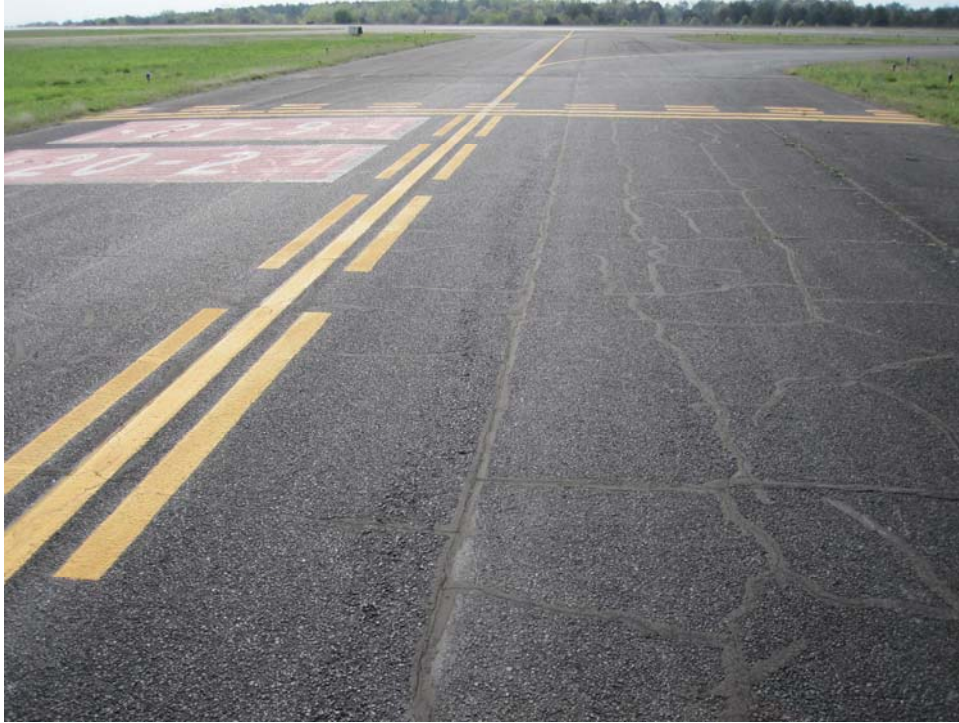
TBAT-15. Overview.
