2012 DeKalb-Peachtree Airport Pavement Management Plan

DEKALB-PEACHTREE AIRPORT

PAVEMENT MANAGEMENT REPORT

DECEMBER 2012

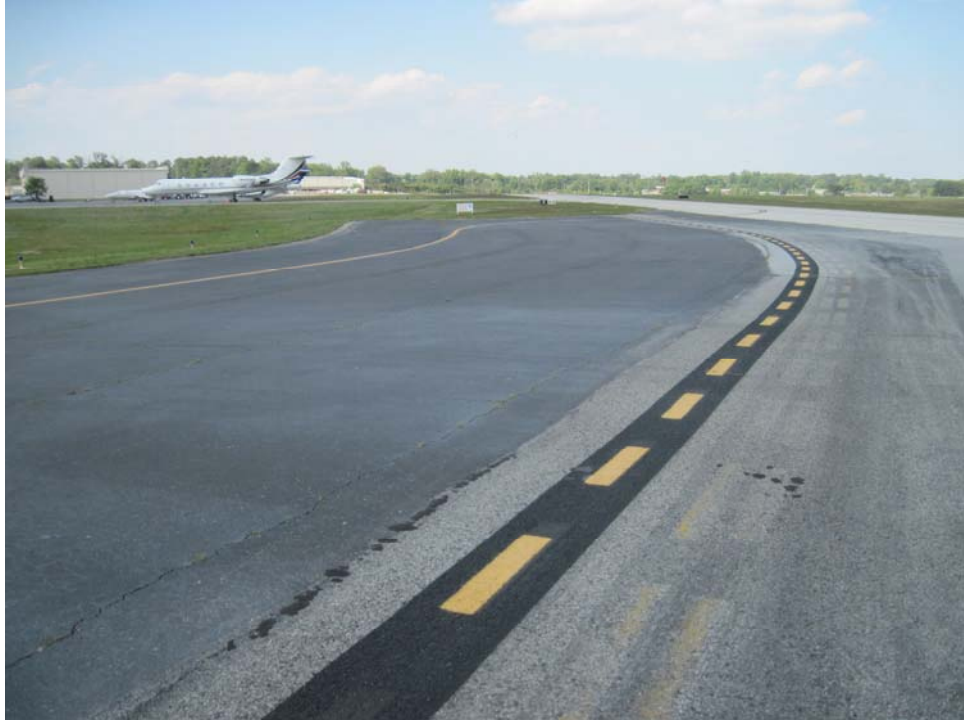
A20RUNUPAP-10. Overview.

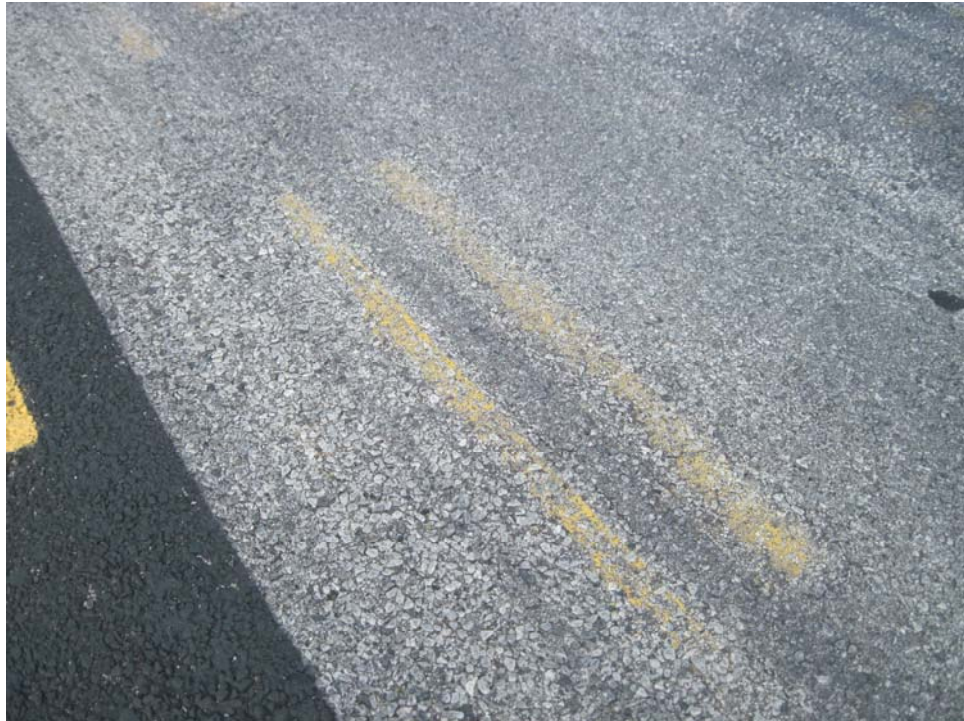
A20RUNUPAP-10. Weathering (Sample Unit #01).

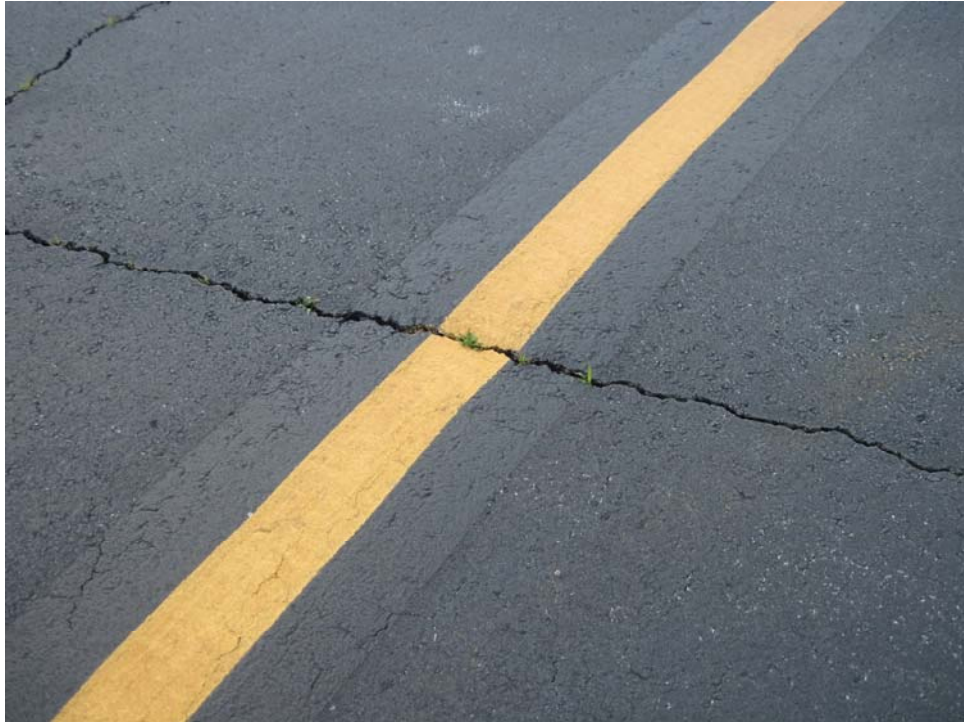
A20RUNUPAP-10. Satisfactory Paint.

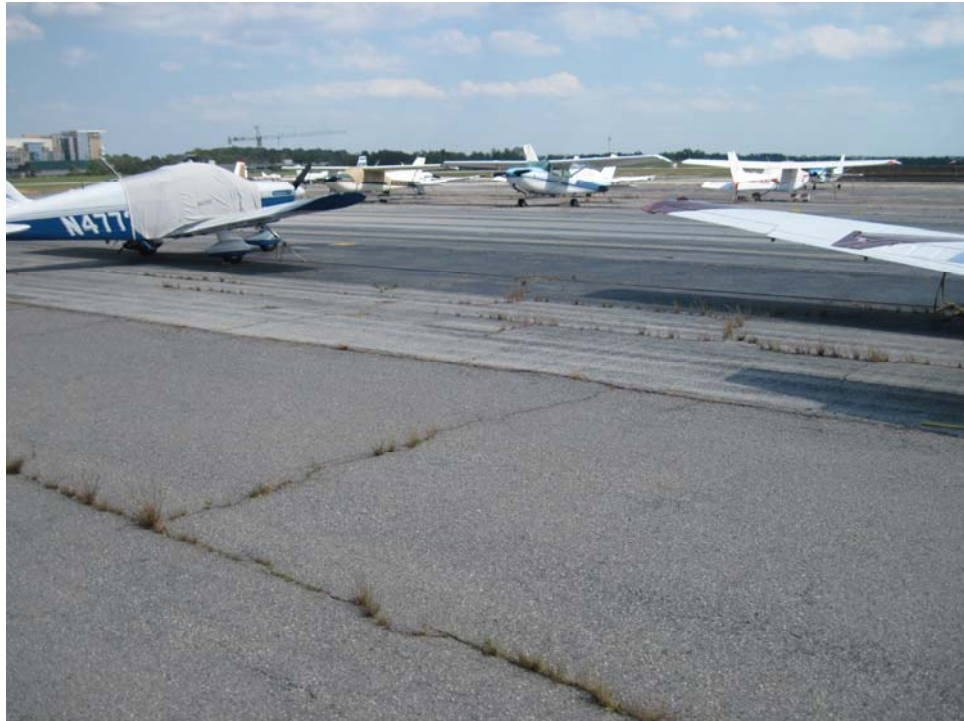
ANERAMPAP-10 Overview

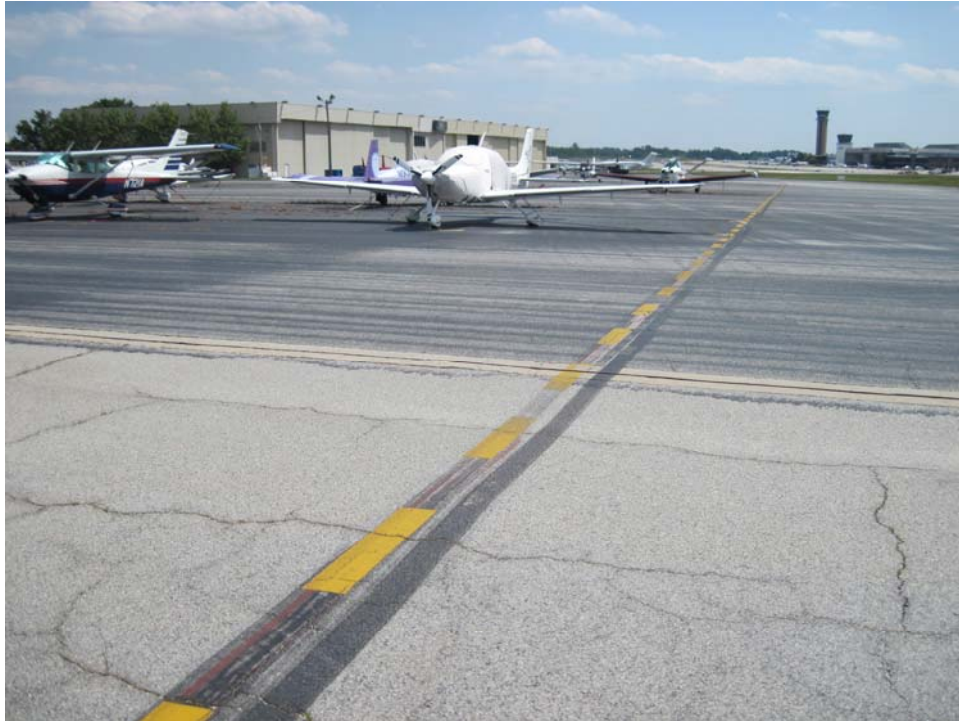
ANRAMPAP-10 Overview.

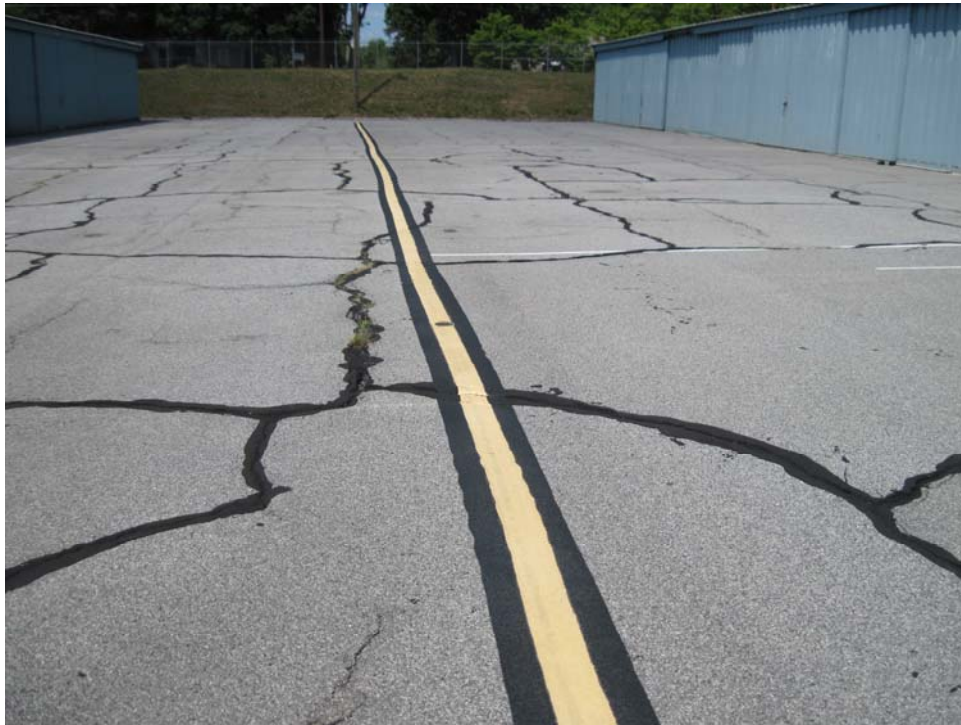
ANWRAMPAP-10. Overview.

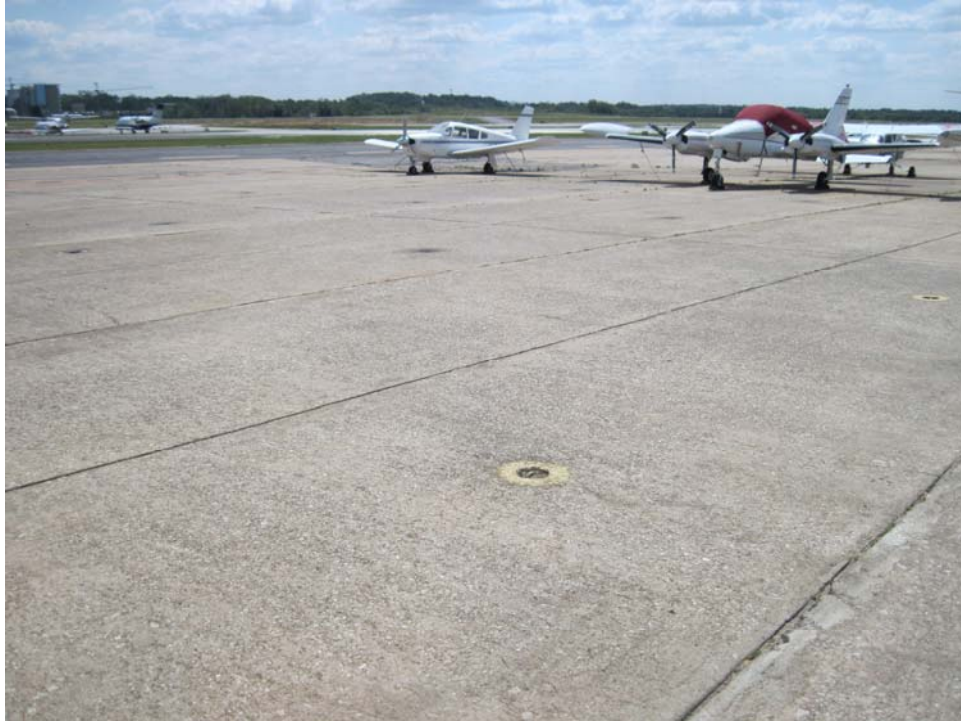
ANWRAMPAP-20. Overview.

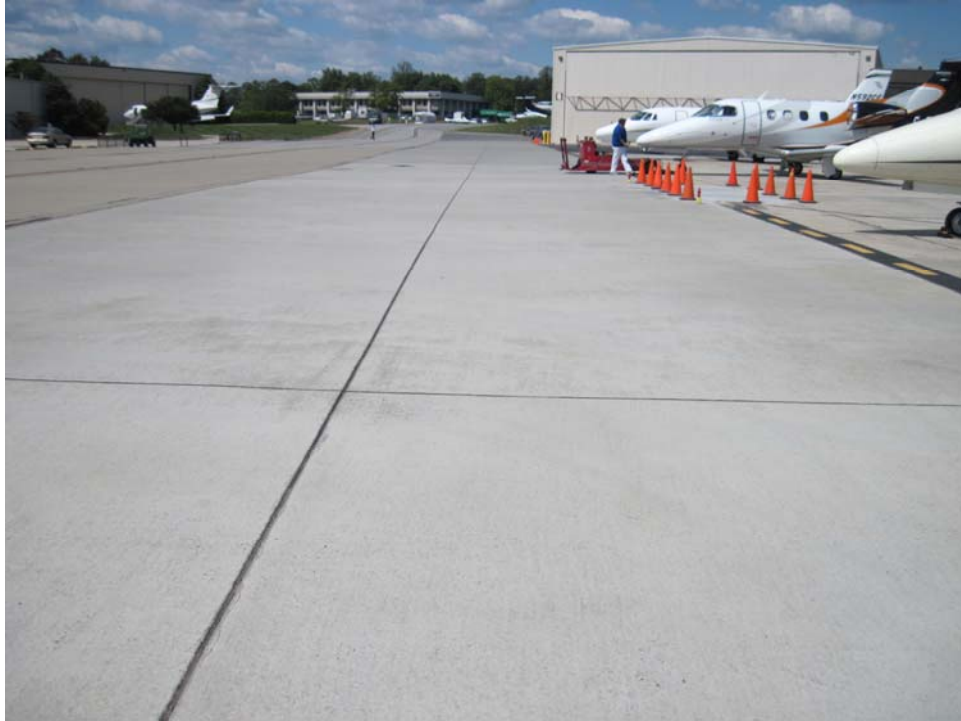
ANWRAMPAP-30. Overview.

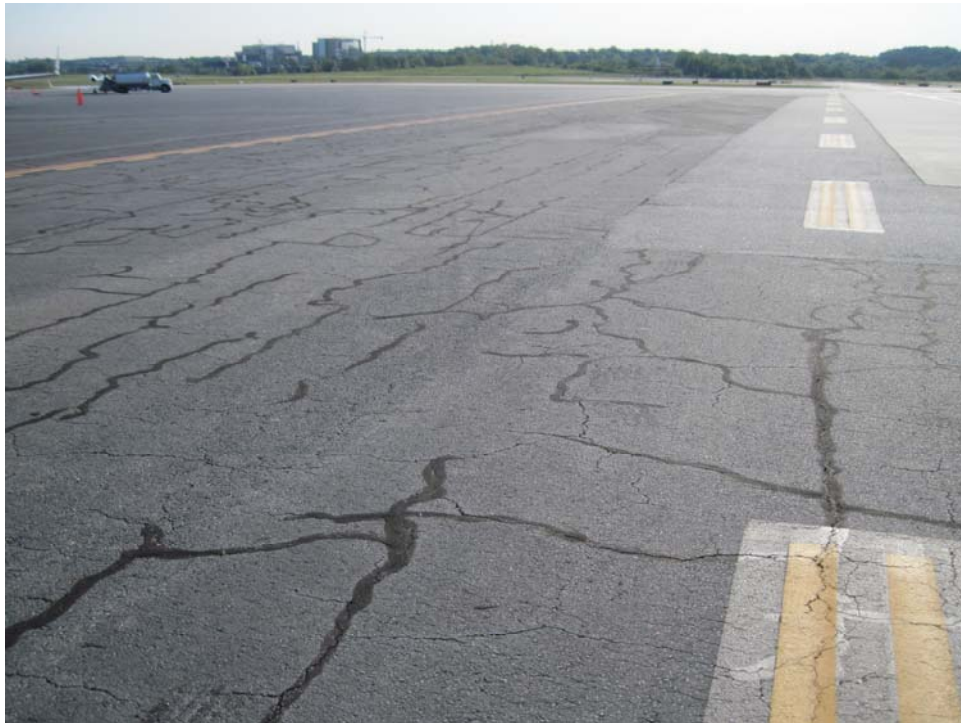
APERIMAP-10. Overview.

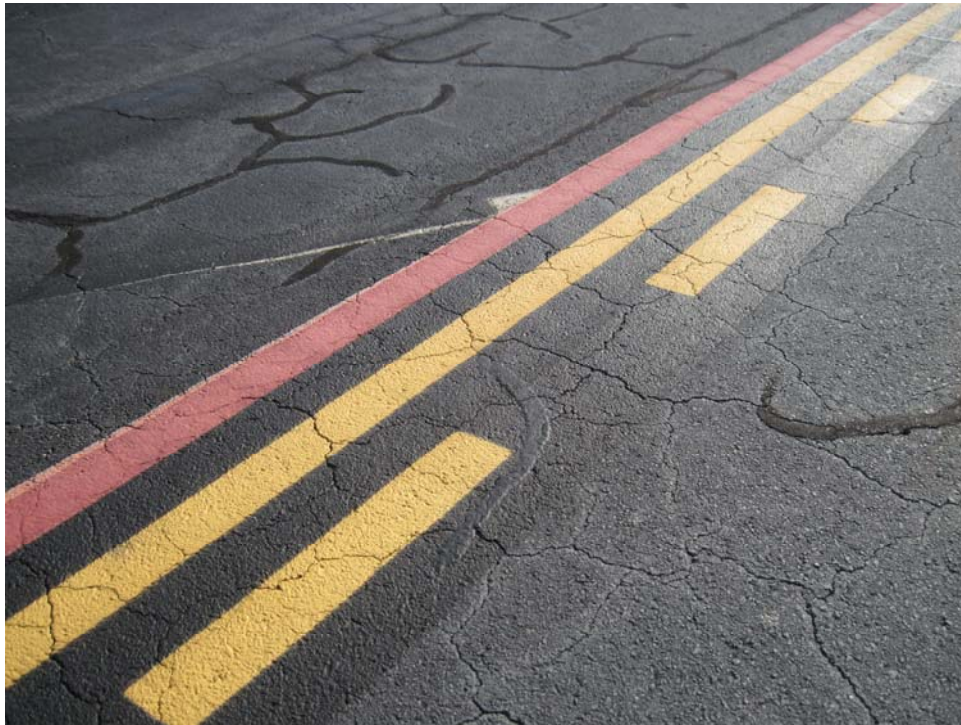
APERIMAP-10. Satisfactory Paint.

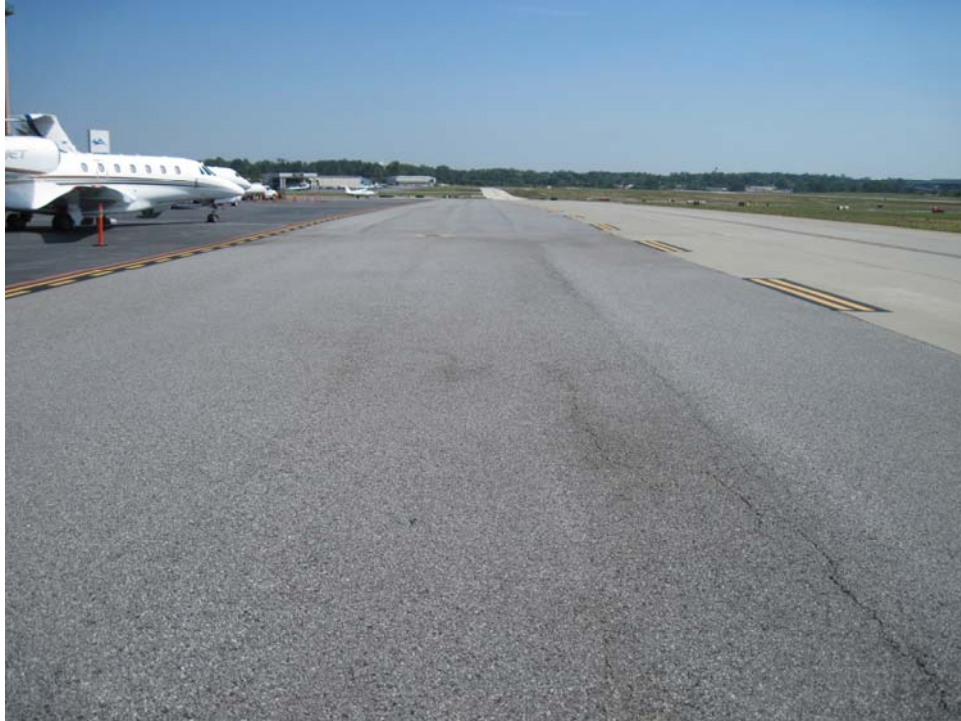
APERIMAP-20. Overview.

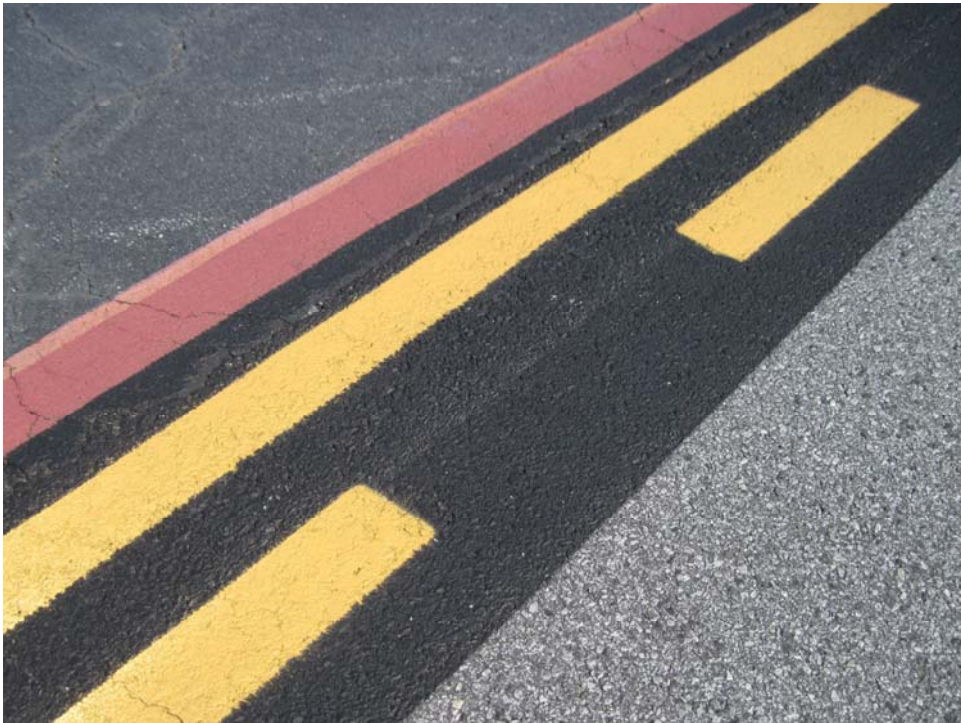
APERIMAP-20. Satisfactory Paint.

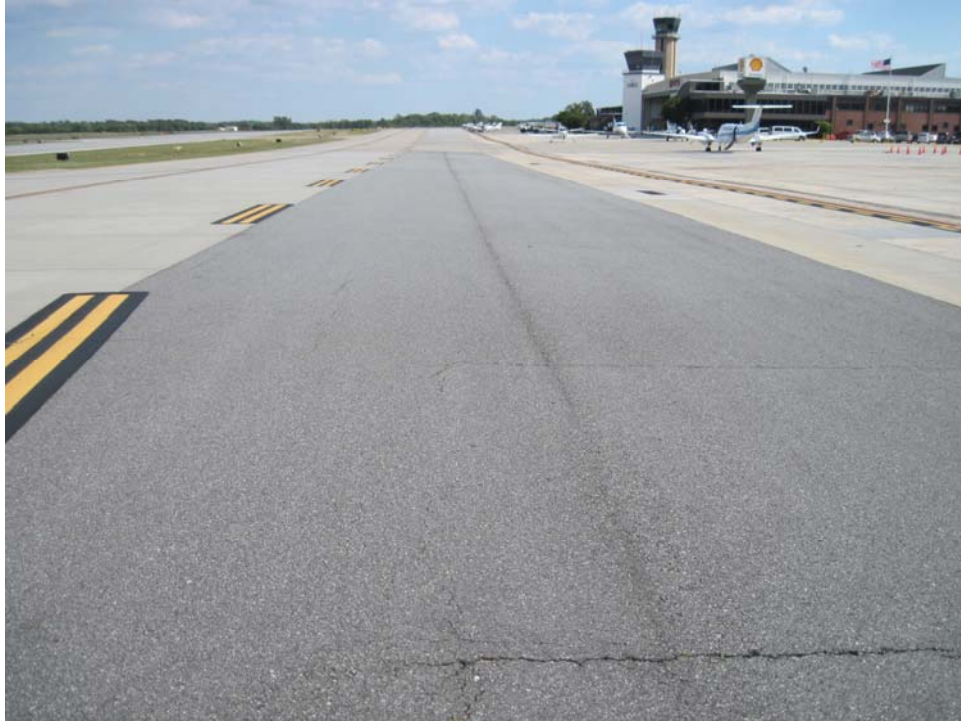
APERIMAP-30. Overview.

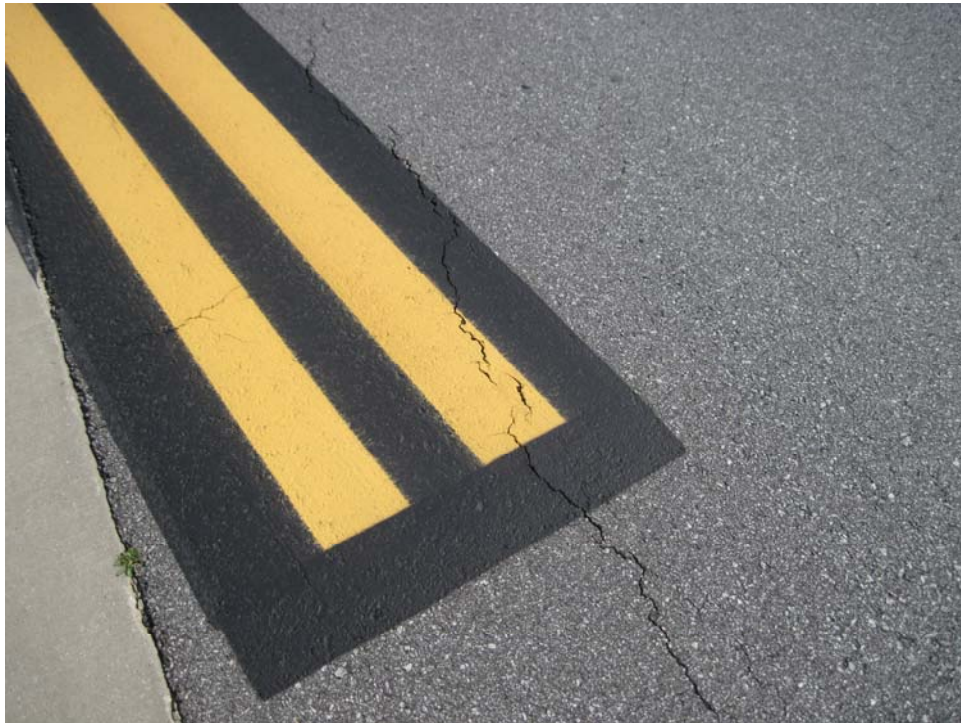
APERIMAP-30. Satisfactory Paint.

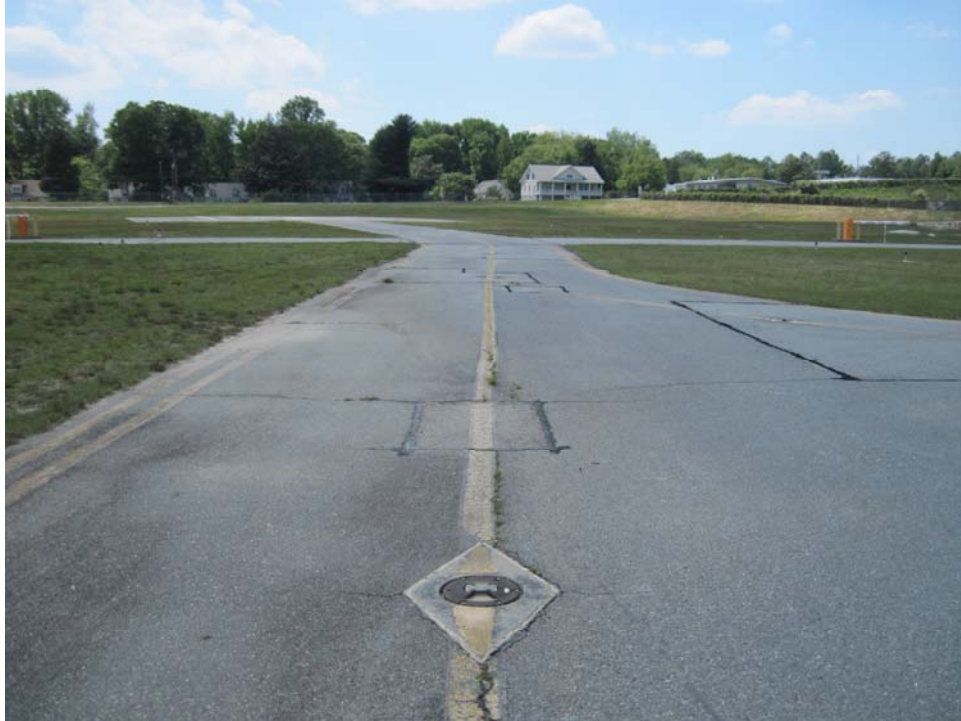
HELIAP-10. Overview.

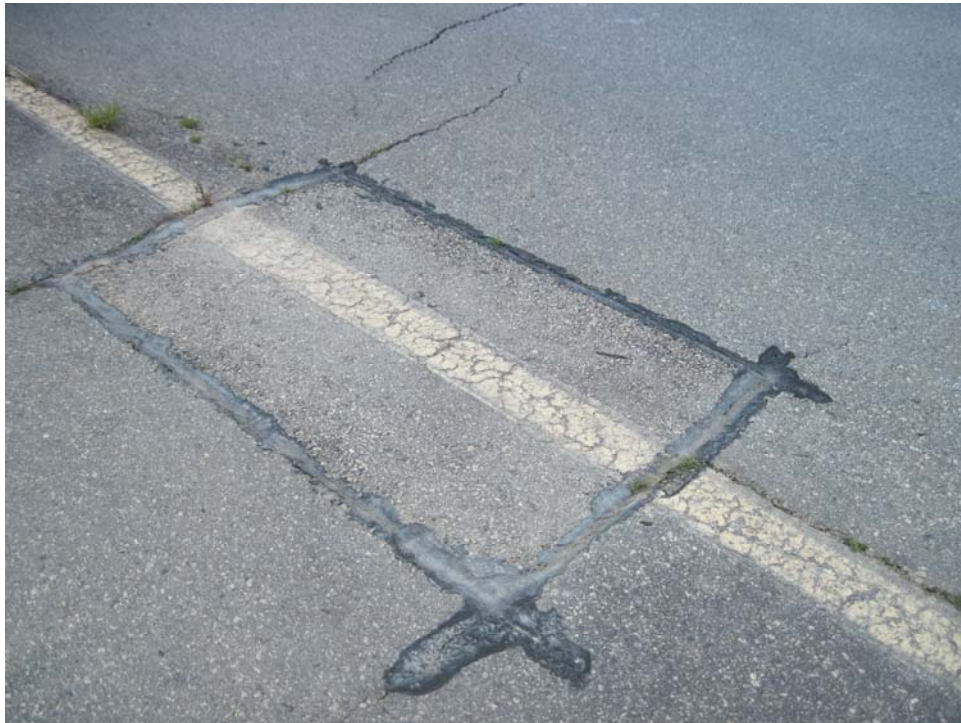
HELIAP-10. Patching (Sample Unit #02).

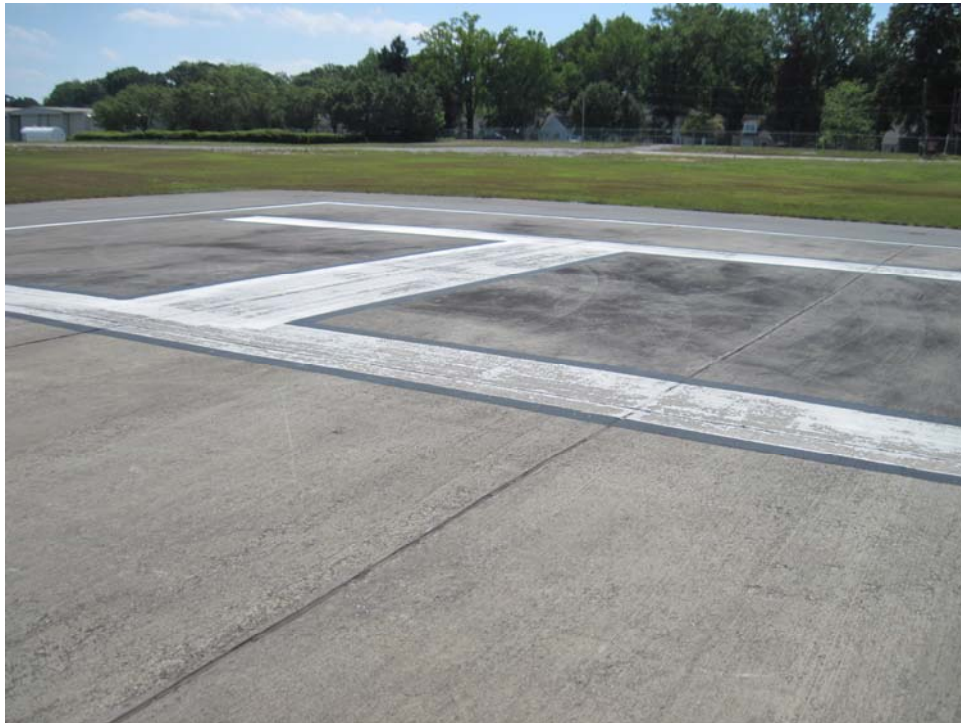
HELIAP-20. Overview.

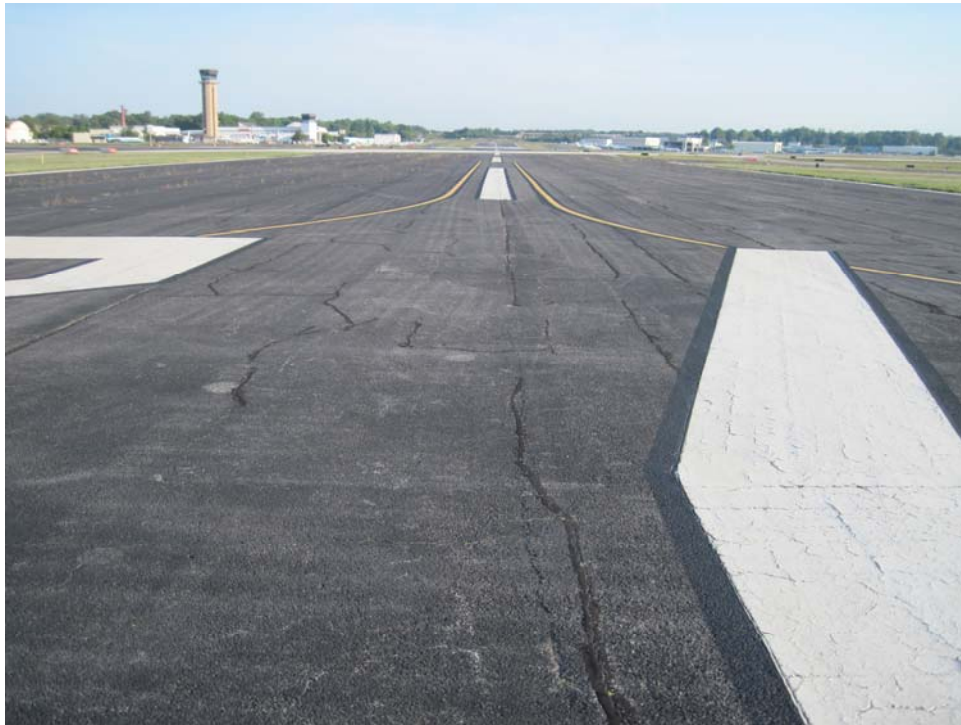
R1634AP-10. Overview.

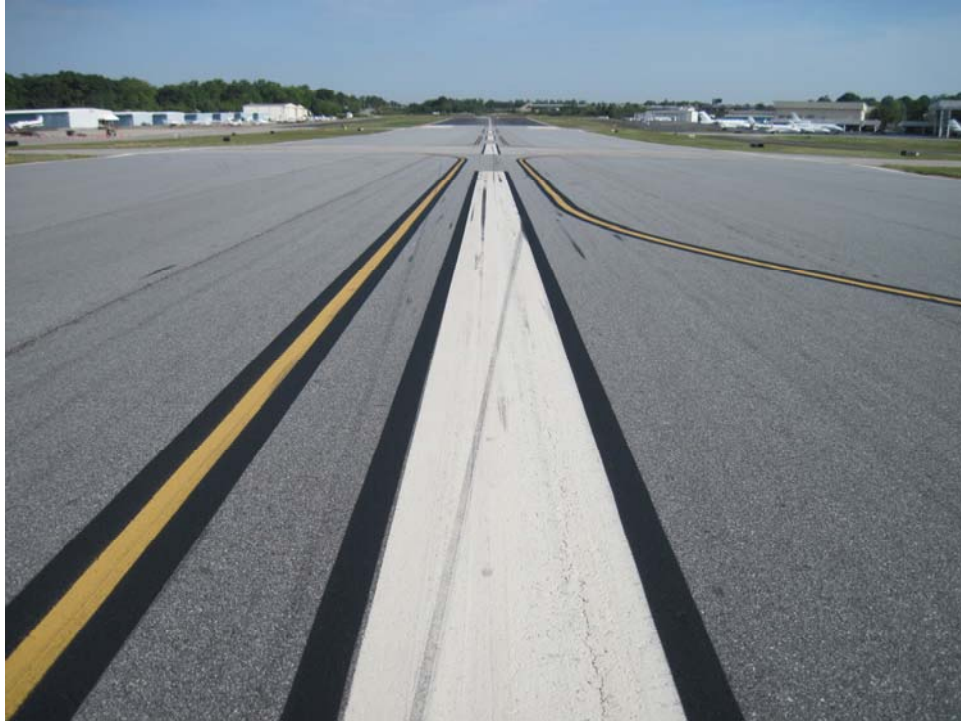
R1634AP-20. Overview.

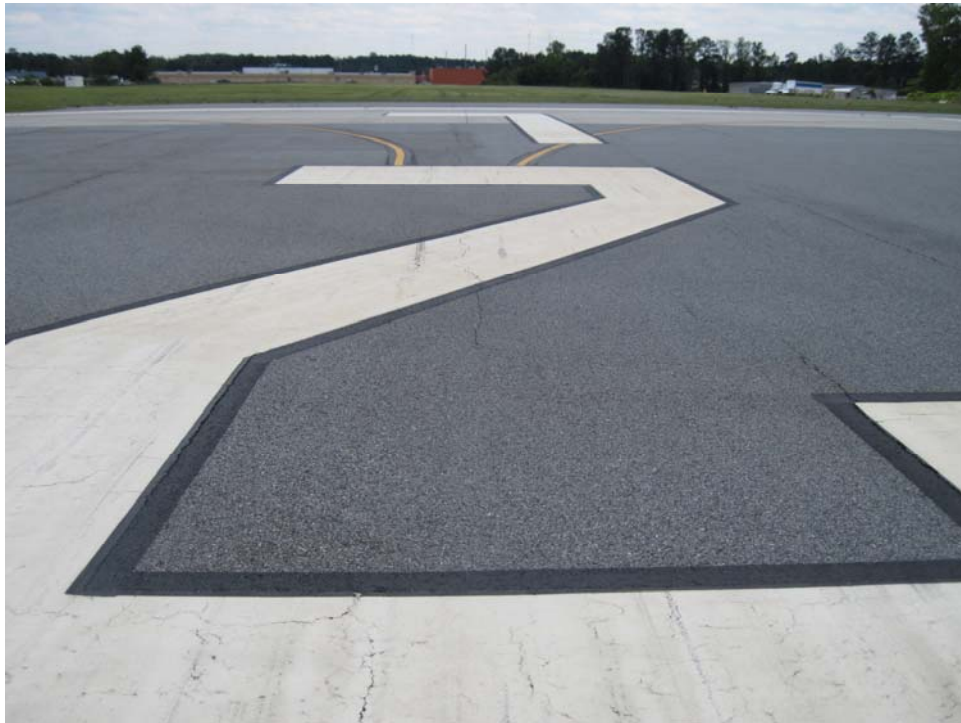
R2L20RAP-10. Satisfactory Paint.

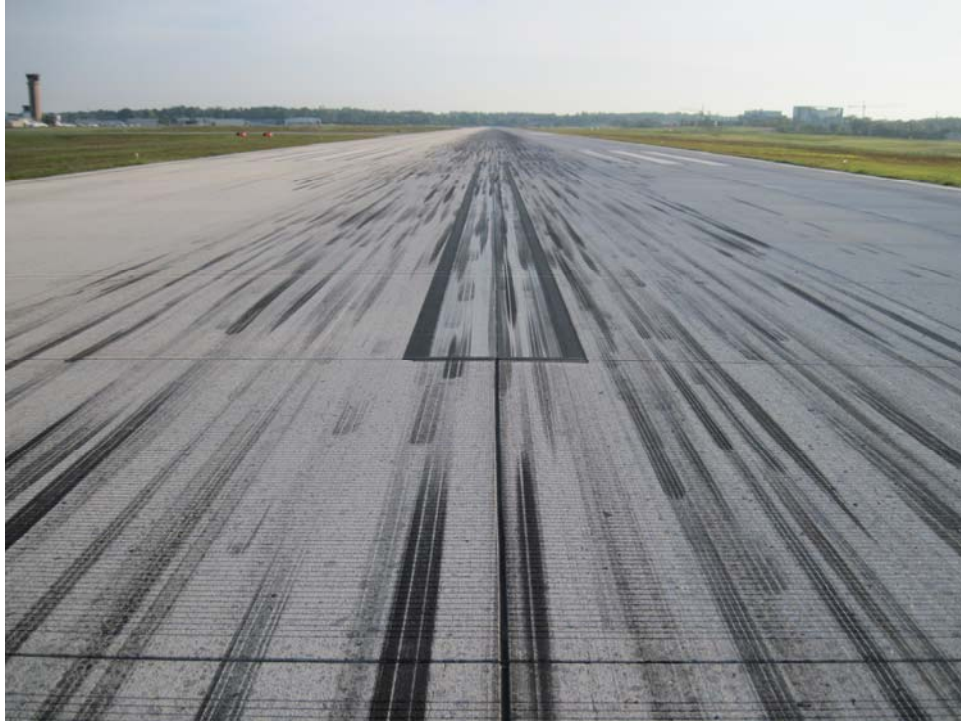
R2L20RAP-20. Satisfactory Paint.

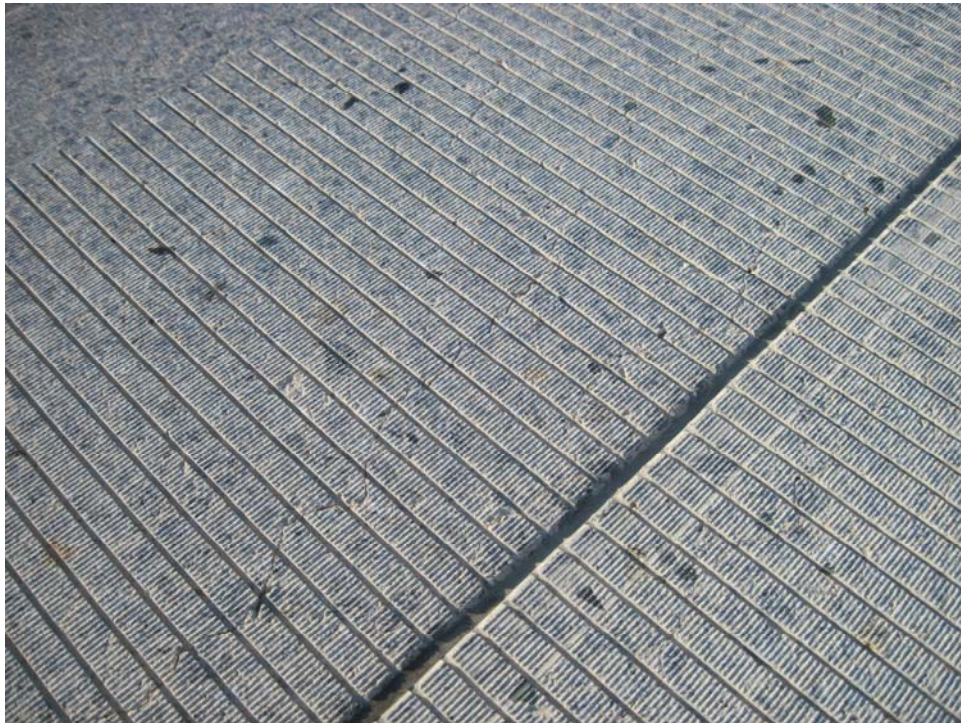
R2R20LAP-10. Overview.

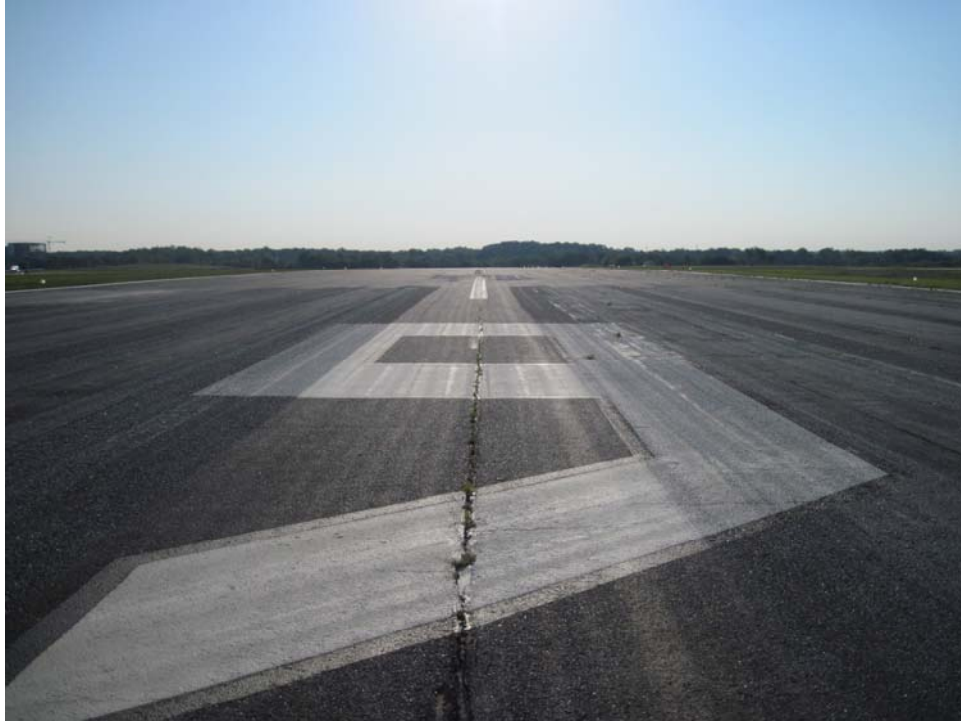
R2R20LAP-10. Satisfactory Paint.

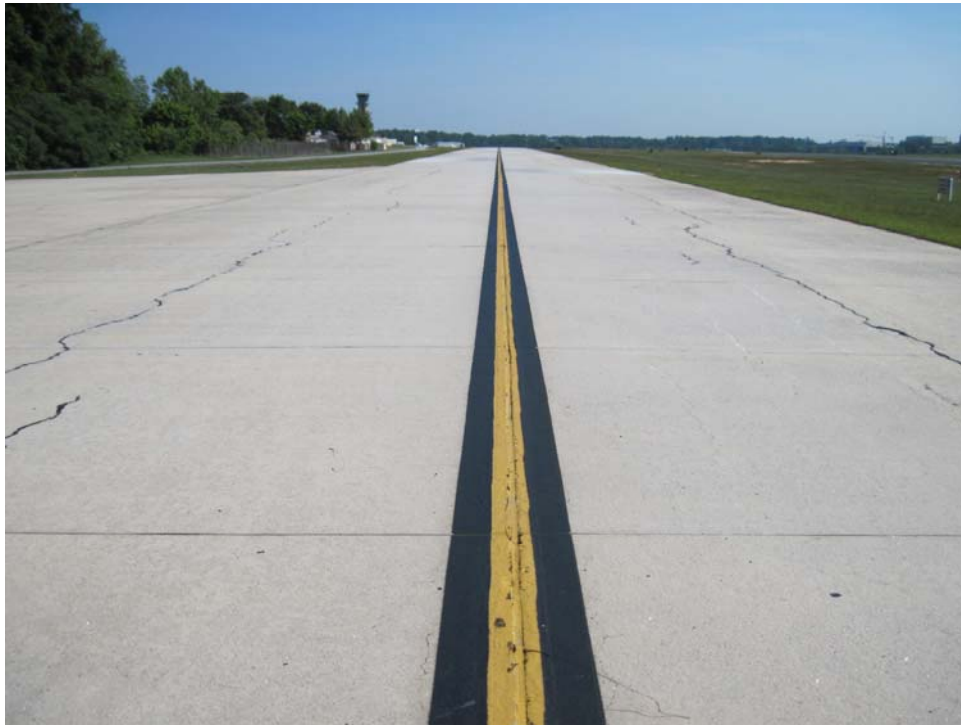
R927AP-10. Satisfactory Paint.

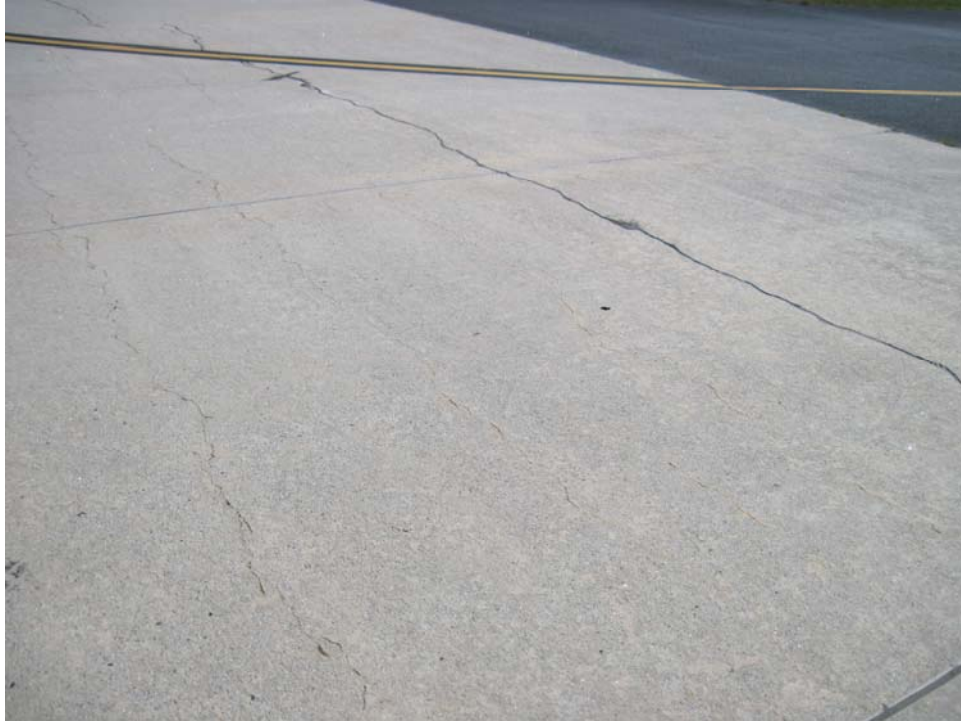
TAAP-10. Overview.

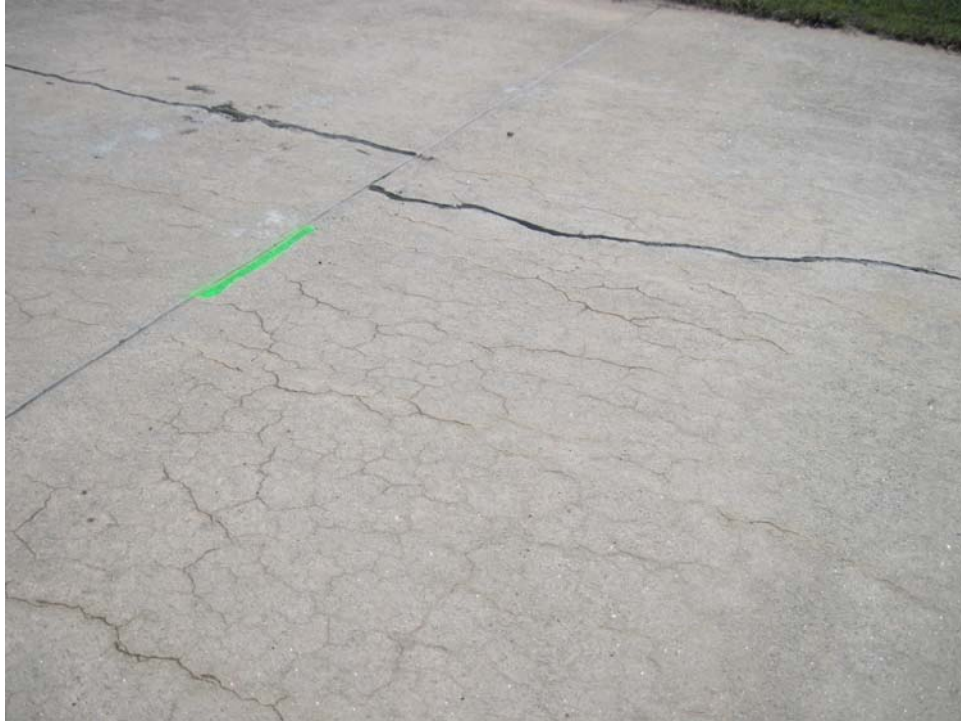
Distress Type	Probable Cause of Distress	Feasible Maintenance Strategies
Alkali Silica Reaction (ASR)	Chemical reaction of alkalis in the portland cement with certain reactive silica minerals. ASR may be accelerated by the use of chemical pavement deicers.	At medium- and high-severity levels, slab replacement is recommended.
Blow-Up	Incompressibles in joints.	Partial- or full-depth patch. Slab replacement.
Corner Break	Load repetition combined with loss of support and curling stresses.	Seal cracks at low-severity. Full-depth patch.
Cracks	Combination of load repetition, curling stresses, and shrinkage stresses.	Seal cracks. At high-severity, may need full-depth patch or slab replacement.
Durability Cracking	Concrete's inability to withstand environmental factors such as freeze-thaw cycles.	Full-depth patch if present on small amount of slab. At higher severity levels, once it has appeared on most of slab, slab replacement.

TAAP-10. ASR (Sample Unit #20) (2).

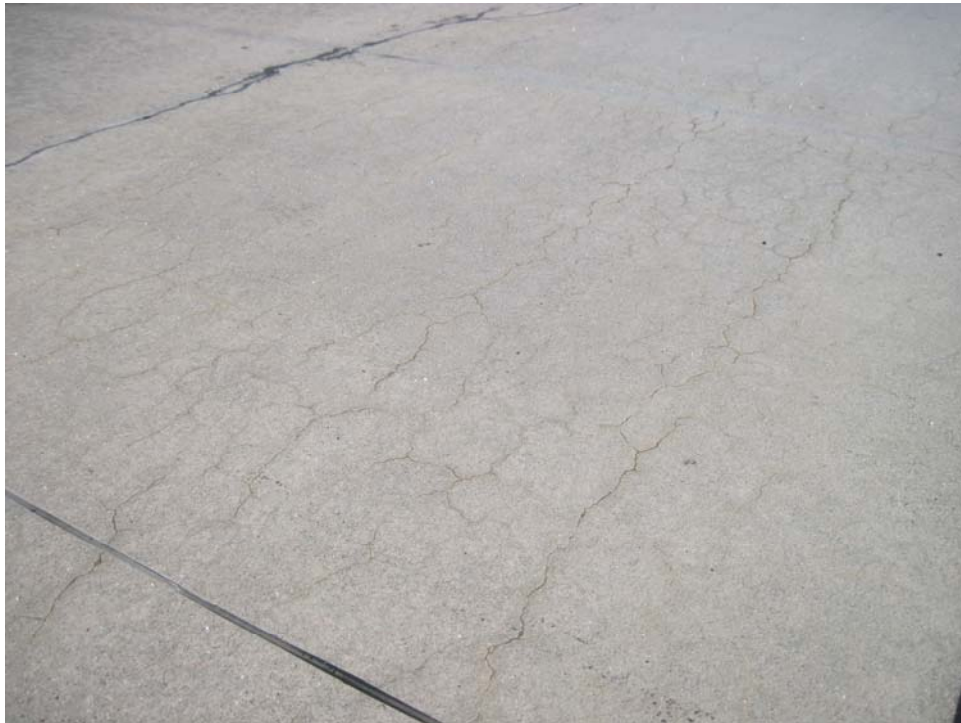
TAAP-10. ASR (Sample Unit #24) (3).

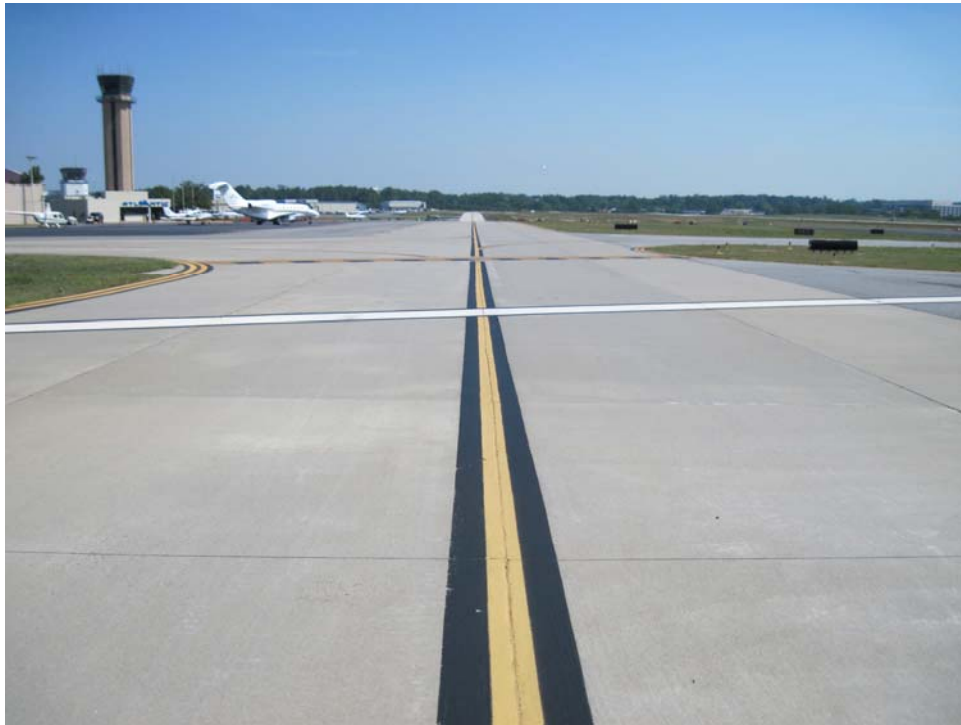
TAAP-10. Satisfactory Paint.

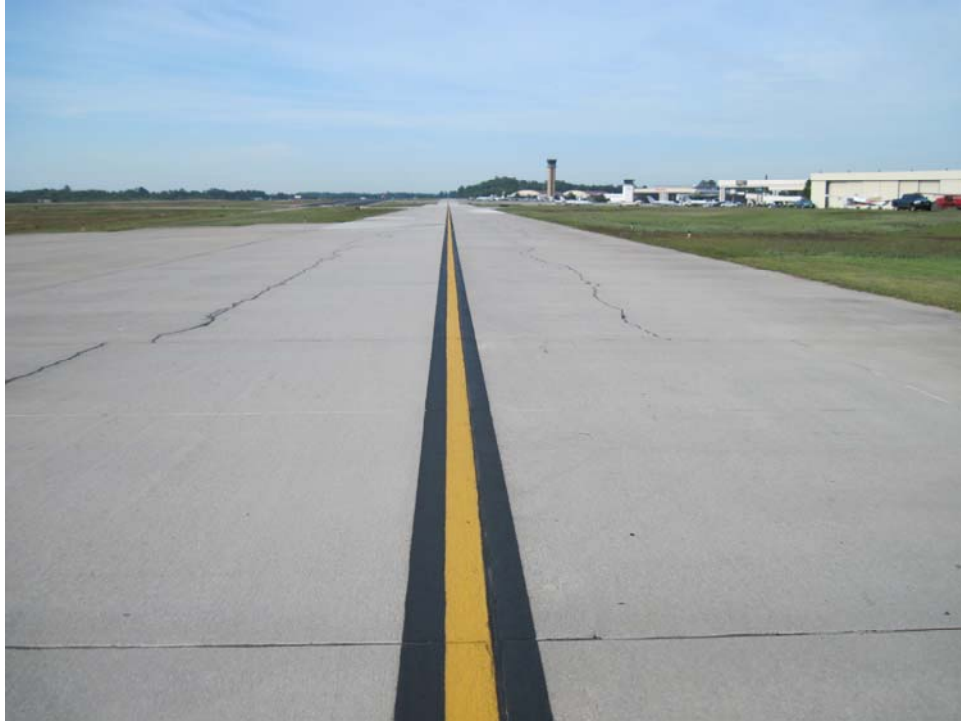
TAAP-20. Satisfactory Paint.

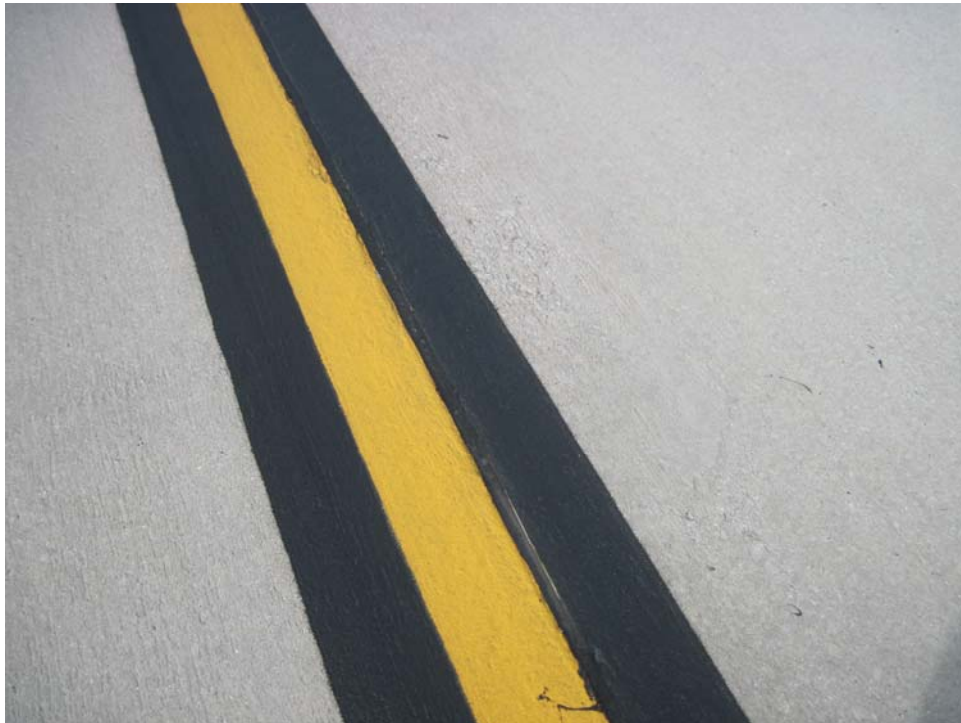
TAAP-30. LTD Cracking and ASR (Sample Unit #29) (2).

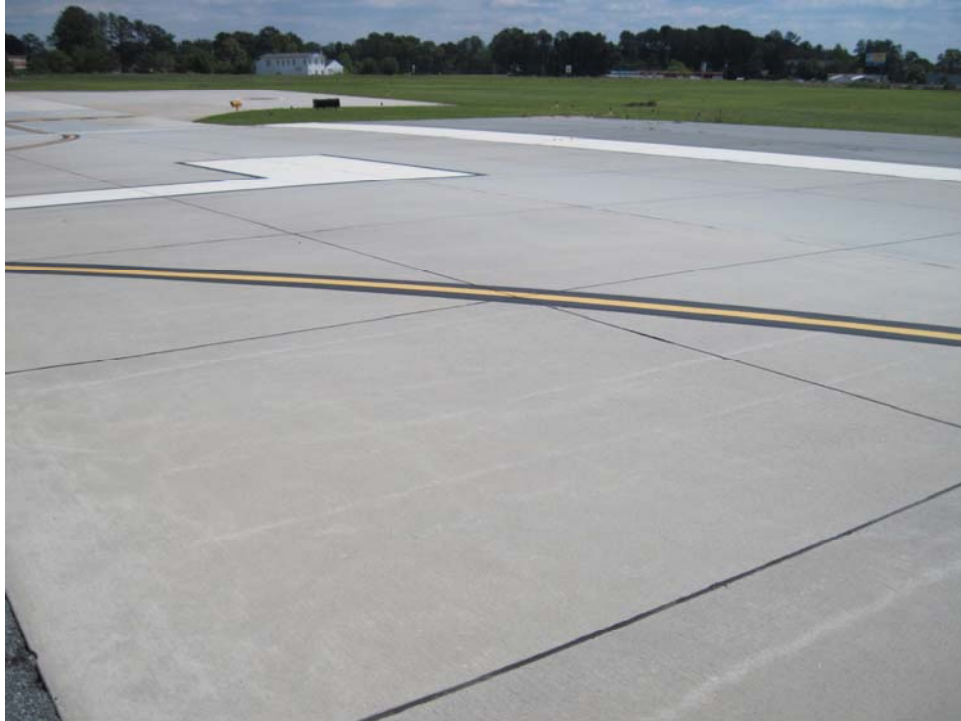
TAAP-30. Satisfactory Paint.

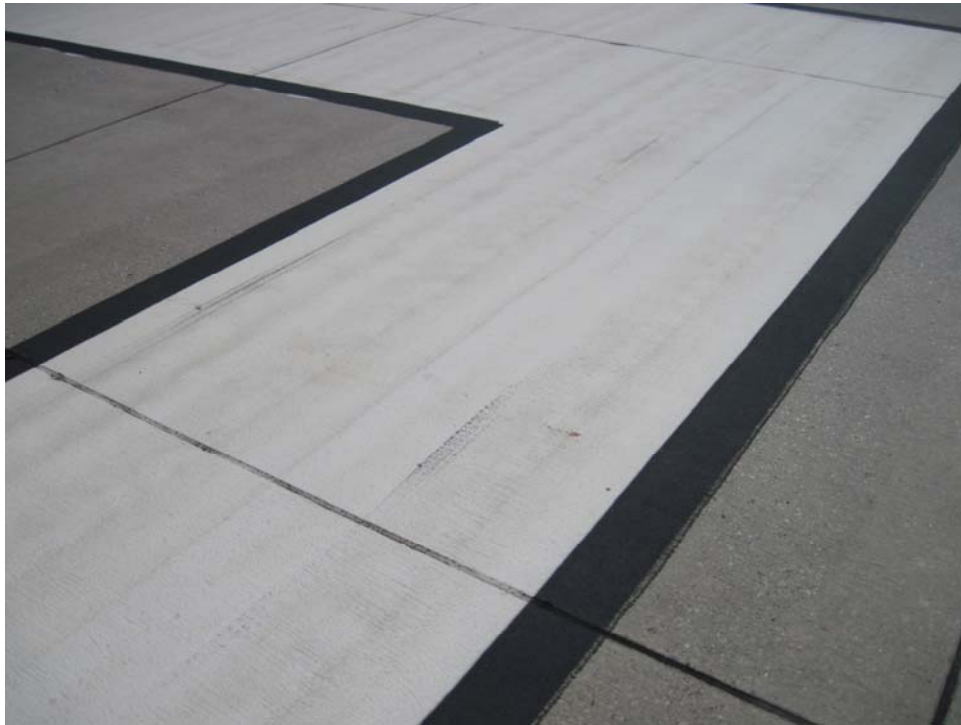
TAAP-40. Overview.
