2012 DeKalb-Peachtree Airport Pavement Management Plan

DEKALB-PEACHTREE AIRPORT

PAVEMENT MANAGEMENT REPORT

DECEMBER 2012

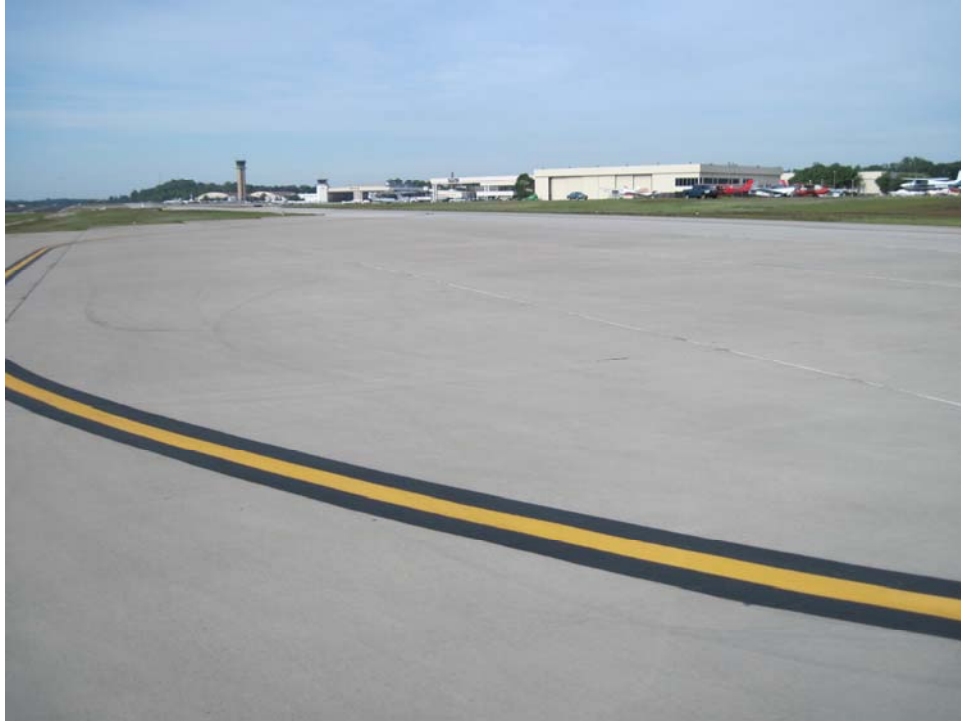
TAAP-40. Satisfactory Paint.

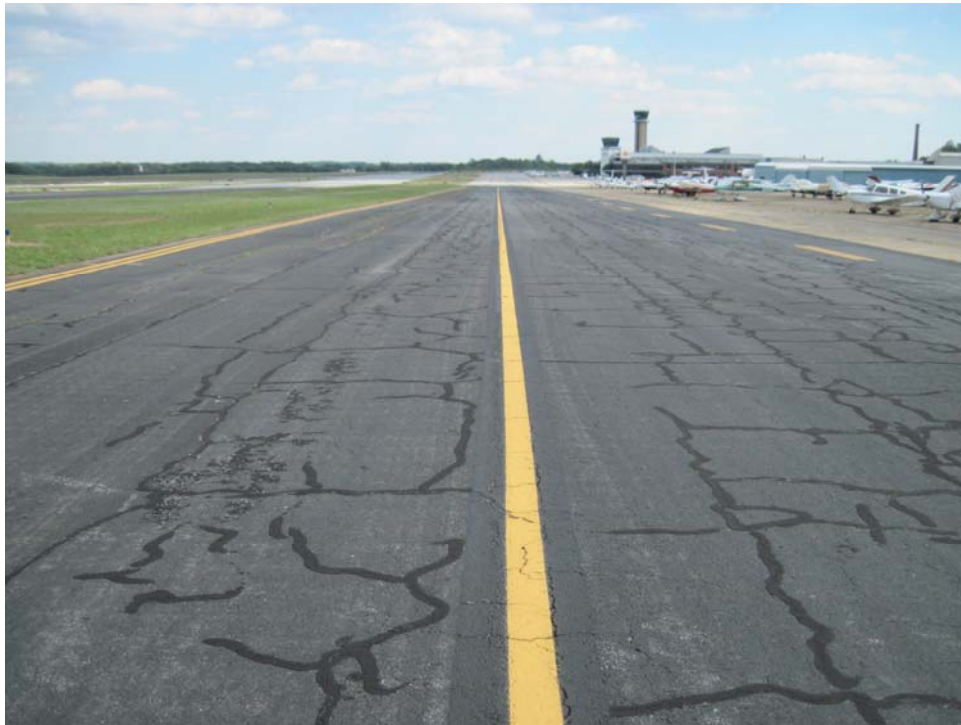
TARUNUPAP-10. Satisfactory Paint.

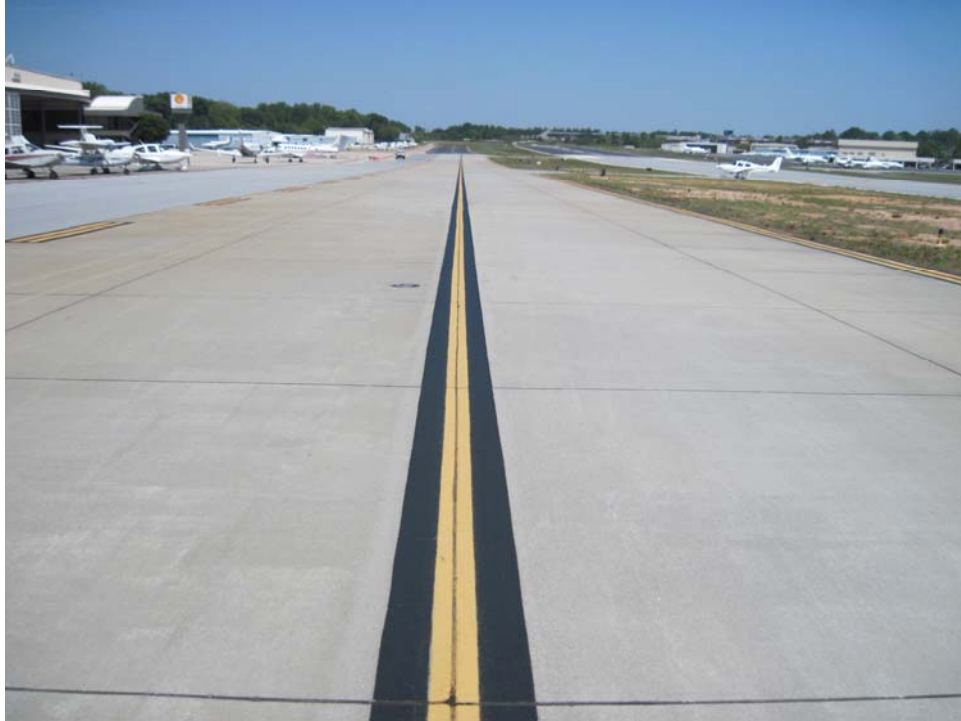
TBAP-10. Satisfactory Paint.

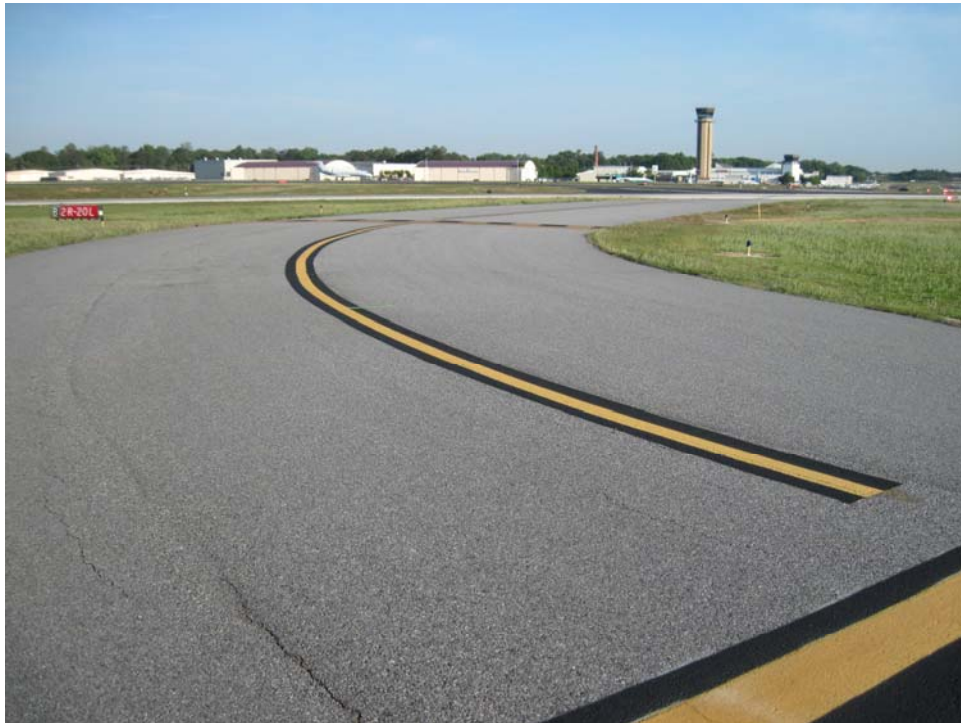
TBAP-20. Satisfactory Paint.

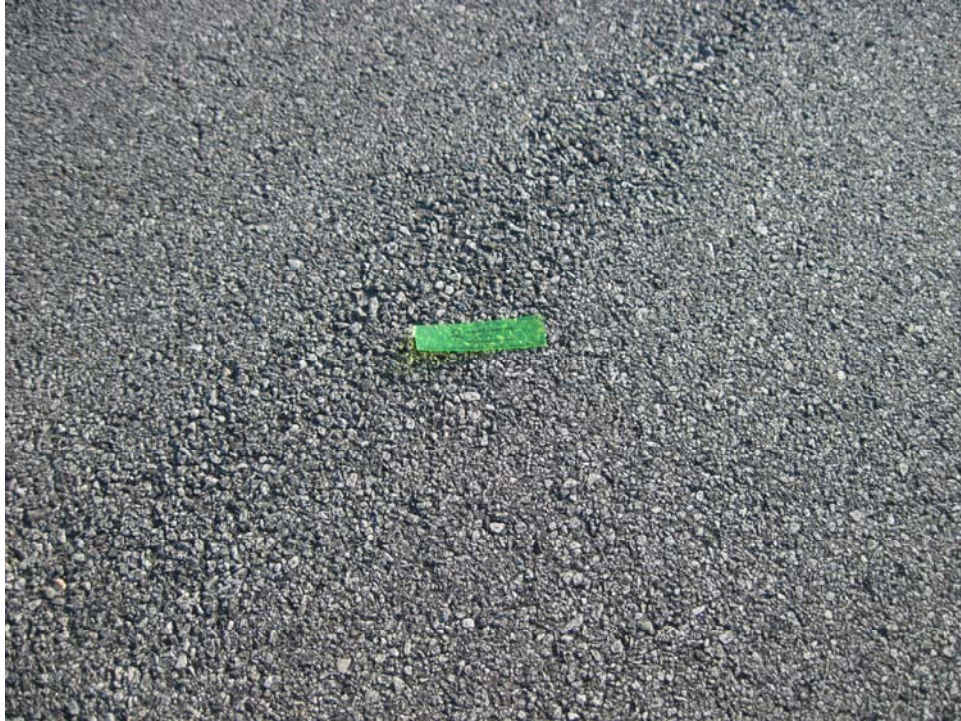
TBAP-30. Overview.

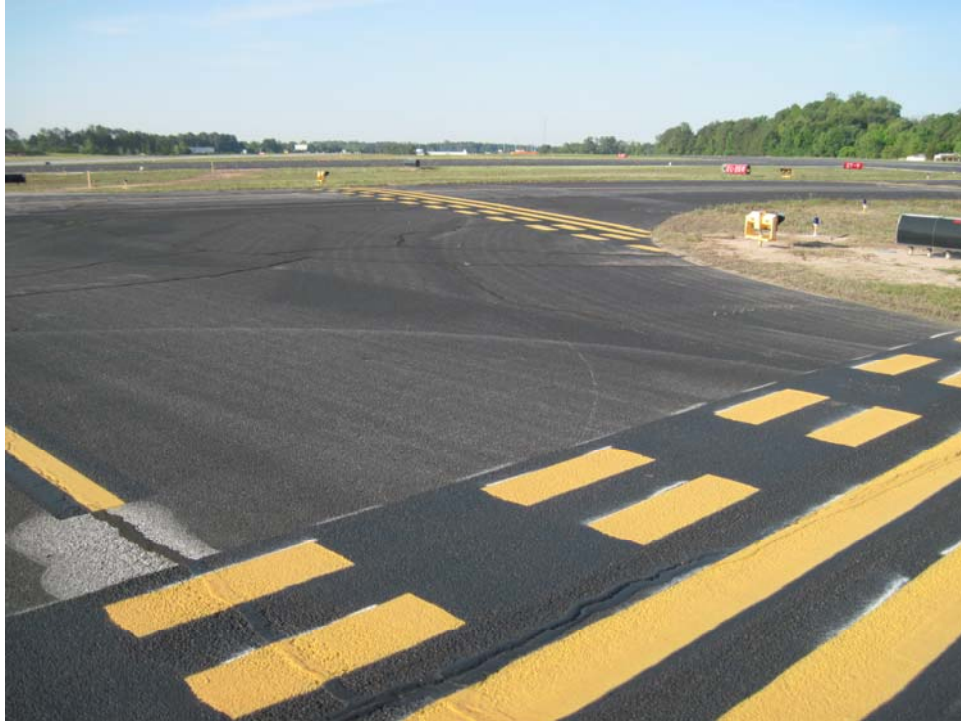
TBAP-30. Satisfactory Paint.

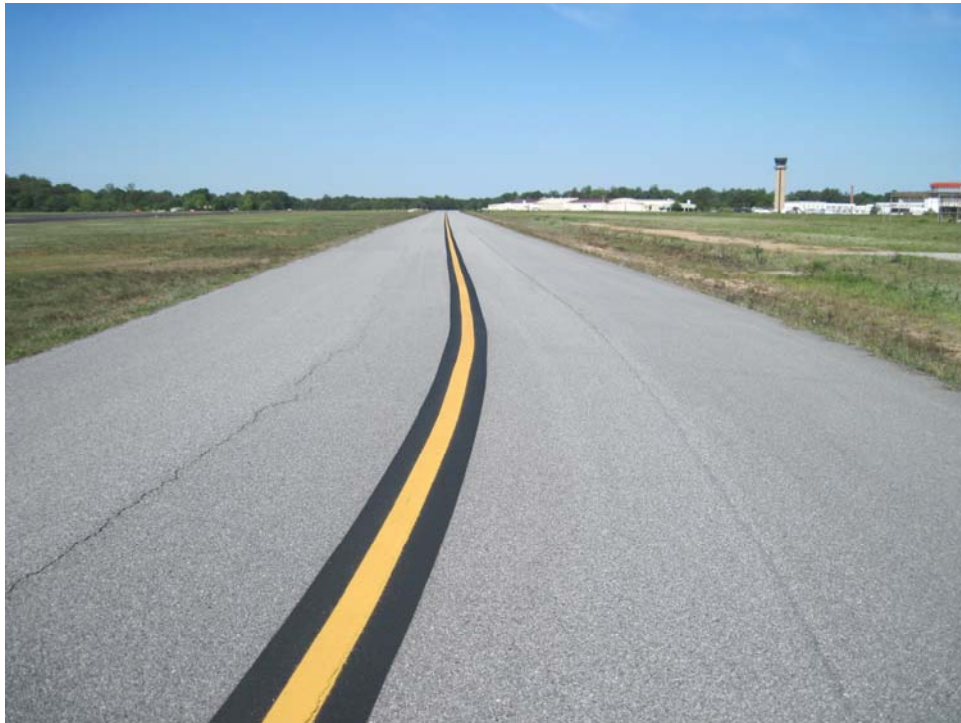
TBAP-40. Satisfactory Paint.

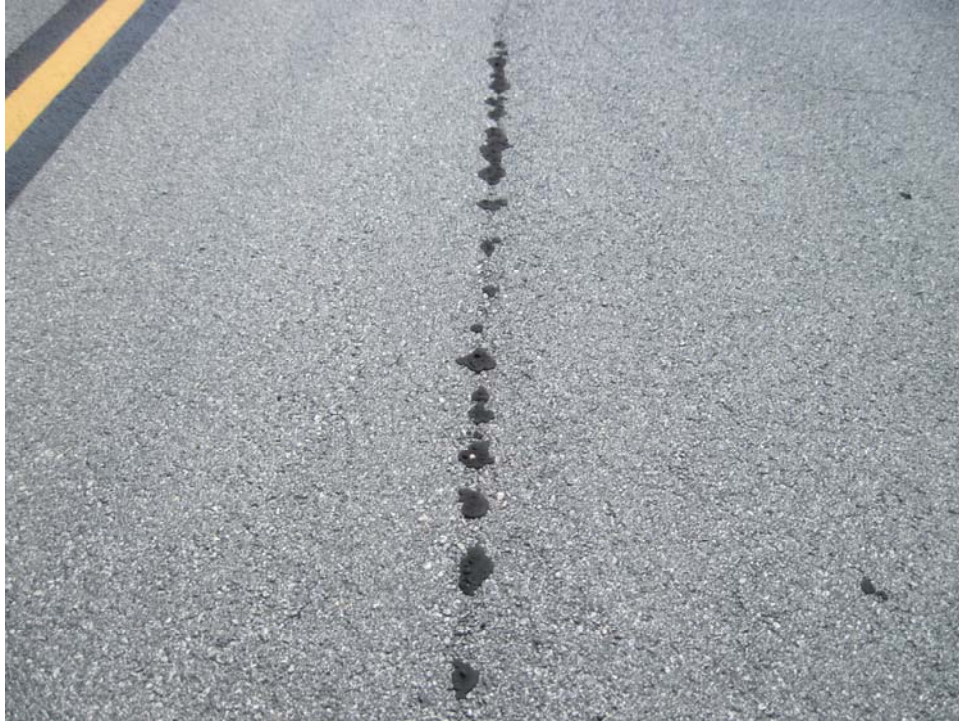
TCAP-10. Overview.

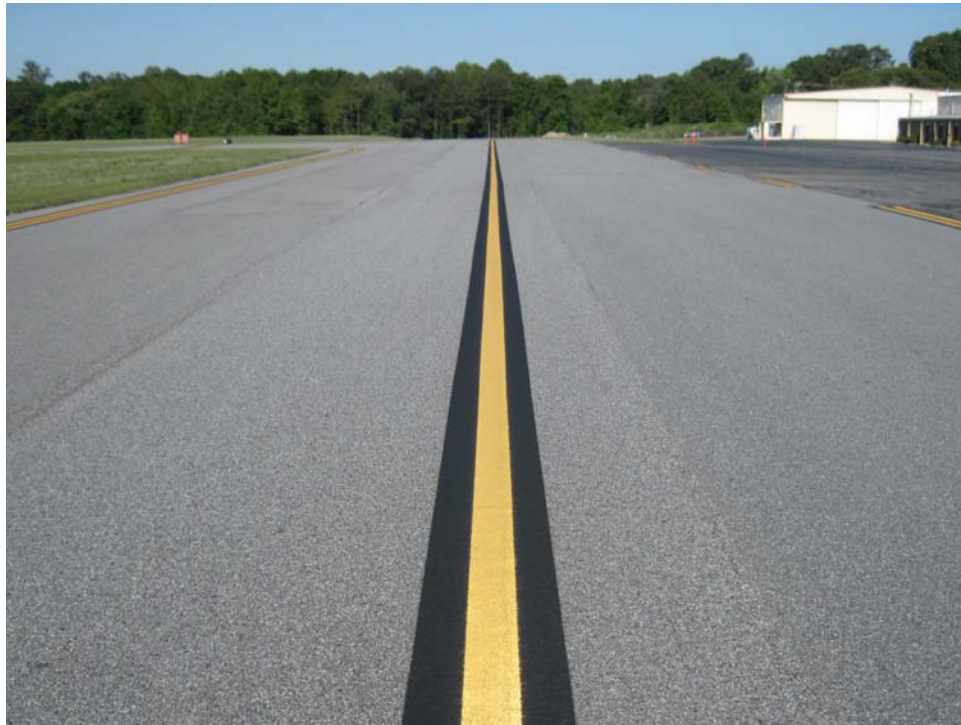
TCAP-10. Satisfactory Paint.

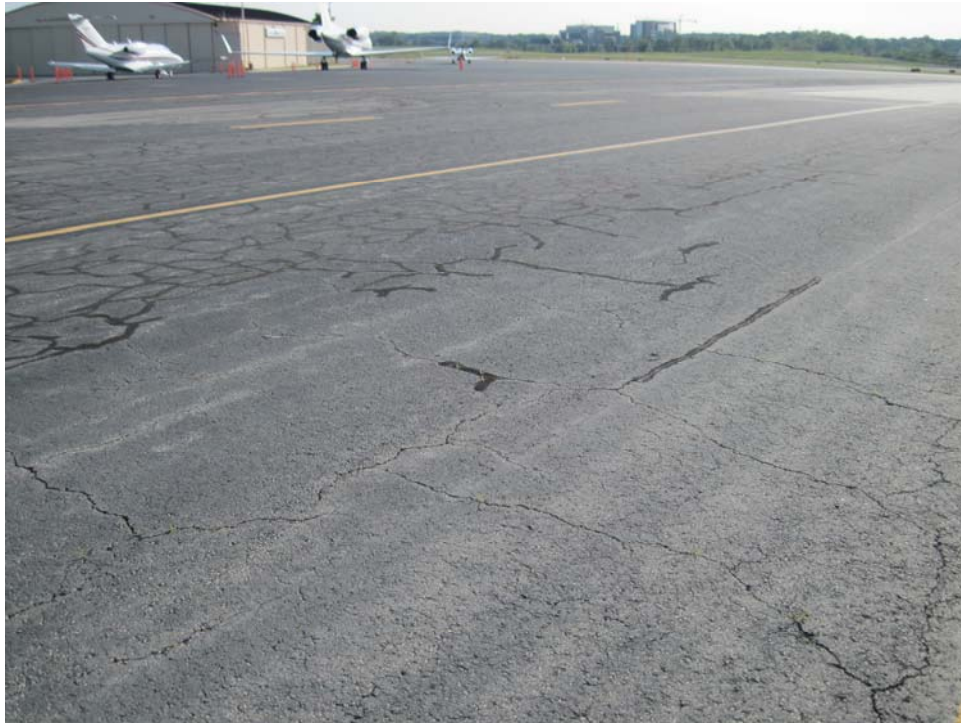
TCAP-20. Satisfactory Paint.

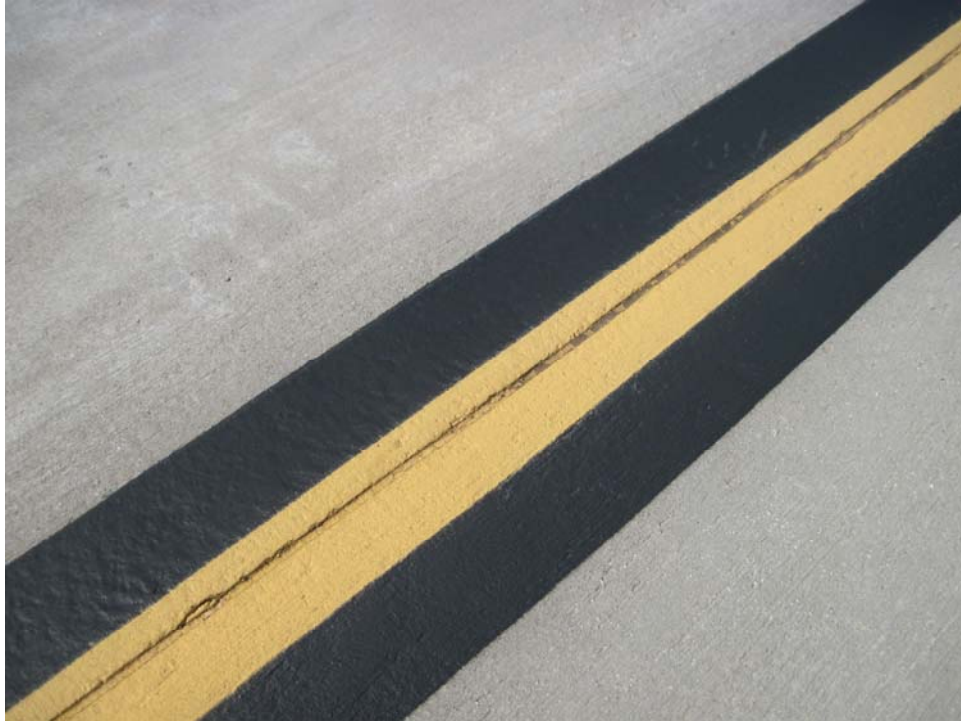
TEAP-10. Satisfactory Paint.

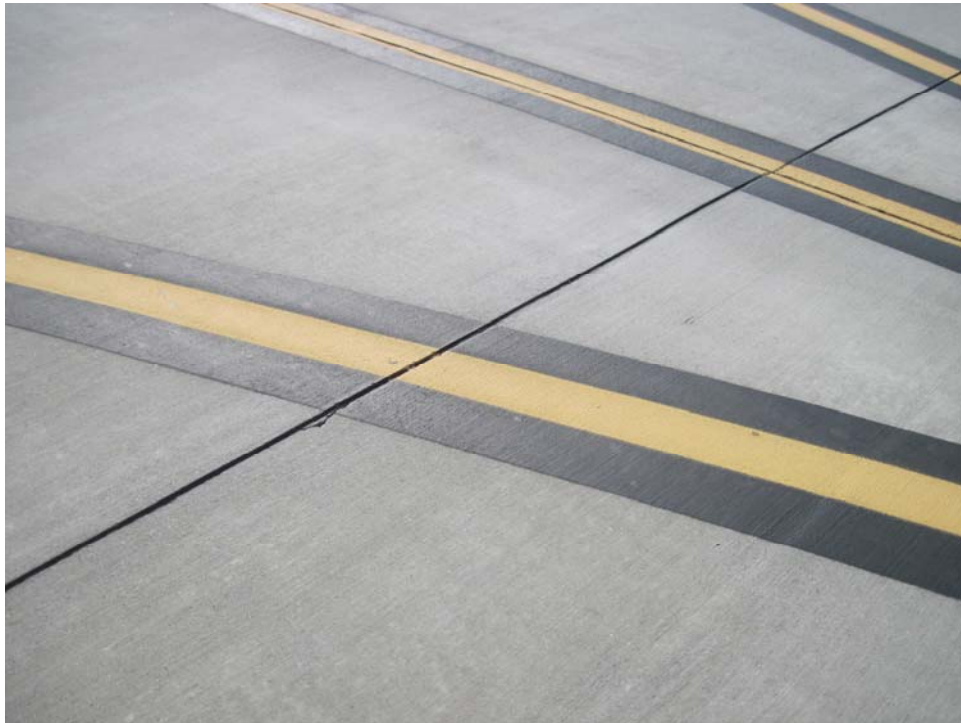
TEAP-20. Satisfactory Paint.

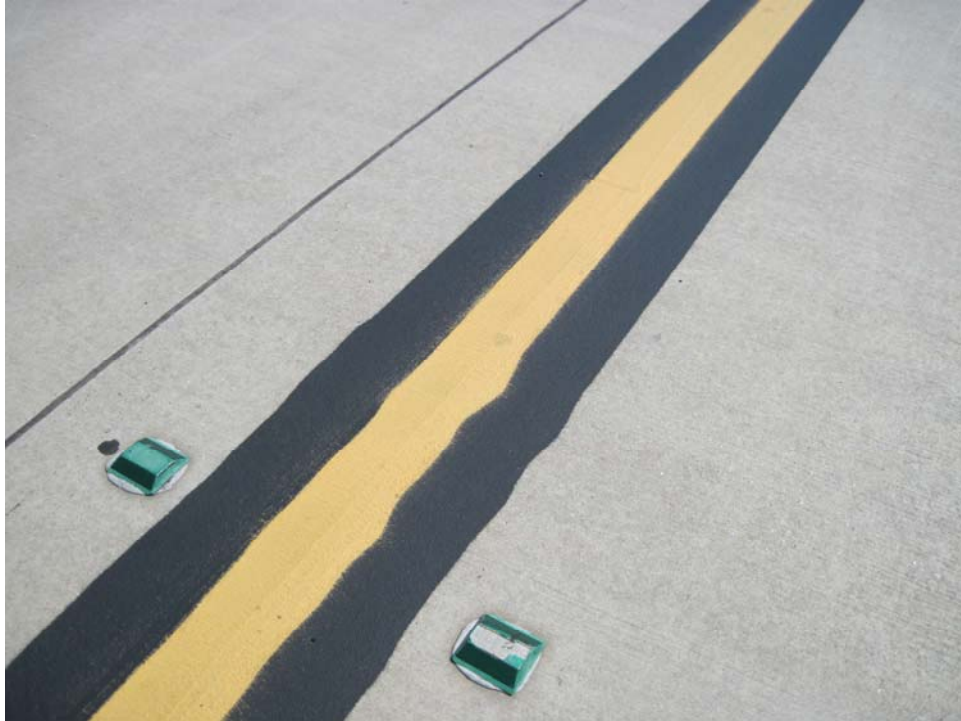
TKAP-10. Satisfactory Paint.

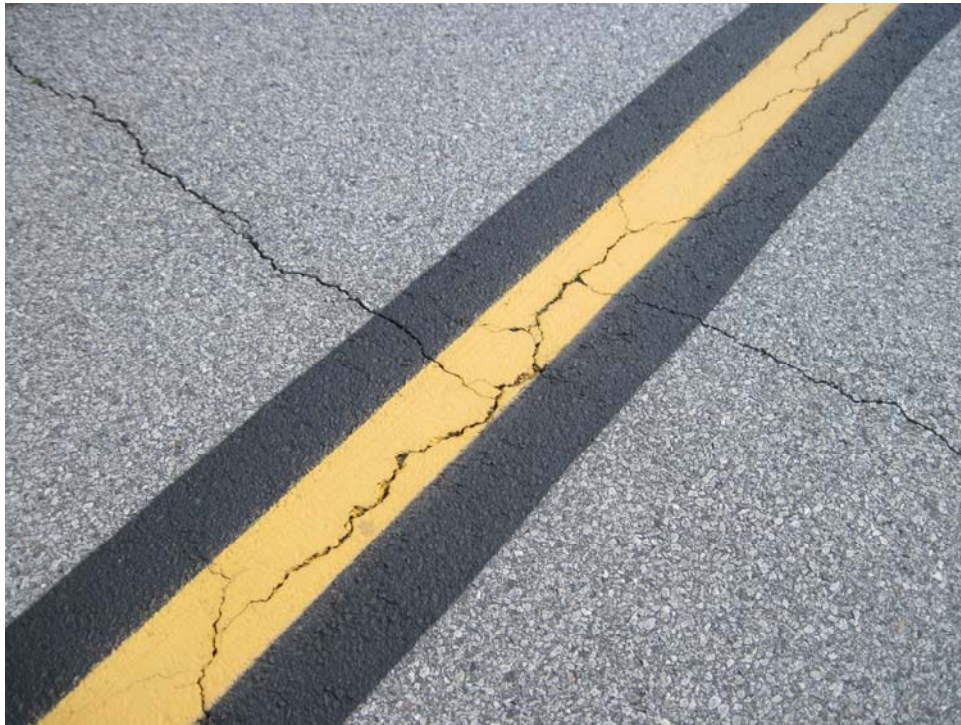
TKAP-20. Satisfactory Paint.
