# 2012 Augusta Regional at Bush Field Pavement Management Plan

# AUGUSTA REGIONAL AT BUSH FIELD

## PAVEMENT MANAGEMENT REPORT

**DECEMBER 2012**

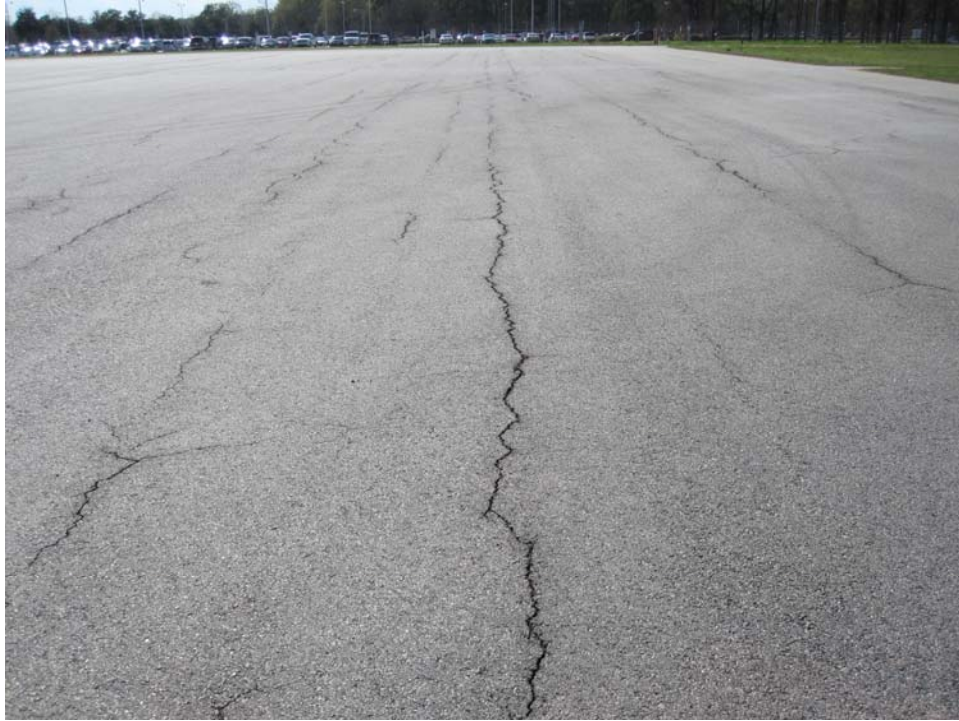
A01AGR-10. Overview.

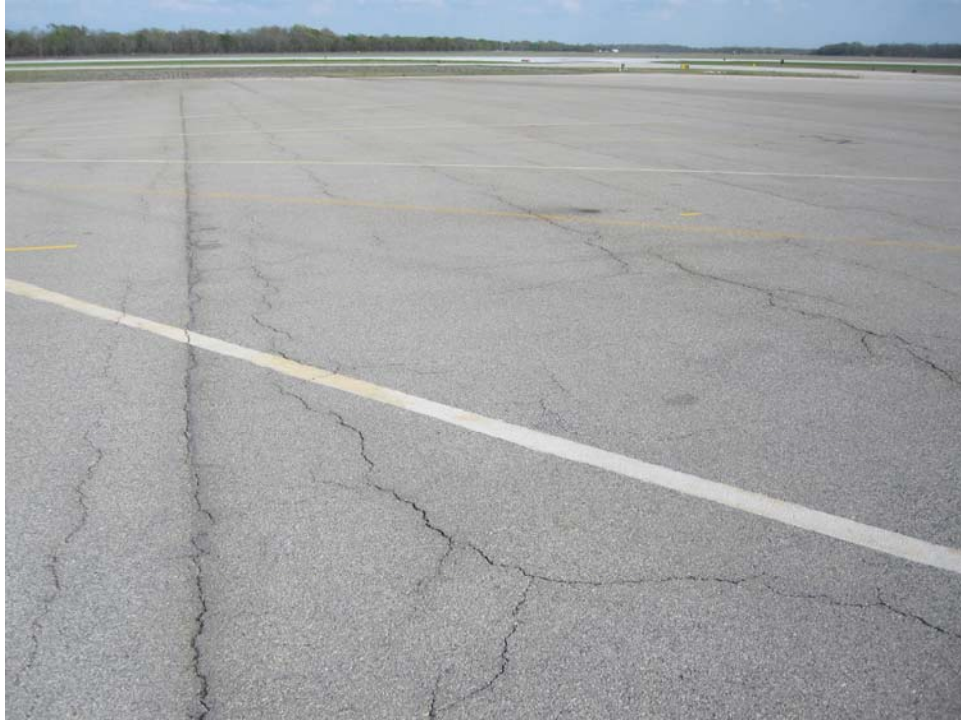
A01AGR-20. Overview.

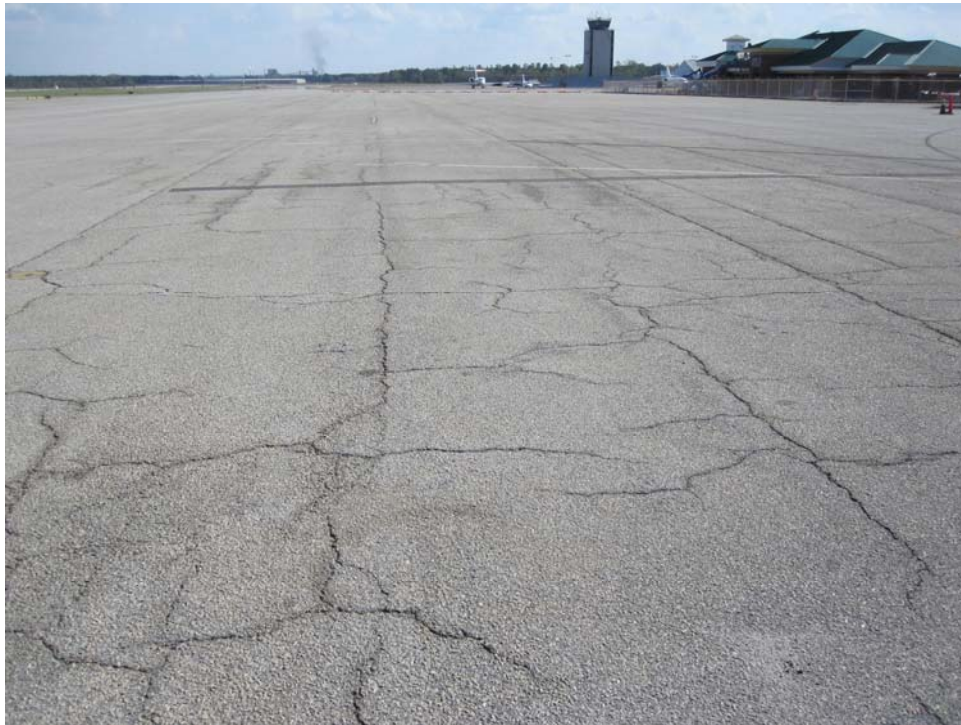
A01AGR-30. Overview.

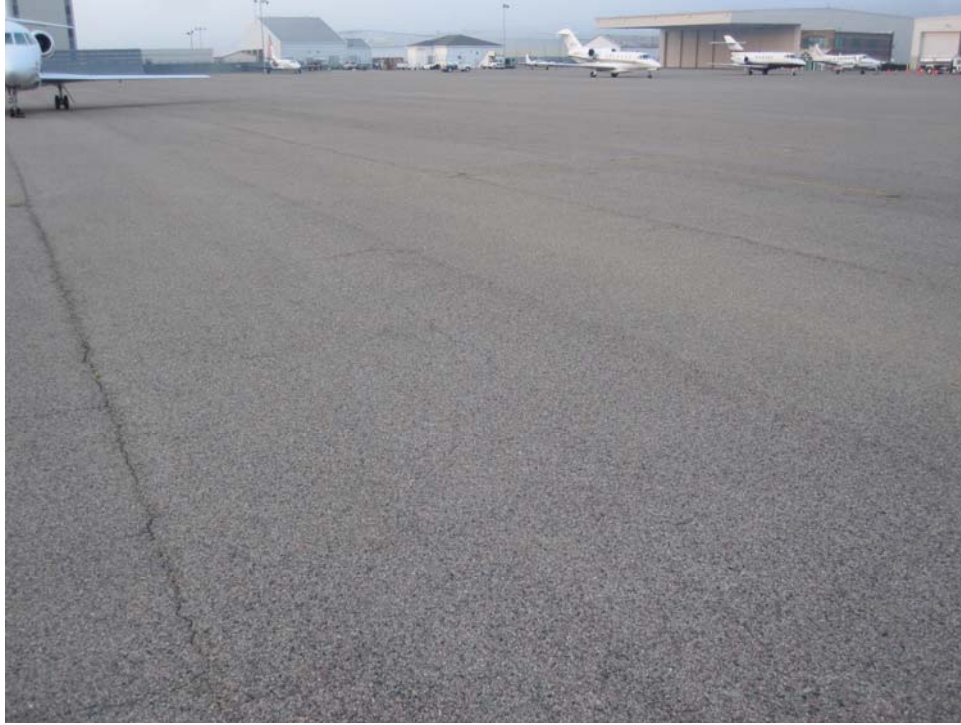
A01AGR-40. Overview.

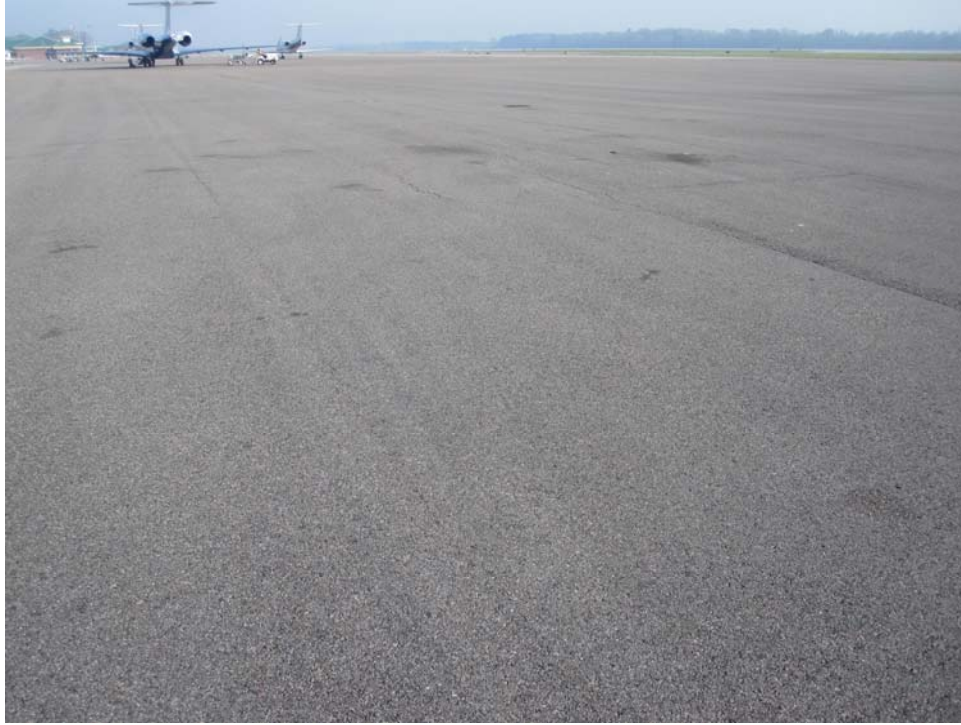
A01AGR-50. Overview.

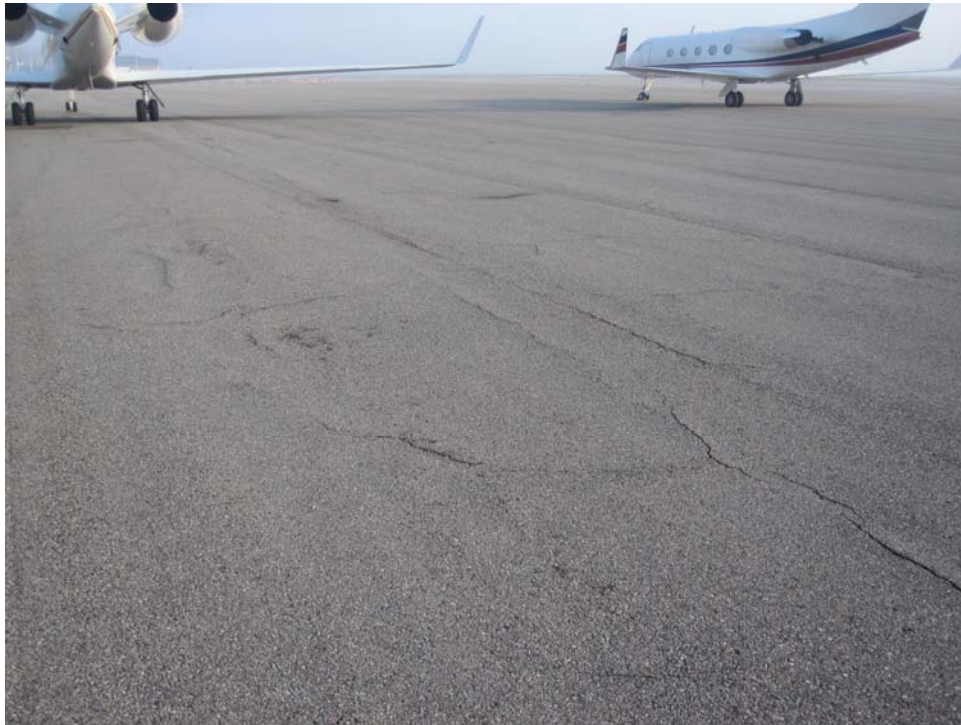
A01AGR-60. Overview.

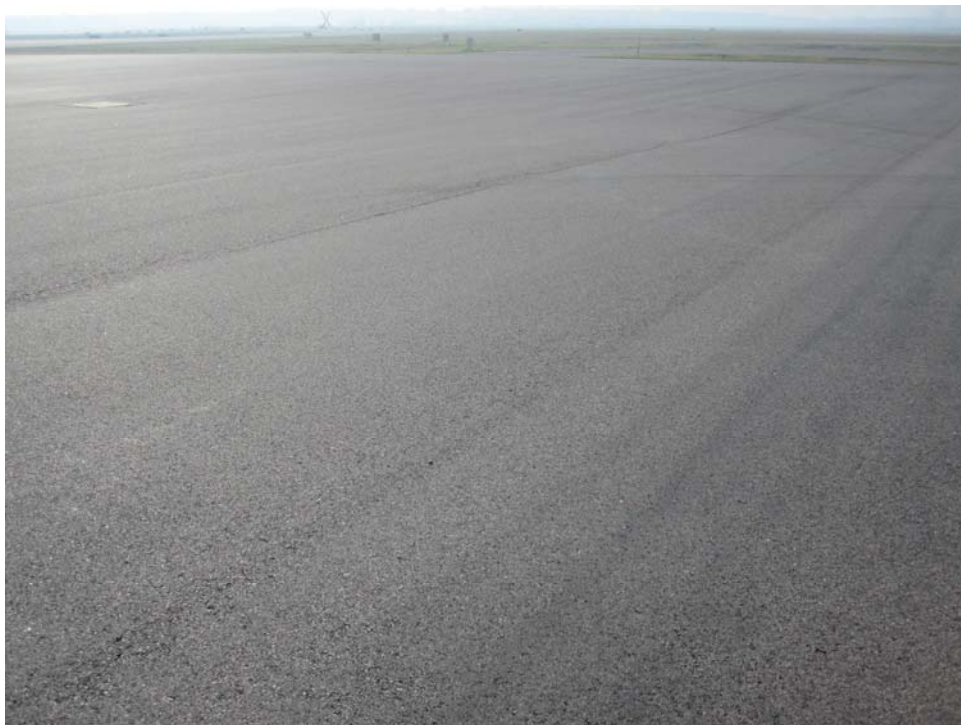
A01AGR-70. Overview.

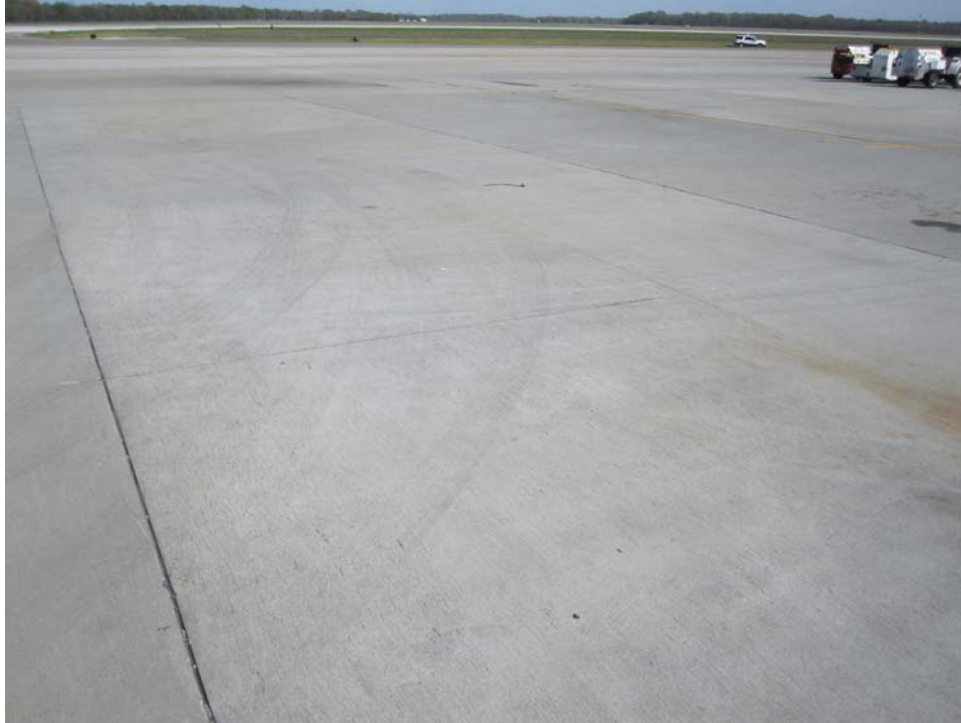
A01AGR-80. Overview.

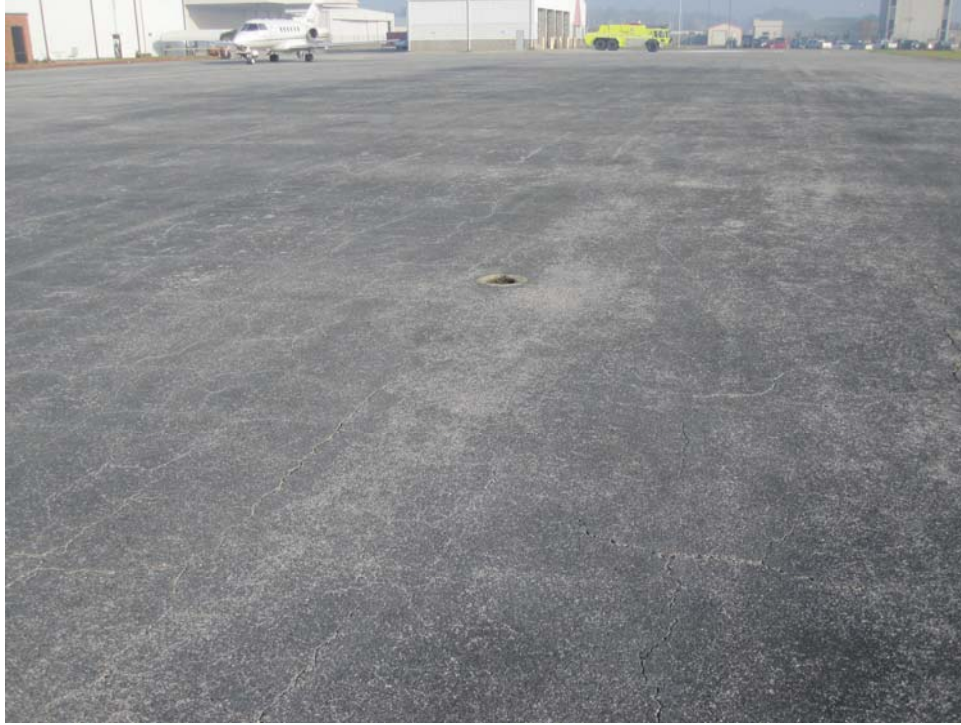
AGARRETAGR-10. Overview.

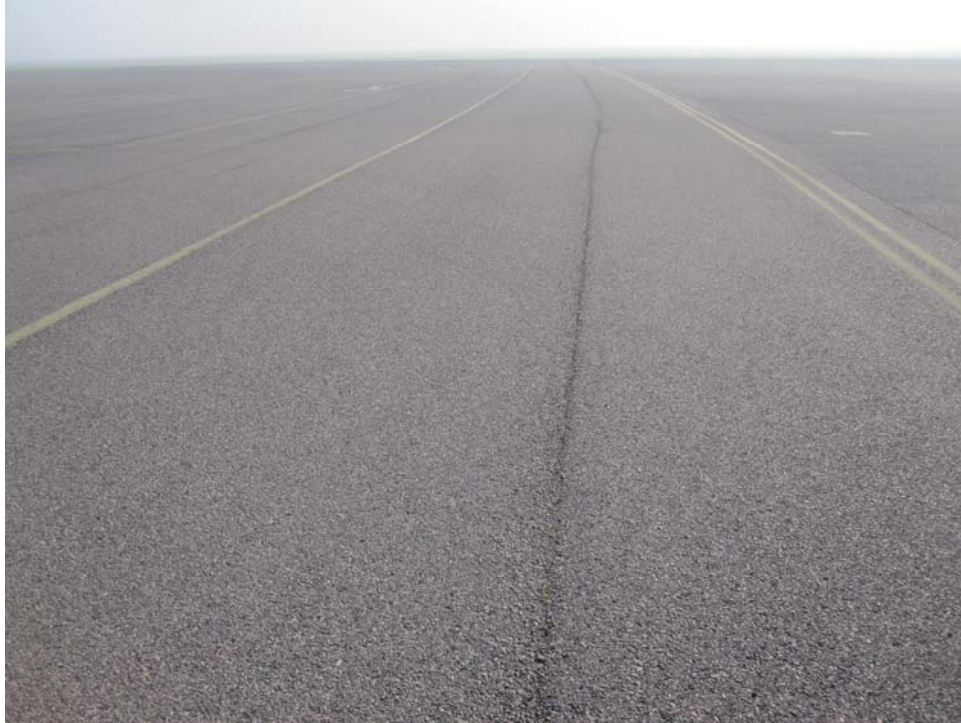
AGARRETAGR-20. Overview.

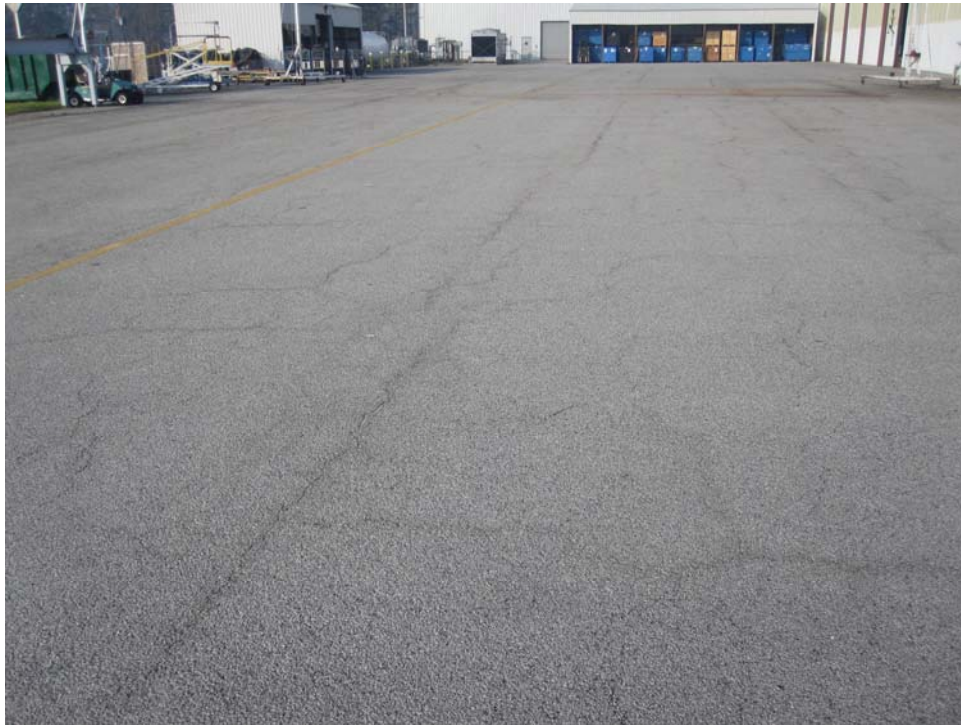
AGARRETAGR-30. Overview.

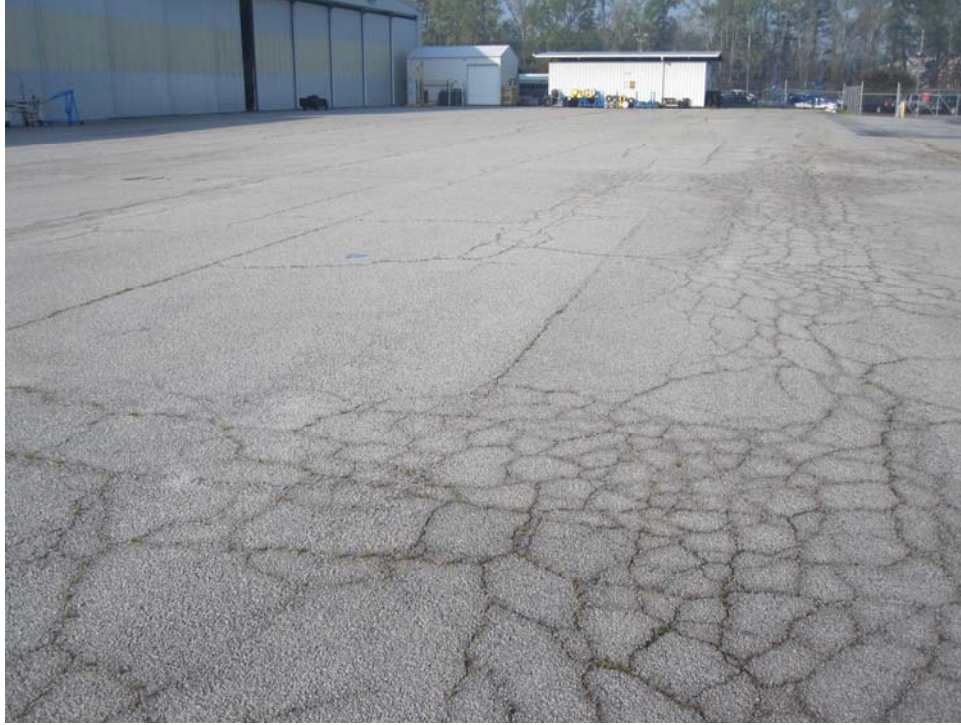
AGARRETAGR-40. Overview.

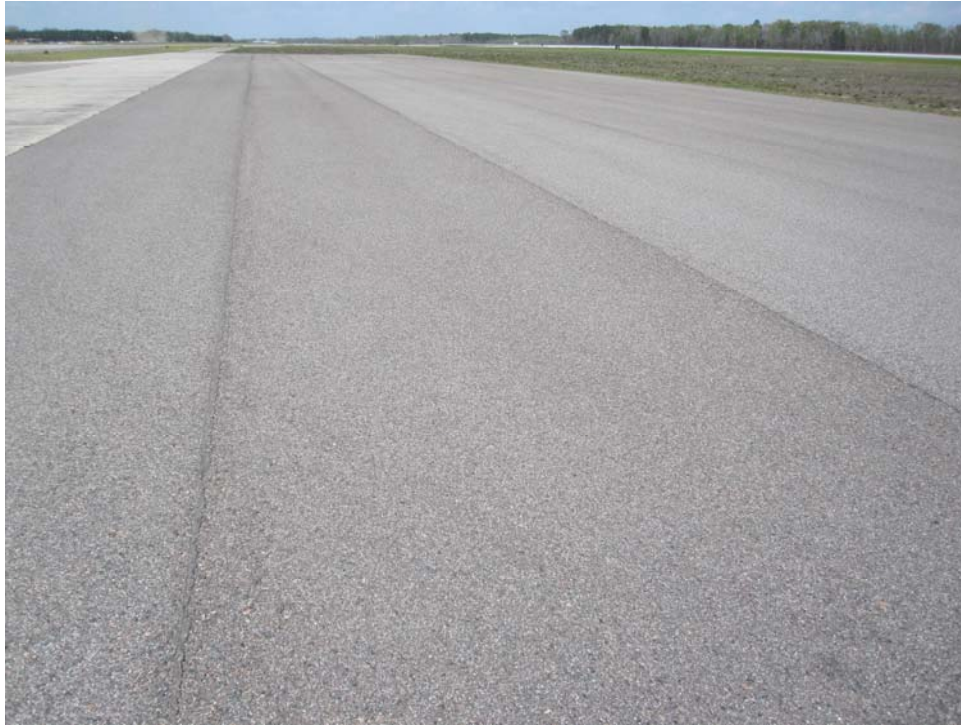
HELIAGR-10. Overview.

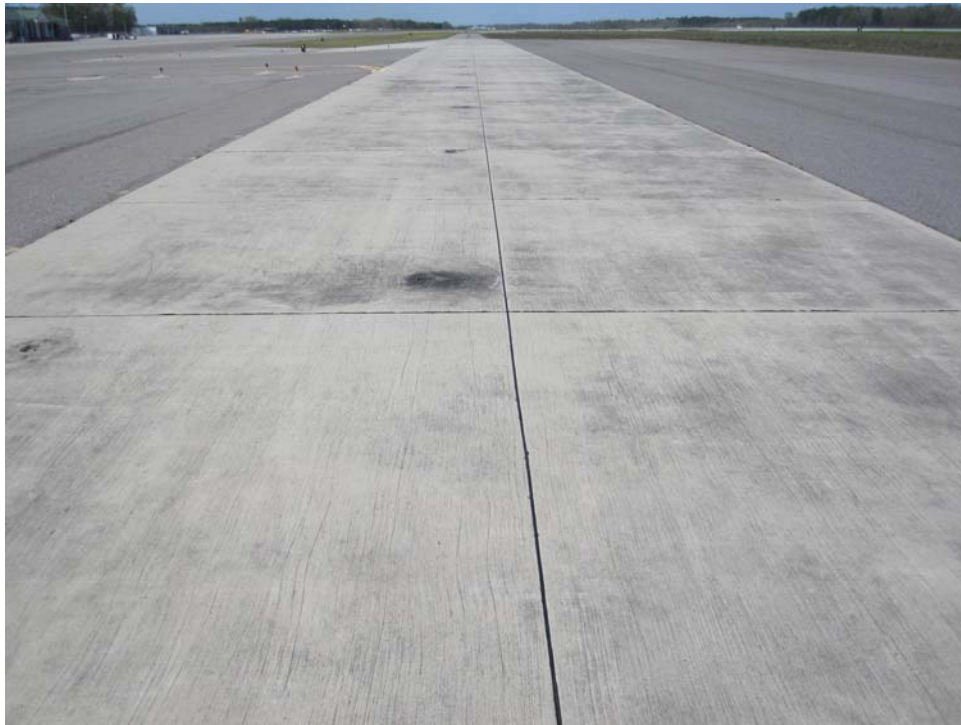
HELIAGR-20. Overview.

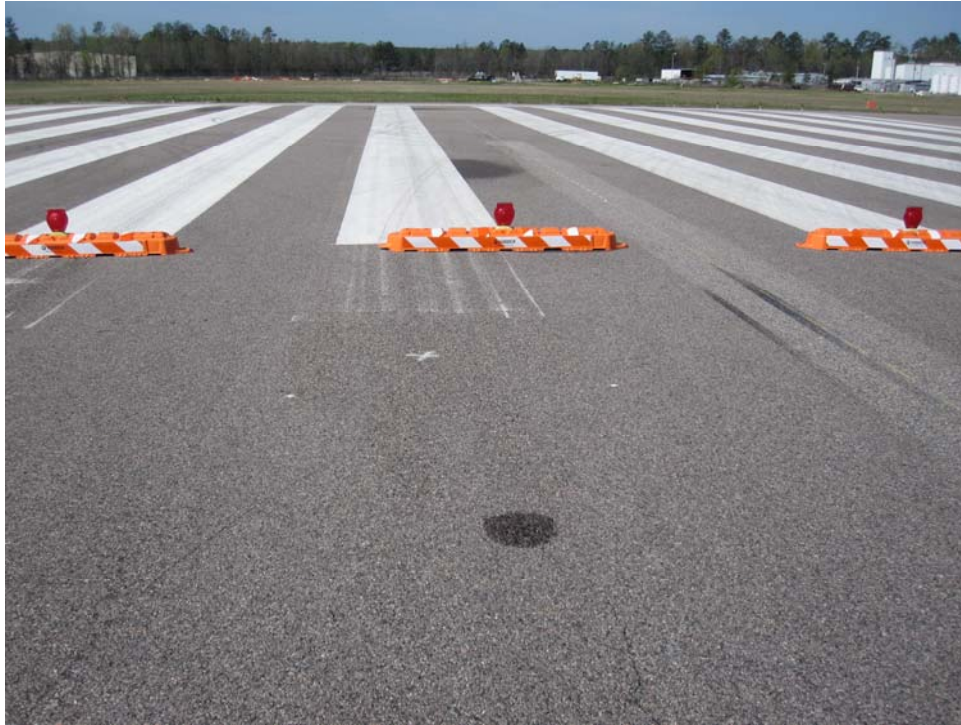
Runway 8-26 was comprised of four sections and received heavy usage during 2011 while Runway 17-35 was closed for reconstruction. Section 10 had a PCI value of 78. The primary distresses identified in this section were low-severity longitudinal and transverse (L&T) cracking and low-severity weathering. In addition, low-severity patching was observed throughout. Section 20 had a PCI value of 79. The primary distresses identified in this section were low-severity weathering and L&T cracking along with smaller quantities of medium-severity L&T cracking. Section 25, located on both sides of Runway 17-35, was reconstructed at the same time as Runway 17-35. This section was in excellent condition with a PCI value of 100. No distresses were observed at the time of inspection. Section 30 had a PCI value of 70. The primary distresses recorded were low-severity weathering, L&T cracking, and patching. Smaller quantities of bleeding, medium-severity L&T cracking, medium-severity weathering, and low-severity raveling were also noted.

R0826AGR-10. Overview.

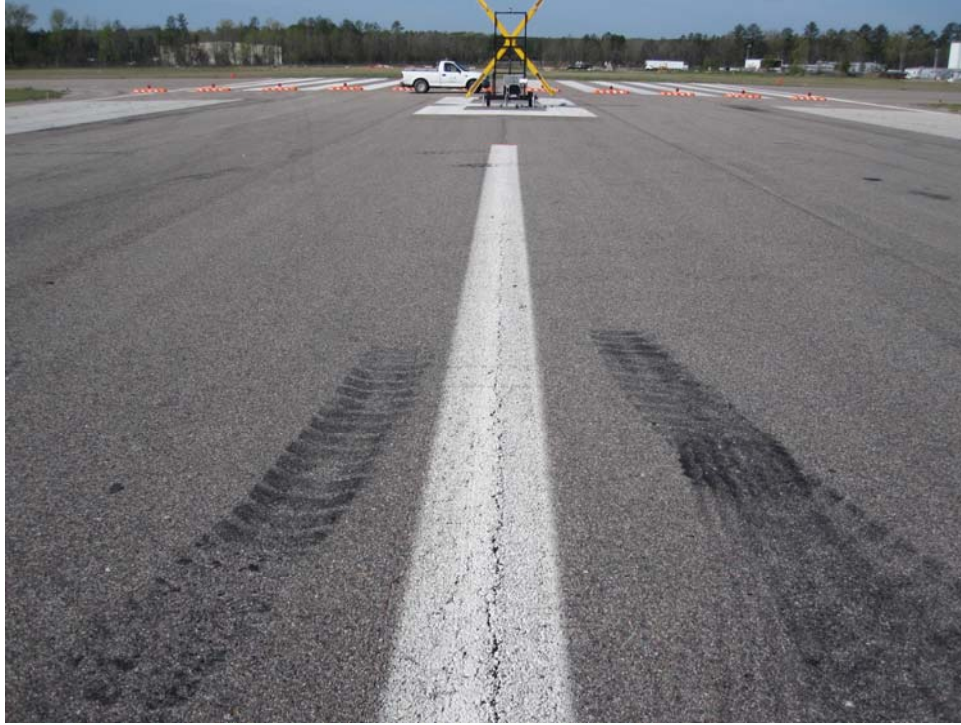
R0826AGR-20. Overview.

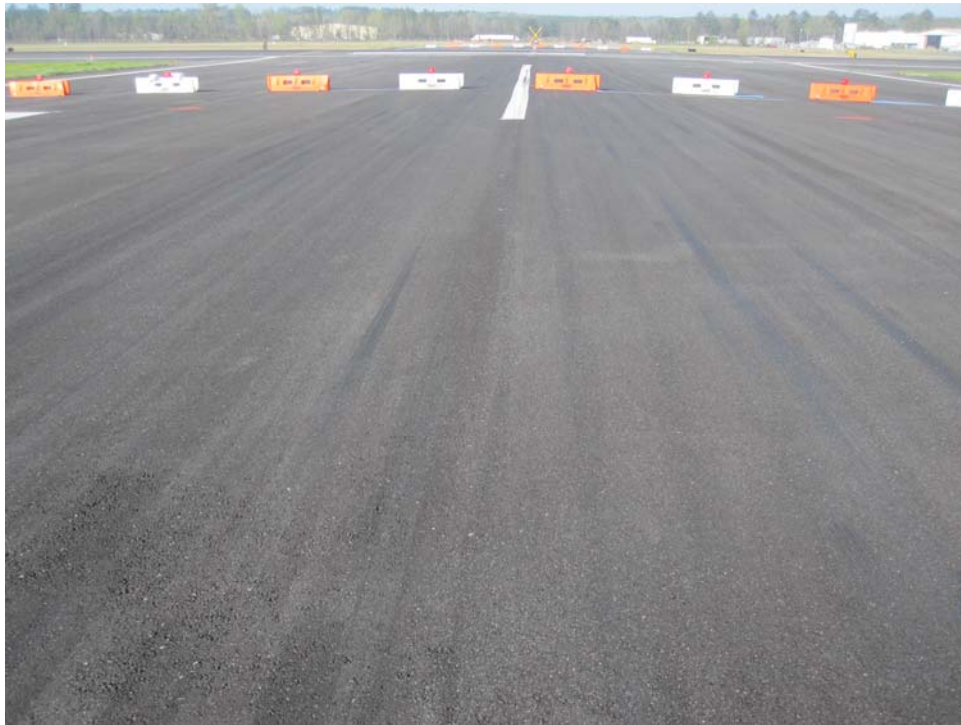
R0826AGR-25. Overview.

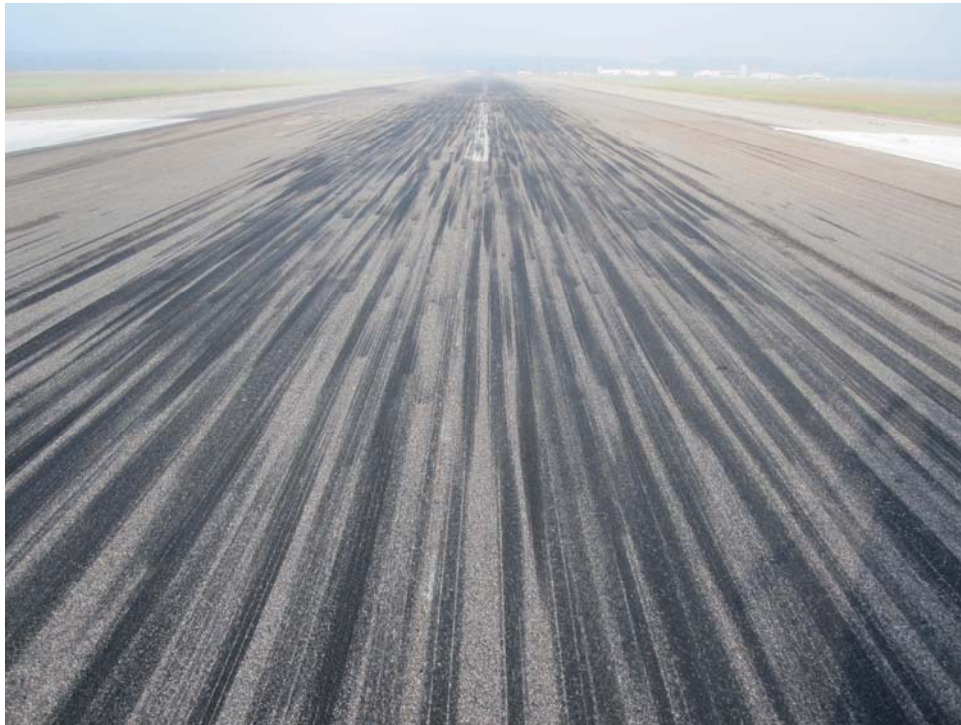
R0826AGR-30. Overview (1).

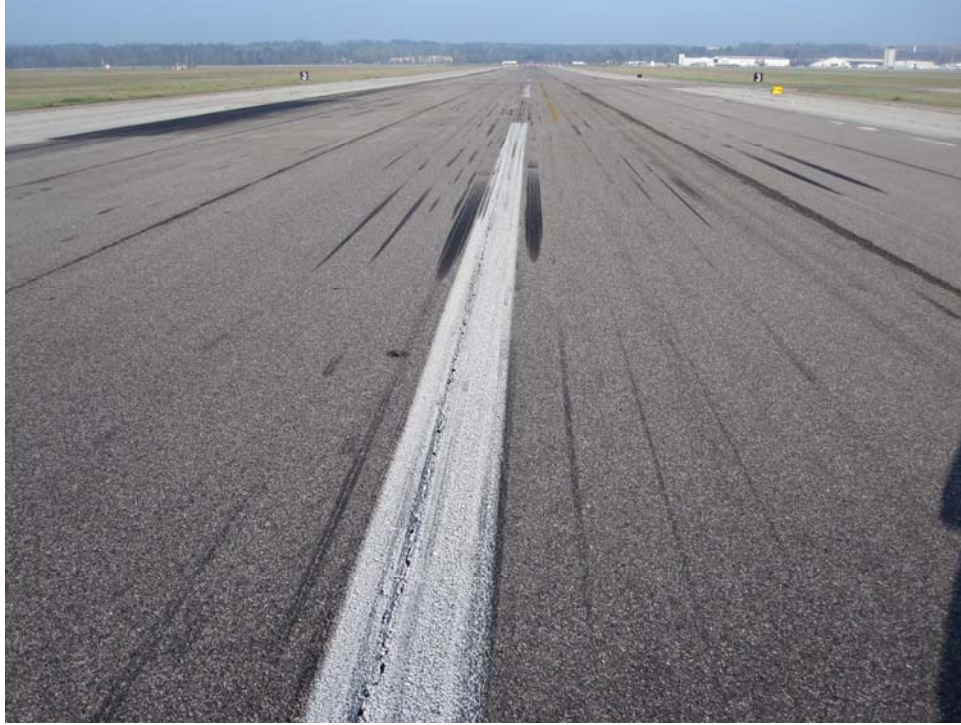
R0826AGR-30. Overview (2).

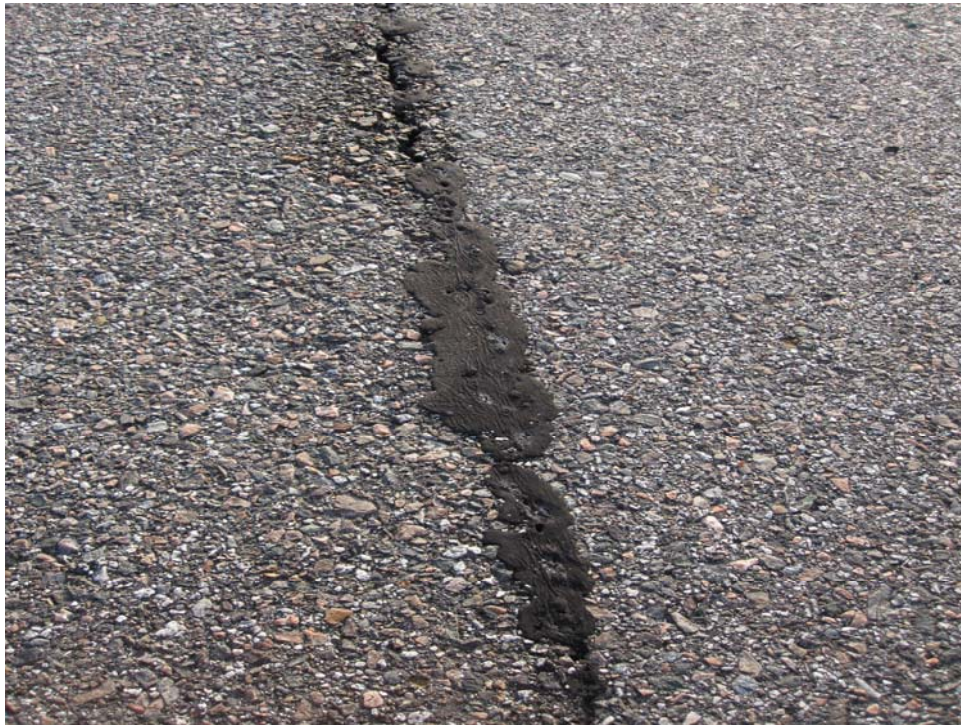
R0826AGR-30. Bleeding (Sample Unit #68).

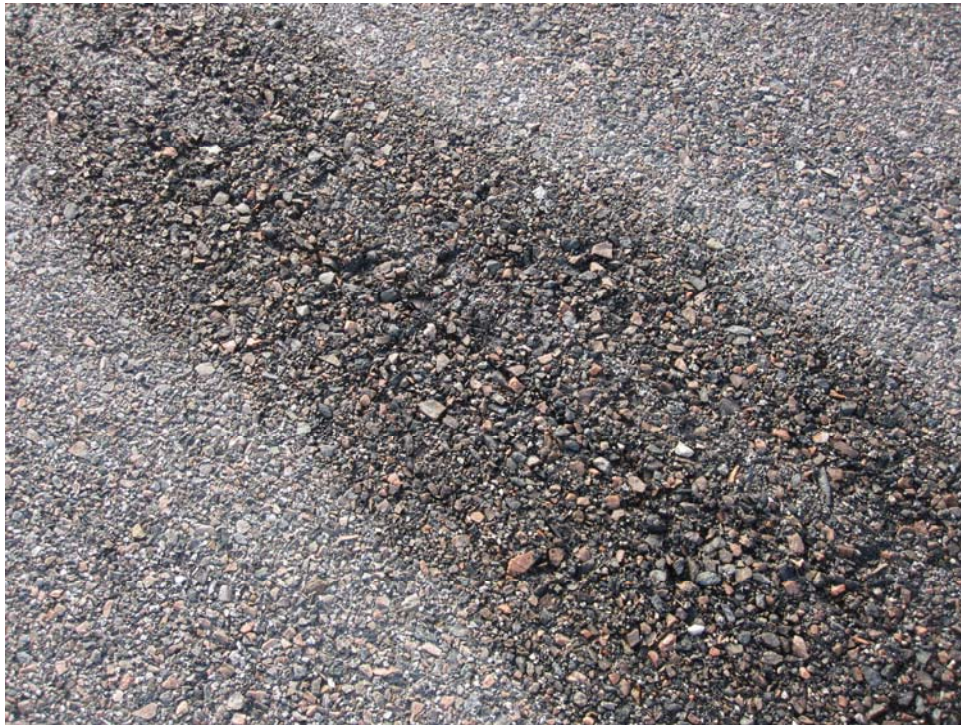
R0826AGR-30. Raveling (Sample Unit #54).

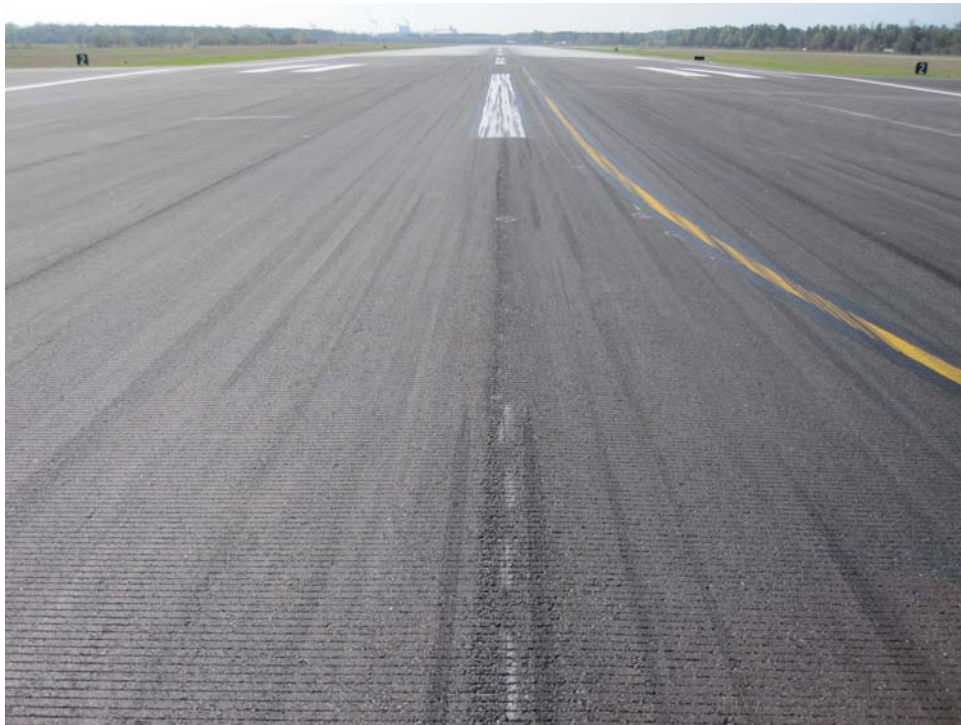
R1735AGR-10C. Overview.

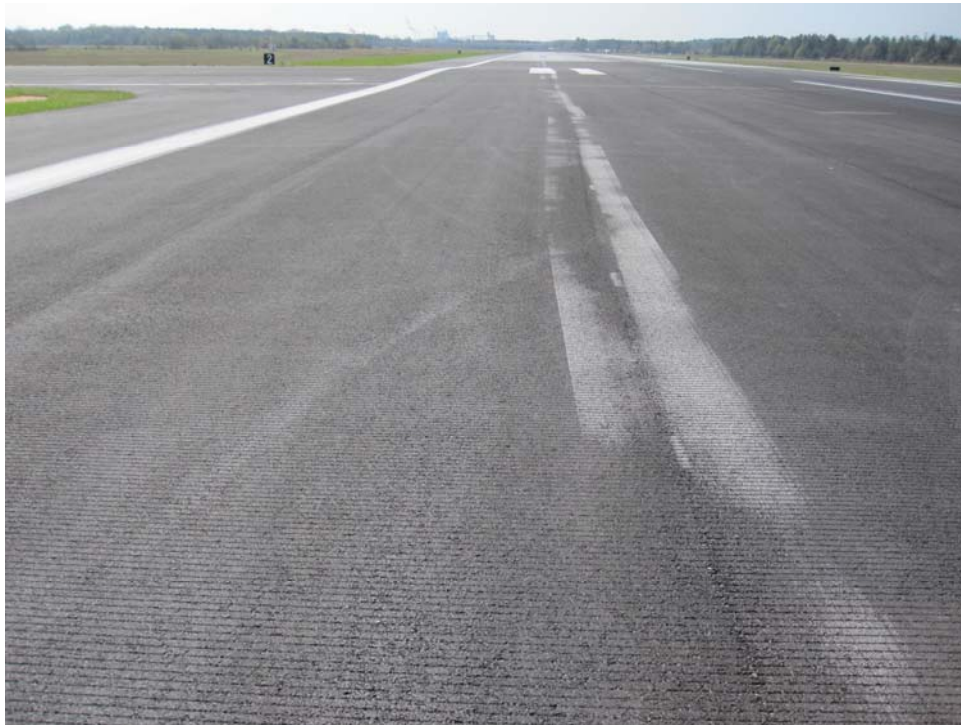
R1735AGR-10E. Overview.

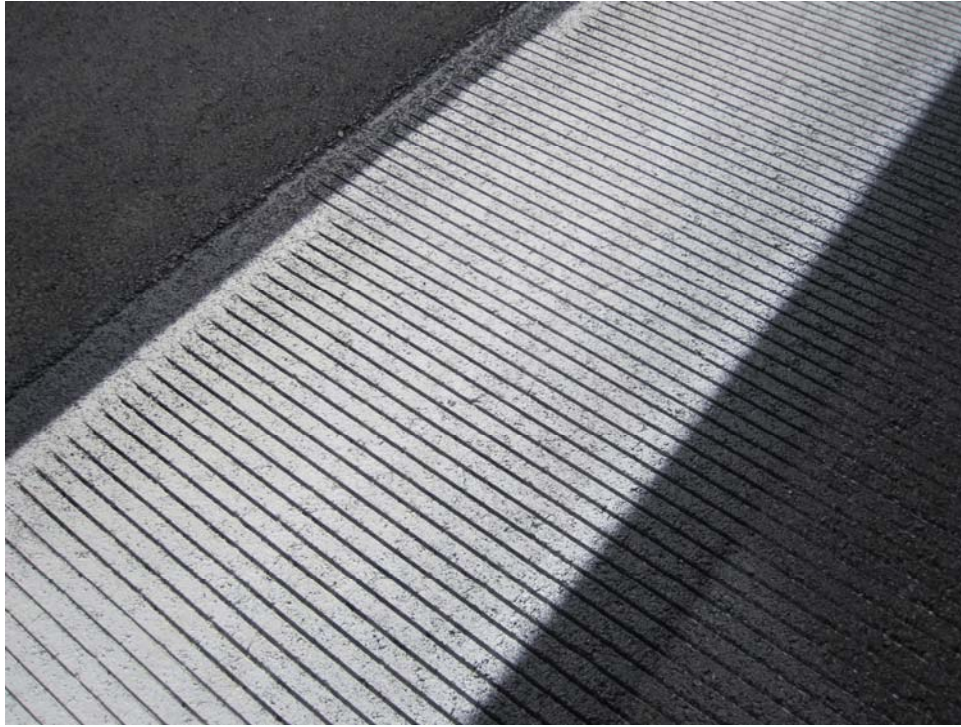
R1735AGR-10E. Satisfactory Paint.

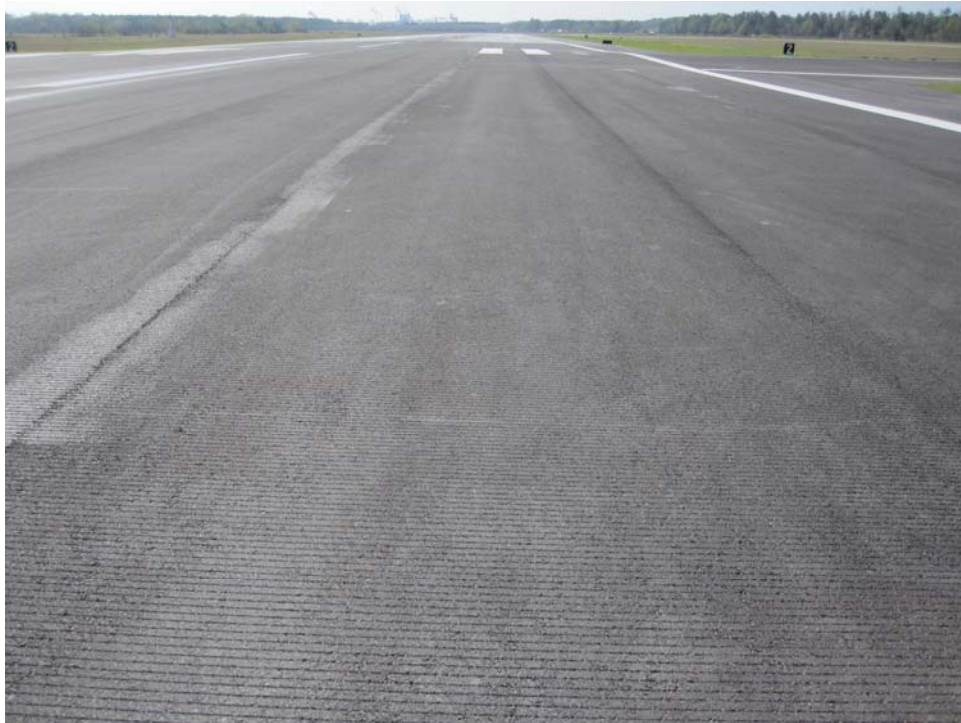
R1735AGR-10W. Overview.

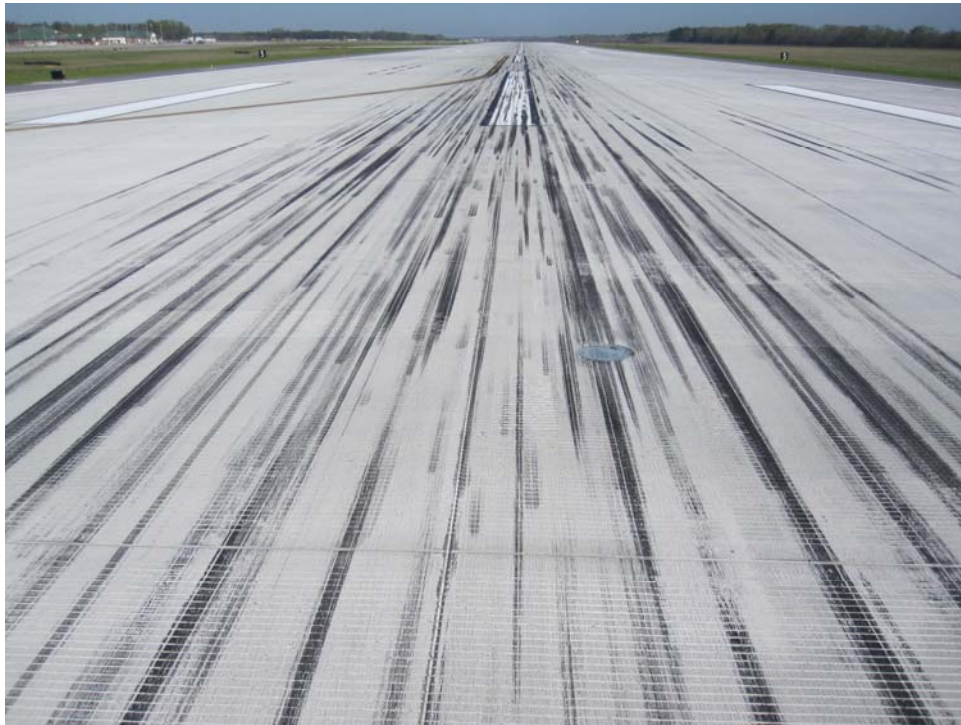
R1735AGR-20C. Overview.

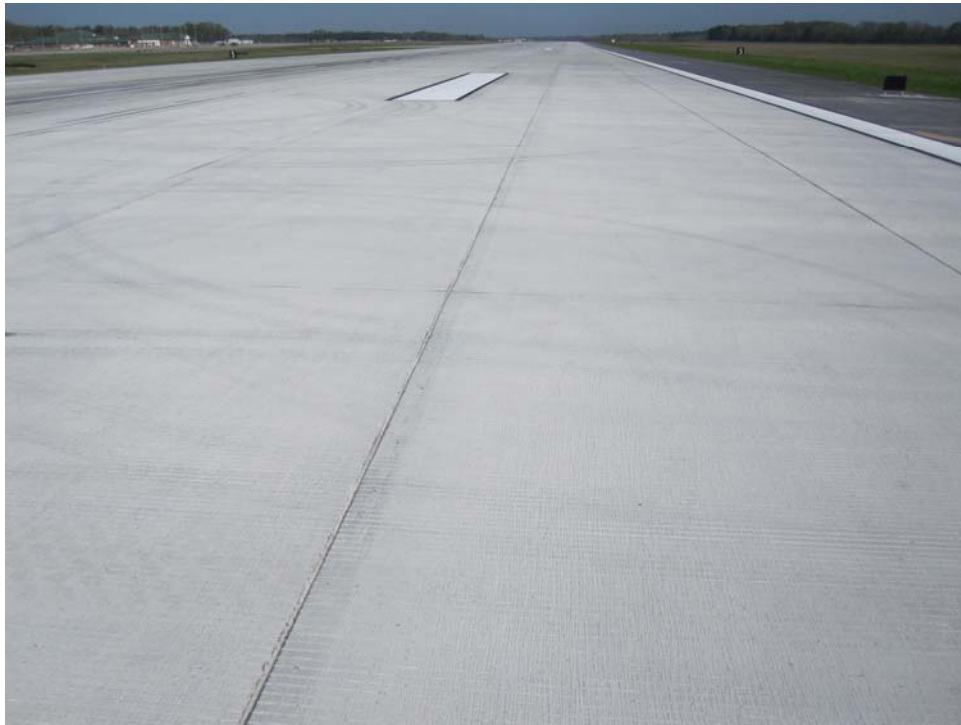
R1735AGR-20E. Overview.

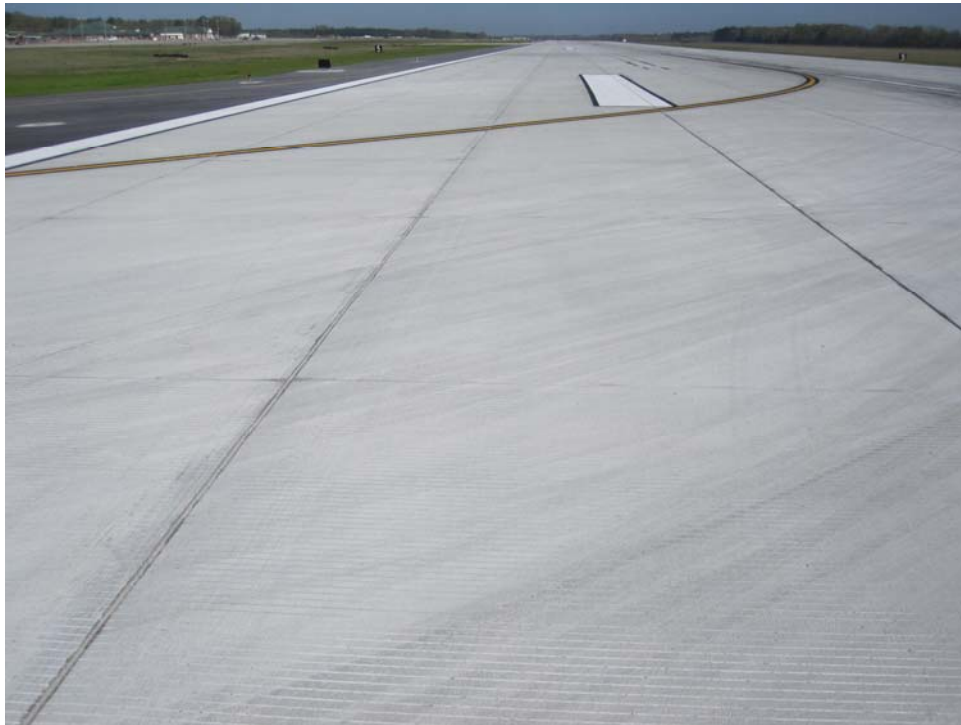
R1735AGR-20W. Overview.

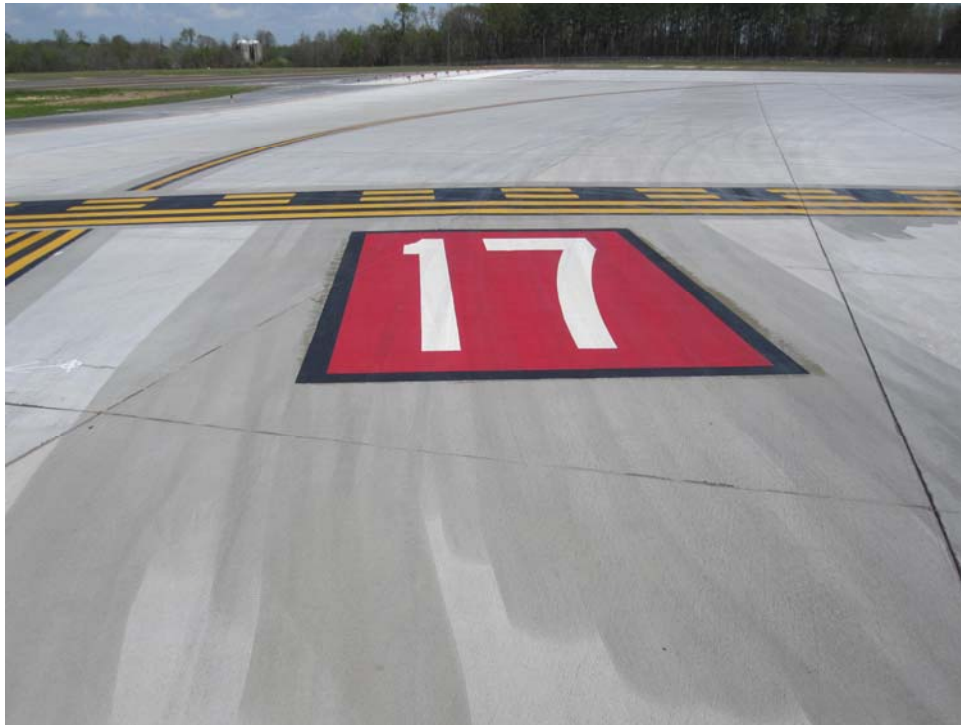
TAAGR-10. Overview.

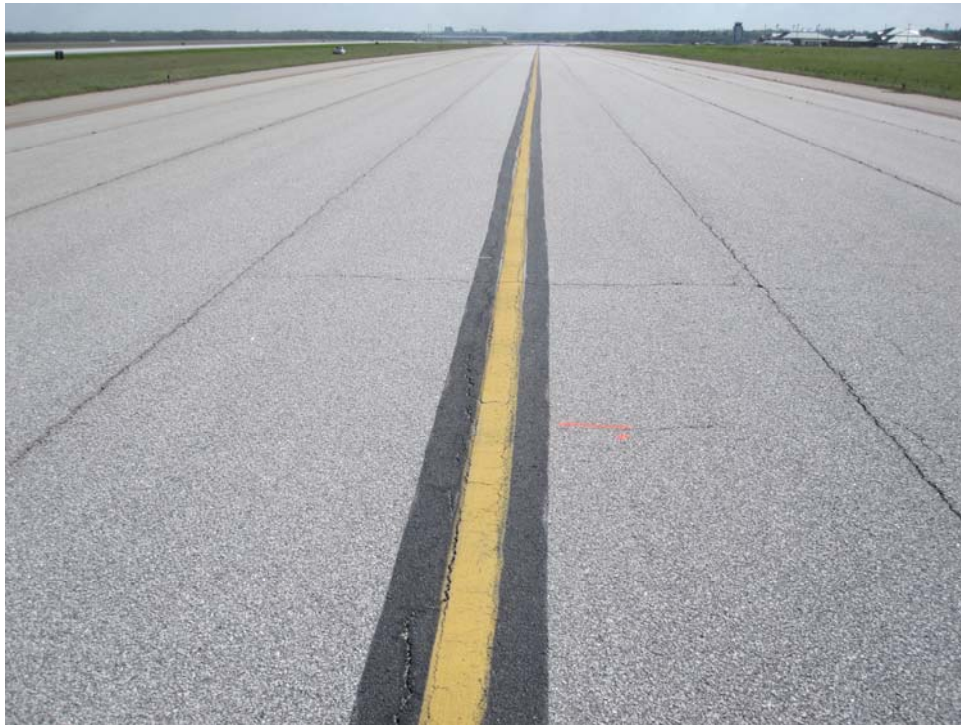
TAAGR-20. Overview.

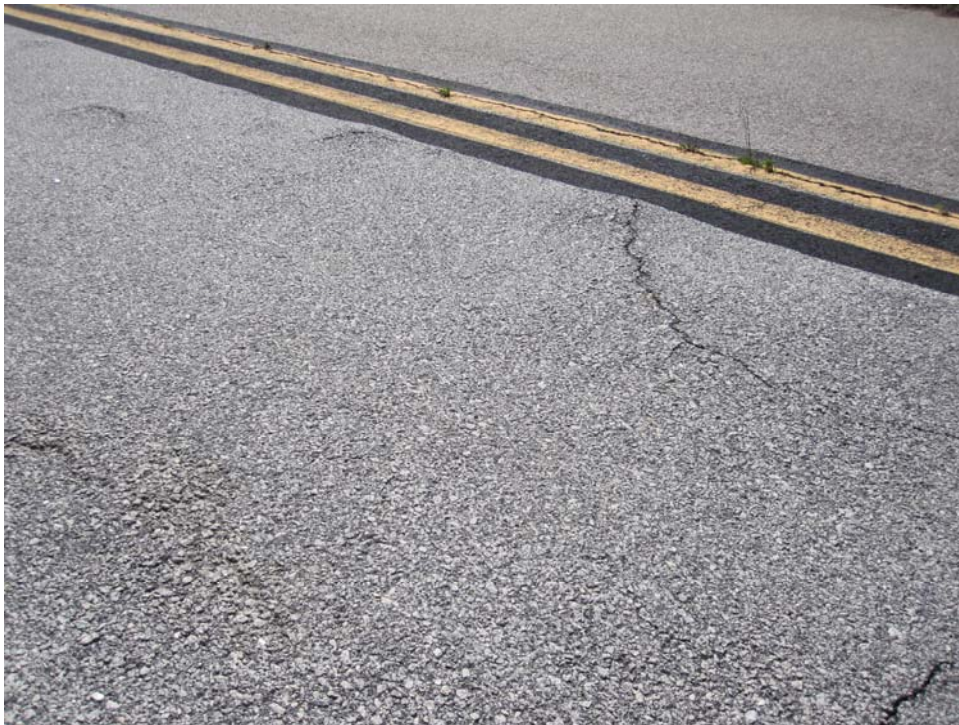
TAAGR-20. Swelling (Sample Unit # 32).

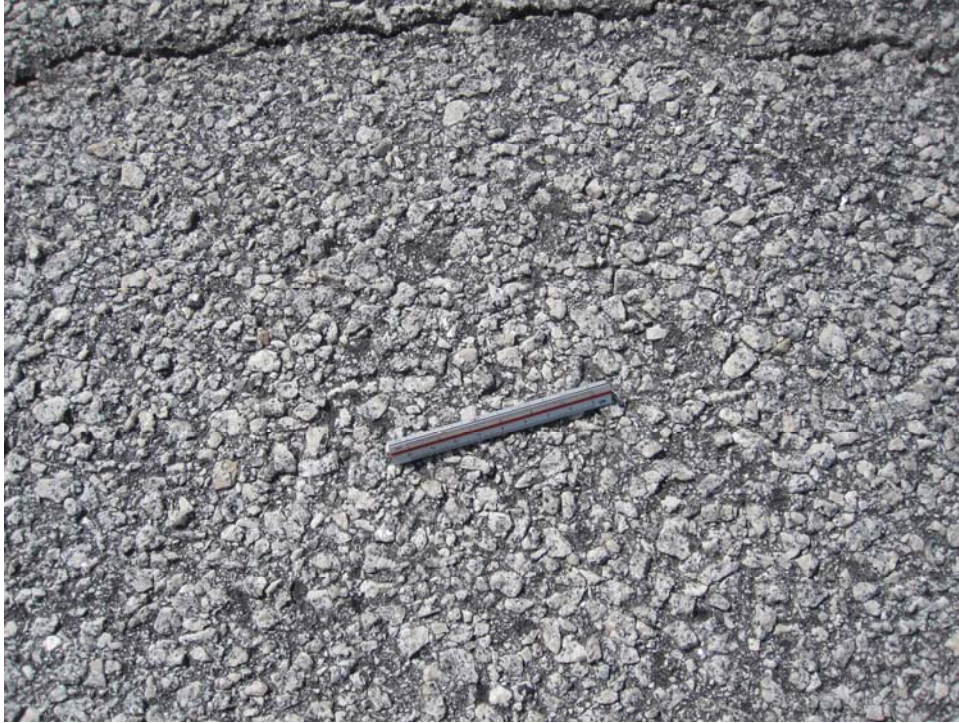
TAAGR-20. Weathering (Sample Unit #27).
