# 2012 Augusta Regional at Bush Field Pavement Management Plan

# AUGUSTA REGIONAL AT BUSH FIELD

## PAVEMENT MANAGEMENT REPORT

**DECEMBER 2012**

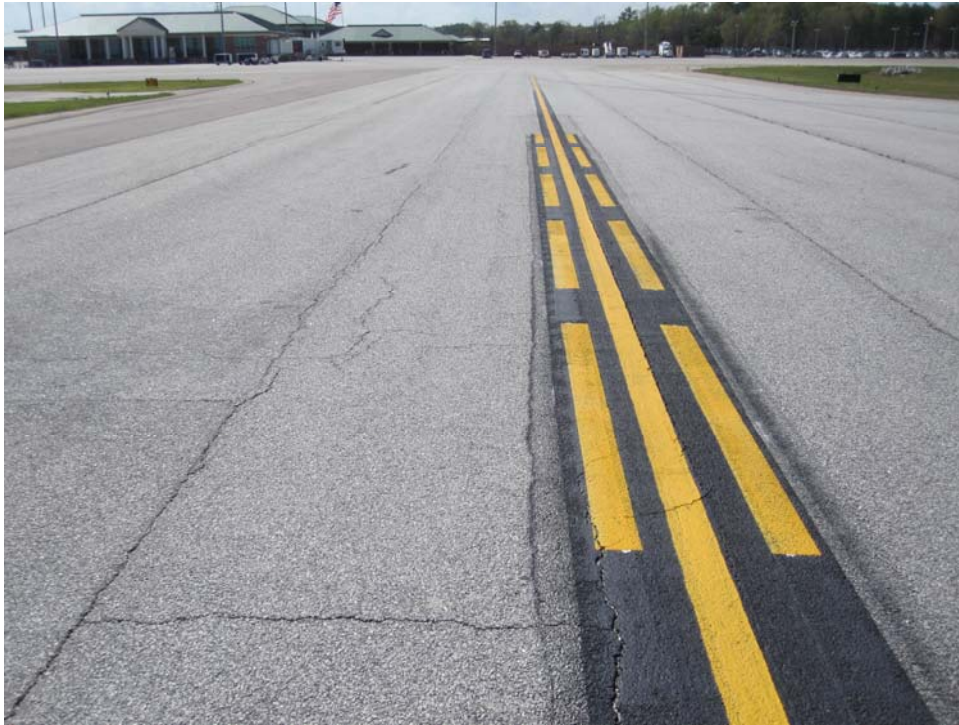
TBAGR-10. Overview.

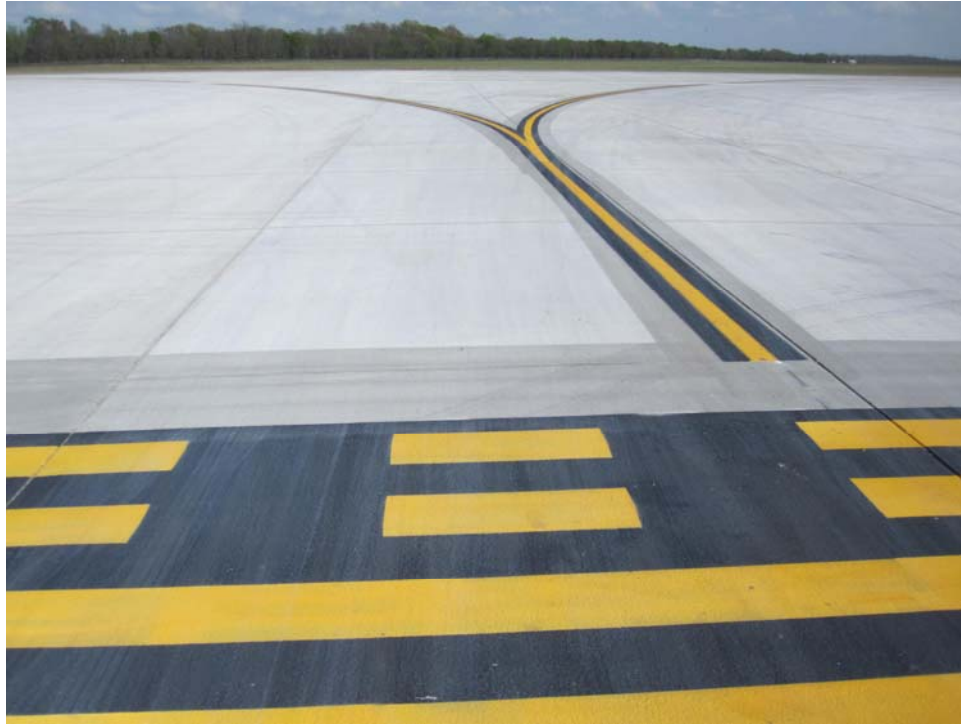
TBAGR-20. Overview.

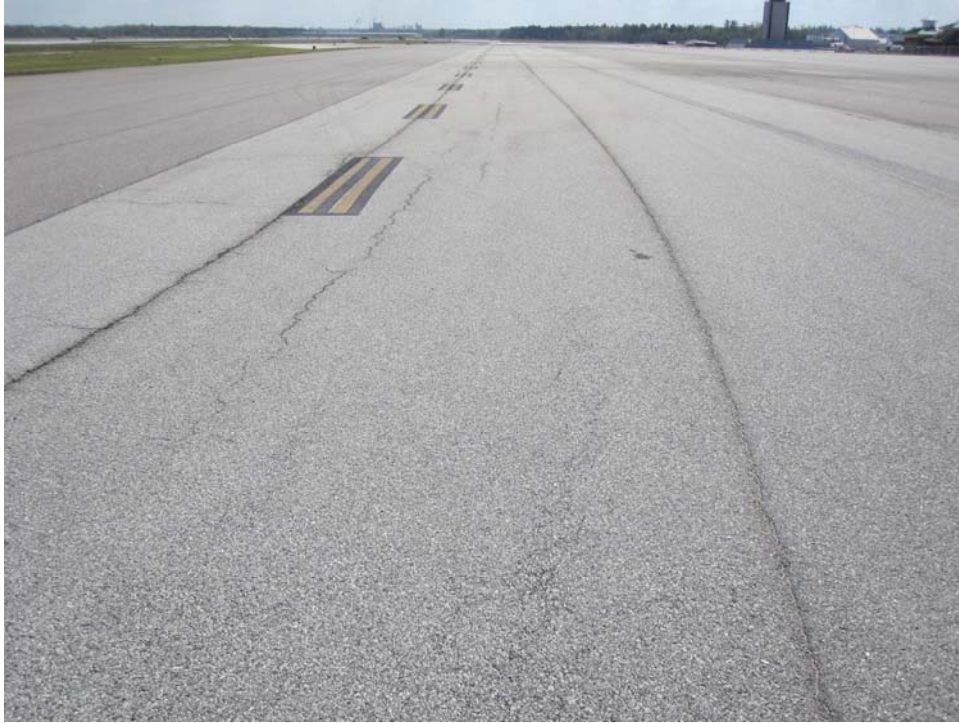
TCAGR-10. Overview.

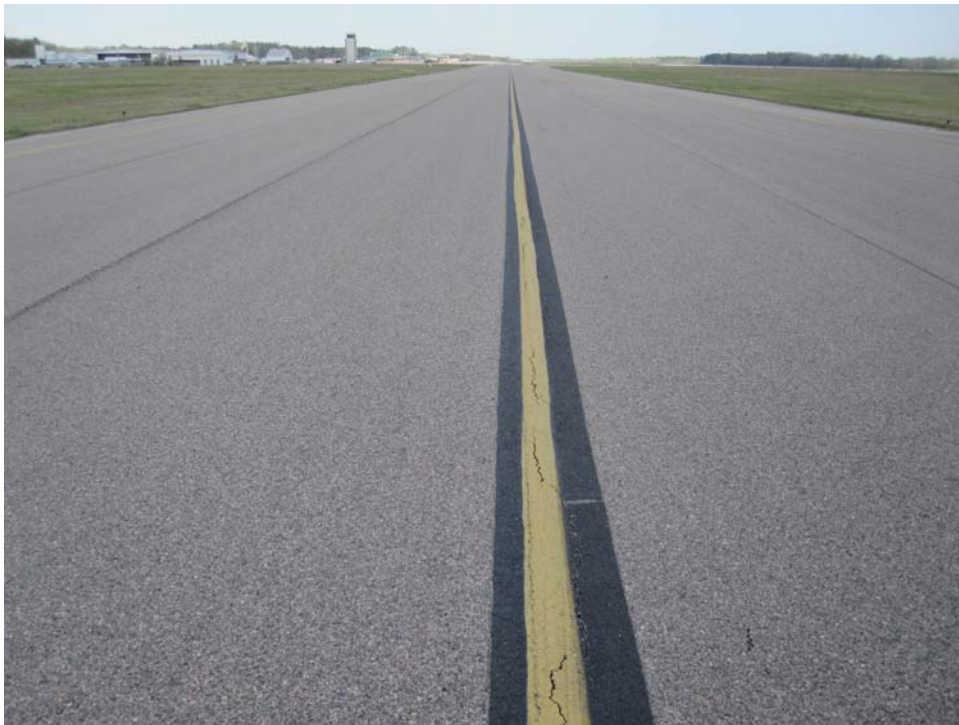
TCAGR-20. Overview.

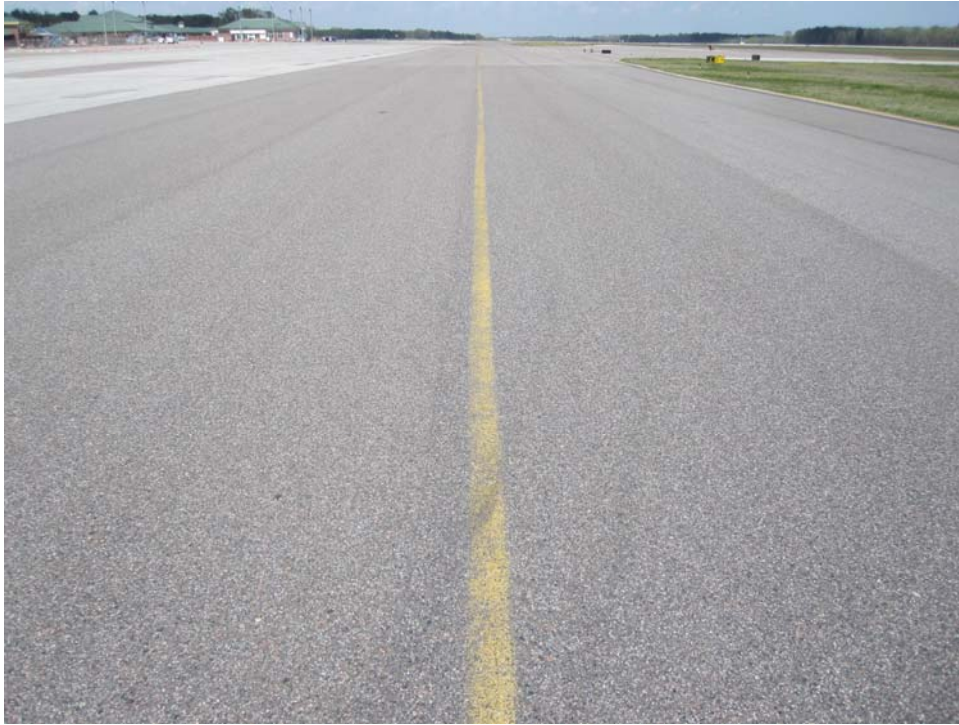
TCAGR-30. Overview.

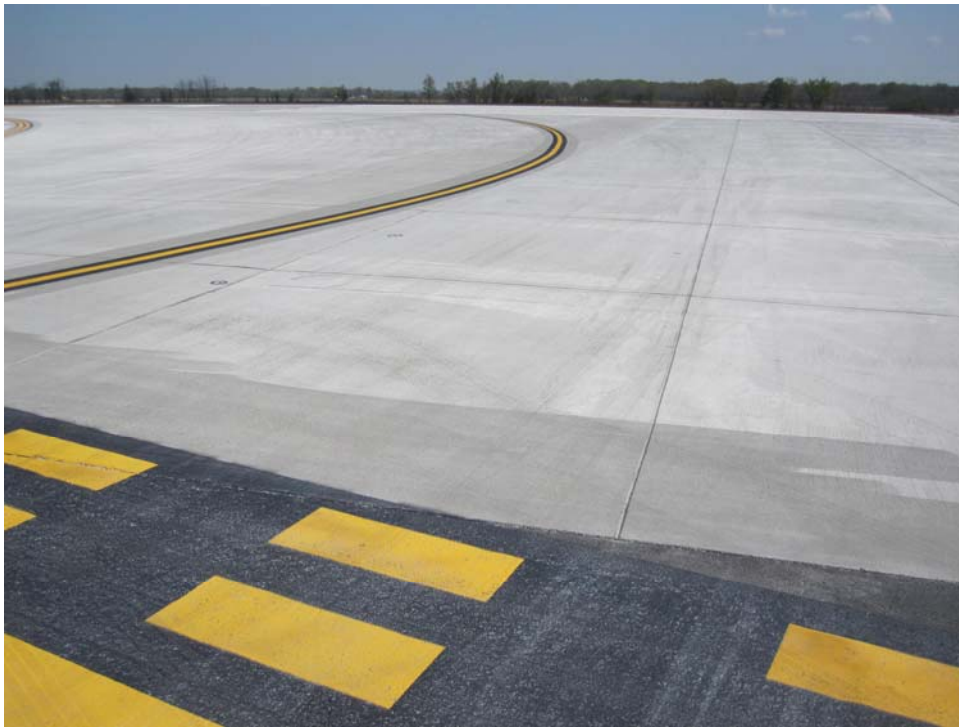
TCAGR-40. Overview.

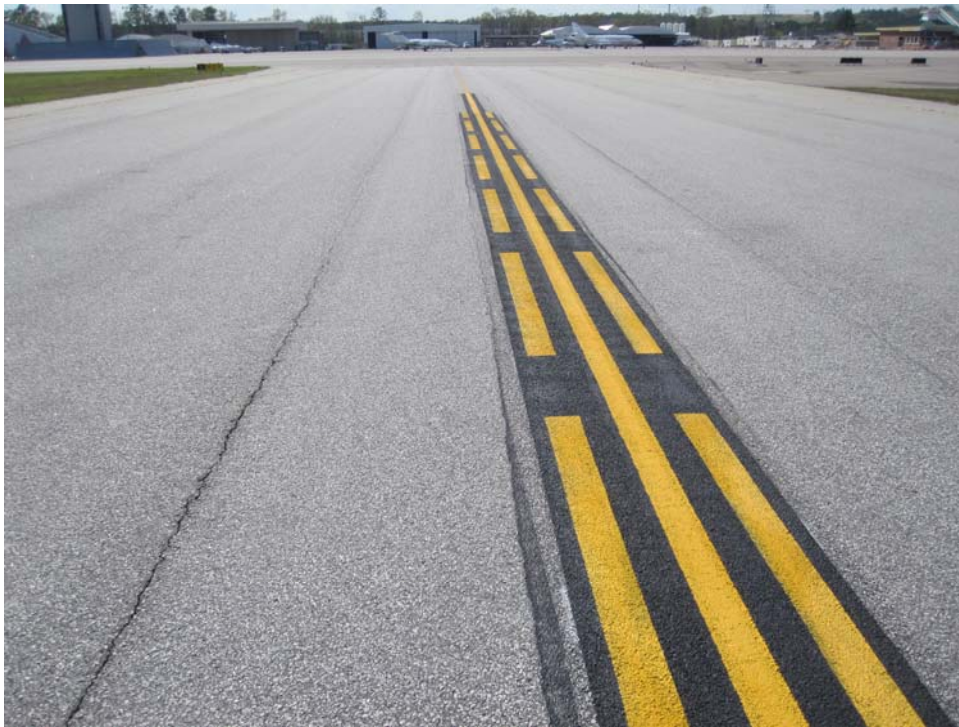
TDAGR-10. Overview.

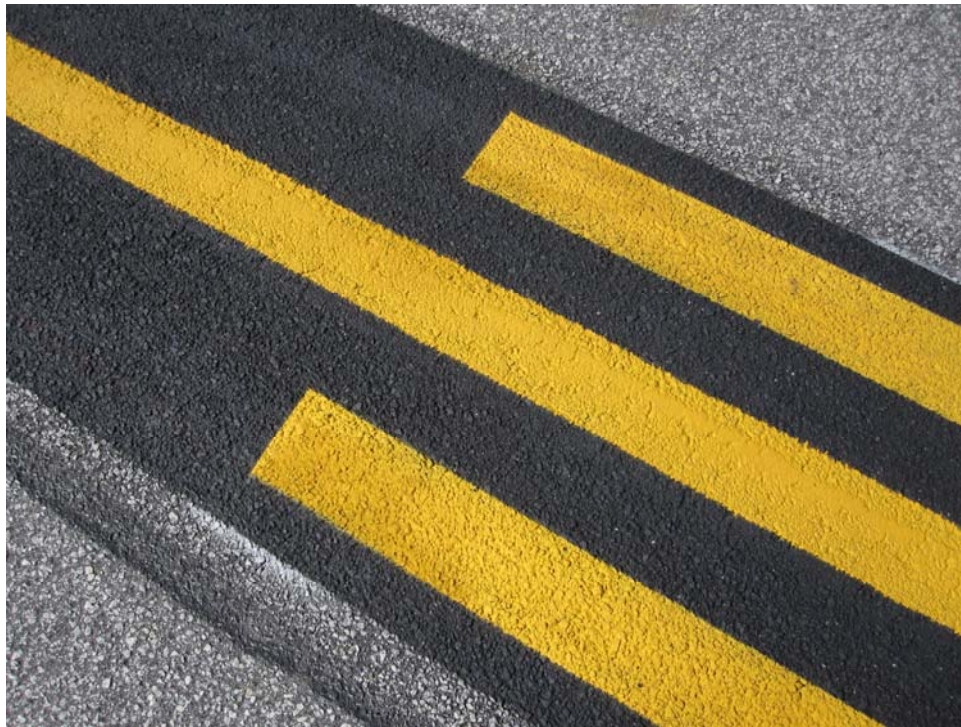
TDAGR-10. Satisfactory Paint.

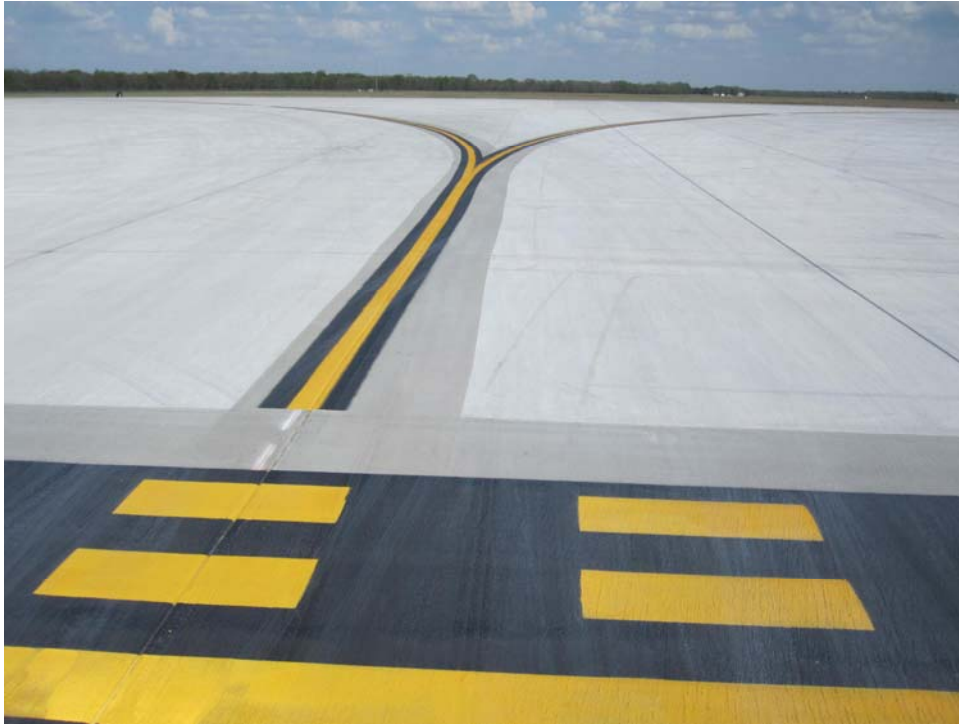
TDAGR-20. Overview.

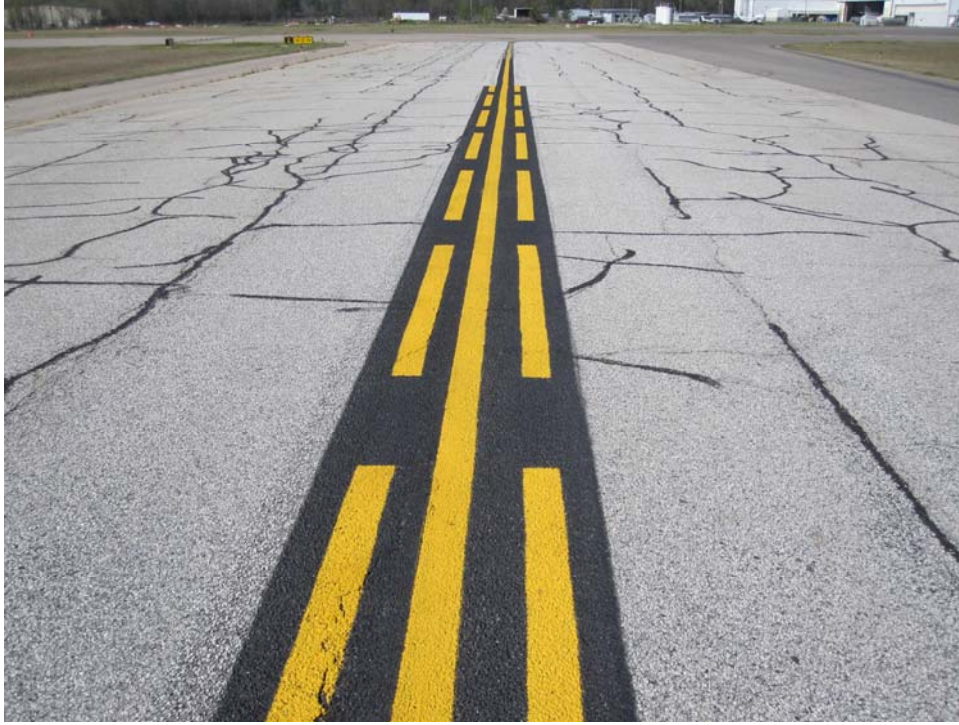
TEAGR-10. Overview.

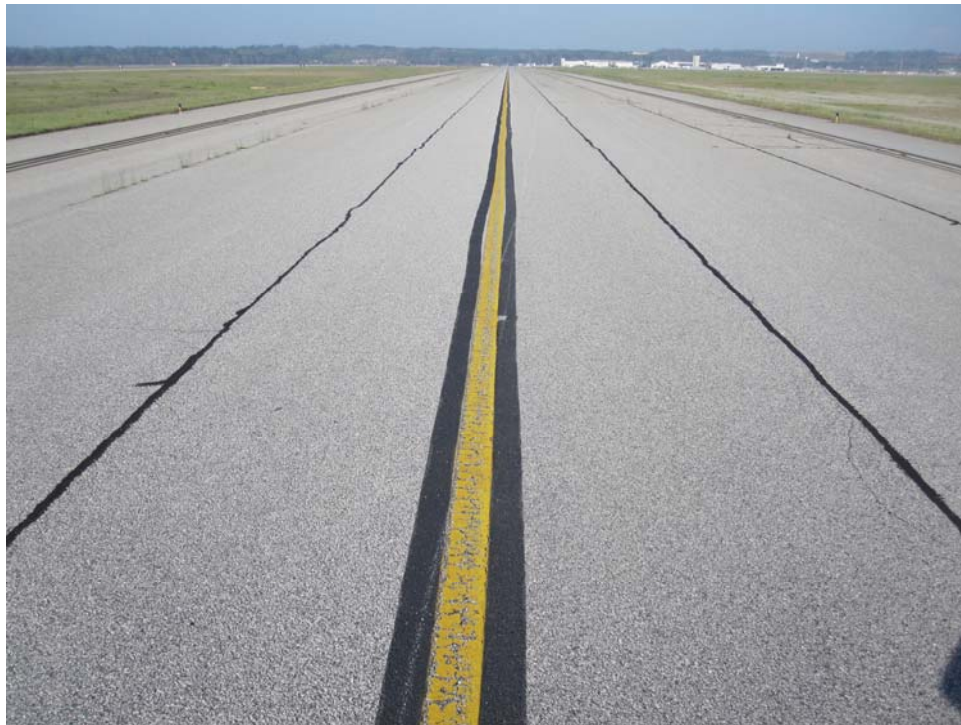
TEAGR-20. Overview.

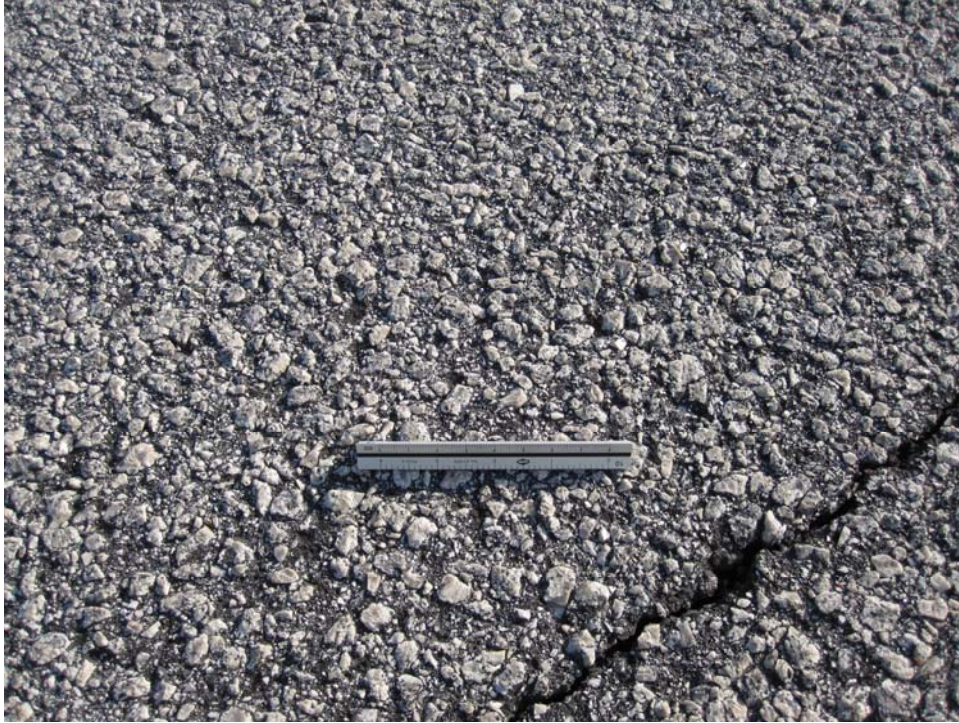
TEAGR-20. Weathering (Sample Unit #54).

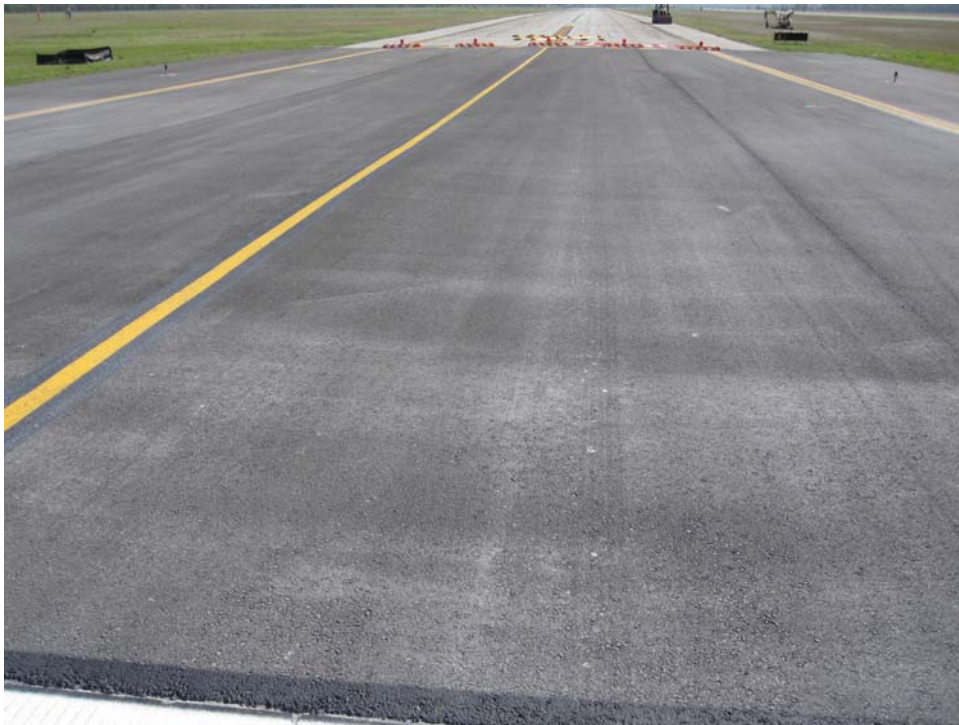
TEAGR-30. Overview.
