# 2012 Middle Georgia Regional Airport Pavement Management Plan

# MIDDLE GEORGIA REGIONAL AIRPORT

## PAVEMENT MANAGEMENT REPORT

**DECEMBER 2012**

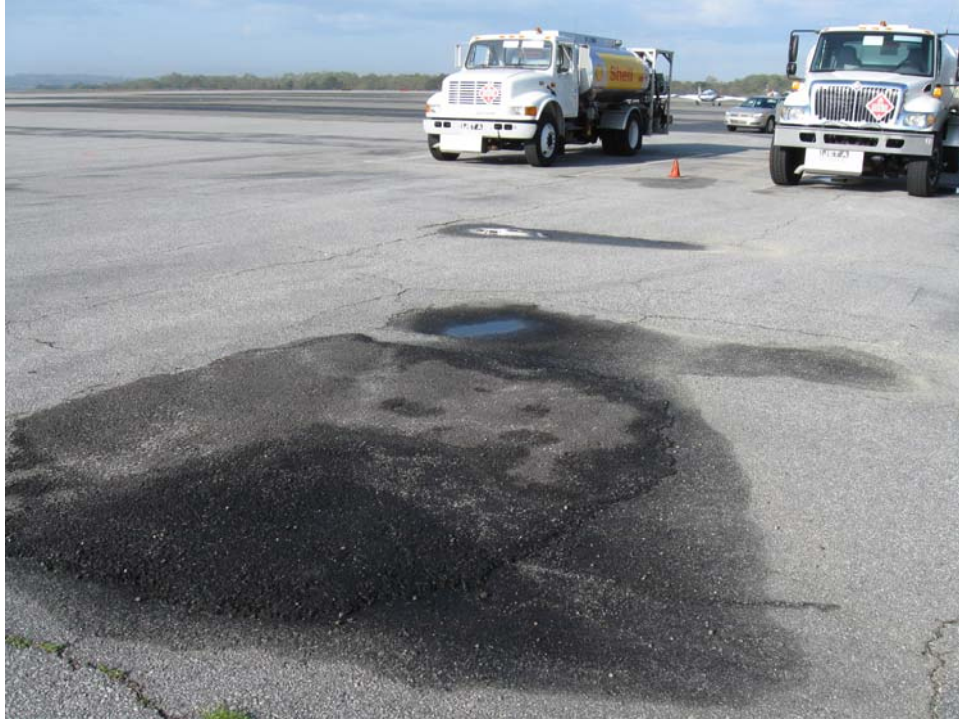
A01MGRA-50. Depression (Sample Unit #02).

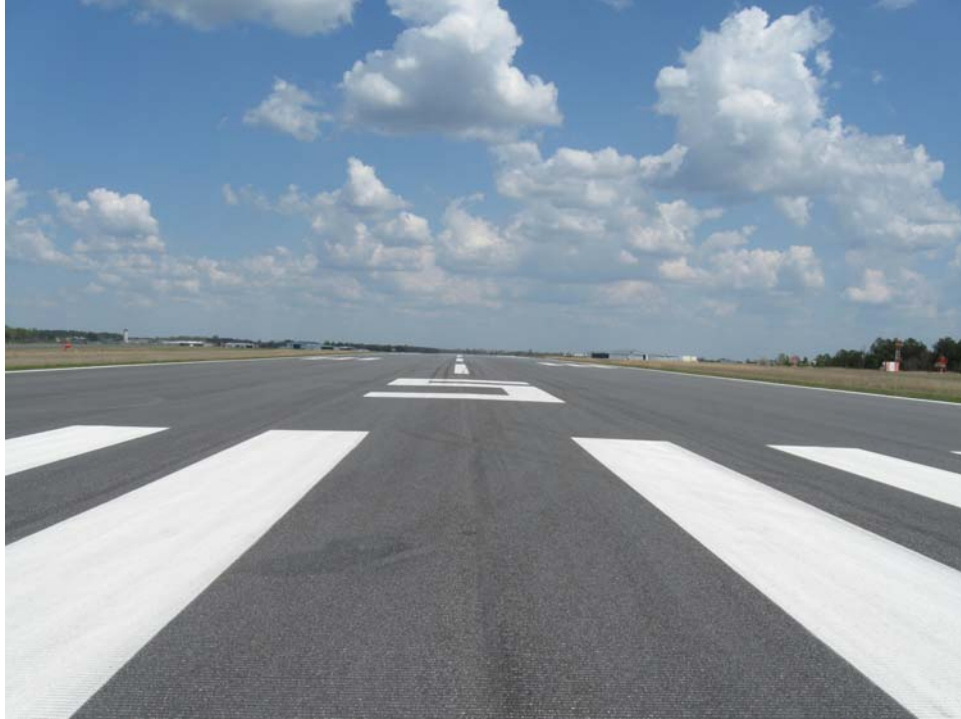
R523MGRA-10C. Overview.

Runway 5-23 consisted of three sections that were recently rehabilitated and in excellent condition with PCI values of 100. No distresses were observed in Sections 10C, 10N, and 10S at the time of inspection.

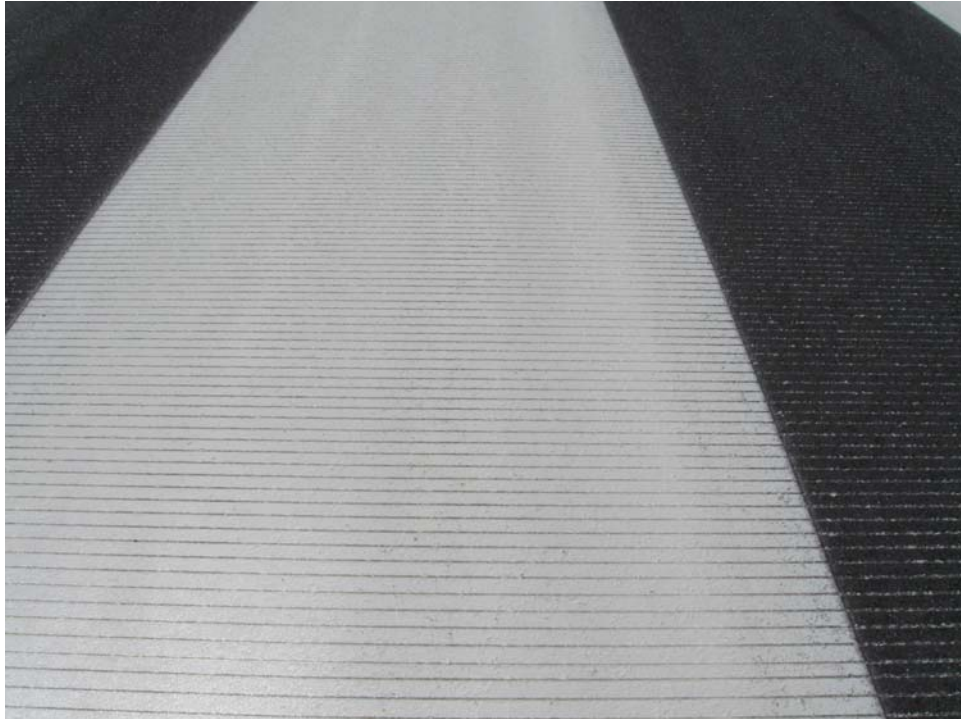
R523MGRA-10S. Satisfactory Paint.

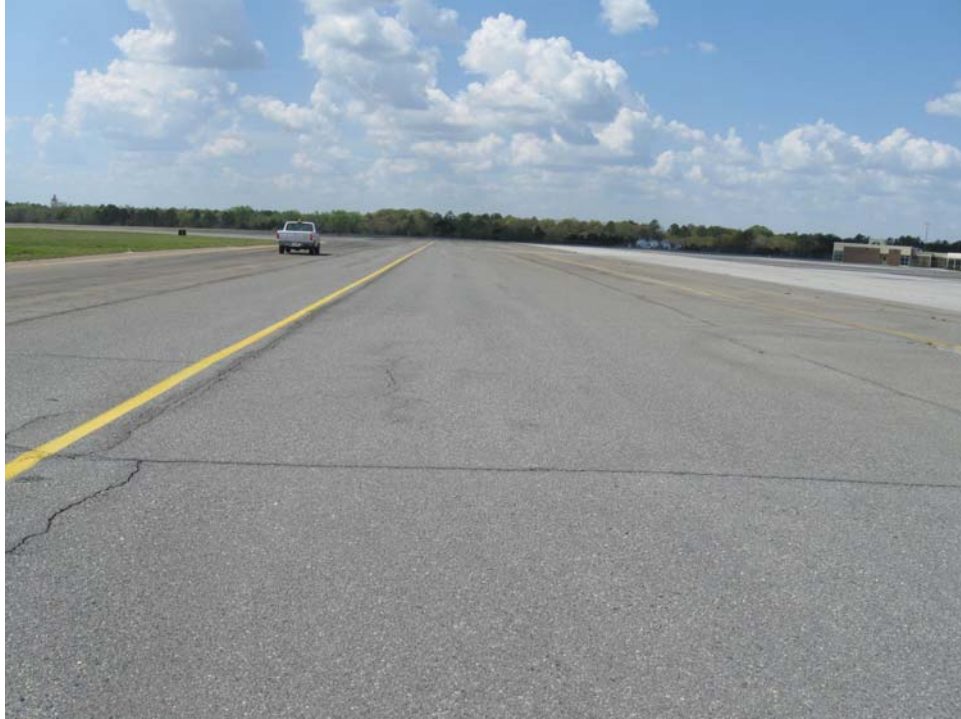
TAMGRA-10. Overview.

Taxiway A was comprised of one section with a PCI value of 45. Extensive amounts of low- and medium-severity L&T cracking, block cracking, and weathering were recorded throughout Section 10. Moderate quantities of low-severity swelling and a small amount of medium-severity depression were also observed.

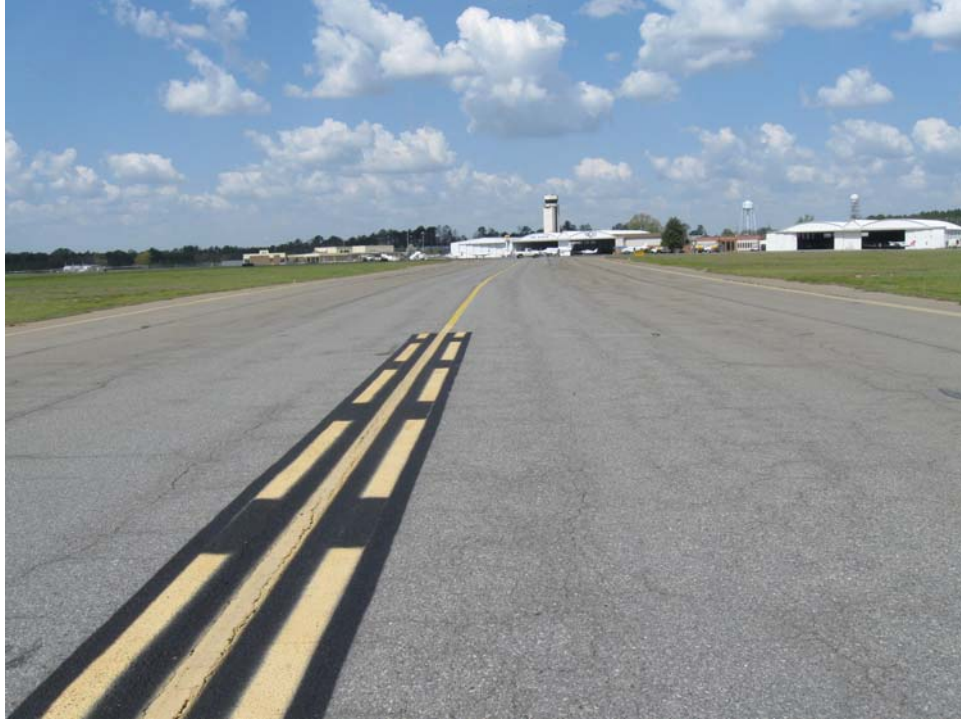
TCMGRA-10. Overview.

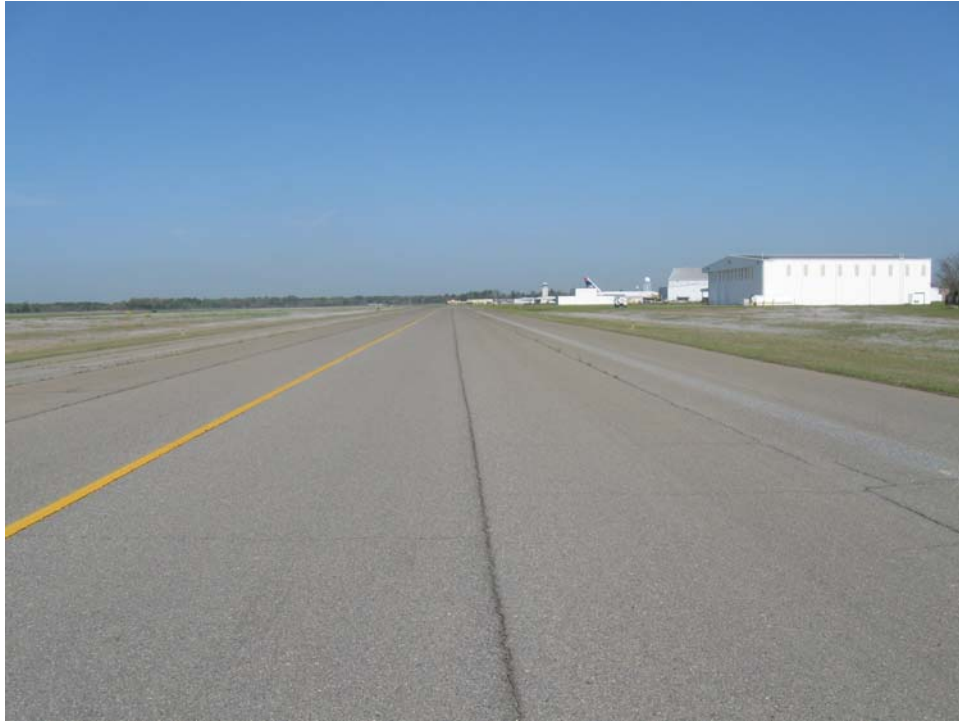
TCMGRA-20. Overview.

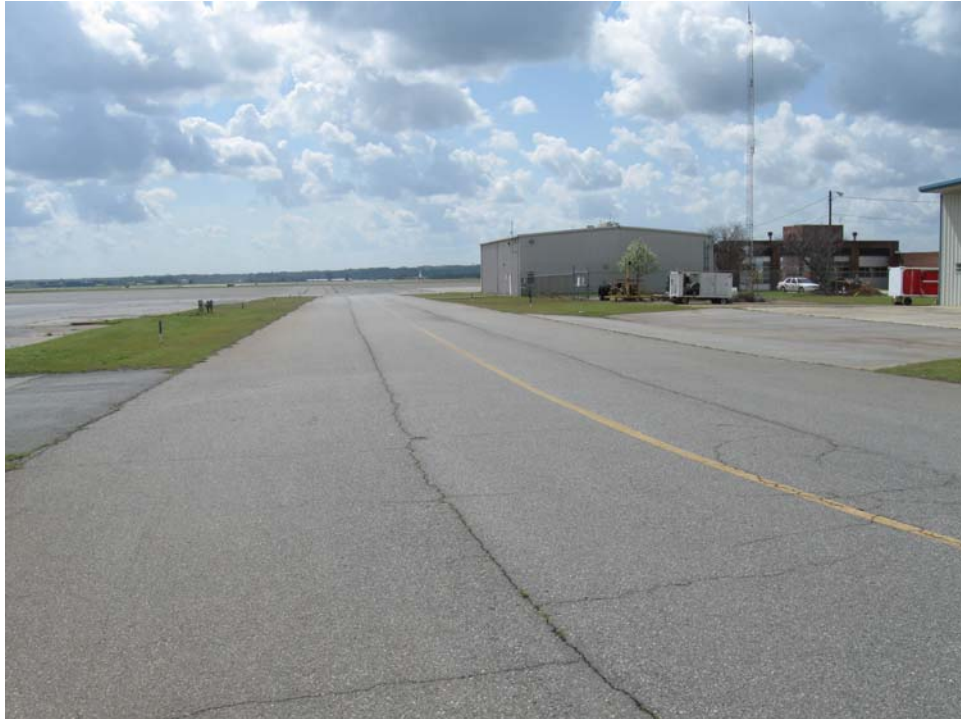
TGAMGRA-10. Overview.

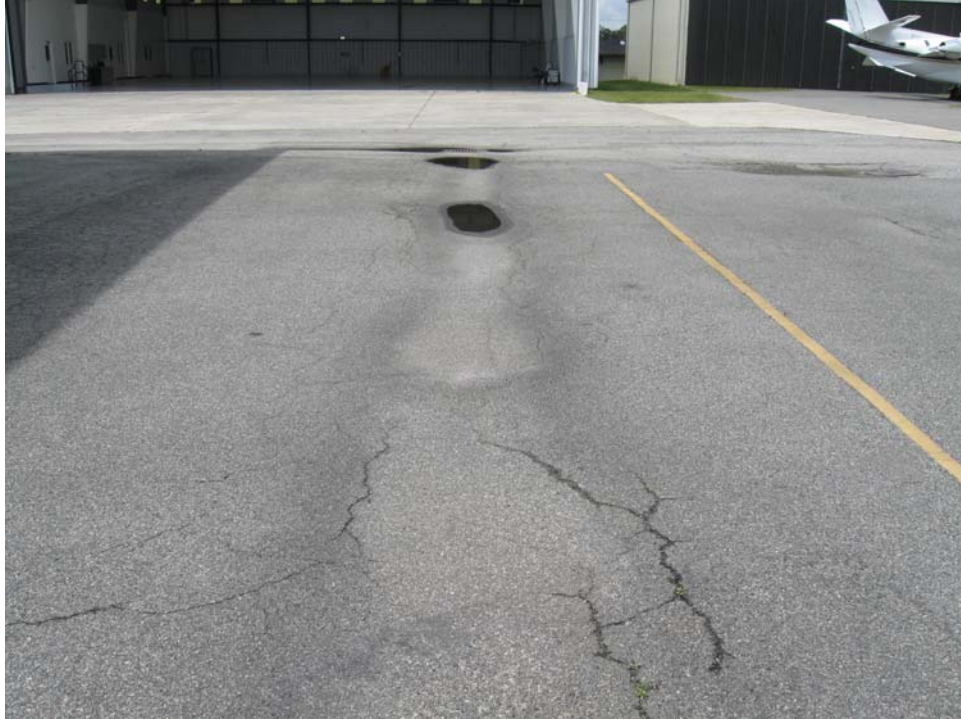
TGAMGRA-10. Depression (Sample Unit #07).
